**Phase I-II  
Geo-Environmental Site Assessment**

**A11463**

**Treetops Nursery**  
Allington Lane  
Fairoak  
Eastleigh  
SO50 7DD

**Omnia ref: A11463/1.0 Draft  
November 2020**

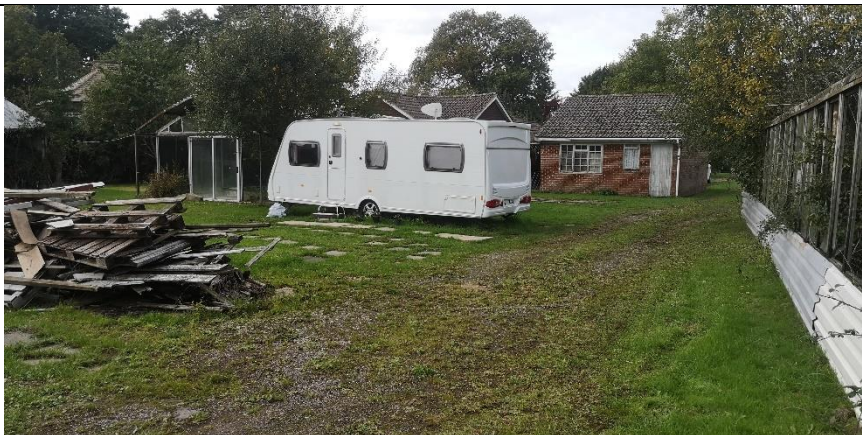
At the time of walkover, a boat, caravan and wood pile were noted towards the south east of the residential property. The ground was primarily grassed with patio slabs and a gravel track leading to the rear of the property.

*Photograph 2 Looking north west showing caravan and residential property beyond and a unkept access road to the right of the photo*

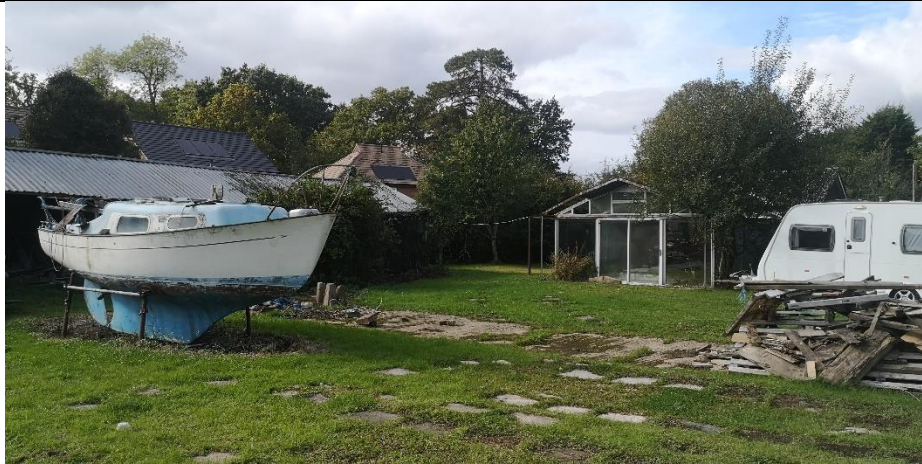
however at the time of walkover the barn was used for storage including, hay, wood, plastic and metal pipework and small machinery equipment. Approximately five (5no.) 20-25 litre plastic containers were noted within the barn beneath a wooden pile and appeared to have contained fuel or oil. In addition, three (3no.) approximately 200 litre steel drums were noted to the north east of the barn within a dense vegetation, the drums were in a poor visual state of repair. No visual or olfactory signs of gross contamination were noted within the vicinity of plastic containers and steel fuel drums at the time of the site walkover.

*Photograph 3 Showing disused boat, outhouse and barn to the west of the site area.*

During the site walkover the open barn in the north west of the site contained waste in the form of hay, wood, plastic, metal and disused machinery equipment. In addition, a wood pile was noted to the south of the residential property.

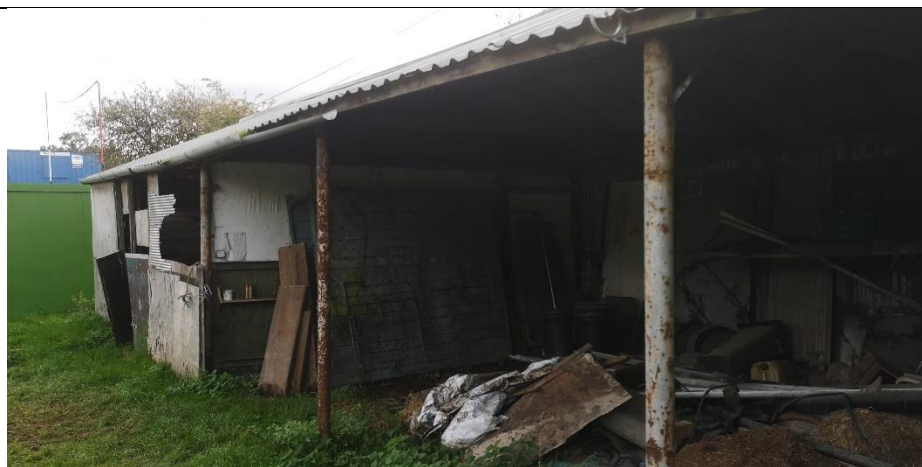
Towards the north west of the residential property was a large wooden barn and adjoining metal framed greenhouse, both were in a poor visual state of repair and were inaccessible at the time of the site walkover.

*Photograph 4 Showing disused barn and stable to the west of the site area.*

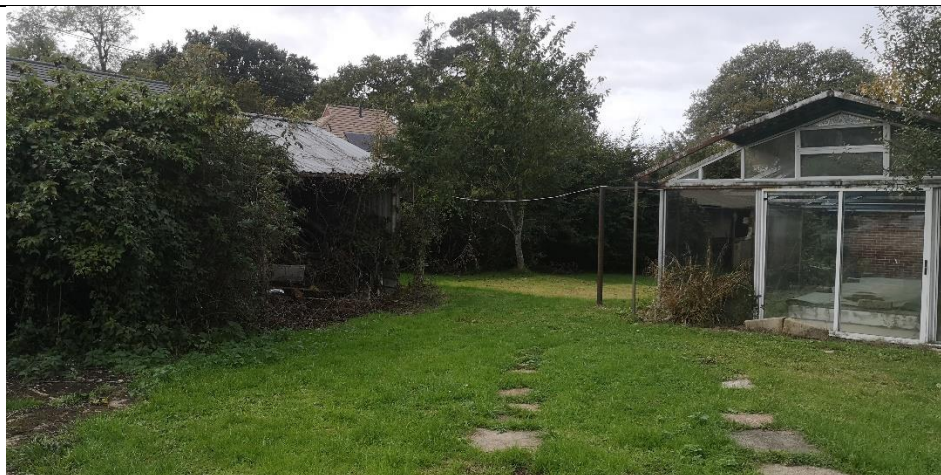
Adjacent to the north east boundary of the site was a large single storey metal structure which is understood to have been a greenhouse associated with the former nursery. At the time of the walkover the majority of the glass panels were noted to have been removed or smashed and the building was overgrown. Access into the greenhouse was note possible due to safety concerns, however, there were no obvious signs of chemical/fuel storage.

*Photograph 5 Showing disused green houses*

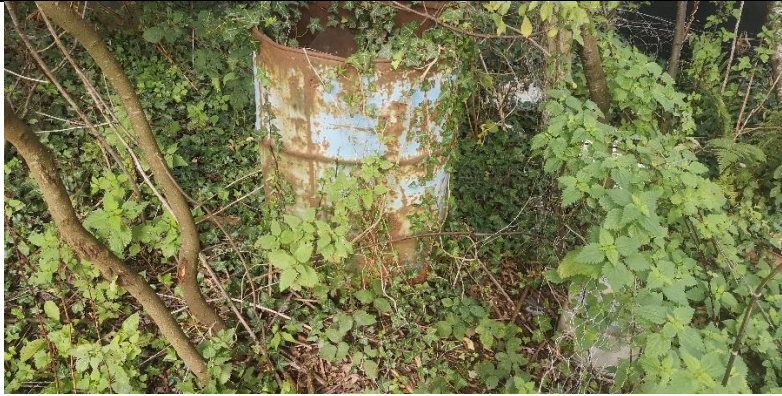
Within an area of dense vegetation to the north east of the site was one (1no.) 200 litre steel drum in a poor state of repair with no visual or olfactory signs of contamination.

As set out in the site description above, four (4no.) approximately 200 litre steel drums in a poor condition. In addition, approximately five (5no.) 20-25 litre plastic containers were noted beneath stored material within the barn. There were no visual or olfactory signs of contamination around the containers.

*Photograph 6 Showing disused steel oil drum.*

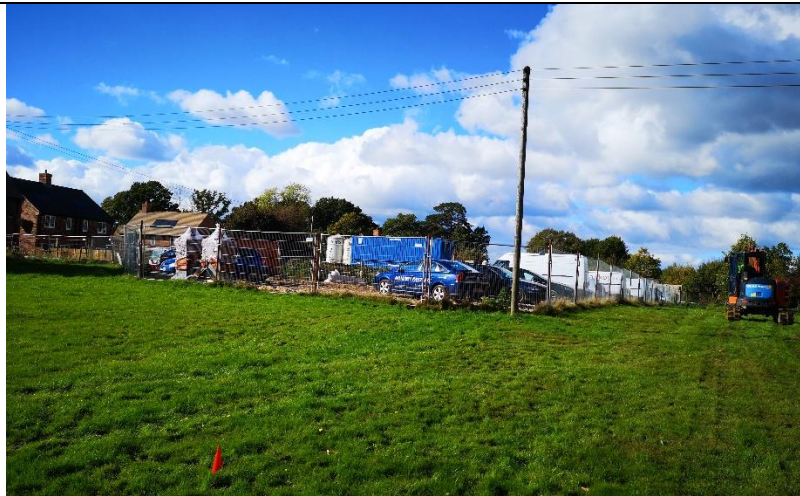
*Photograph 7 Showing a section of the site used as a compound area for the adjacent site.*

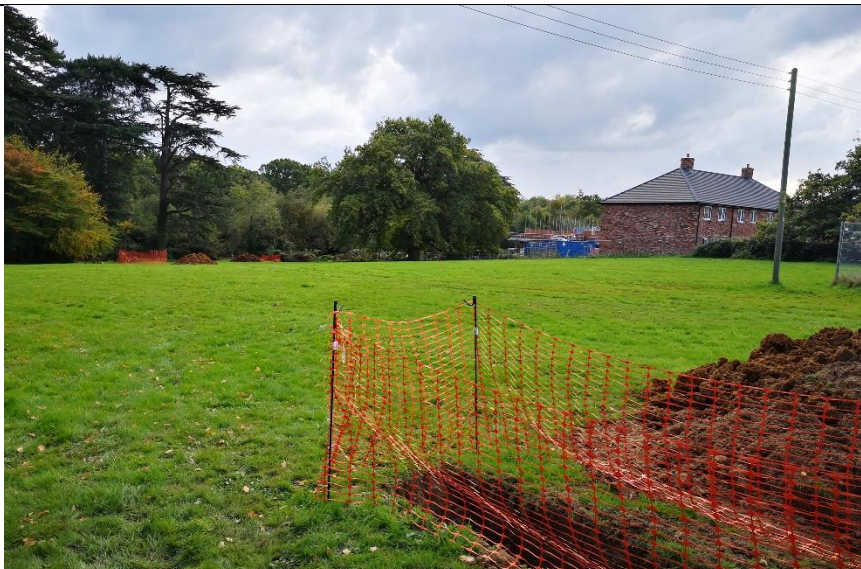
*Photograph 8 Showing trial pitting in the south of the site area.*
