Phase 1 & 2 Bat Surveys:

**5 Lennox Close,**

Survey and report by: Vesper Conservation & Ecology Limited

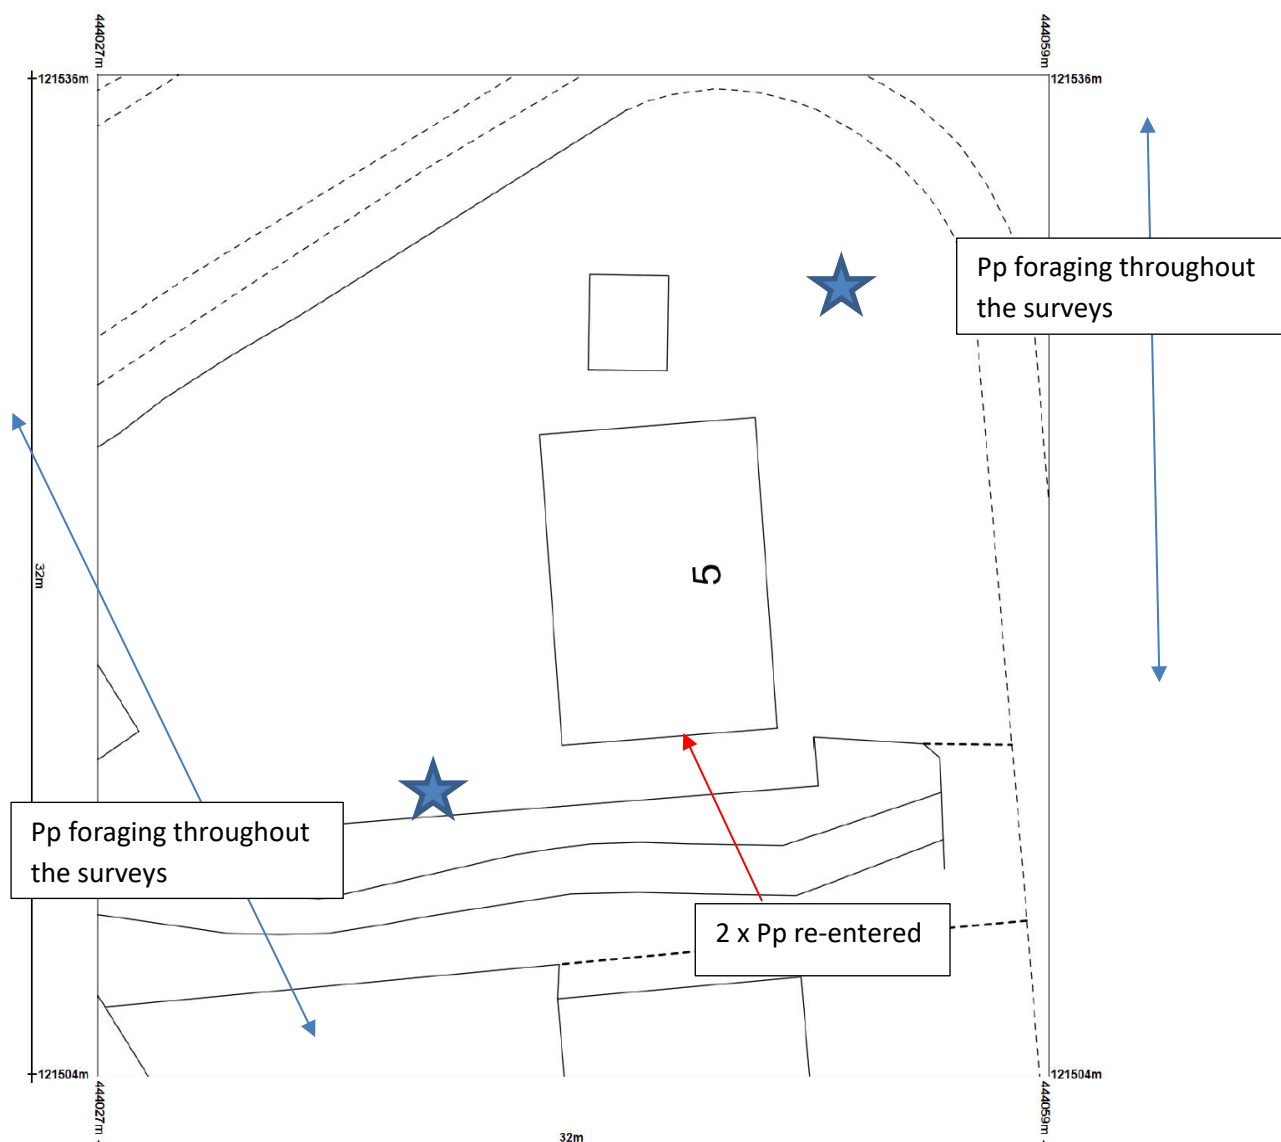
**Figure 1:** Dawn survey result 14/07/2022

3.4 During the bat activity survey (14/07/22) 2 species were recorded (Common Pipistrelle bats). **2 X Common Pipistrelle** bat were seen re-entering into the building into the hanging tiles above the window on the northern elevation. Foraging in and around the gardens was frequent throughout the survey (See figure 1) (Rob West and Pete Allen).

3.5 During the activity surveys bats were seen emerging/re-entering from the building. The grounds around the house had plenty of activity on all three of the surveys.

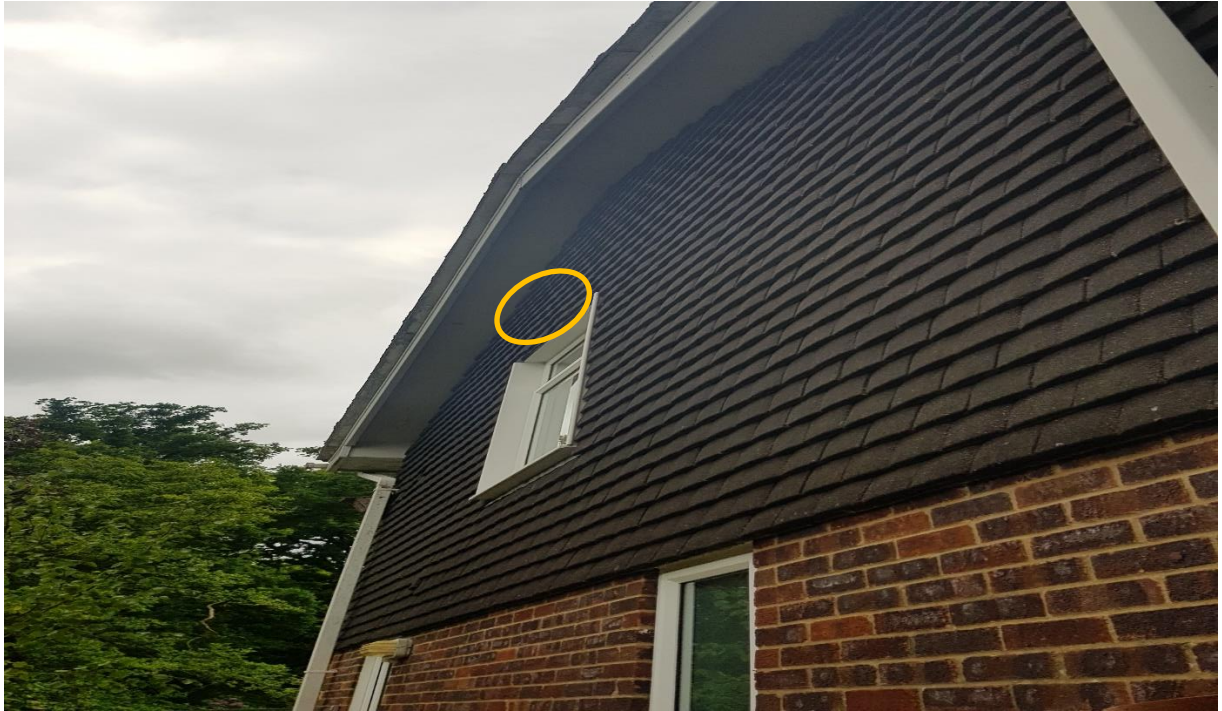
**Figure 2: Showing the area the bats re-entered on the southern elevation**

- 4.4 The activity surveys showed that 1 species of bat are using the building as a roost, the roost is above the window on the southern elevation, and this building **is a confirmed bat roost**.

- 4.5 The proposed works on the northern elevation of this building will not affect the bats roosting area, the hanging tiles will not be changed on any other part of the building apart from the northern elevation.

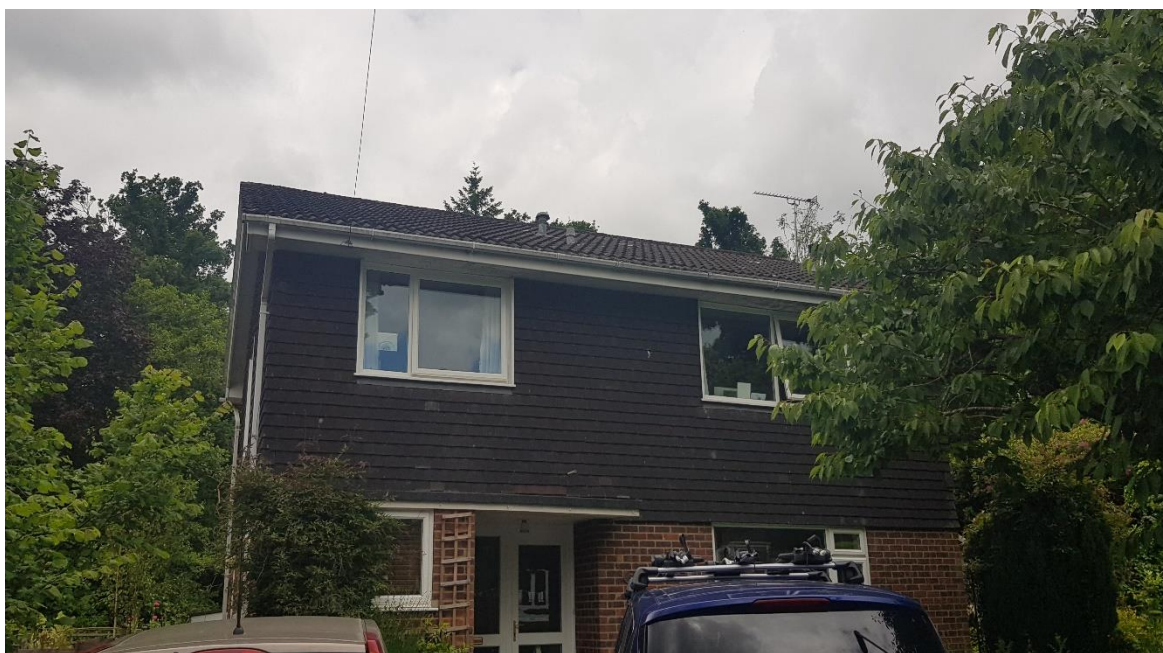
**Picture 1:** Showing the eastern (front)elevation

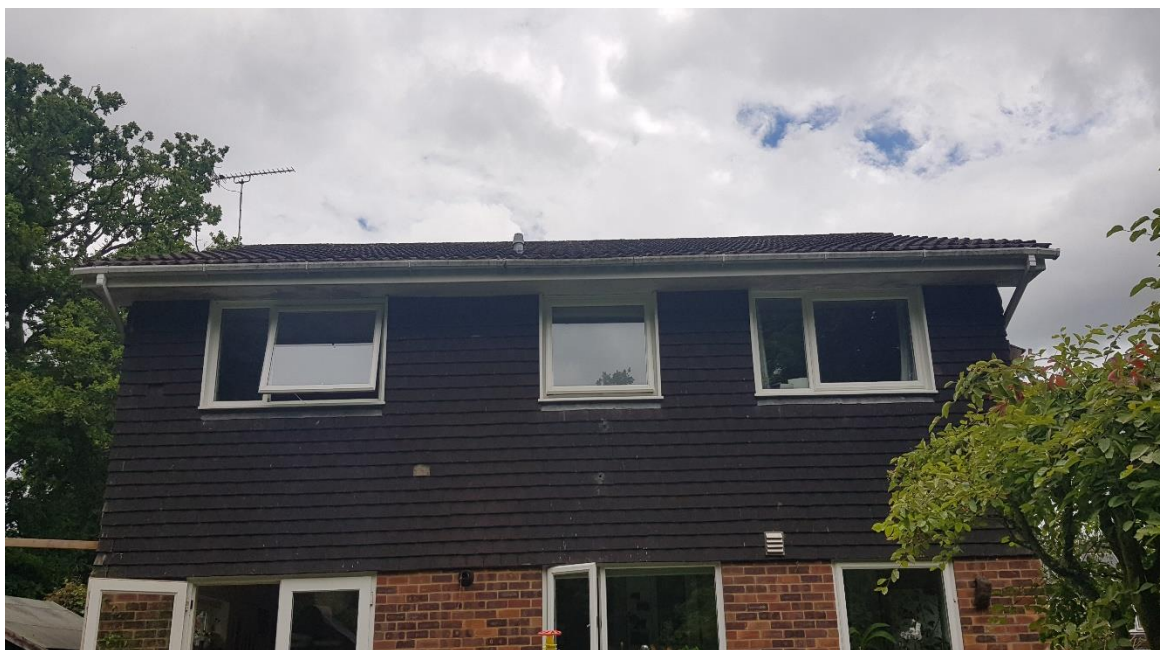
**Picture 2:** Showing the western (rear) elevation.

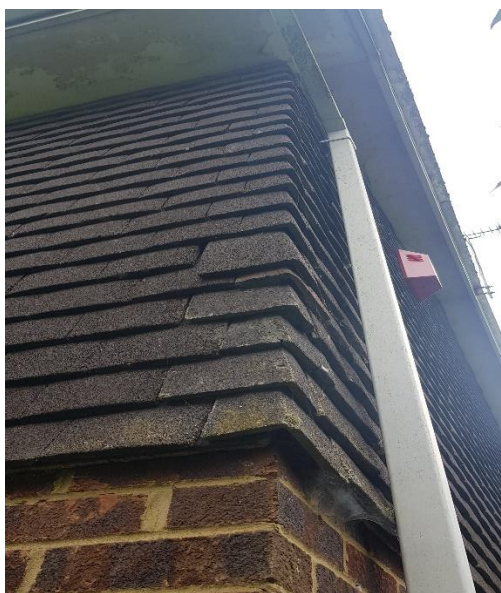
- 
- 2.9 All elevations have small tight fitting hanging tiles, there are a couple of gaps at the corners especially on the north-western end, otherwise the tiles are close fitting with no obvious big gaps that would allow bat access.
  - 2.10 The external inspection showed that this building has a low potential for bats to be roosting within its structure.

**Picture 3:** Showing the gaps on the hanging tiles on the north western end of the house

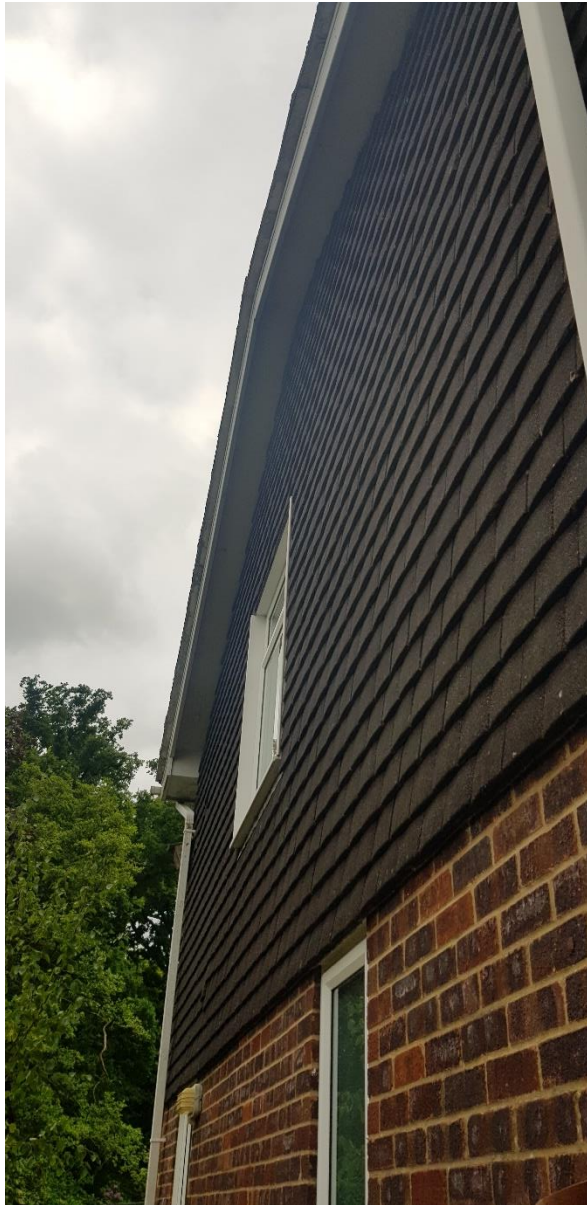
**Picture 4:** Showing the hanging tiles on the southern elevation

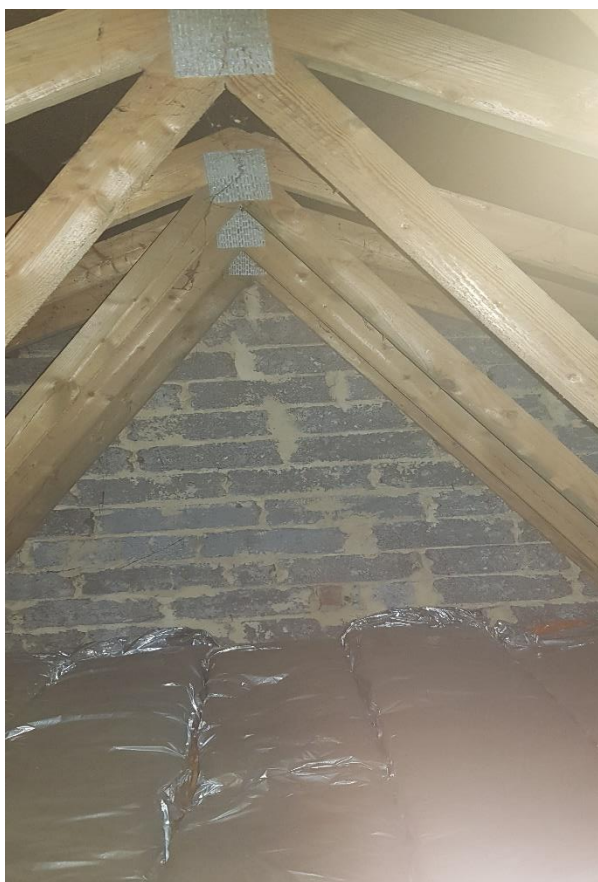
- 2.11 This property has a roof space that covers the whole of the house; access was easy throughout. The floor was boarded almost throughout the roof space.
- 2.12 The roof is constructed with a truss frame and is about 2 m to the ridge, all though there is no physical ridge beam.
- 2.13 The tiles of the house are backed with bitumen felt, this is in good condition
- 2.14 The floor of the roof was covered with a thick layer of glass fibre insulation throughout. No light was seen coming in through the eaves.
- 2.15 No physical signs of bats were seen during this survey, the roof was also very clear of any obvious rodent activity, there were no signs of birds nesting with the roof either.
- 2.16 The internal inspection of this property showed that this building has a **low potential** for bats to be roosting within.

**Picture 5:** Showing the internal roof space
