## Phase I Desk Study

Barton Peveril Sixth Form College, Chestnut Avenue, Eastleigh SO50 5ZA

On behalf of Barton Peveril Sixth Form College c/o Bidwells

| Report Reference: GWPR5268/DS/April 2023 | | | Status: Final |

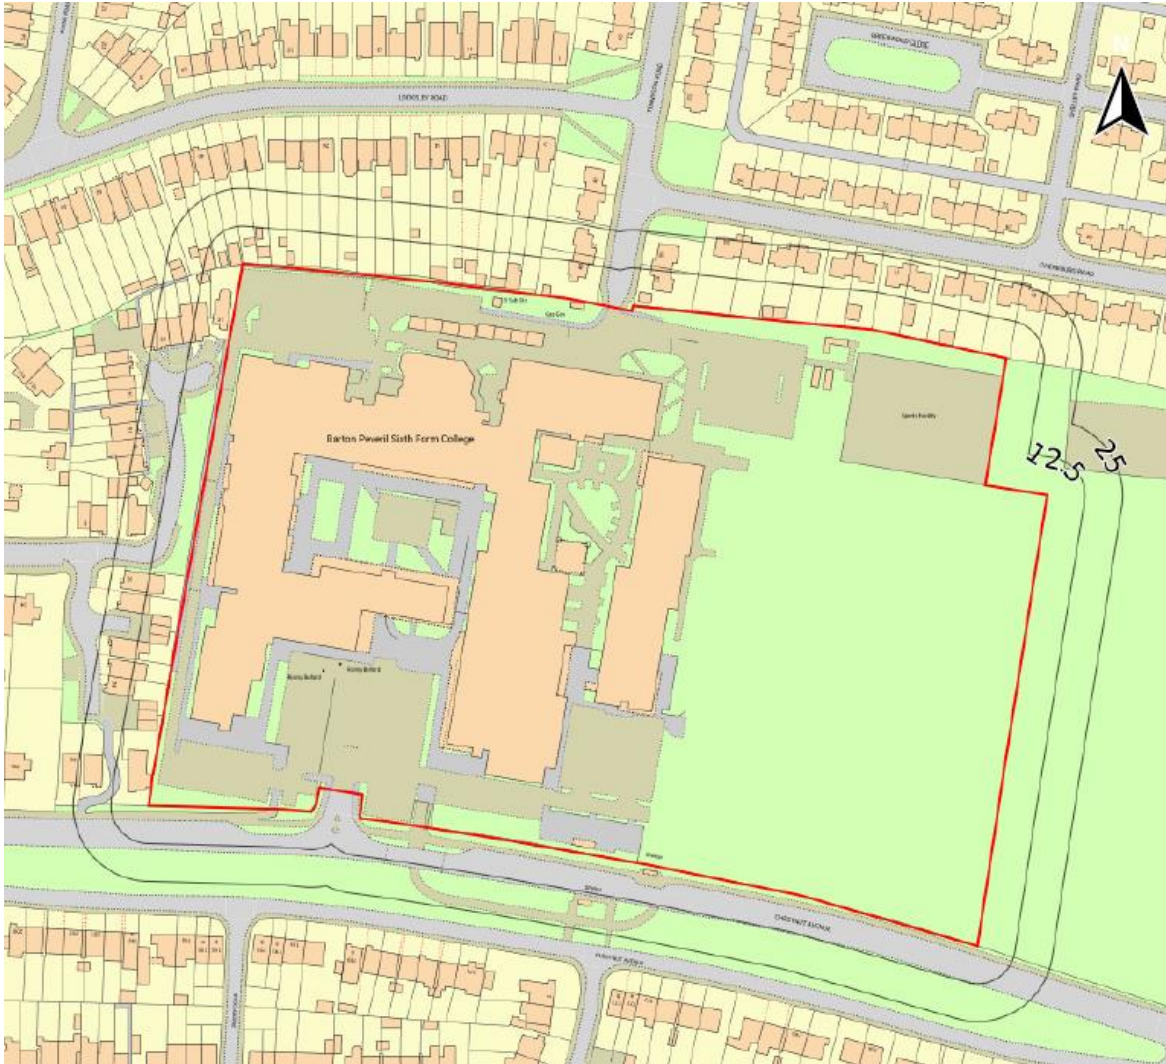
**Figure 2 – Site Development Area**

◇ Site Boundary

The national grid reference for the centre of the site was approximately SU 44653 18273. A site location plan is given within Figure 1. A site development area plan is shown in figure 2 and an aerial photograph of the site shown in figure 3.
