## Phase II Site Investigation Report

Barton Peveril Sixth Form College, Chestnut Avenue, Eastleigh SO50 5ZA

On behalf of Barton Peveril Sixth Form College c/o Bidwells

| Report Reference: GWPR5268/GIR/April 2023 | | | Status: Final |

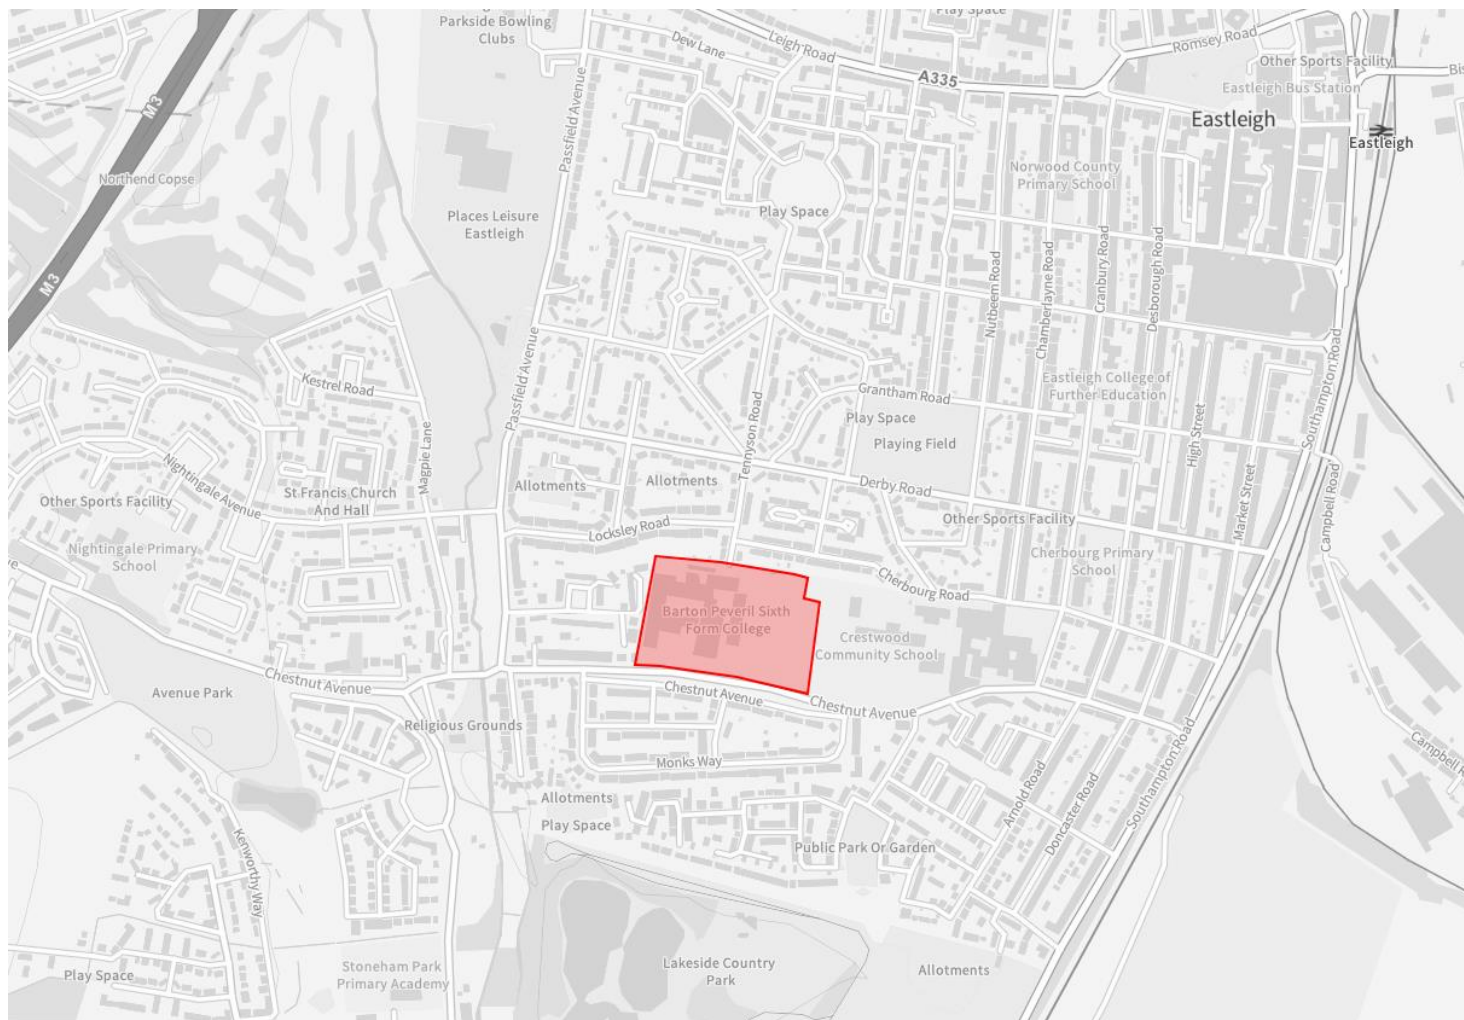
**Figure 1 – Site Location Plan**

The national grid reference for the centre of the site was approximately SU 44653 18273. A site location plan is given within Figure 1. A site development area plan is shown in figure 2 and an aerial photograph of the site shown in figure 3.
