## Drainage Strategy and Flood Risk Statement

### Land at Home Farm, St John's Road Hedge End, Hants

**Reference:** 22066

1 17/4/2023

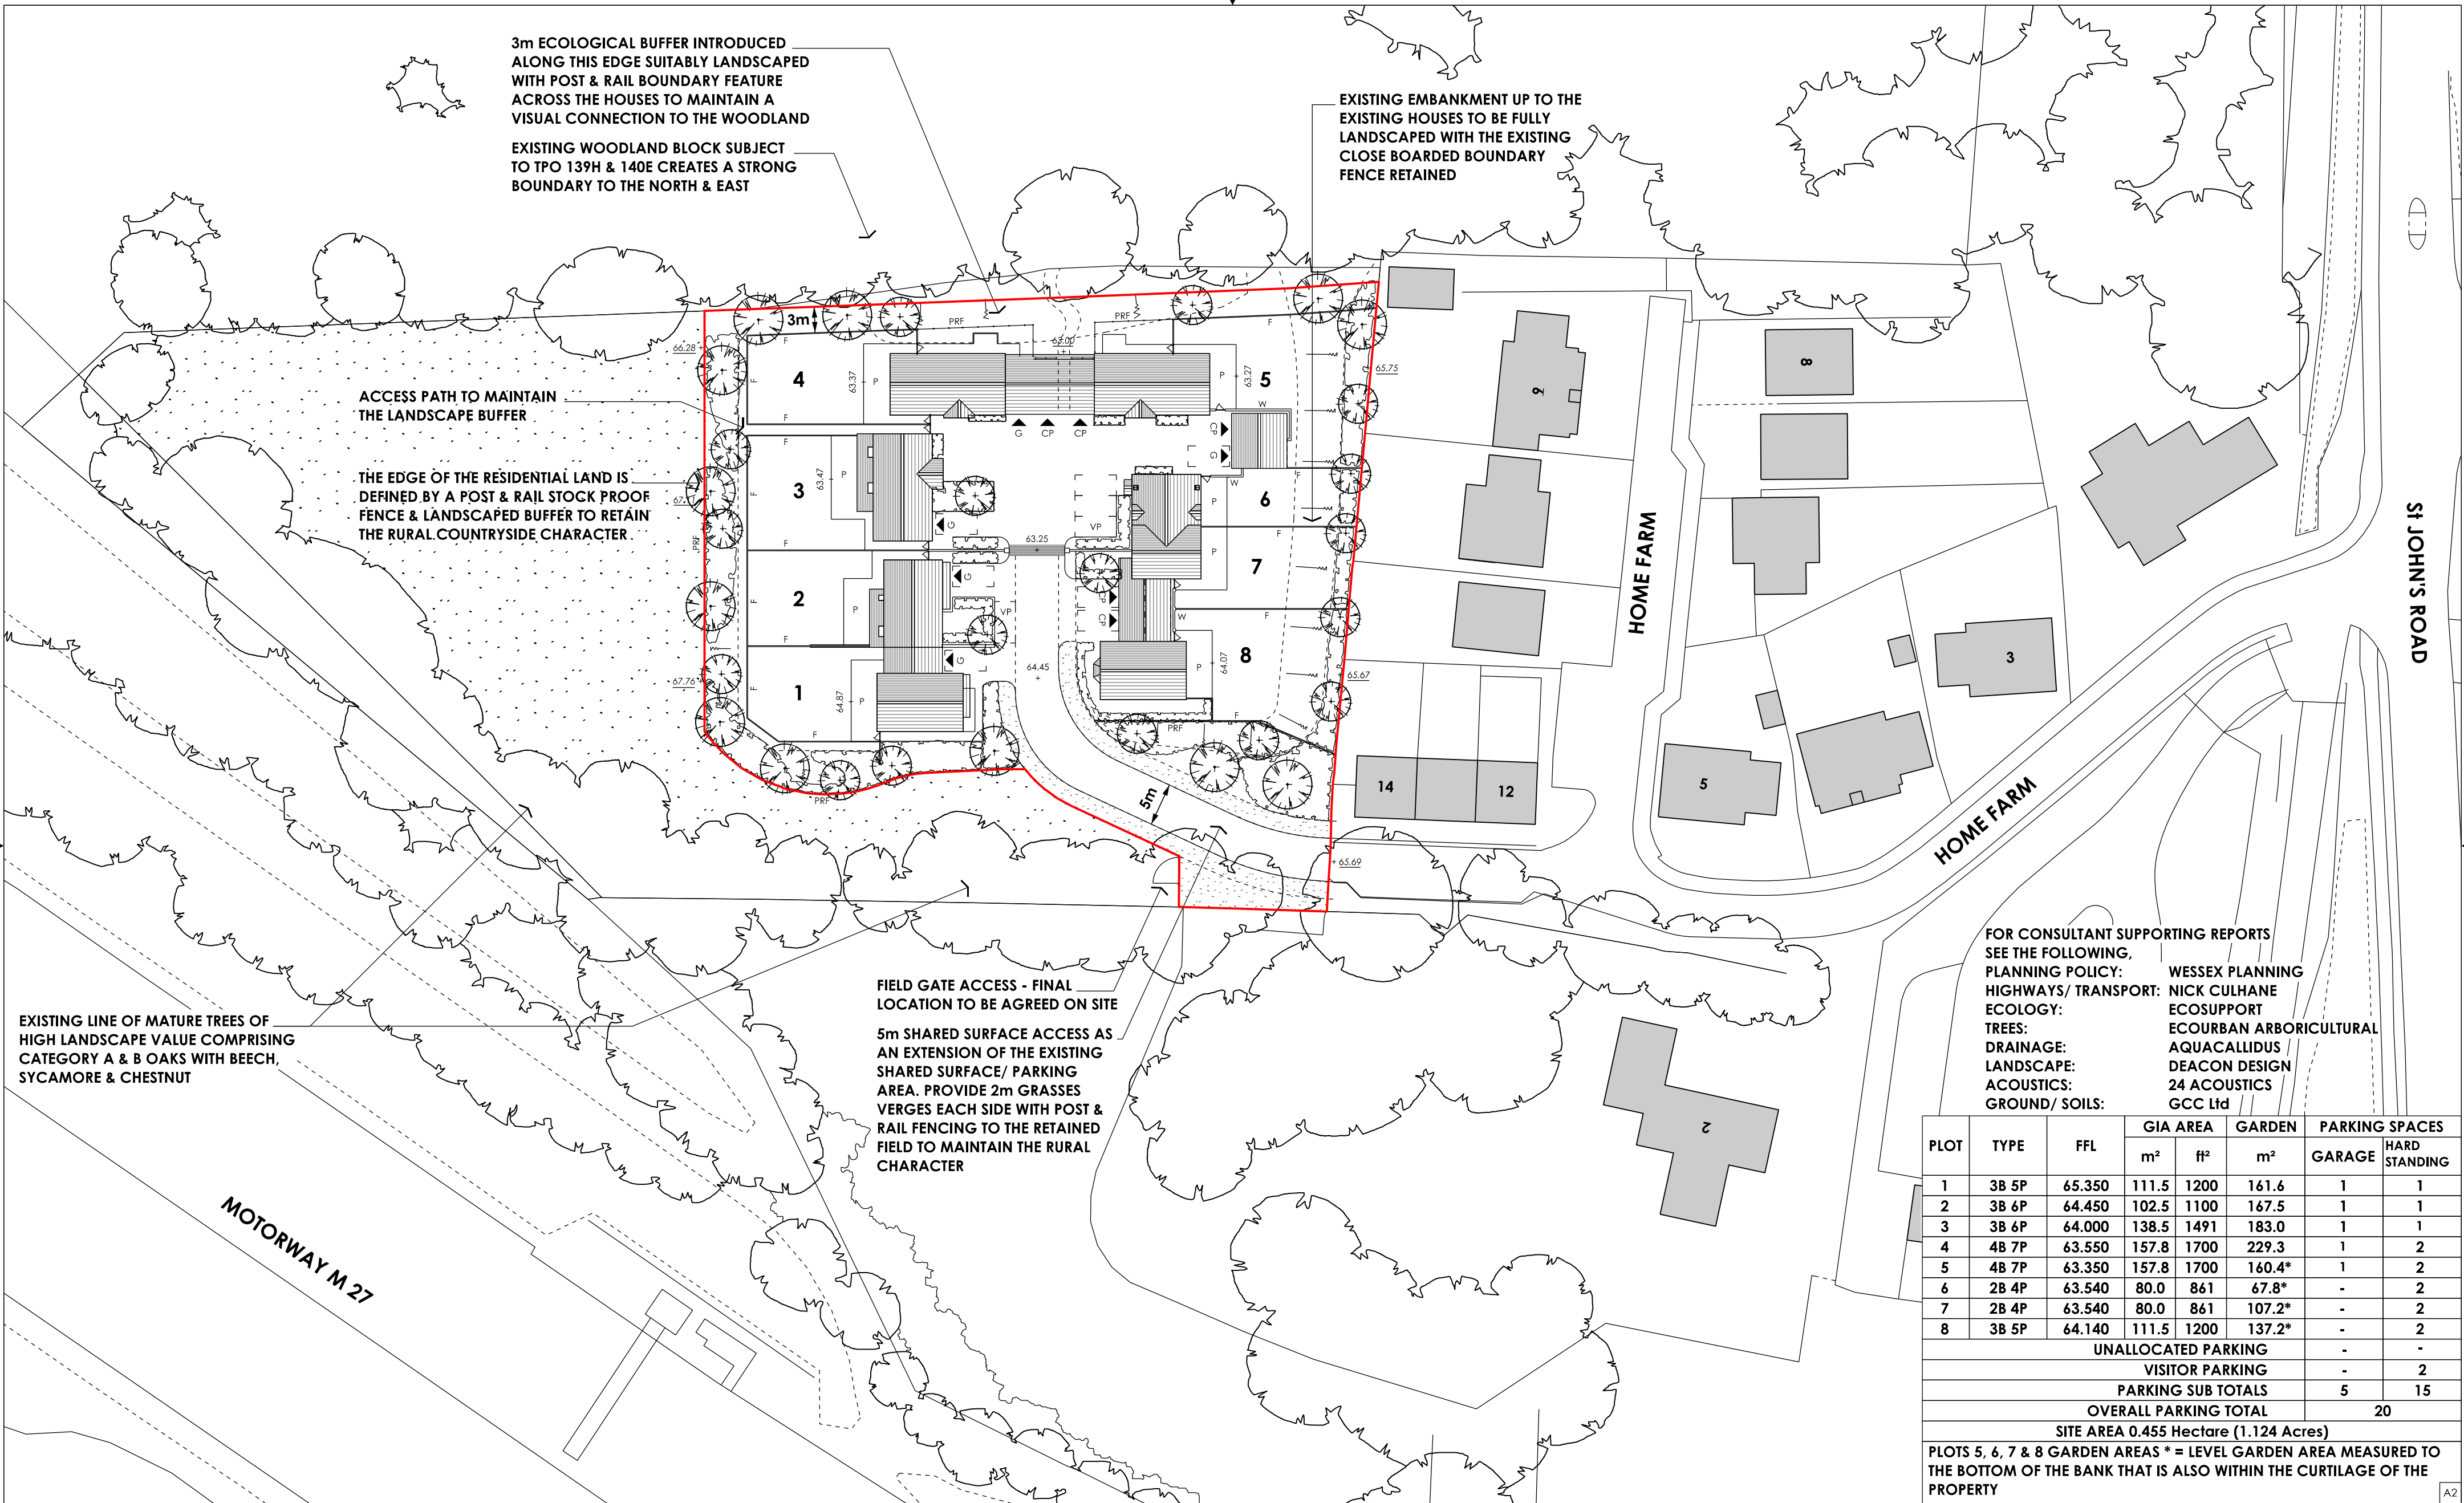
DRAWING NO: PP1433/ 101

- 2.1 The site comprises 0.455 Ha of grass paddock at the Home Farm, St John's Road, Hedge End, Hants (grid ref 448275 112100). The site extents are indicated on the annotated aerial photograph in Appendix A. The existing topography is shown on Encompass Surveys drawing ENC-290922-2458-S1 sheets 1 and 2 contained in Appendix A of this report.
- 2.2 It is proposed develop the site for 8 served by access off of Home Farm estate to the south. The proposed layout is identified on Pope Priestley Architects drawing number PP1433-101-P1 contained in Appendix A of this report.

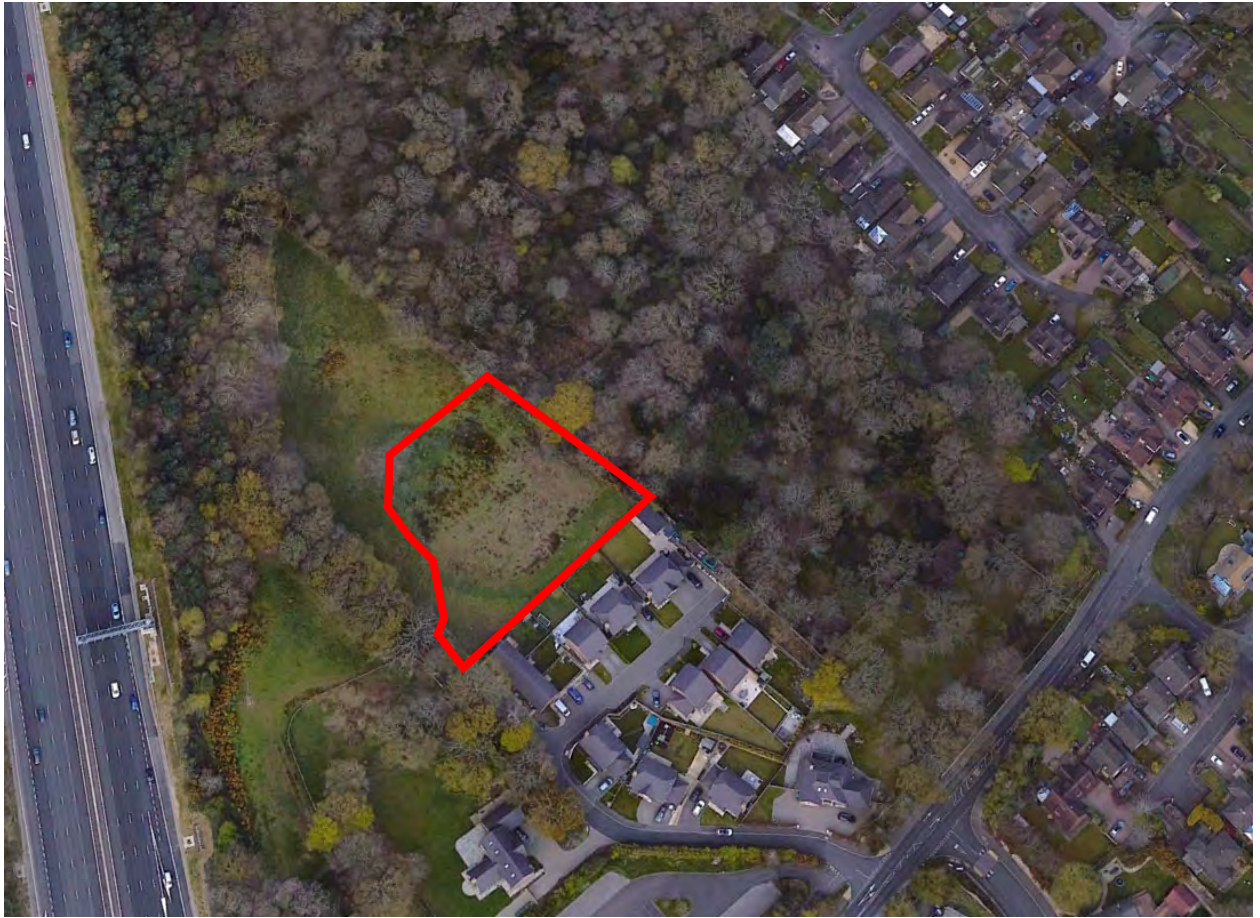
Aerial view of site

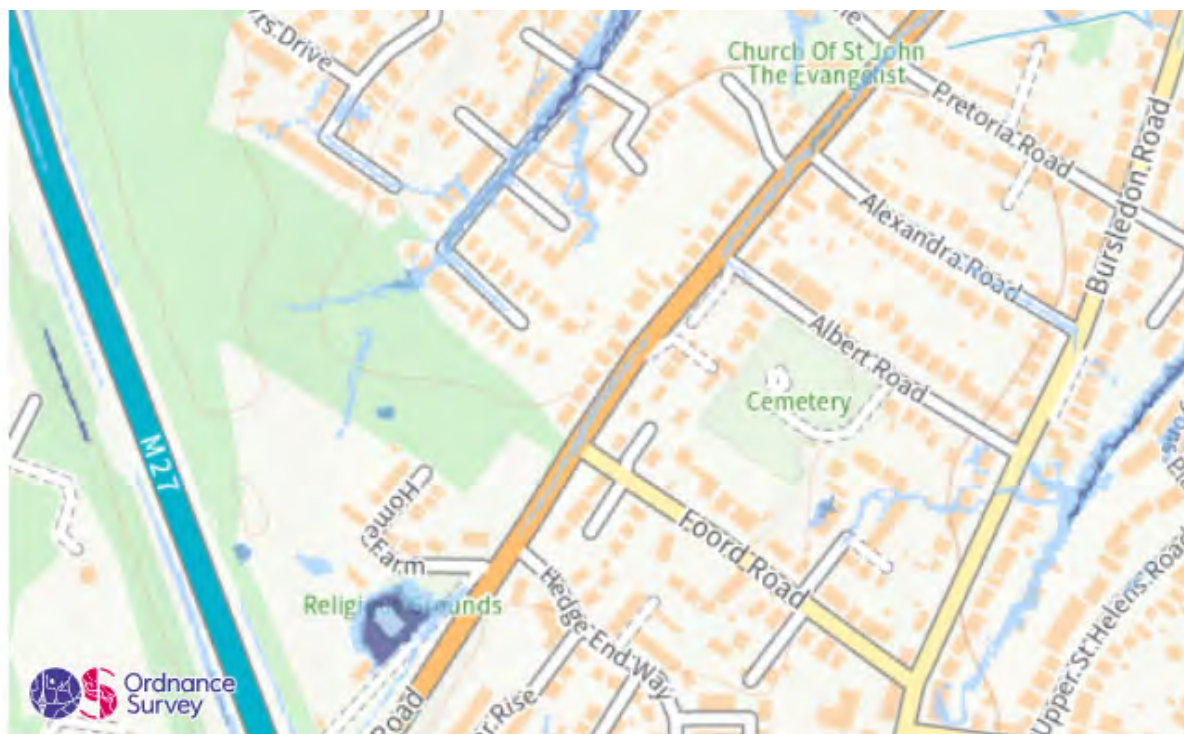
Extent of flooding from surface water

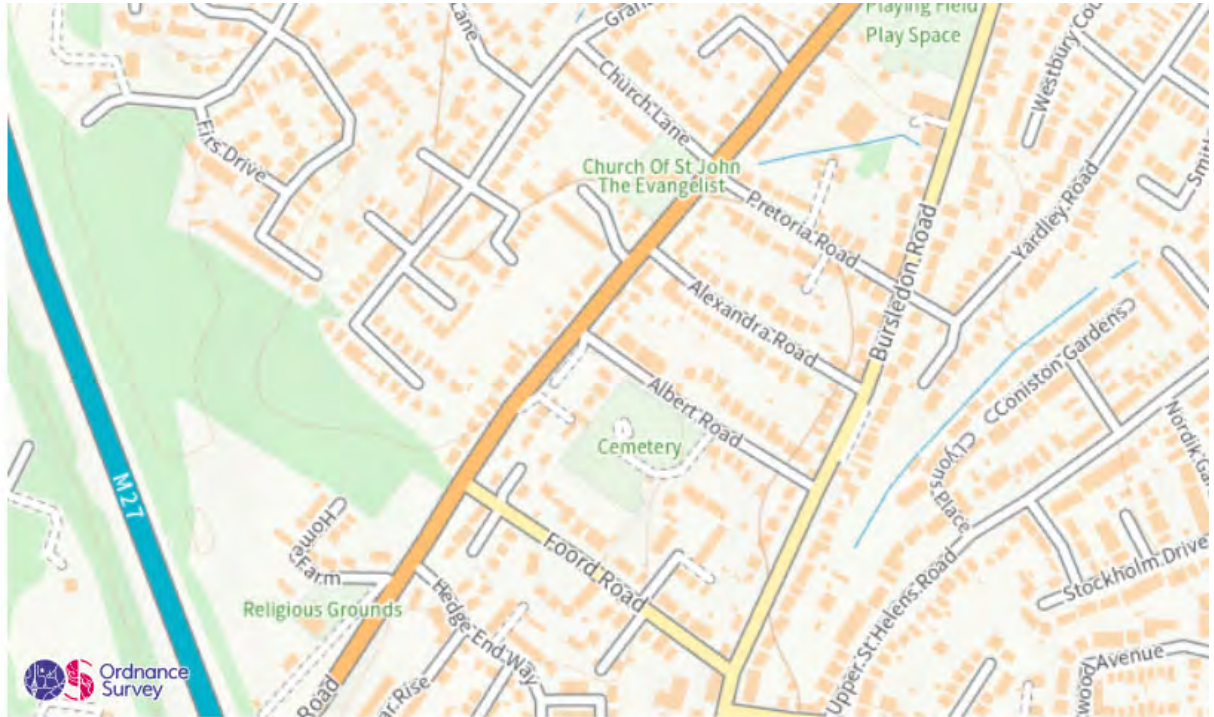
Maximum extent of flooding from reservoirs:

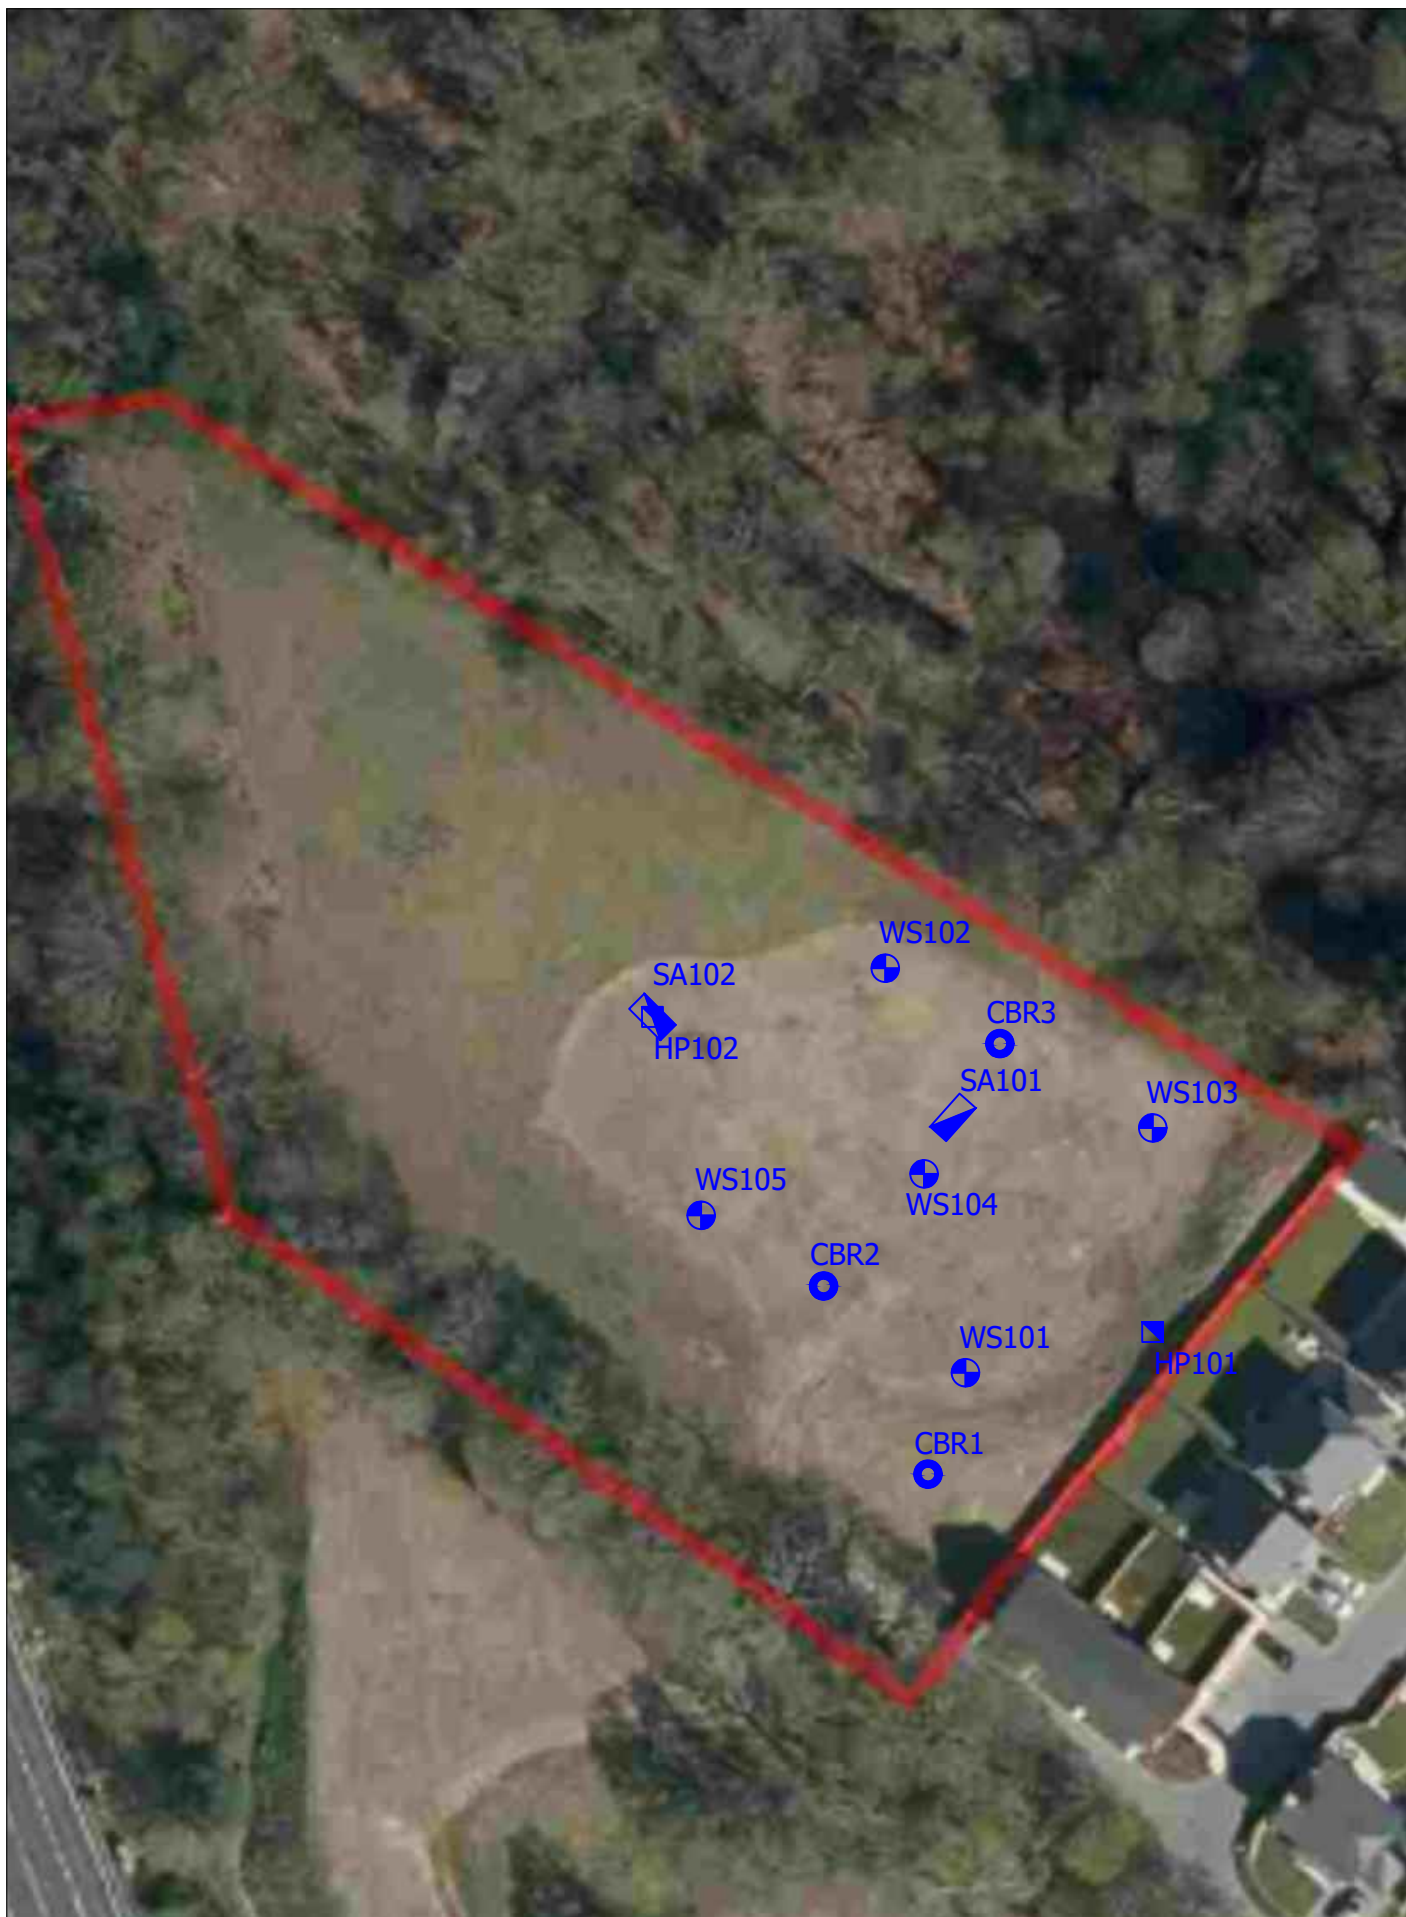
**FIGURE 2: INVESTIGATION LOCATION PLAN**

- 5no. windowless sample boreholes (WS101-105) to a maximum depth of 5.45mbgl.
- 2no. hand excavated trial pits (HP101-HP102) to a maximum depth of 0.5mbgl.
- 3no. CBR tests by TRL DCP method.
- 2no. machine excavated trial pits for infiltration testing purposes (reported under separate cover)

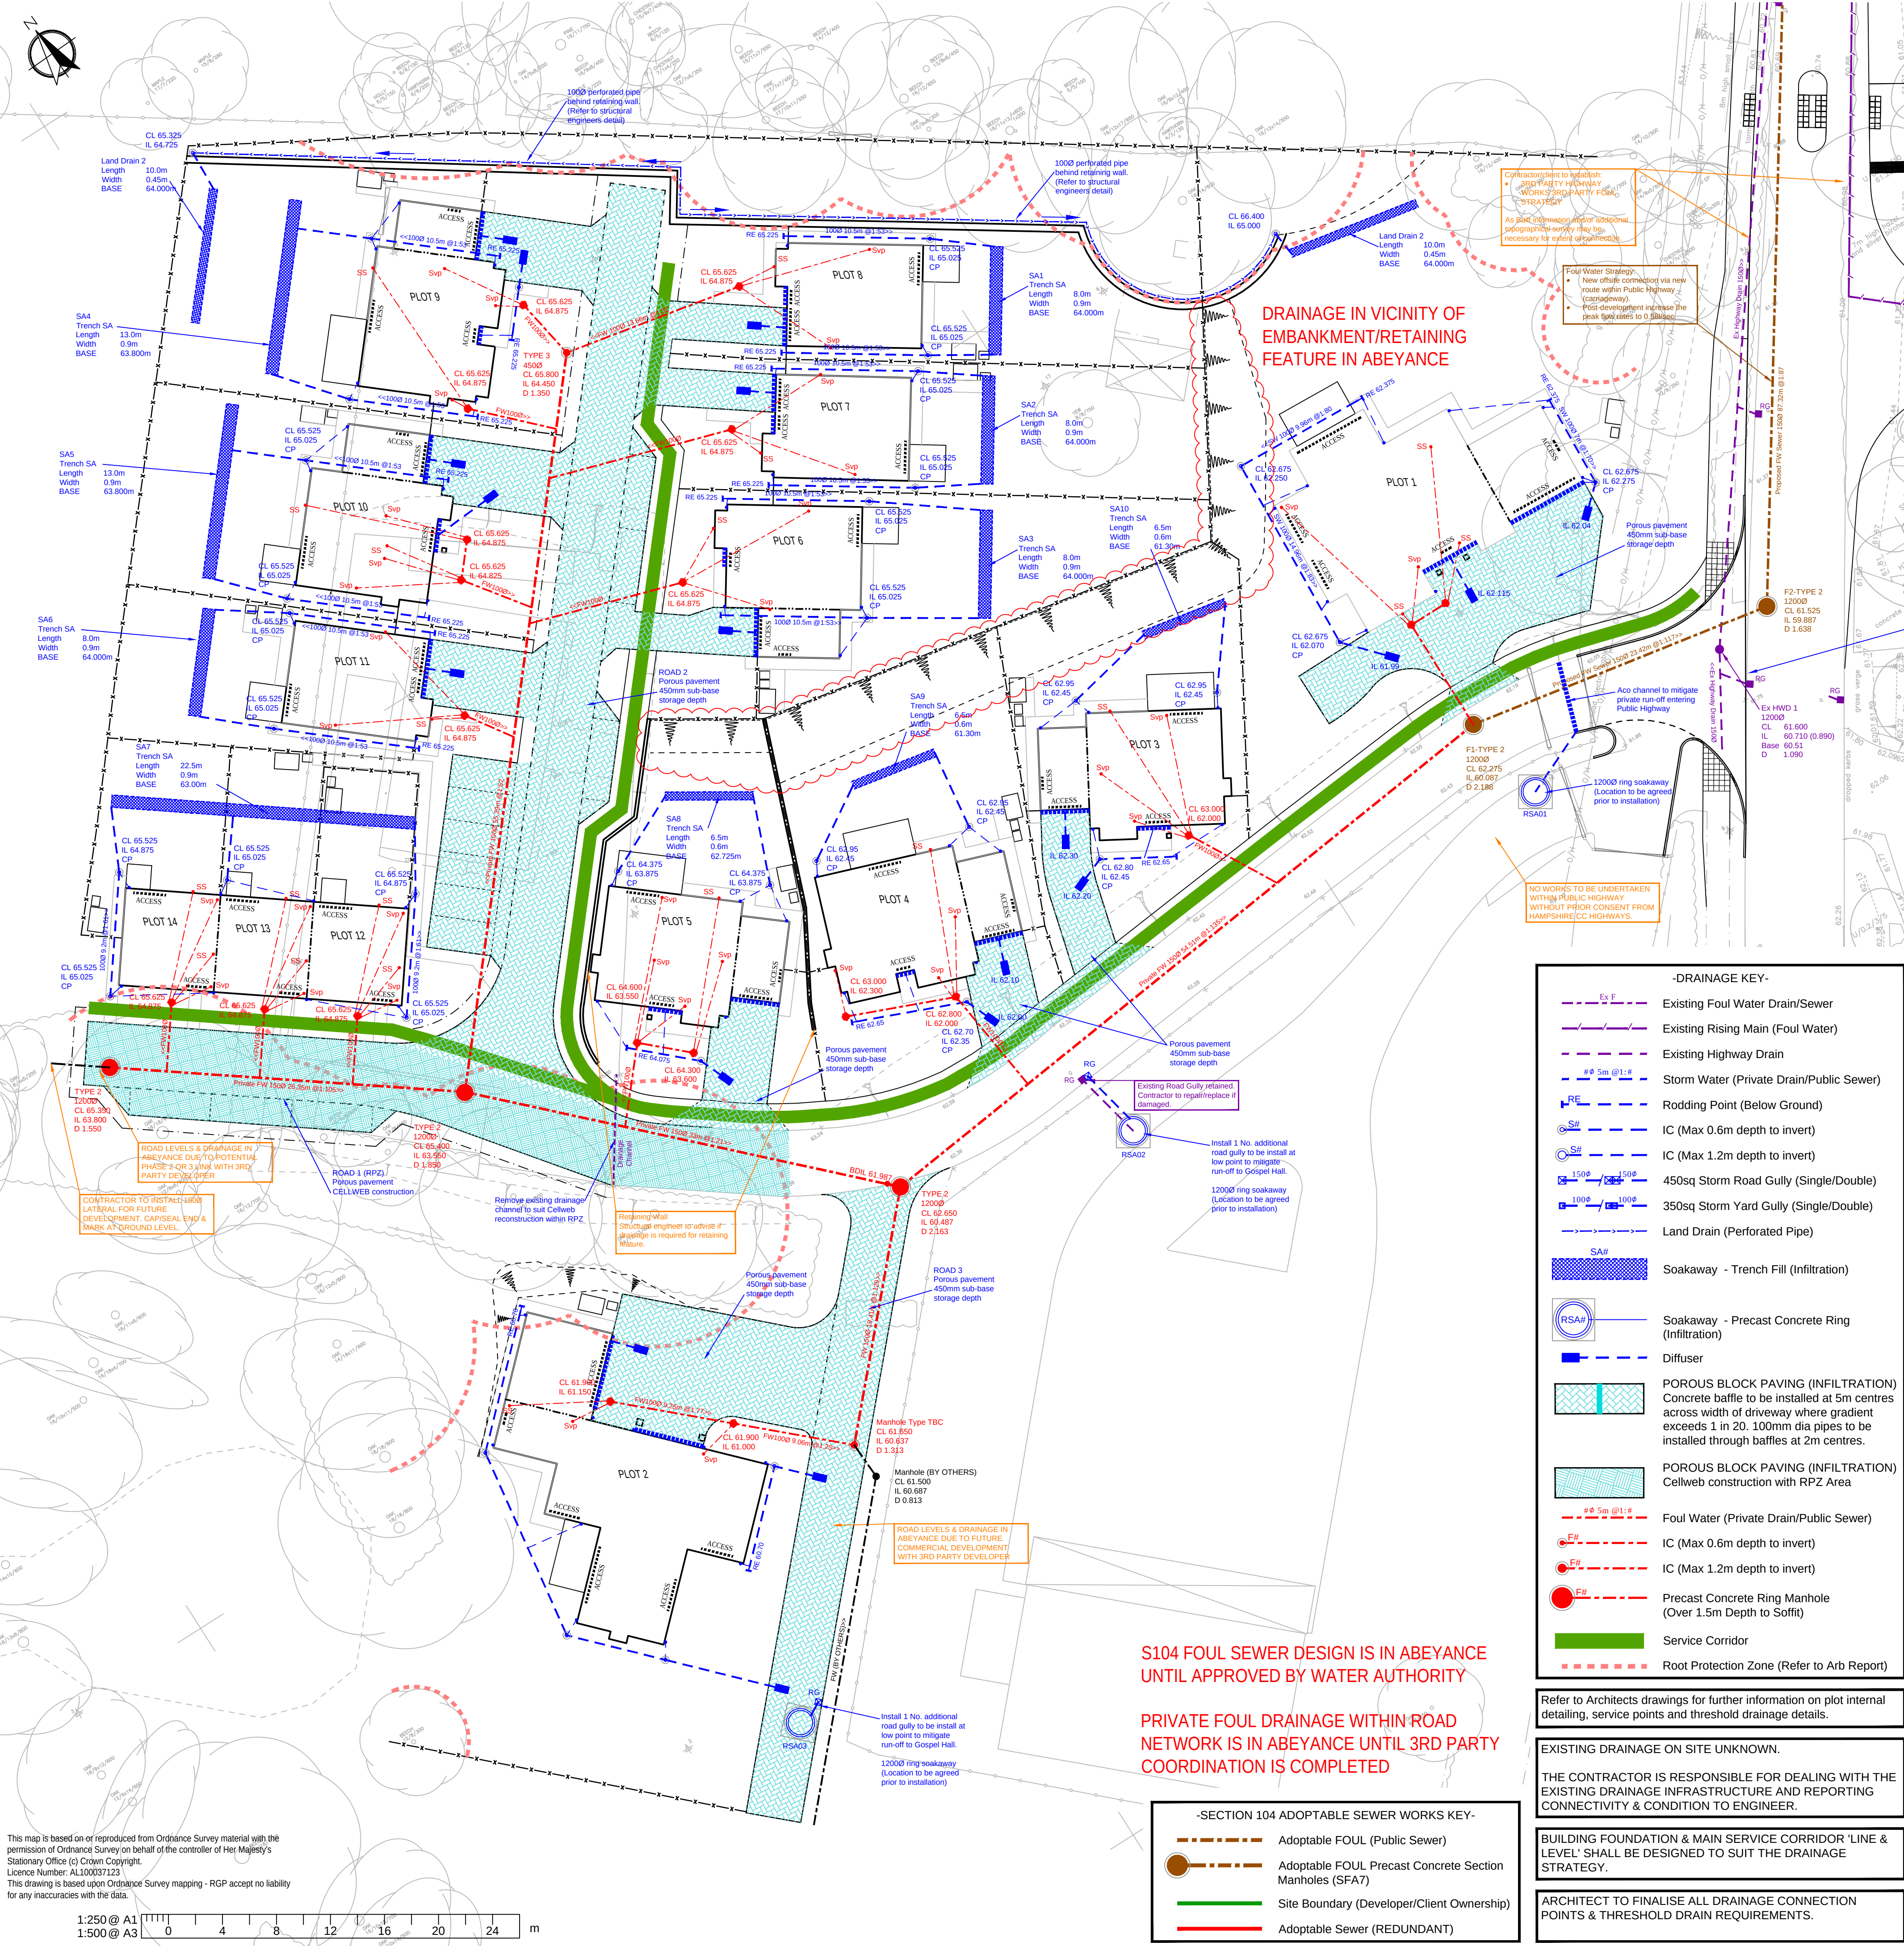
DRAWING STATUS: PLANNING ISSUE

- 4.4 The proposed drainage layout is shown on drawing ACC22066-01 contained in Appendix C.
- 4.5 The change of use is generally low and very low pollution hazard levels (C753 Table 26.2) and does not require groundwater risk screening.
