## **Main Investigation Report**

**Samsons Gym, 237 Chamberlayne Road,  
Eastleigh, Hampshire SO50 5JB**

**Eastleigh Borough Council**

**Reference: I9I92/MIR\_R27  
May 2021**

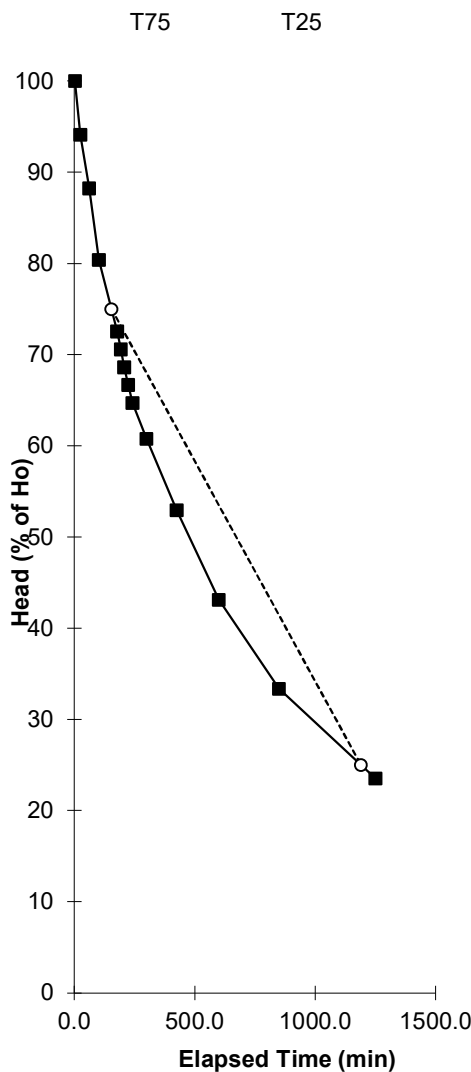
## Comments

extrapolated after 241.2 minutes.

A single test was attempted in TPSA1 however the test did not complete in the time available due to slow infiltration and therefore the test result was extrapolated, and the results outlined in Table 3.1.

The Trial Pit Soakage test carried out in TPSA1 did not complete in the time available due to slow infiltration and the extrapolated rate was  $1.604 \times 10^{-6}$  m/sec and therefore it is considered that alternative means of surface water disposal should be considered.

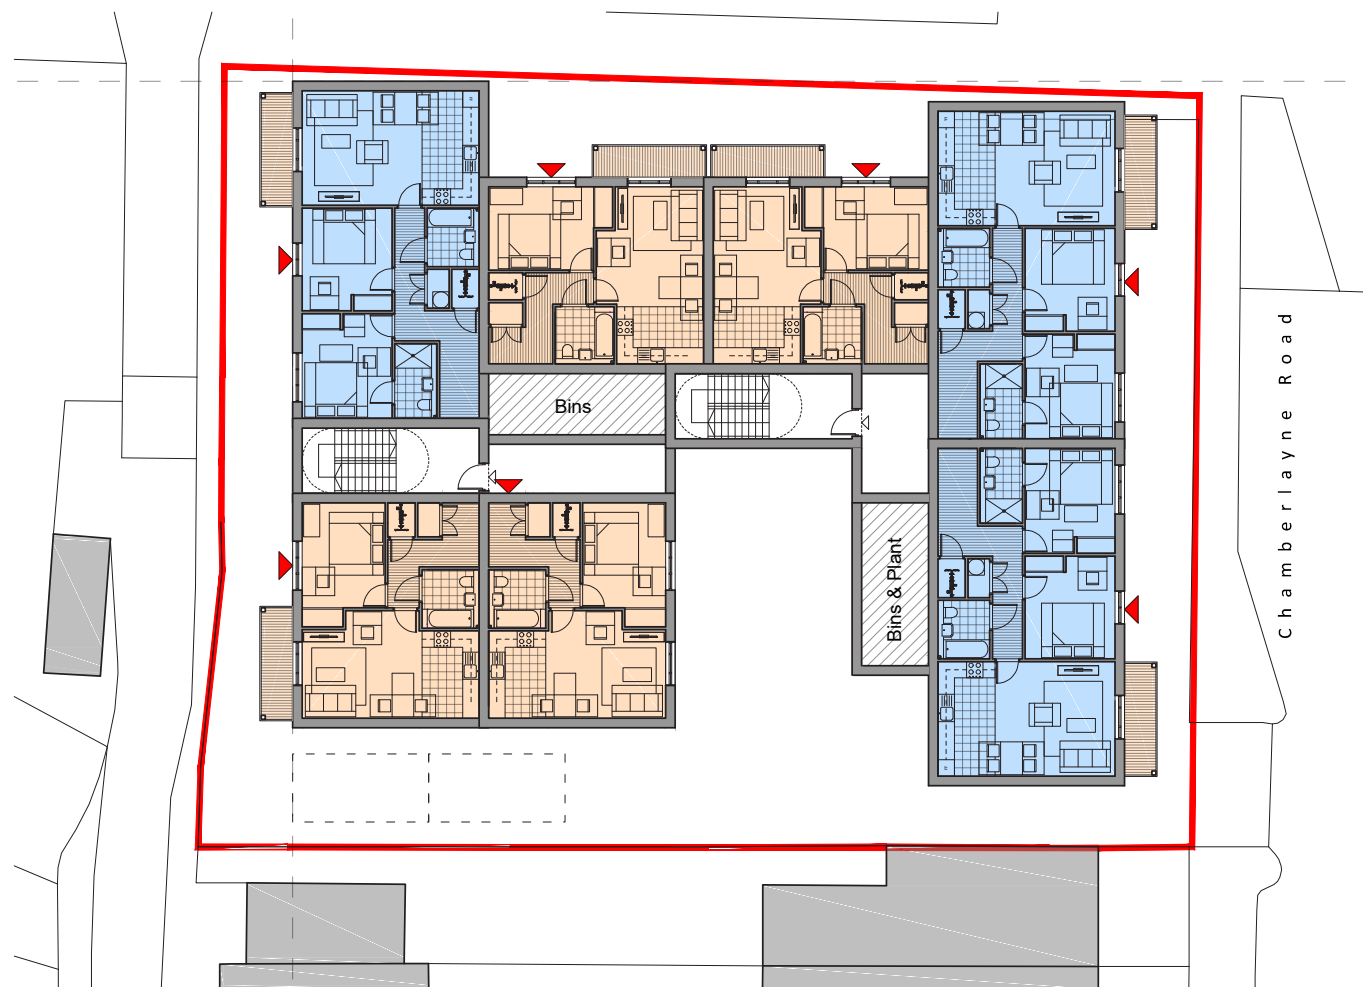
**Ground Floor**

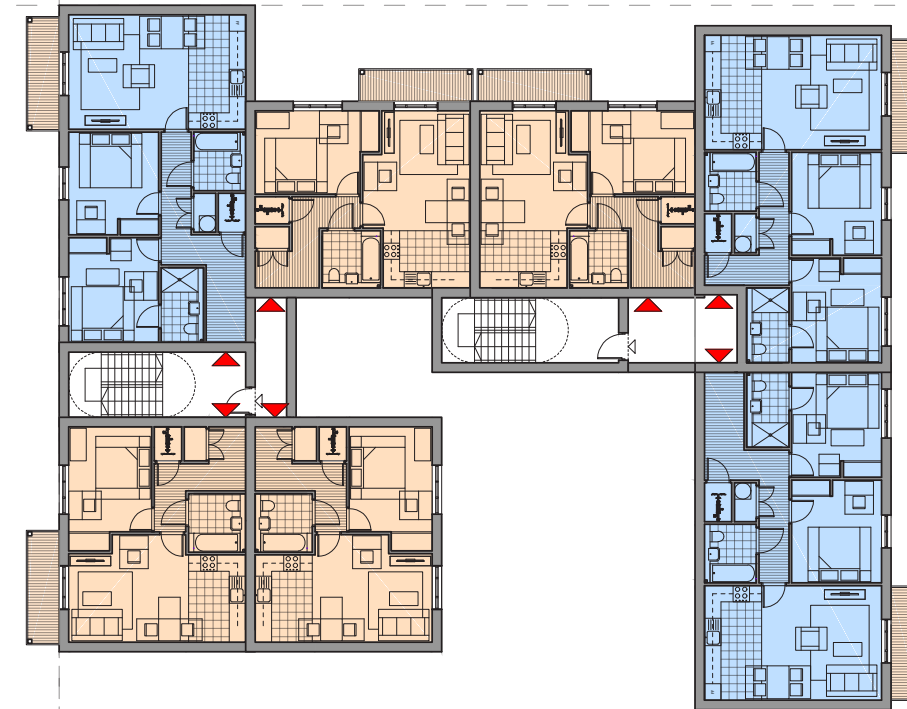
**First Floor**

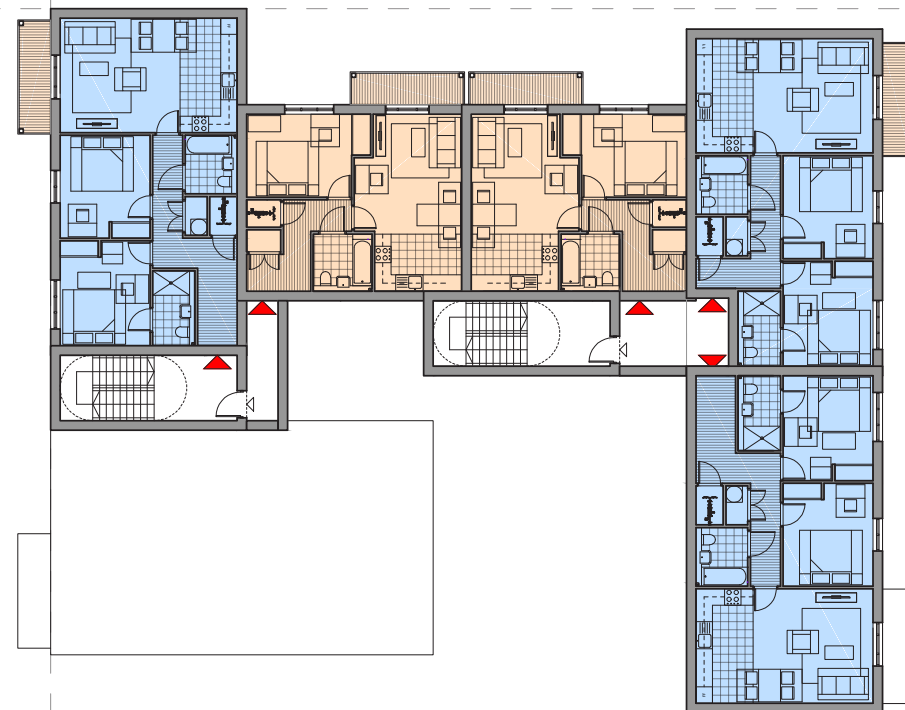
**Second Floor**

- Option 02c - 3 Storey**  
19 Units - Car Club Parking Only
- 1 Bed Unit @ 51.3m<sup>2</sup> - 10No
  - 2 Bed Unit @ 78.2m<sup>2</sup>- 9No
  - 2 Parking Spaces for Car Club
