**CHURCHILL RETIREMENT LIVING**

**LAND AT TOYNBEE ROAD, EASTLEIGH, SO50 9DP**

**GROUND INVESTIGATION REPORT**

June 2022  
Report No. CCLo3552.CQ14-R1

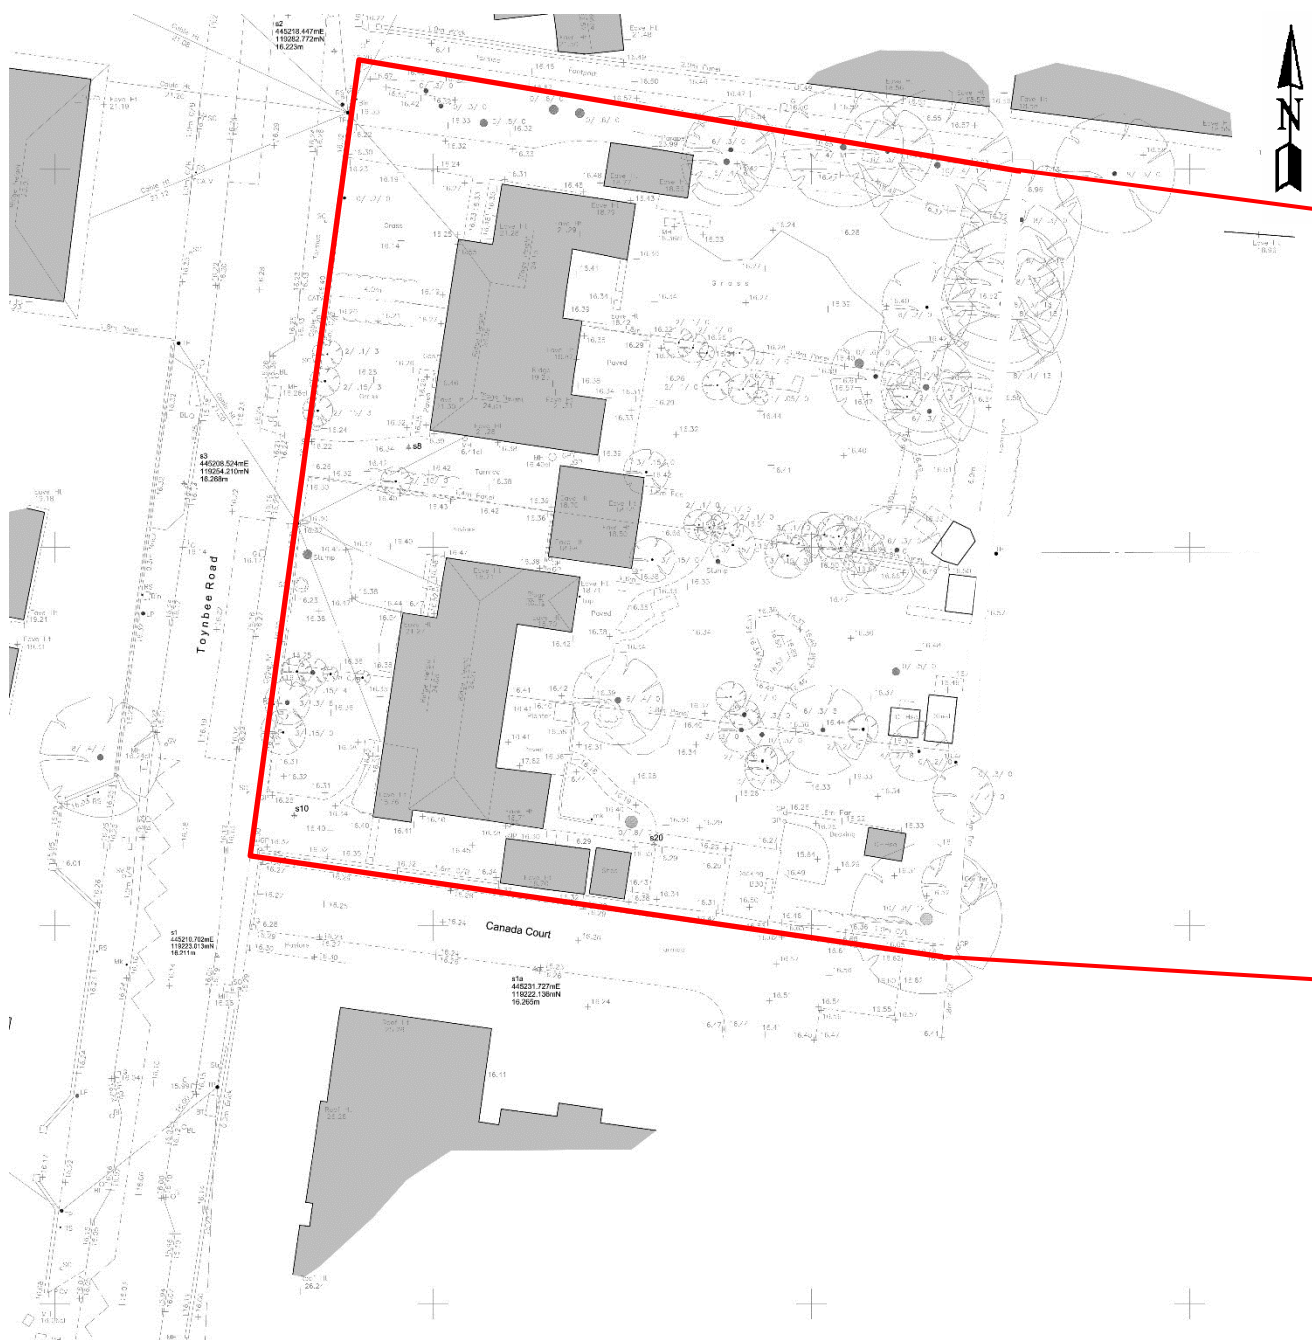
**FIGURE 3**

**TOPOGRAPHICAL SURVEY (WESTERN PART)**

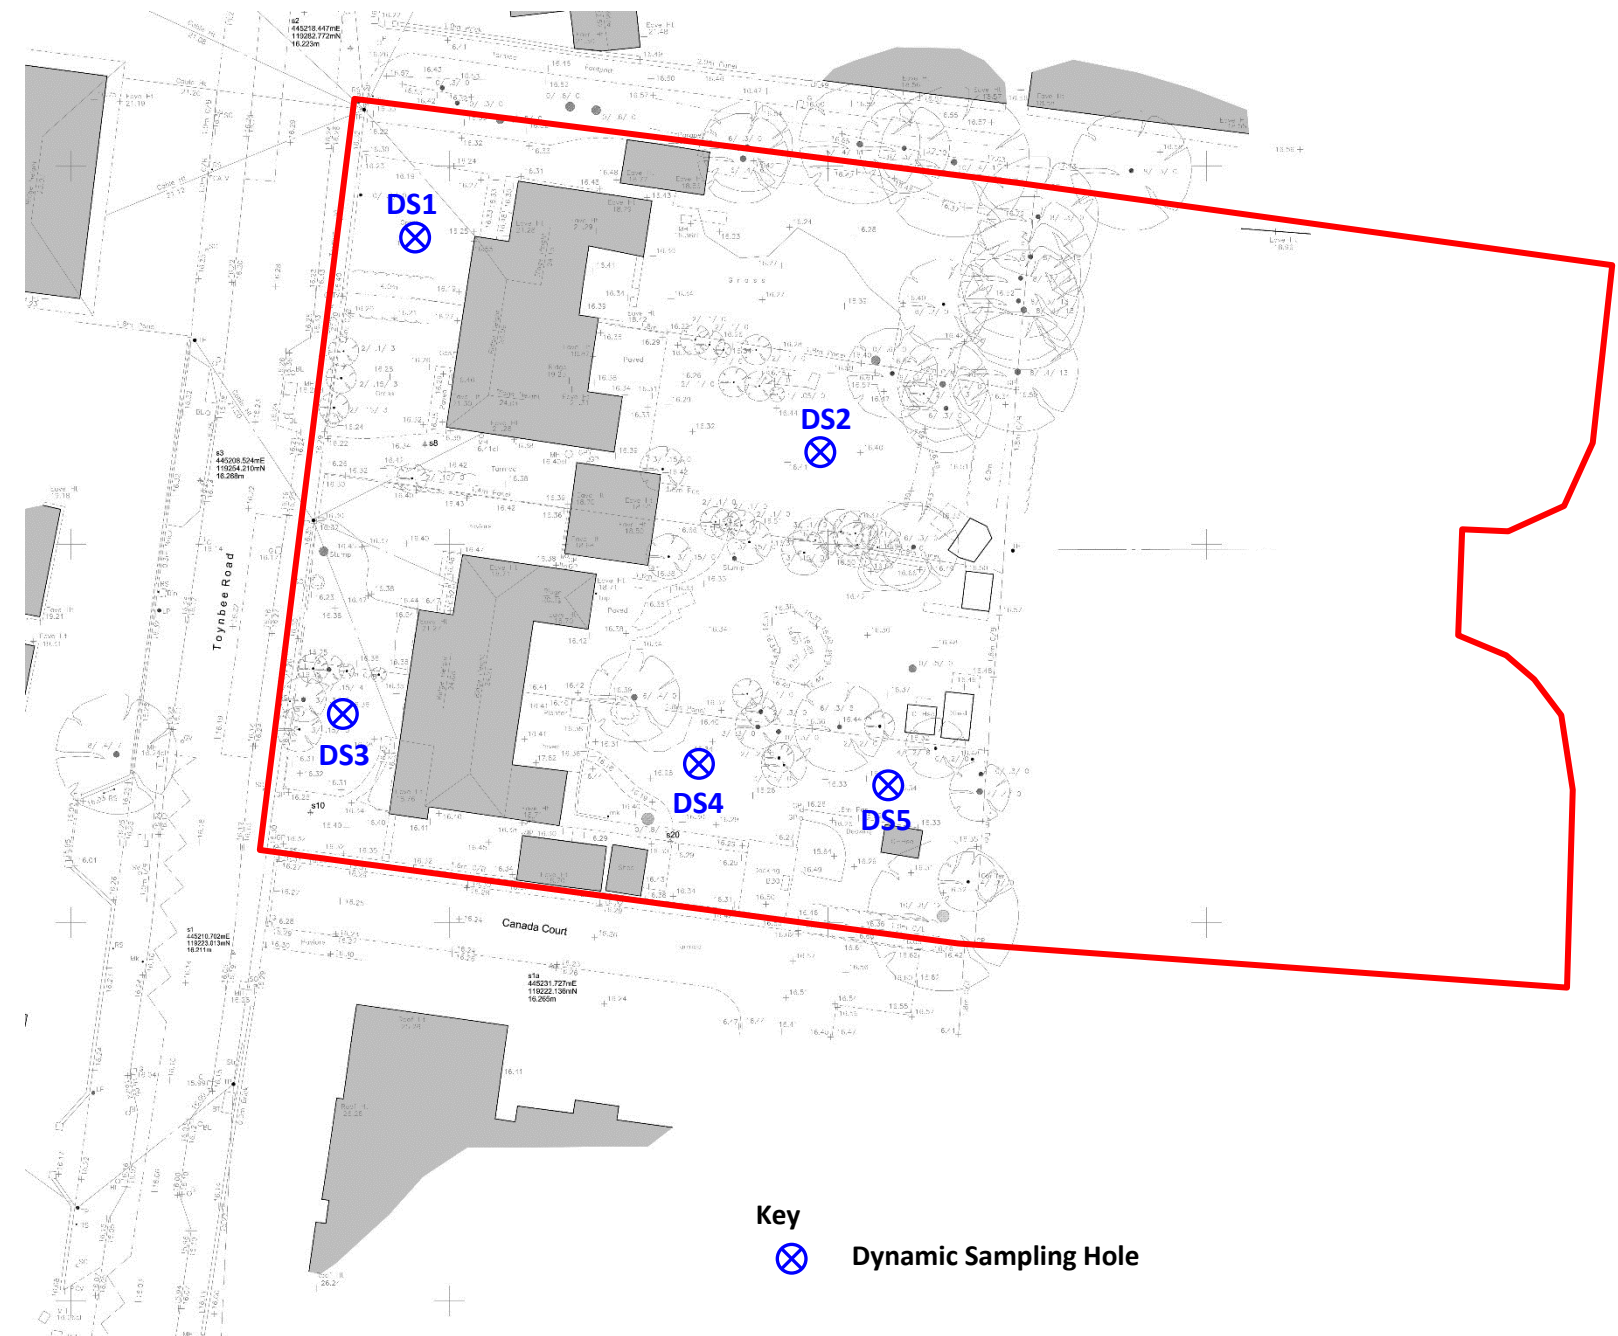
FIGURE I-1

EXPLORATORY HOLE LOCATIONS  
Scale 1:500 approx

Plan based on Drg No. SU01 Rev A by D & H Surveys and Planning Issues Drg No. 22/SW051/FP06

| Exploratory Hole and Technique | Rationale for Hole Location | Depth (m) | Sampling/In Situ Testing and Monitoring |
|---|---|---|---|
| DS1-DS5 | All exploratory hole locations were chosen to provide data in relevant areas of the site and to allow for samples to be taken for environmental and geotechnical assessments | Up to 5.0 m | Representative samples of Made Ground recovered for analytical testing<br><br>Representative samples of potential founding strata recovered for geotechnical testing<br><br>Standard penetration tests (SPT) undertaken at regular depth intervals. |
