## **Main Investigation Report**

**Samsons Gym, 237 Chamberlayne Road,  
Eastleigh, Hampshire SO50 5JB**

**Aspect (Eastleigh) Ltd**

**Reference: I9192/MIR\_R27/REV101  
May 2021**

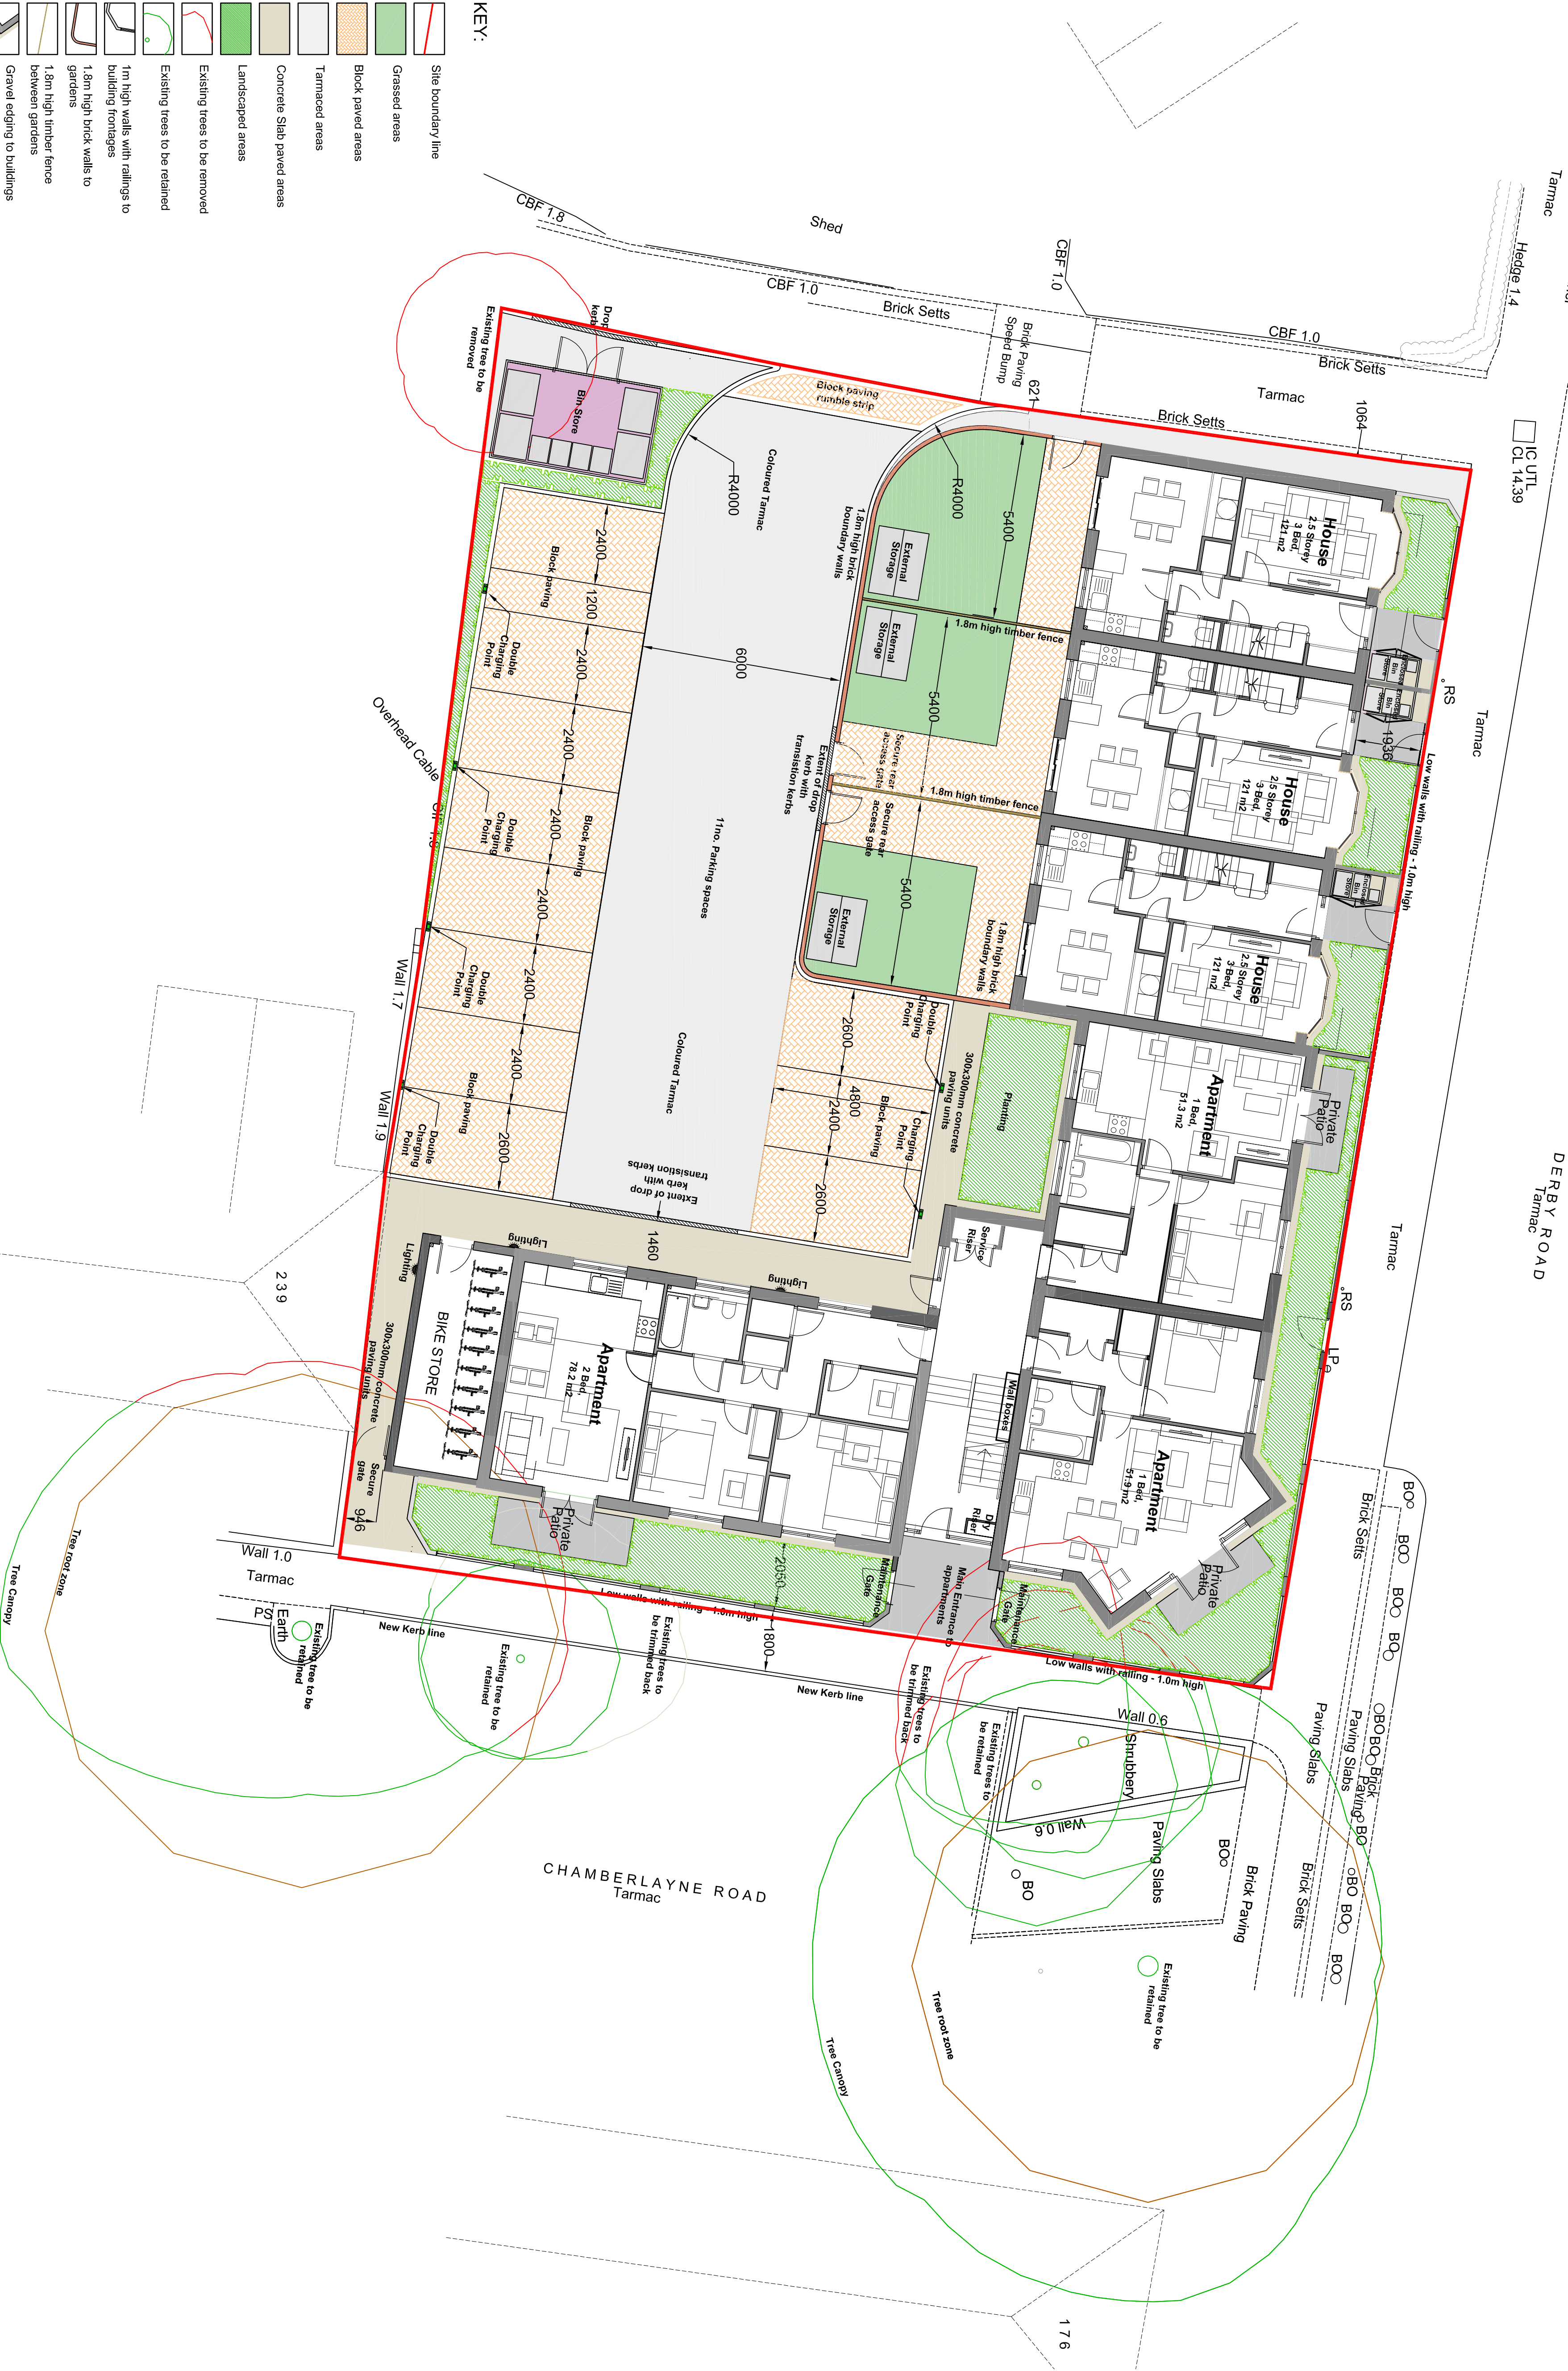
**PROPOSED  
SITE PLAN**

- KEY:**
- Site boundary line
  - Grassed areas
  - Block paved areas
  - Tarmaced areas
  - Concrete Slab paved areas
  - Landscaped areas
  - Existing trees to be removed
  - Existing trees to be retained
  - 1m high walls with railings to building frontages
  - 1.8m high brick walls to gardens
  - 1.8m high timber fence between gardens
  - Gravel edging to buildings
  - Concrete Kerbs
  - Concrete Drop Kerbs
  - Car Charging point
