## Flood Risk Assessment and Drainage Strategy

### Lowford Methodist Hall School Road, Lowford, Hants

**Reference:** 1917

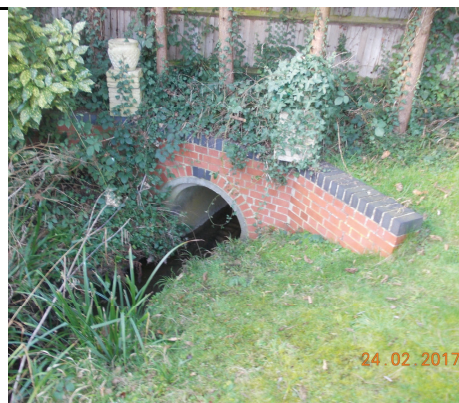
**Inlet / Headwall Details**

Size(mm): 3880(w) x 1410(h)  
Construction Material: Brick  
Pipe Shape/Size: Circular - 825mm  
Location Details: In gardens  
Grid Reference: 448258 110173  
Access Restrictions: Private land  
Construction Features: Headwall with wing walls  
Condition: Good

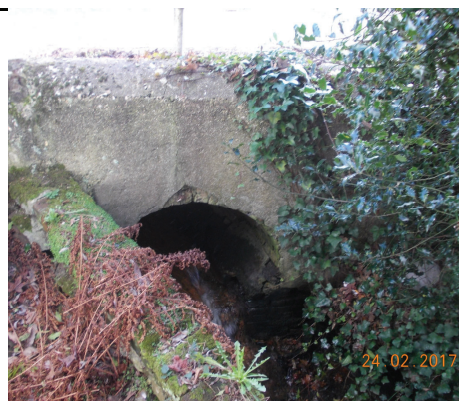
**Outlet / Headwall Details**

Size(mm): 1200(w) x 1520(h)  
Construction Material: Concrete  
Pipe Shape/Size: Circular - 825mm  
Location Details: Next to a road  
Grid Reference: 448245 110170  
Access Restrictions: Located next to a blind bend in the road  
Construction Features: Headwall  
Condition: Good
