**Methodist Church Site, School Road,  
Lowford, SO31 8BU**

**Bat Survey Report**

Report Number: 0630

Date of Issue: 13<sup>th</sup> July 2023

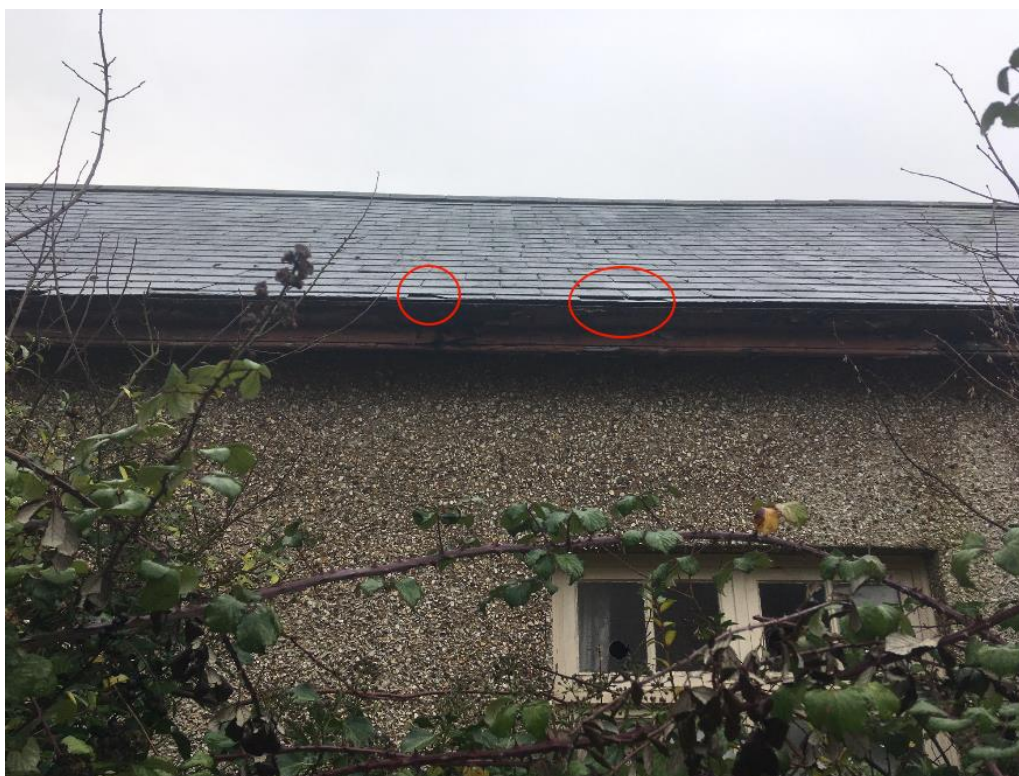
- 4.3 The building has bat roosting potential. There are gaps under the slate tiles (**figure 3**), under the soffits (**figure 4**) and where rafters protrude through the external walls (**figure 5**). The roof has no lining under the slate tiles. Bats may also roost in cavity walls. There also smashed windows where bats could gain access to the building.

**Figure 3:** Slate tile roof with potential gaps for bats.

- 4.4 The lack of a lining under the slate roof tiles allows greater access for bats to access the attic and the building in general. Although no direct evidence of bats was found, the building has features with bat roosting potential and if these areas cannot be avoided and have minimal levels of disturbance during construction then further surveys would be necessary to ascertain the bat roosting status and to determine if a European Protected Species licence is required to proceed with the proposals. The proposals include two new dormer windows and several conservation style rooflights, all of these will be where there are existing slate tiles with no bat access potential and therefore it is unlikely that there will be an impact on bats. There were no signs of bats in the attics so losing the attic to the development is considered to have a negligible impact on bats.

- 5.1 The proposal is to internally convert the church into flats.
- 5.2 The slates required to be removed for the dormer windows and the rooflights will be done so under ecological supervision after a tool box talk has been given. The toolbox talk must be carried out by a suitably qualified ecologist prior to any works on site to highlight locations with bat potential and the required working practices regarding these or near to them.
- 5.3 Any new external lighting must be avoided wherever possible. Where it is necessary, it should be pointed downwards and away from any trees and buildings in the vicinity of the site.
- 5.4 Two new bat roosting crevice features will be incorporated into the proposals under the eaves facing south, see Appendix E.
- 5.5 The site will be monitored during construction to ensure bat features are installed correctly.

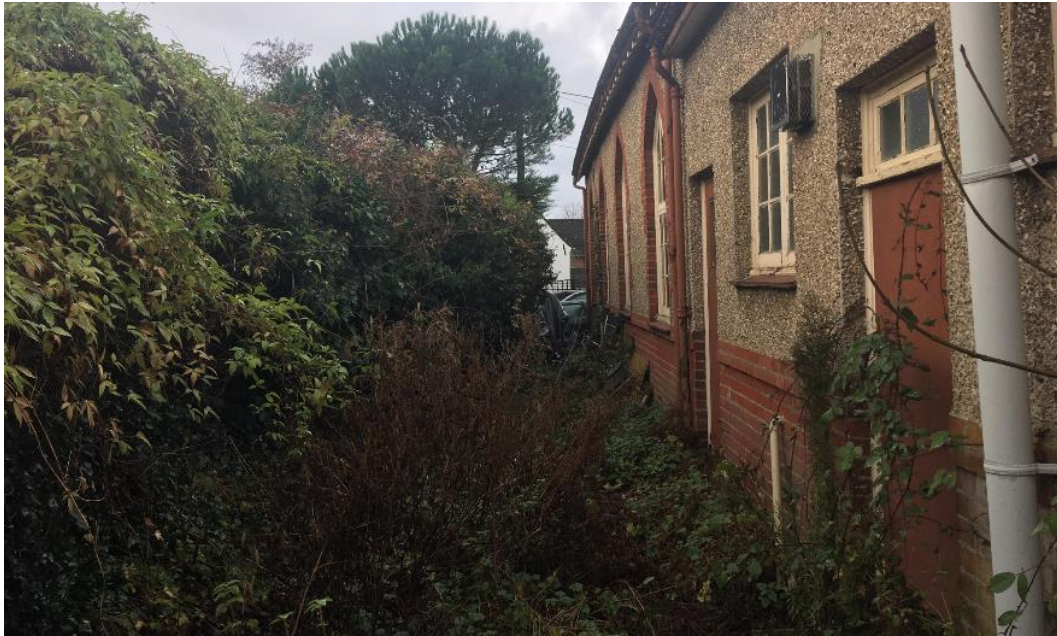
**Figure 6:** Southern aspect of building

- 4.5 The woodier species of trees and bushes adjacent to the building at the site boundary (**figure 6**) provide some low quality foraging habitat for bats. These should be retained and protected from any disturbance during building works and protected from external lighting post construction, however if this is not possible then new planting will need to be included as part of the scheme.
