## BAT ROOST ASSESSMENT

39 VERDON AVENUE, HAMBLE-LE-RICE, SOUTHAMPTON, SO31 4HW

FINAL REPORT

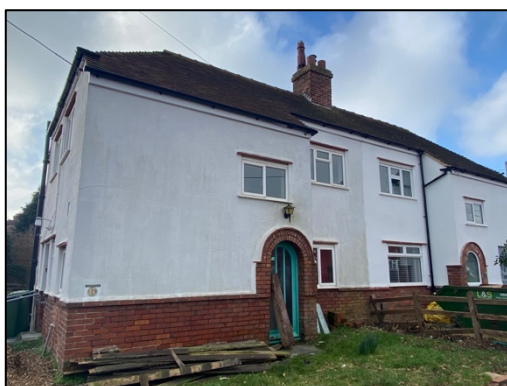
The building comprises a two-storey brick-built and rendered semi-detached house which rises to a pitched and hipped roof design clad with clay roof, ridge and hip tiles (Figure 1). The building is oriented north-east to south-west. The easternmost end of the north-eastern elevation extends beyond the wall plate and features a small catslide roof. A single-storey mono-pitched conservatory and brick-built extension protrude from the south-western elevation of the main house (Figure 2). The conservatory is clad with polycarbonate sheets and the extension with clay roof tiles. The roof of the house extends beyond the wall plates and the eaves are enclosed with uPVC fascia and underboards with uPVC guttering closely adjoining the eaves. Two brick-built chimney stacks are present and surrounded by lead flashing at their respective bases. All windows and doors are set in either wooden or uPVC frames and all are tight fitting to surrounding brickwork.

**Figure 1** – north-eastern elevation of the house

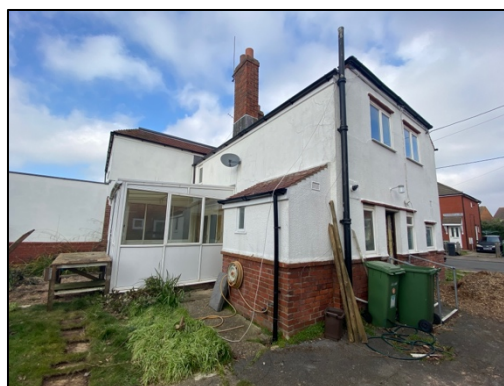
**Figure 2** – rear conservatory and brick-built extension

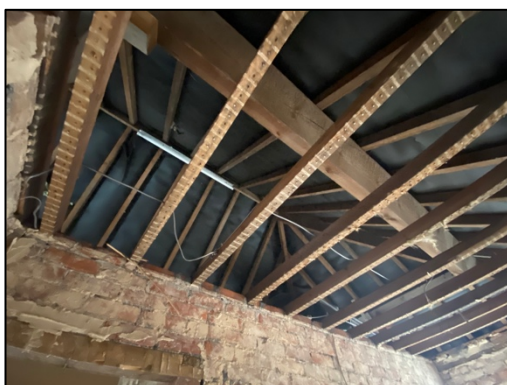
Internally, the house does not support a roof void. The house is stripped, with the wooden beams and underside of the heavy-duty bitumen felt lining exposed (Figures 3 & 4). All rooms remain open with direct continuous access throughout.

**Figure 3** – open interior with exposed bitumen lining

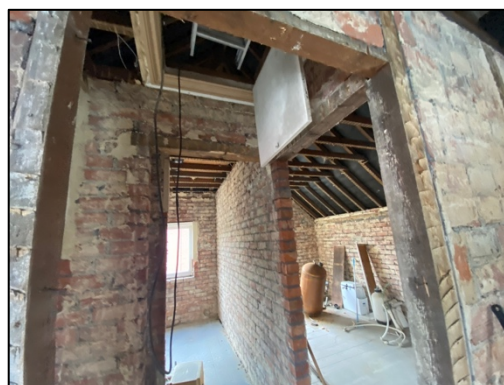
**Figure 4** – direct continuous access between all interior rooms

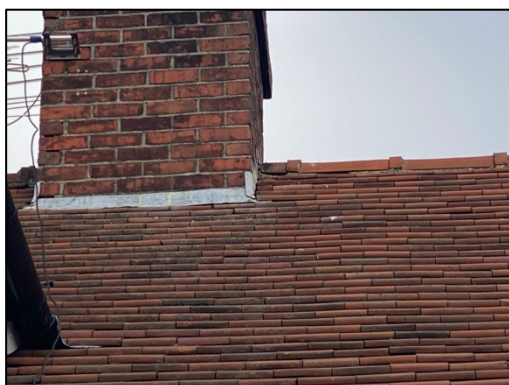
| | <i>Suitability</i> | <i>Evidence</i> |
|---|---|---|
| <i>Exterior</i> | <p>The following suitable access/egress and roosting features were recorded externally during the survey:</p> <ul style="list-style-type: none"> <li>- Gaps under the roof tiles (Figure 5).</li> <li>- Lifted lead flashing surrounding the main chimneys.</li> <li>- Missing mortar under ridge and hip tiles (Figure 6).</li> </ul> | No evidence of roosting activity was recorded externally during the survey. |

**Figure 5** – gaps under roof tiles and under lead flashing

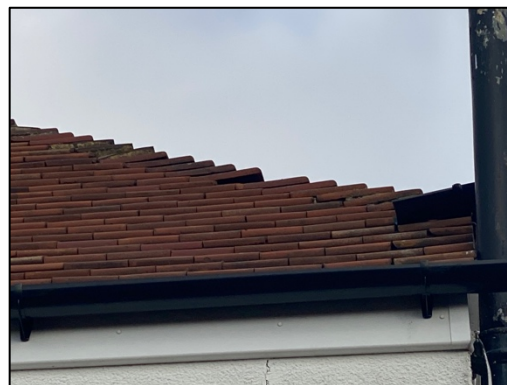
**Figure 6** – missing mortar under hip tiles
