Our ref: GE21681/FG02/230703

**RE: STOKE PARK FARM SANG – Preliminary Information**

Further to your instruction and our recent investigation works in relation to the intrusive investigation of the above-named site, we write to provide the preliminary information.

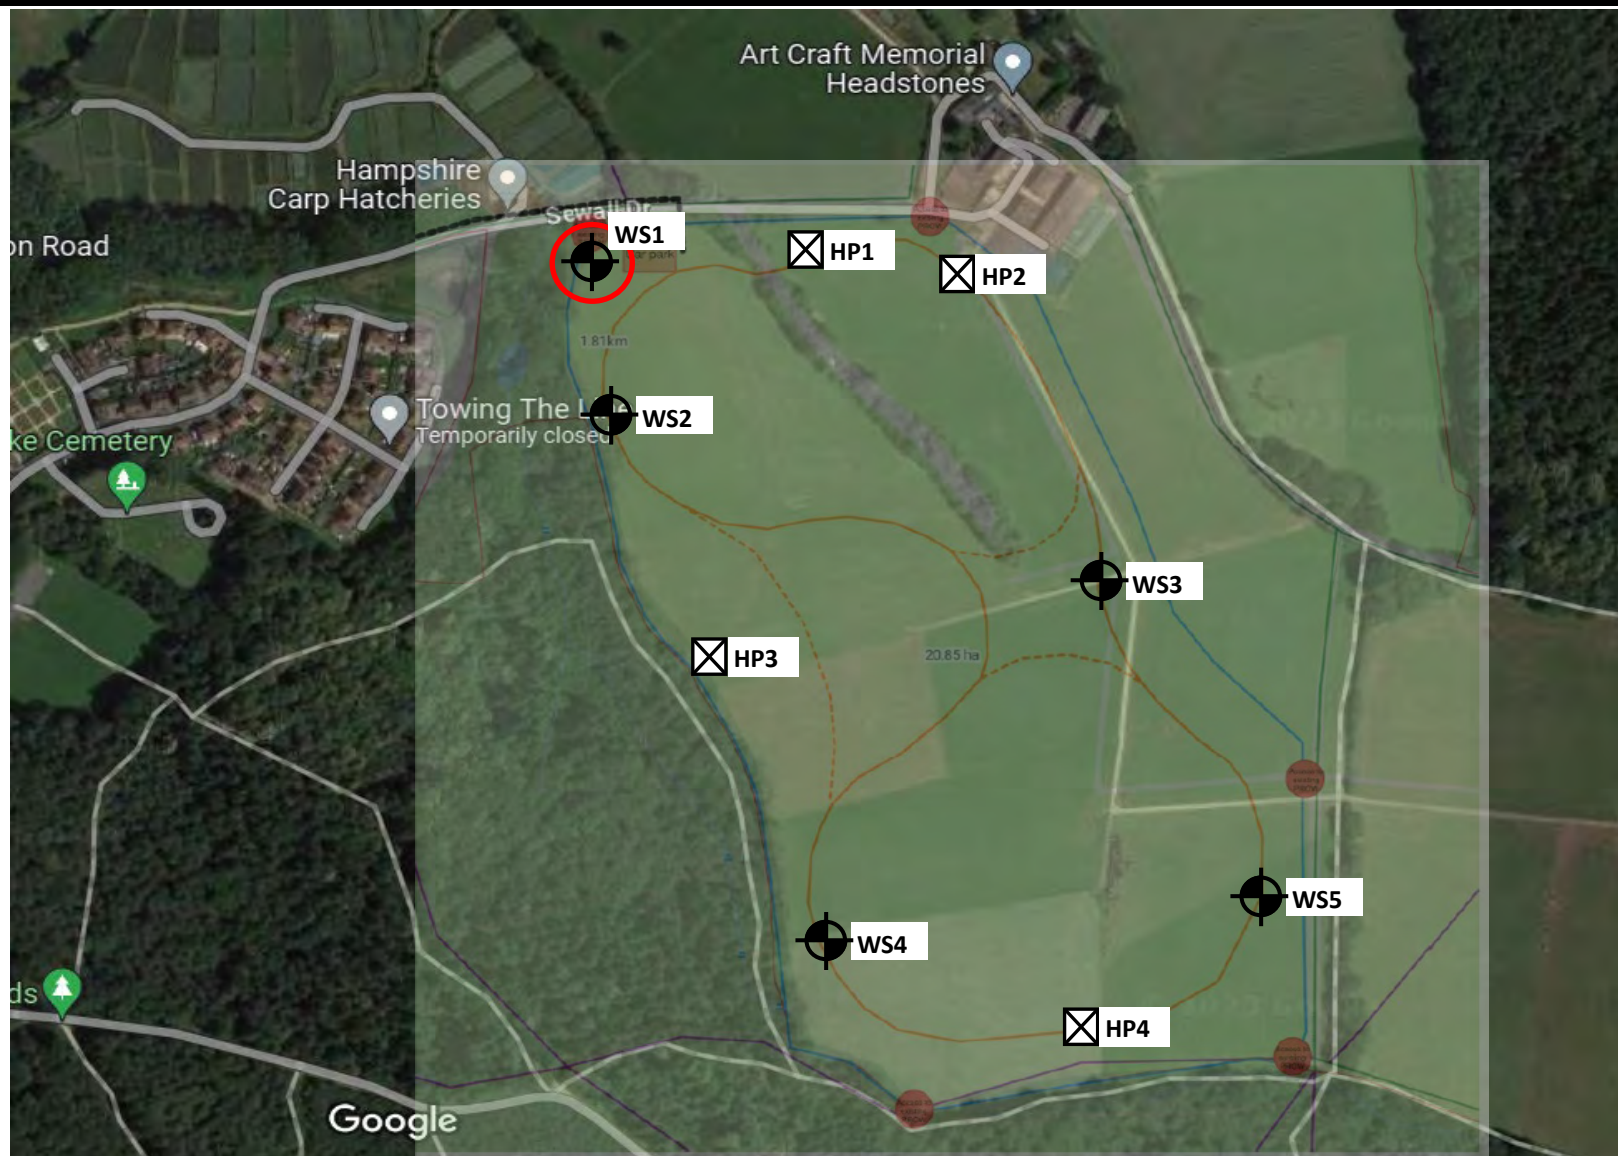
| <b>Figure:</b> 2 | <b>Scale:</b> Not To Scale | | |

The preliminary exploratory hole logs are presented within Appendix A and the exploratory hole location plans for are presented in Figure 2a and 2b.

| <b>Project:</b> Stoke Park Farm SANG | | <b>Title</b> Proposed Window Sample and Hand Pit Locations | |

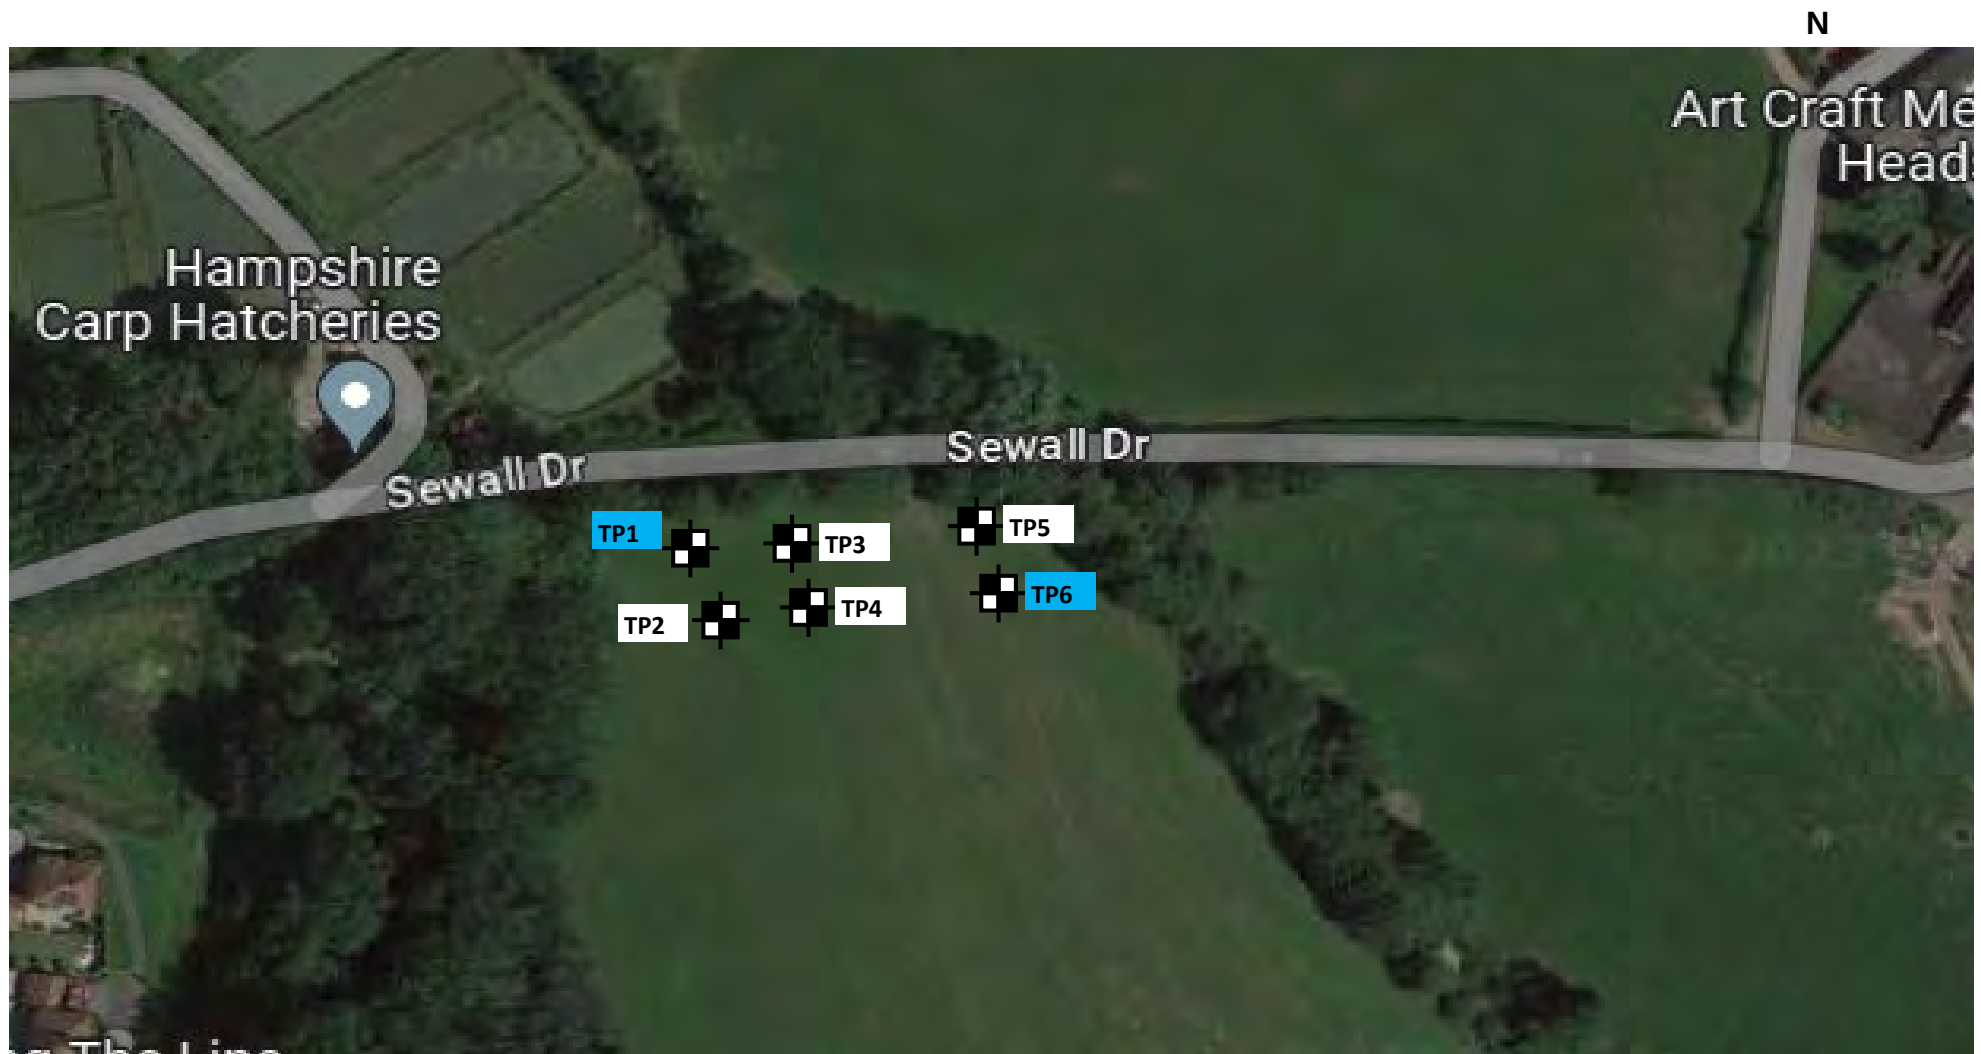
| <b>Project:</b> | Stoke Park Farm SANG | | | <b>Title</b> | Proposed Trial Pit Locations | |

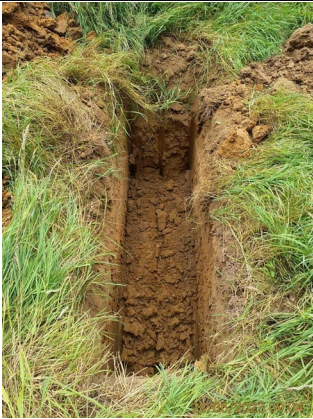
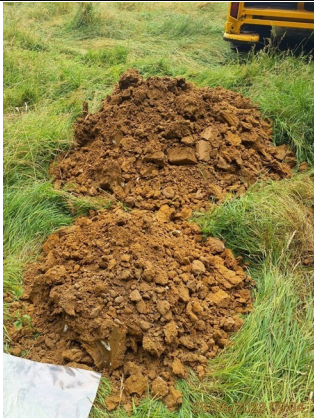
| 0.50<br>0.50 | B1<br>D1 | PP=4.5kg/cm2 | 25.27 | 0.15<br><br>(0.40) | <br><br> | Grass over dark brown silty CLAY with frequent roots and rootlets<br>TOPSOIL<br>Stiff orange brown CLAY with occasional roots and rootlets and rare flint gravel<br>LONDON CLAY | | 0.5 | |
| 1.00<br>1.00 | B2<br>D2 | PP=1.5kg/cm2 | 24.87<br><br>24.42 | 0.55<br><br>1.00 | | Firm orange brown slightly sandy CLAY with rare roots and rootlets<br>LONDON CLAY | | 1.0 | |
| Soakage | | | | | | | | | |

Soakage testing was undertaken within 2No. trial pits, at 1m bgl in TP01 and at 1.70m bgl in TP06. The soakage testing was undertaken in general accordance with BRE Digest 365.

There was an insufficient fall in head to calculate an infiltration rate for the tests undertaken within location TP01 and TP06 over the testing period and, as such, the tests are deemed to have failed.

The results of the soakage testing indicate that the use of soakaways within the cohesive London Clay Formation would not be suitable and therefore an alternative drainage solution will need to be considered. The results from the soakage testing are presented within Appendix B.

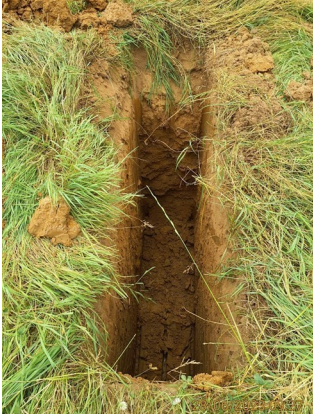
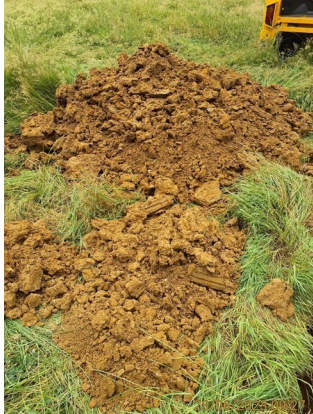
During the intrusive investigation works groundwater was encountered as slight seepages in the base of the exploratory hole locations within the following locations TP02, TP06, WS04 and WS05.

| 0.10 | ES1 | PP=3.2kg/cm2 | 26.16 | 0.20 | | Grass over dark brown slightly silty CLAY with frequent roots and rootlets<br>TOPSOIL | | 0.5 | |

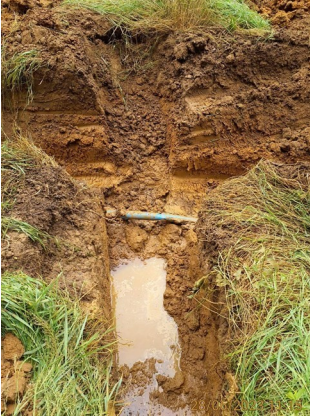
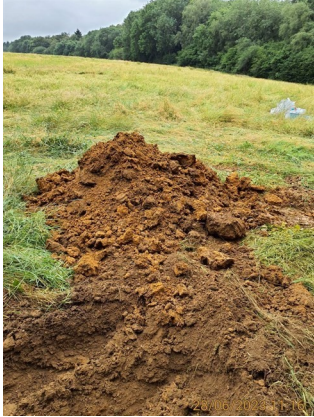
A mains water supply pipe, supplying Stoke Park Farm and associated commercial buildings and farmhouse was encountered within TP03 at 0.86m bgl. The water supply pipe was a plastic 63mm diameter pipe which ran in an east-west direction within TP03. The pipe appeared to have been laid by moling as no discernible granular trench fill was encountered and there were no marker tapes or other protection measures encountered over the pipe. The pipe could not be detected or traced due to its composition and lack of granular trench fill which might have provided a contrast for the GPR equipment.

| Mains water pipe at 0.86m bgl | | | | | | | | | |

It must be noted that this water supply pipe is located within the area of the site where it is proposed to locate the car park for the SANG. Therefore, if any drainage or construction is proposed to be completed/undertaken with this area of the site at the depth of, or close to the encountered pipe (c.0.8m bgl), consideration for protection of this water supply pipe must be given at design stage. Alternatively, redirection/relocation of this water supply pipe might need to be considered.

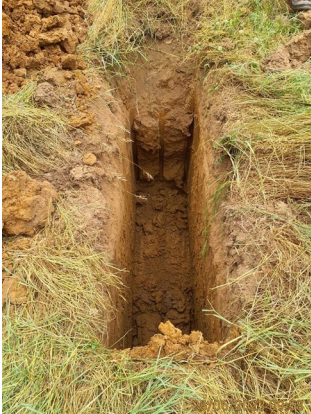
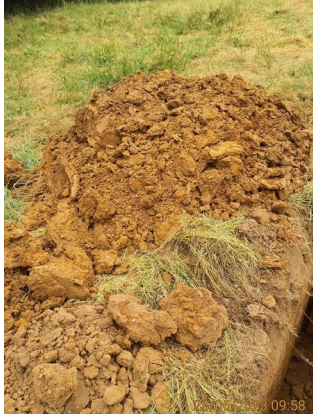
| Soakage | | | | | | | | | |
