## Preliminary bat roost assessment

| Site Location | 20 Sycamore Avenue, Chandler's Ford, SO53 5RH |
| Document reference | CE4227 |

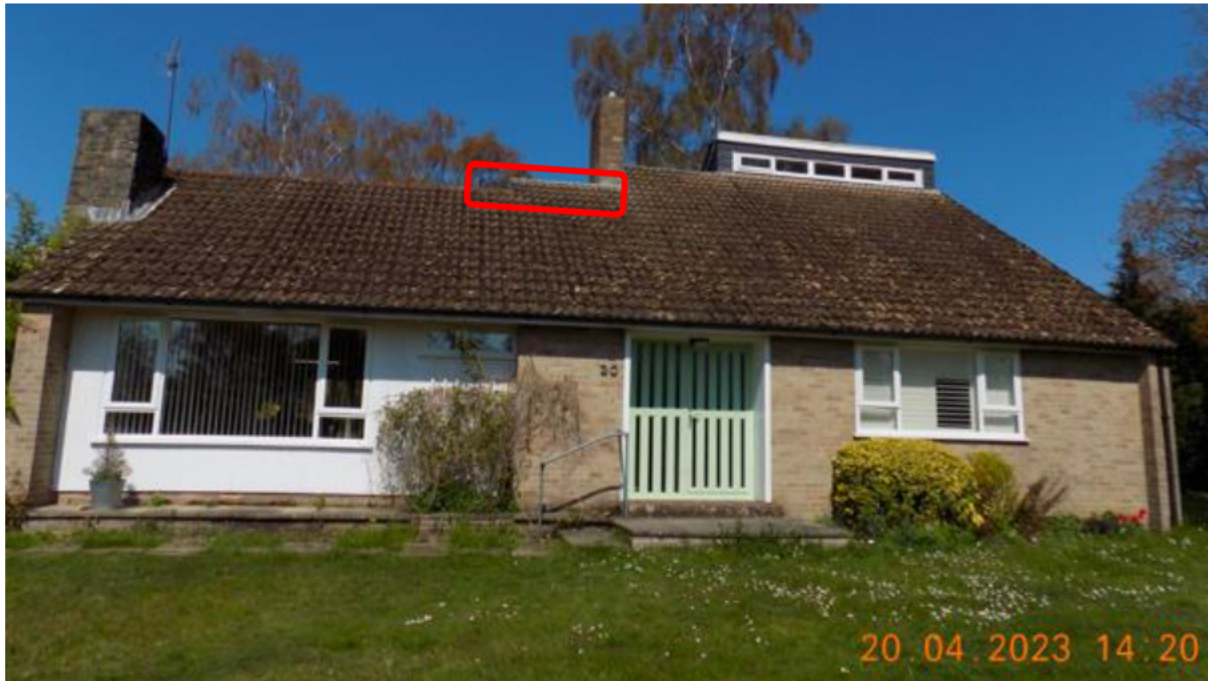
| External | Features of value to bats | Notes |
|---|---|---|
| Roof coverings | Yes | Viewed from the front elevation, a section of raised tiles & leadworks look to offer gaps of adequate proportions which would offer likely shelter/access opportunities for bats within.<br><br>The rear roof coverings have also demonstrated a moderate moss covering in areas which may obstruct visibility of any further gaps of value to bats. |

Image 1 – South facing elevation of the property where raised areas of leadworks and tiles look to offering gaps of adequate proportions for likely shelter/access opportunities

- 6.4** The main dwelling has evidenced roosting features of low value within the ridge coverings which look to offer access and availability to both void & crevice dwelling bats and could not be fully ruled out during the Preliminary Roost Assessment without causing disturbance to materials which in effect may cause disturbance to possible bat roosts within.

- 6.5** No evidence of bats was identified during the visit; however, we are unable to rule out or confirm any roosting evidence within the roof coverings where a section of raised tiles looks to offer gaps with likely shelter/access opportunities of which habitats of value to crevice dwelling species would be available. Evidence such as droppings would always be visible externally.

- 6.6** From viewing the proposed elevations, the identified features of value would suffer disturbance during the planned works.
- 6.7** In line with current accepted guidelines, a structure that has demonstrated low value such as the main dwelling must have a further single emergence or re-entry surveys to rule out or confirm activity from bats. This survey should be carried out within the recommended survey season from May to August.

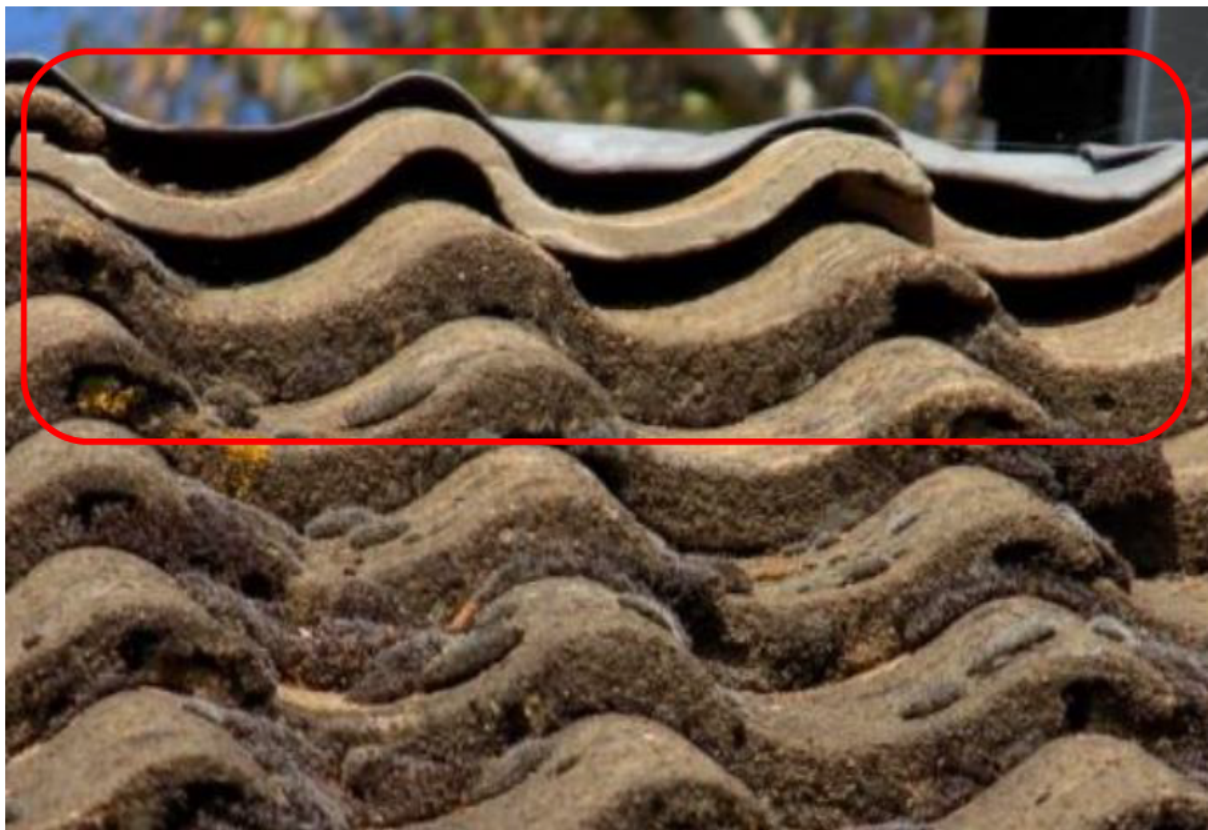
Image 2 – As per image one above

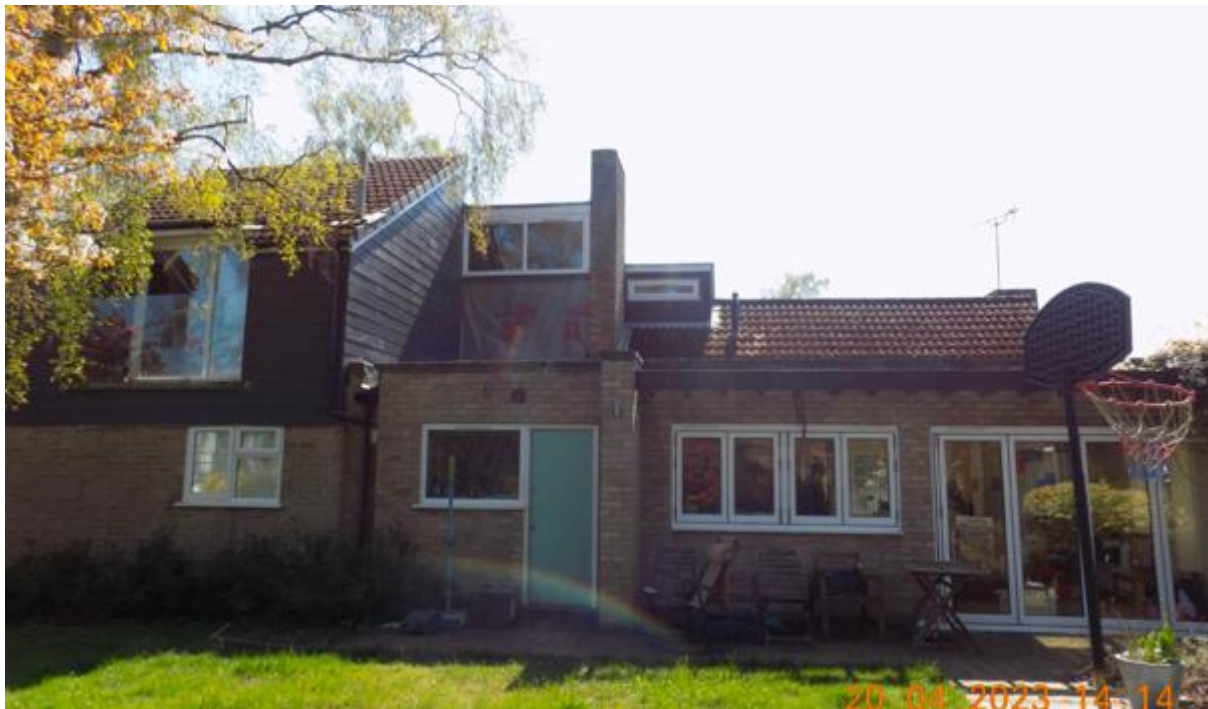
Image 3 – North facing elevation of the property

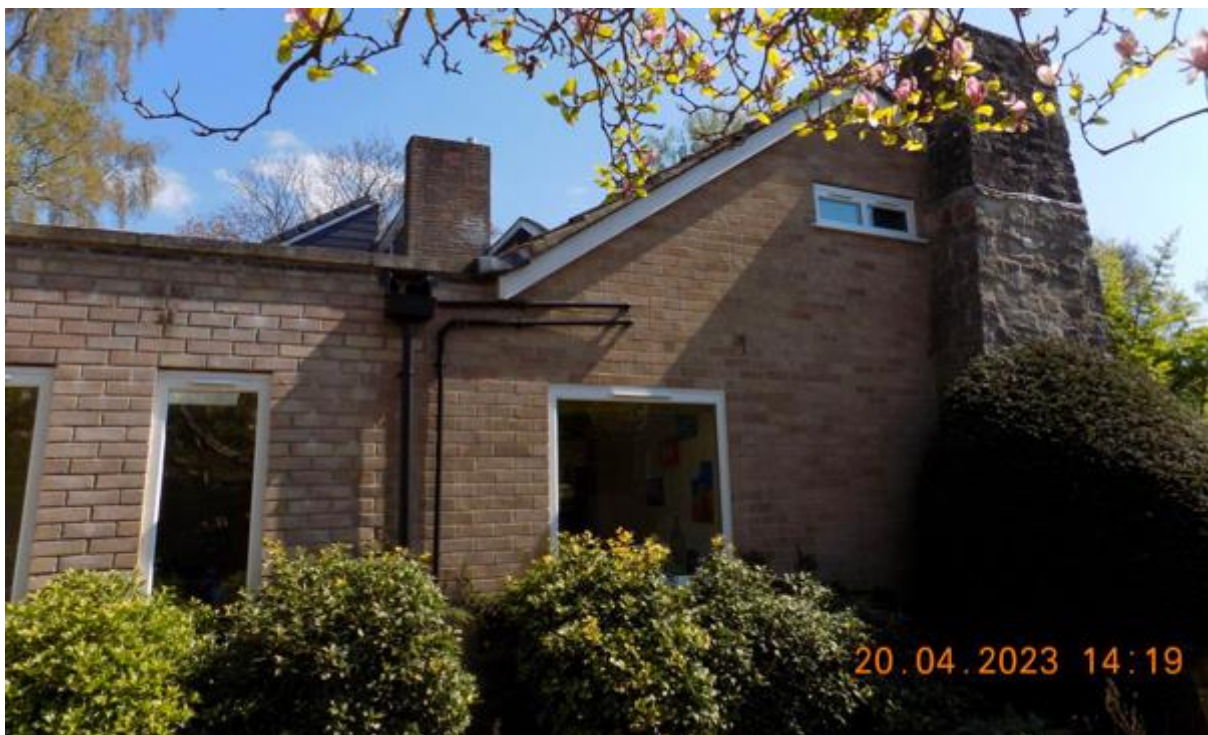
Image 4 – West facing elevation of the property

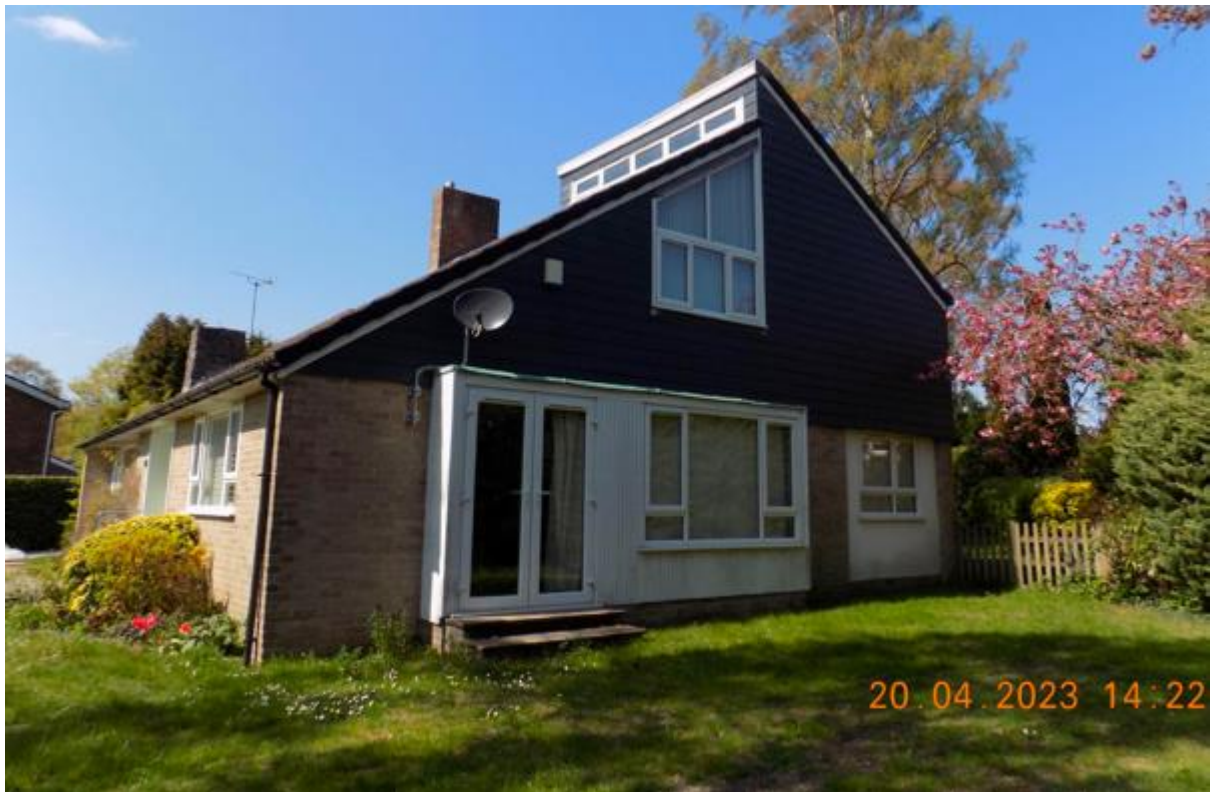
Image 5 – East facing elevation of the property

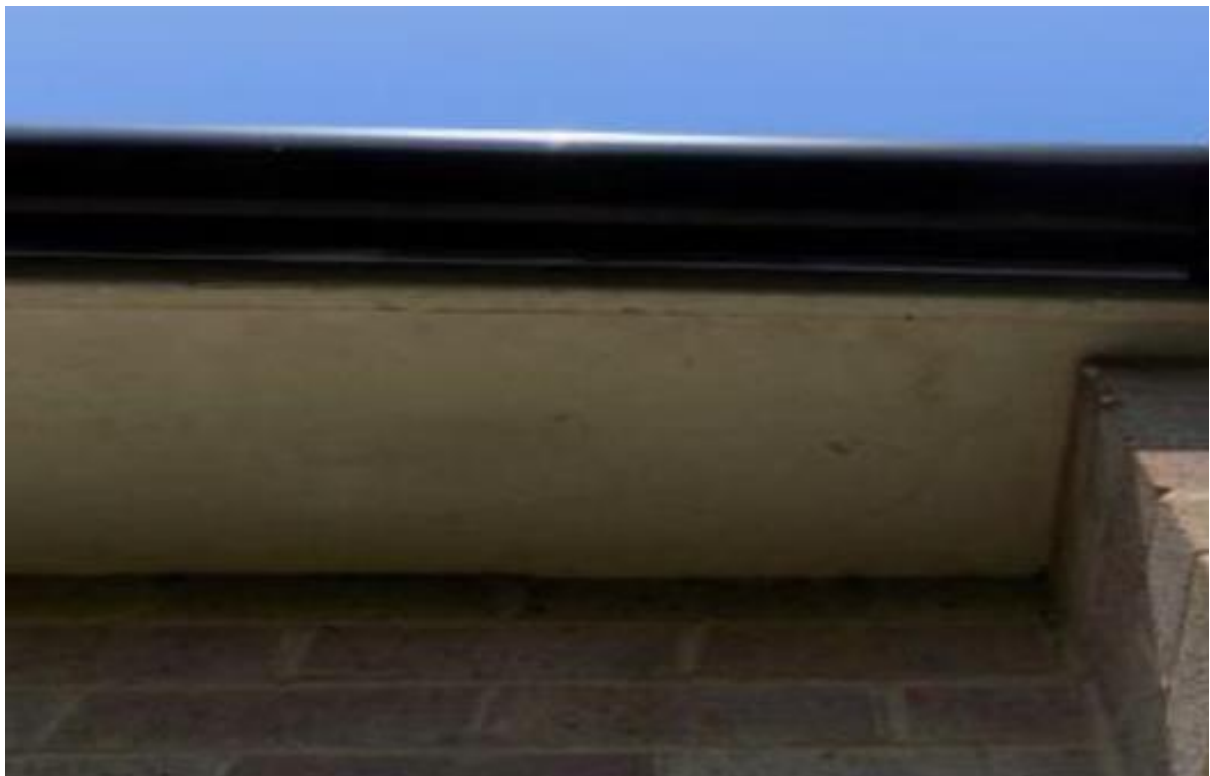
| External | Features of value to bats | Notes |
|---|---|---|
| Eaves coverings | No | The eaves coverings to the structure have demonstrated a fair level of condition with no observed features of value to bats noted. |

Image 6 – Close view of the main eaves coverings which have demonstrated a fair level of condition throughout

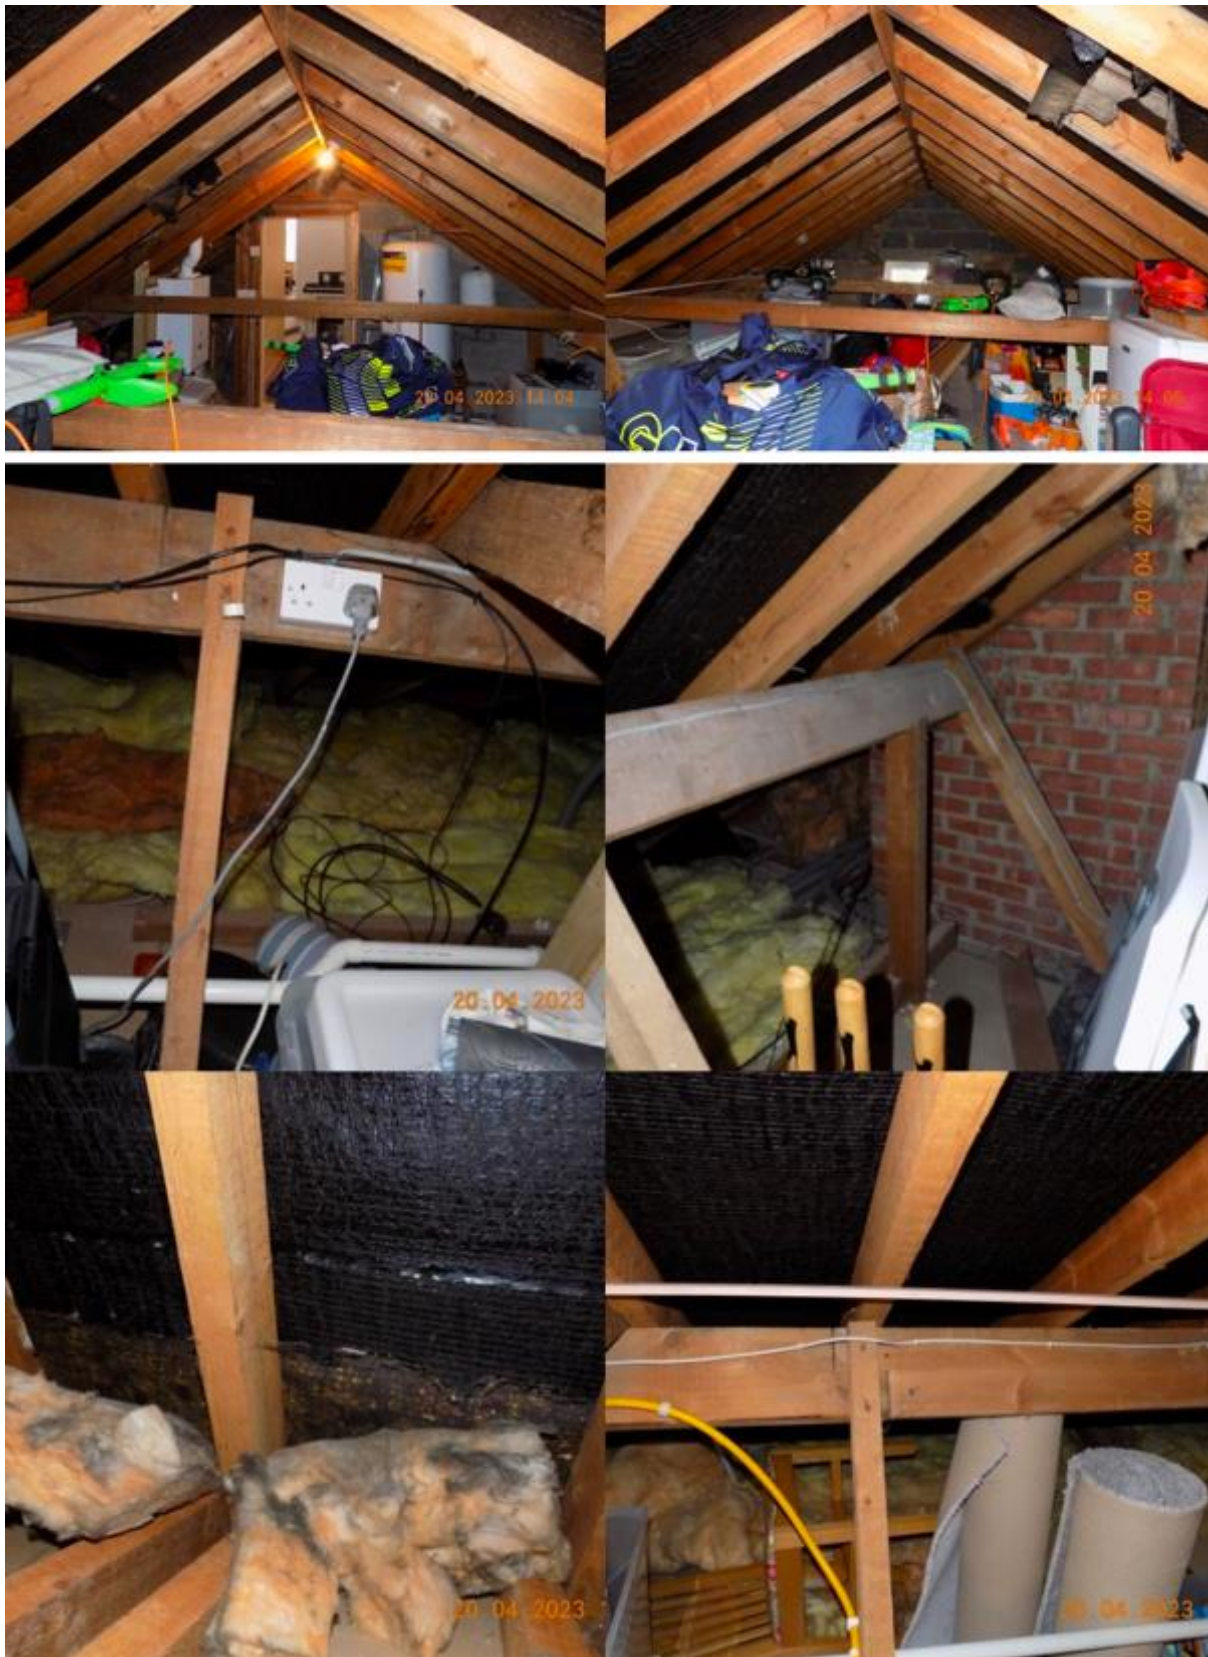
| Internal | Features of value to bats | Notes |
|---|---|---|
| Membrane coverings | Yes | A felt membrane covering was observed within the main roof void spaces below the roof tiles. |

| | | Such coverings would likely offer further roosting habitats for bats between the membrane and roof tiles where external gaps look to provide access. |

Image 7 – Internal view from within the accessible roof void spaces of the property

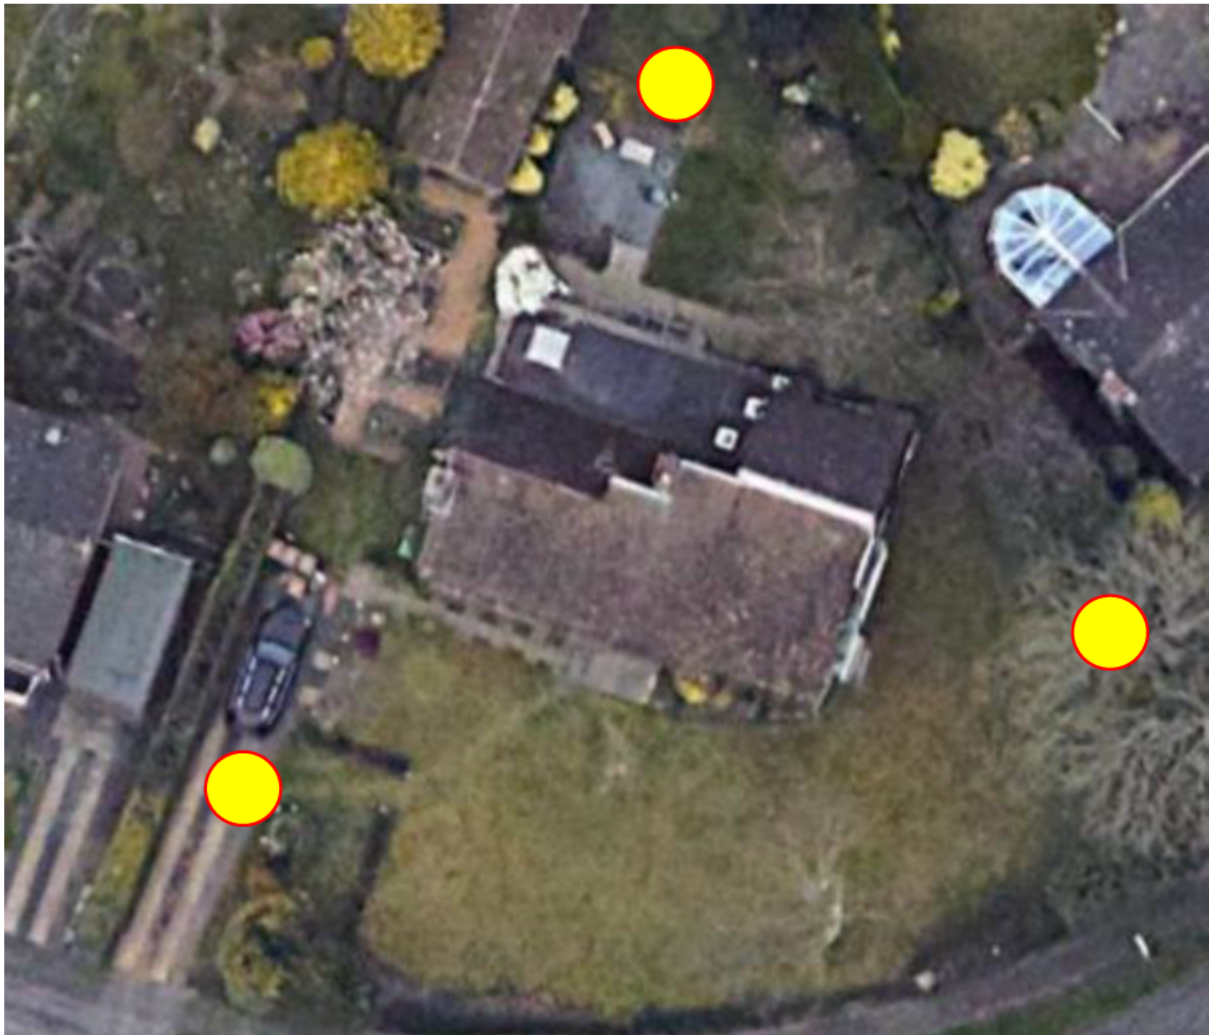
#### Appendix 4: Emergence Survey Location Points

Below site view to show suitable surveyor location points during each emergence survey to maintain visibility of the property.

In line with best practice survey guidelines, a total of three surveyors will be required to visually cover all elevations of the structure during each emergence survey.
