## BAT ROOST ASSESSMENT

13 WAVERLEY AVENUE, NETLEY ABBEY, SOUTHAMPTON, SO31 5AR.

FINAL REPORT

August 2023

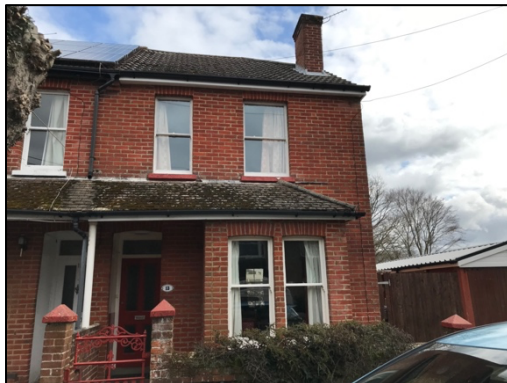
The house comprises a two-storey brick-built semi-detached structure which rises to a pitched, half-hipped and gable end design roof, which is clad with concrete interlocking roof and ridge tiles (Figure 1). The rear area is under a mono-pitched roof against the ridge parapet. The house is oriented south-west to north-east; the half-hipped section comprises the westernmost section of the house, with the gable end extending north-east from the rear. The roof extends beyond the wall plate and the eaves are enclosed with uPVC soffit boxes on the front elevation, and a mix of uPVC and wooden fascia boards and barge boards on the rear and side elevations (Figure 2). The eaves are formed from the ends of rafters just beyond the wall plate. The front section of roof supports two brick-built chimneys with lead flashing, one each extending from the south-western and north-eastern roof faces. A ground floor hipped porch and bay window are present to the front with windows set in wooden or uPVC frames. To the rear, the two-storey section creates a gable end with the neighboring property with a raised roof line composed of brick and concrete. The easternmost ridge supports one chimney stack which is unsupported and to be removed (Figure 3). A wooden framed conservatory set on a brick plinth with glass roofing sheets extends from the south-eastern elevation of the house (see Figure 3). Lead flashing covers the joins between the conservatory and the house.

Figure 1 – south-western elevation of house

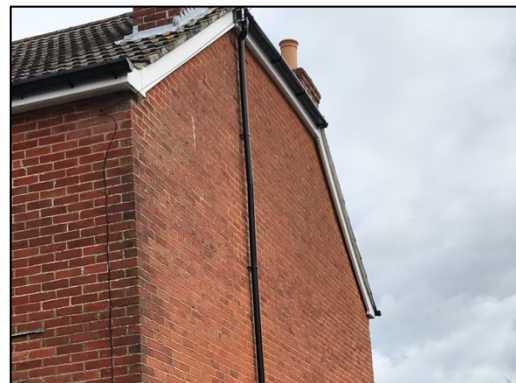
Figure 2 – south-eastern elevation of the house

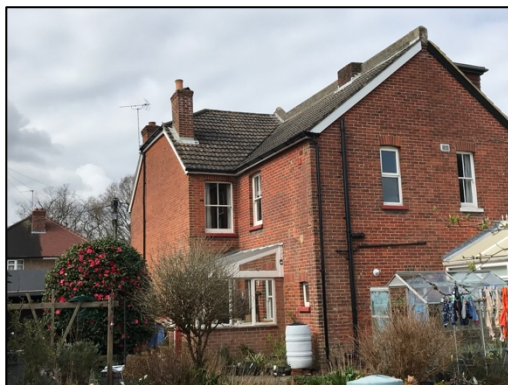
**Figure 3** – north-eastern elevation, also showing the conservatory at side elevation.

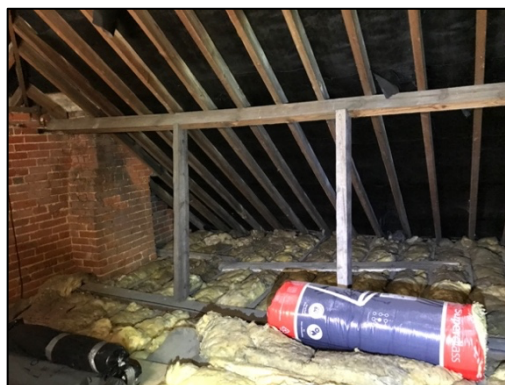
Internally, the house comprises a single roof void. The void floor is insulated with fibreglass insulation and the roof is lined with heavy-duty bitumen felt (Figure 4). The void is not boarded and supports moderate cobwebbing throughout as well as an abandoned wasp nest.

**Figure 4** – internal view of the roof void, facing south-west.

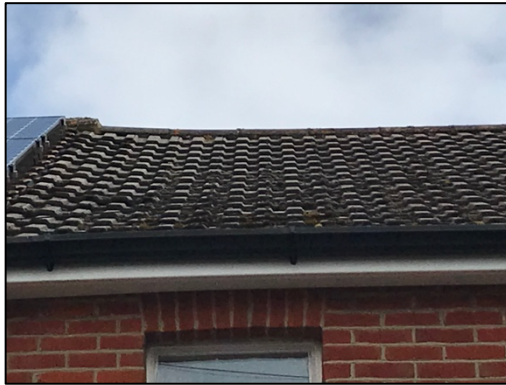
| <b>Suitability</b> | <b>Evidence</b> |
|---|---|
| <b>Exterior</b><br>The following suitable access/egress and roosting features were recorded externally during the survey: <ul style="list-style-type: none"> <li>- Missing mortar under front ridge tile. (Figure 5).</li> <li>- Lifted roof tiles, including behind front chimney.</li> <li>- Lifted flashing around easternmost chimney.</li> <li>- Missing mortar in brickwork.</li> <li>- Gaps between soffits and brickwork (Figure 6).</li> </ul> | The following evidence of activity was recorded externally during the survey: <ul style="list-style-type: none"> <li>- Possible fur staining at the entrance to a gap between the soffit boxes and brickwork on the south-eastern elevation.</li> </ul> |

**Figure 5** – missing mortar under front ridge tile.

- Modified ridge tiles - A roosting void beneath two ridge tiles will be created on the re-roofed property. Access to the void will be created by leaving a gap in the mortar line below the ridge tiles. A batten measuring at least 20mm high by 50mm long will be inserted into the wet mortar and removed in order to create a gap of sufficient size.
- Traditional roof membrane - modern breathable membranes can be extremely harmful to bats, causing them to become entangled and die, while the bats make the membrane ineffective as they damage it. Traditional bitumen membrane should be used instead. Natural England will refuse bat licence applications where modern breathable membranes are proposed. See <https://www.bats.org.uk/our-work/buildings-planning-and-development/non-bitumen-coated-roofing-membranes> for more information on the current research into this.

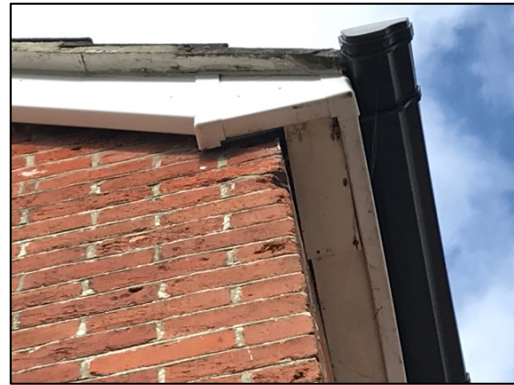
**Figure 6** – lifted soffits at back corner section.

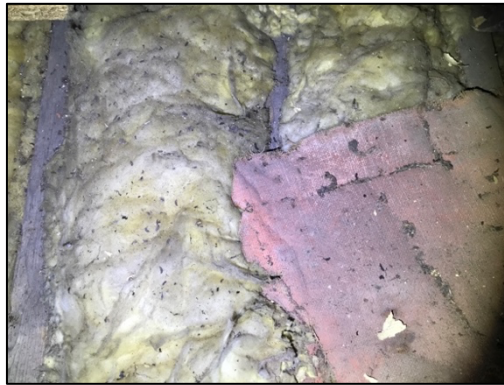
| <b>Suitability</b> | <b>Evidence</b> |
|---|---|
| <b>Interior</b><br>The following suitable access/egress and roosting features were recorded internally during the survey: <ul style="list-style-type: none"> <li>- Light visible at the eaves, indicating potential gaps.</li> <li>- Gaps in brickwork, mainly around chimney breast.</li> <li>- Exposed beams and loose lining.</li> </ul> | The following evidence of activity was recorded internally during the survey: <ul style="list-style-type: none"> <li>- Approximately 40 long-eared bat type droppings under front left hip (Figure 7).</li> </ul> |

**Figure 7** – concentration of long-eared bat type droppings under the front hip in the south-west corner in the roof void.

The phase 2 surveys have confirmed that the house supports a brown long-eared bat transitional roost (confirmed during the preliminary roost assessment) and no further roosts (no bats were recorded emerging or re-entering during the activity surveys).

The completed house will support roost features which replicate existing characteristics and are proportionate to the roost which will be lost. The roof will be constructed using similar materials. As such, by undertaking simple modifications it will be possible to replicate existing roost conditions. The proposed features will comprise:
