**Garage at  
24 Kingsway,  
Chandler's Ford,  
Hampshire,  
SO53 1EN**

## **PHASE 1 BAT SURVEY**

**September 2023**

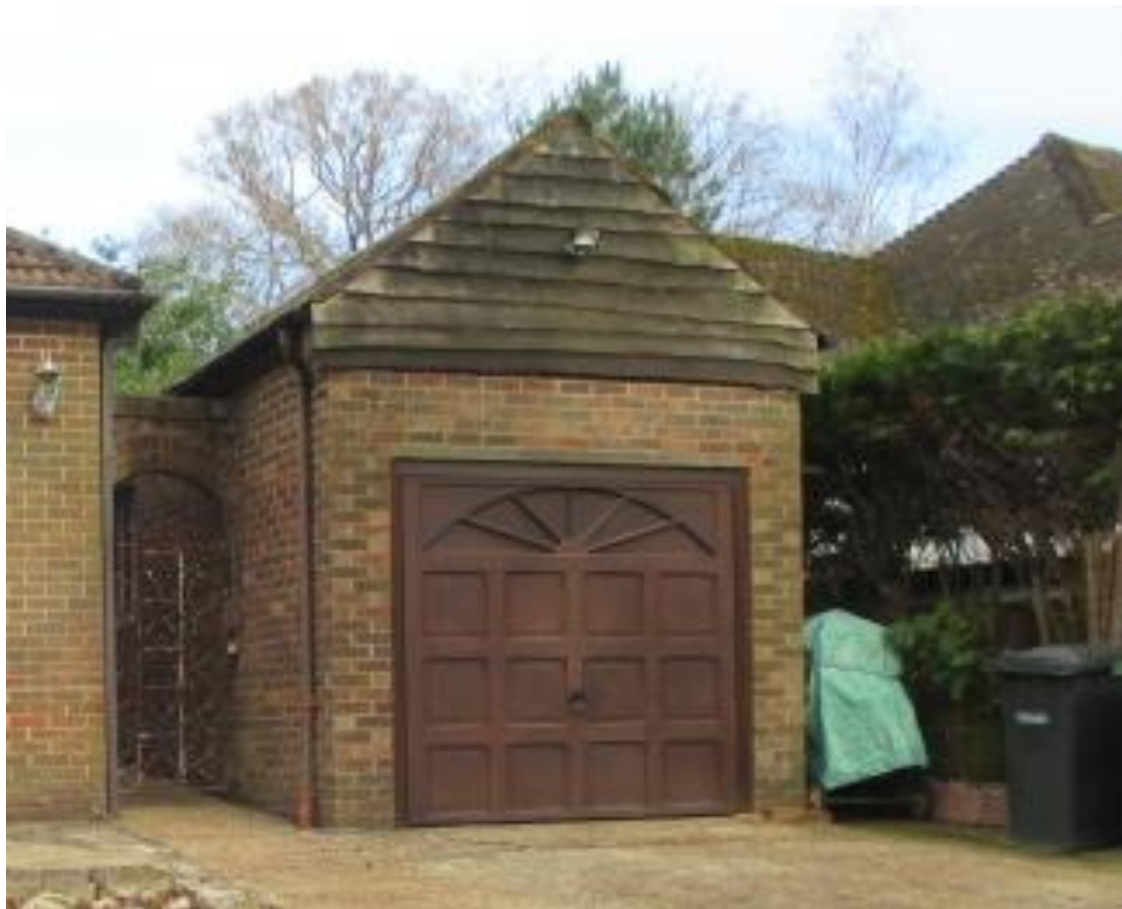
The property is a detached single garage built in the late 20<sup>th</sup> Century. The walls are of plain brick with a small section of lap-planking on the south gable above the up-and-over door (see figure 1).

**Figure 1. Garage looking northeast.**

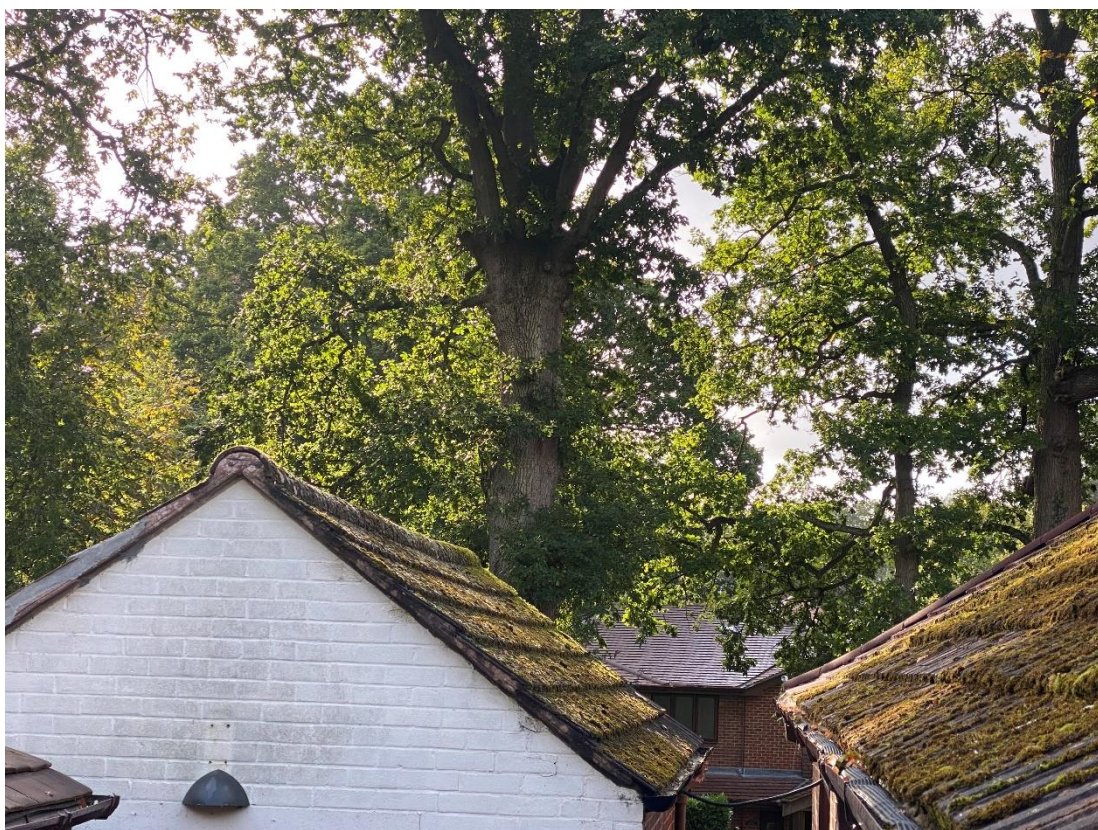
The roof is of close-fitting cement tiles which are in good order with an abundant covering of moss (see figures 2-3). The lap planking is slightly warped, but the gaps do not open into the space between the brick gable and the timbers. The small opening at the southwest corner was examined and does not open into a void (see figure 5). The eaves are sealed off with no potential openings (see figure 4)

**Figure 2. Western and northern elevations looking south.**

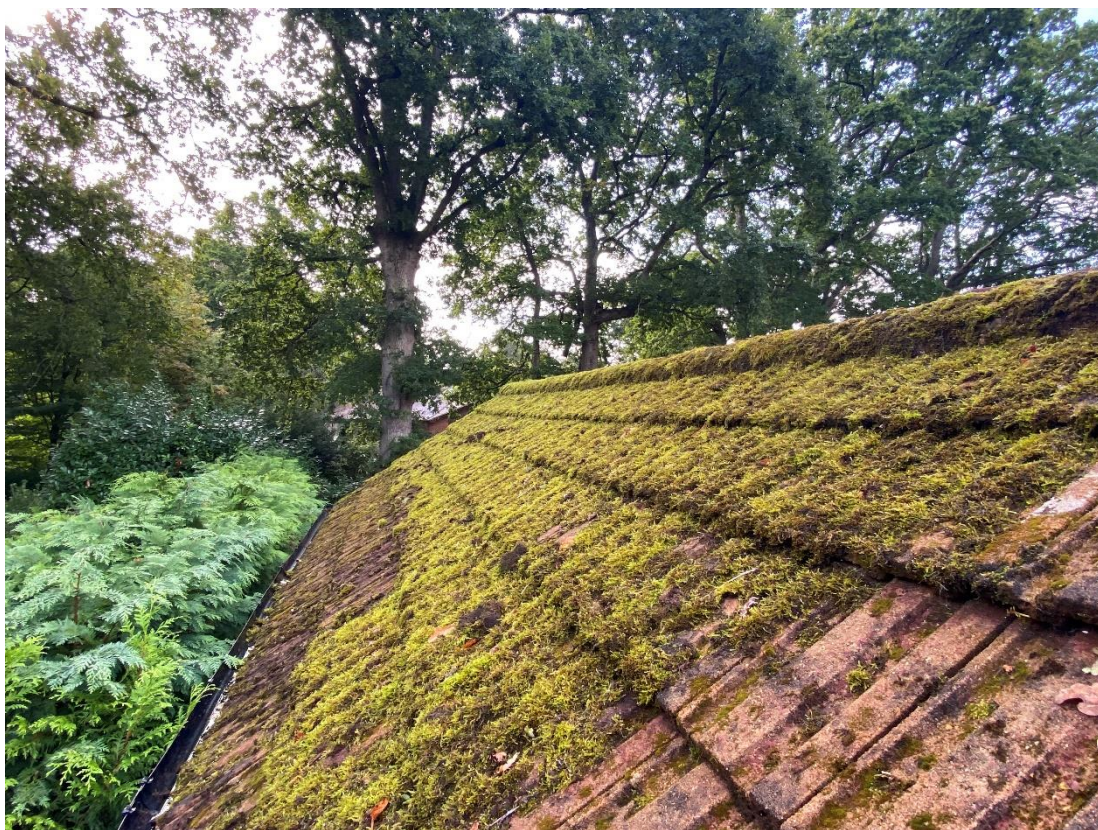
**Figure 3. East face of roof looking south.**

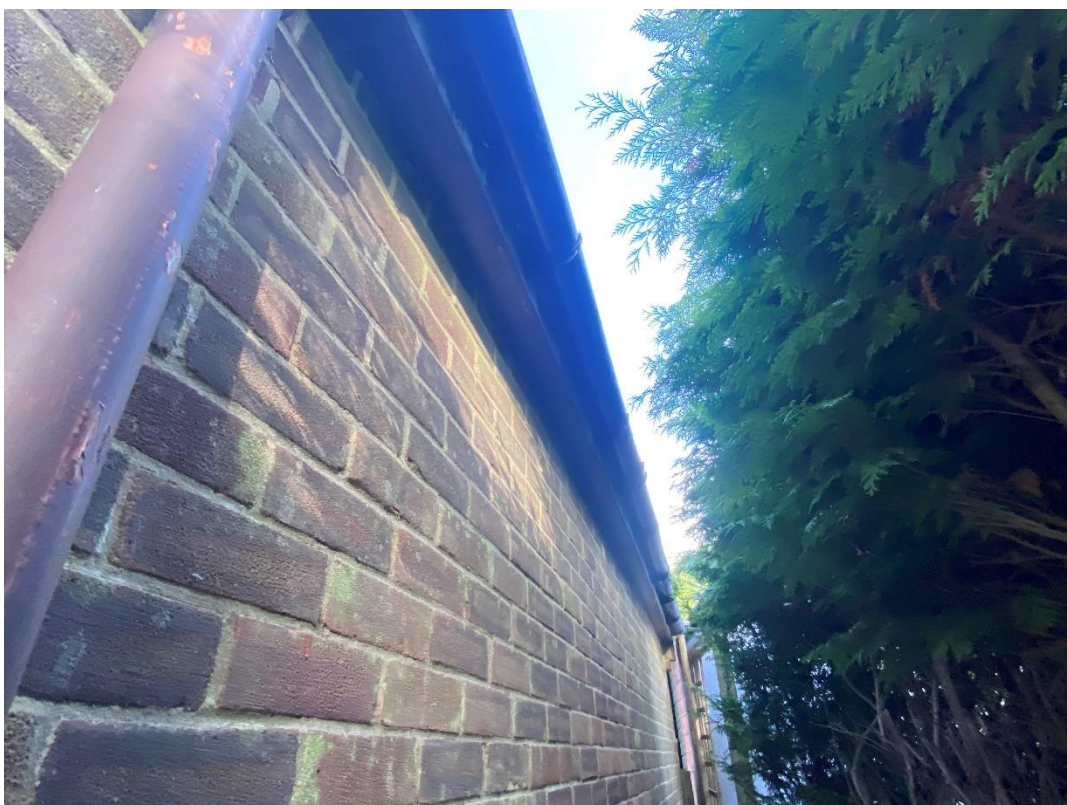
**Figure 4. East face of garage looking north.**

The roof has no openings into potential roosting spaces behind the lap planking, and the under eaves and roof tiles are all sealed off. Therefore, the garage has negligible potential for roosting bats and a phase 2 emergence survey is *not* recommended.

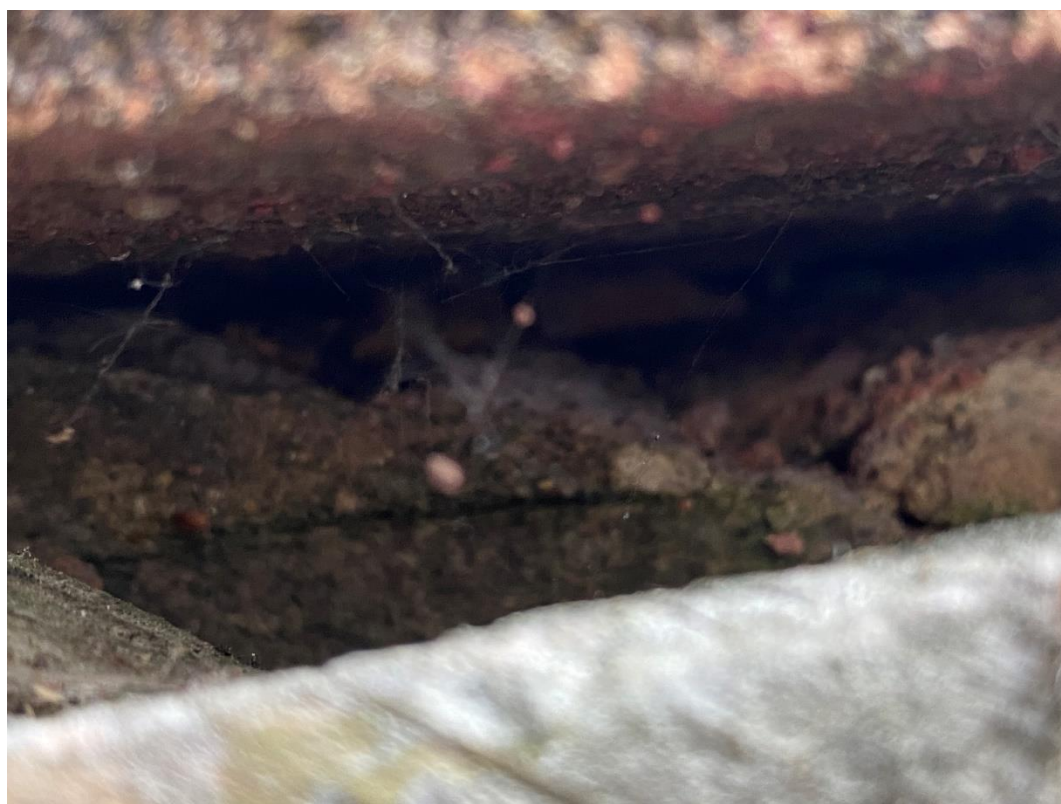
**Figure 5. Detail of opening at southwest corner adjacent to gutter: The space beneath is a shallow, closed off opening 40mm deep.**

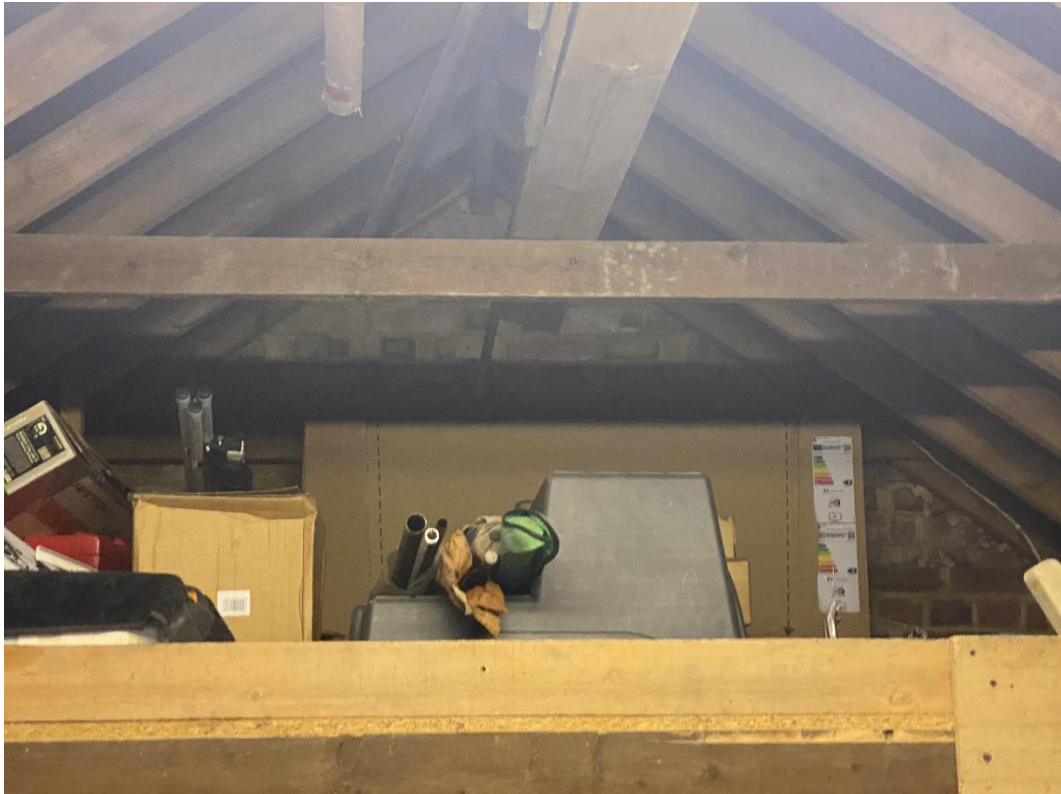
The roof space is incorporated into a garage which is permanently illuminated via windows on the north gable (see figure 4). There was no sign of any bat activity inside the garrge.

**Figure 4. Inside of roof space looking south**
