## PRELIMINARY BAT ROOST ASSESSMENT

KISMSET ALLINGTON LANE, WEST END, SOUTHAMPTON, SO30 3HQ

FINAL REPORT

September 2023

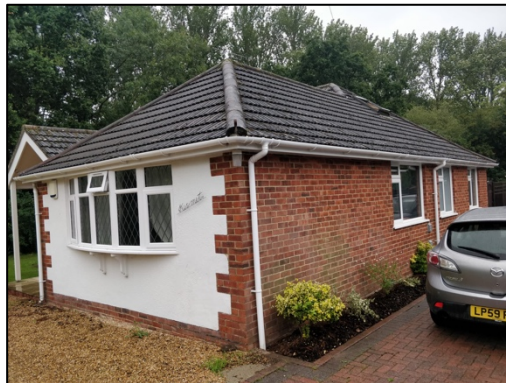
The structure comprises a brick-built bungalow which rises to a pitched and hipped roof design clad with concrete interlocking roof, ridge and hip tiles (Figures 1 and 2). The building is oriented south to north. Two extensions protrude from the southern elevation of the structure, the first features a pitched and hipped roof and the second a pitched roof with a gable end. Both extensions are clad with the same concrete roof tiles as the main building (Figure 3). A flat roofed single-storey extension protrudes from the northern elevation of the bungalow lined with roofing felt. The eaves extend beyond their wall plates and are enclosed in uPVC fascia, underboards and barge boards with closely adjoining uPVC guttering. A flat roofed dormer window clad with roofing felt is located on the northern roof face (Figure 4). A brick-built chimney extends from the southern roof face and two Velux windows are located on the eastern and western hipped roof faces. All windows and doors are set in uPVC frames which are tight fitting to the surrounding brickwork.

**Figure 1** – south-eastern corner of the bungalow

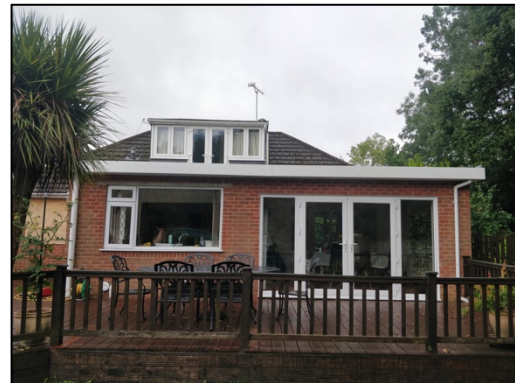
The zone of impact on the bungalow comprises the entire northern elevation, roof face, northern flat roofed extension and dormer window.

**Figure 2** – northern elevations of the bungalow

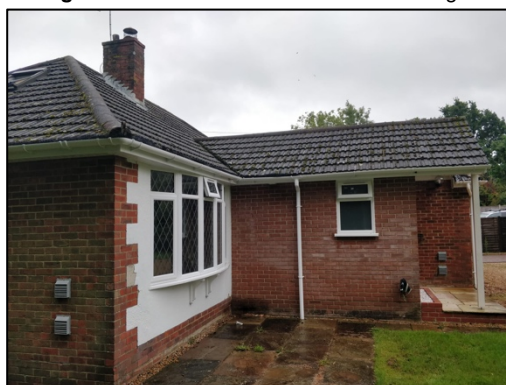
**Figure 3** – southern gable end porch extension

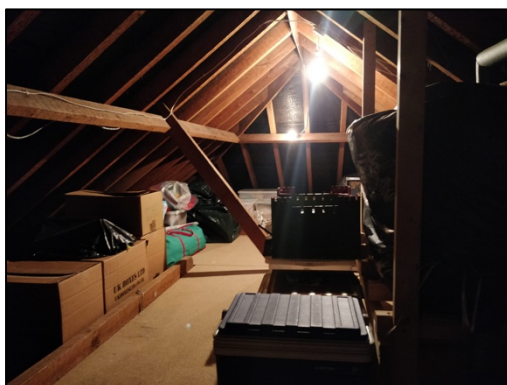
Internally, the structure supports a single roof void which runs along the full length of the southern hipped extension and wraps around the southern and western side eaves of the main roof (Figures 5 and 6). The void comprises heavy-duty bitumen felt lining under the roof, and fibreglass insulation on the floor. The void is partly boarded and used for storage with light cobwebbing throughout.

**Figure 5** – roof void in southern hipped extension

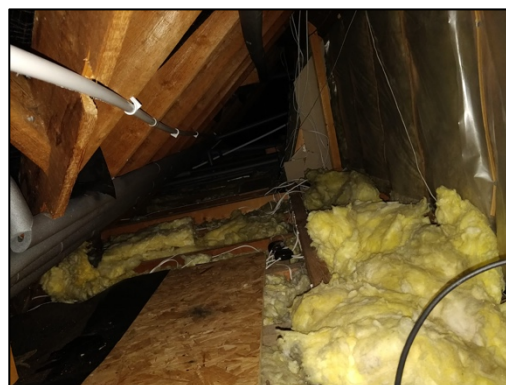
**Figure 6** – roof void extending along the side eaves.

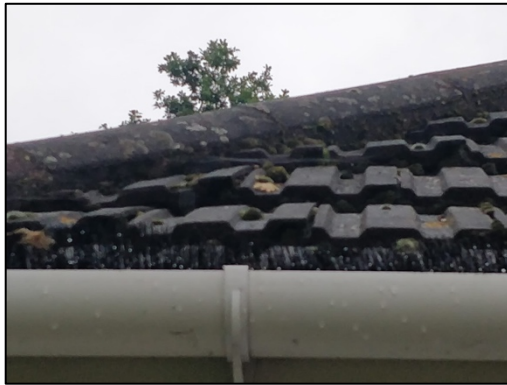
| <b>Suitability</b> | <b>Evidence</b> |
|---|---|
| <p><b>Exterior</b></p> <p>The following suitable access/egress and roosting features were recorded externally during the survey:</p> <p>Inside ZOI:</p> <ul style="list-style-type: none"> <li>- N/A</li> </ul> <p>Outside ZOI:</p> <ul style="list-style-type: none"> <li>- Gaps under lifted tiles (Figure 7).</li> <li>- Lifted lead flashing around the southern chimney (Figure 8).</li> </ul> | <p>No evidence of roosting activity was recorded externally during the survey.</p> |

**Figure 7** – lifted concrete tiles

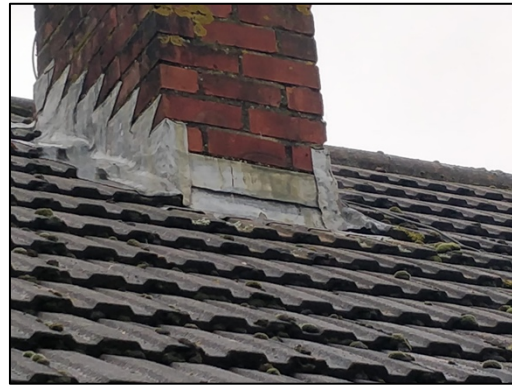
**Figure 8** – sections of lifted lead flashing around chimney
