**Phase I - II  
Geo-Environmental Site Assessment**

**Land east of Moorhill Road, West End, Southampton, SO30 3AX**

**July 2023**

***Omnia ref: A11641/1.3***

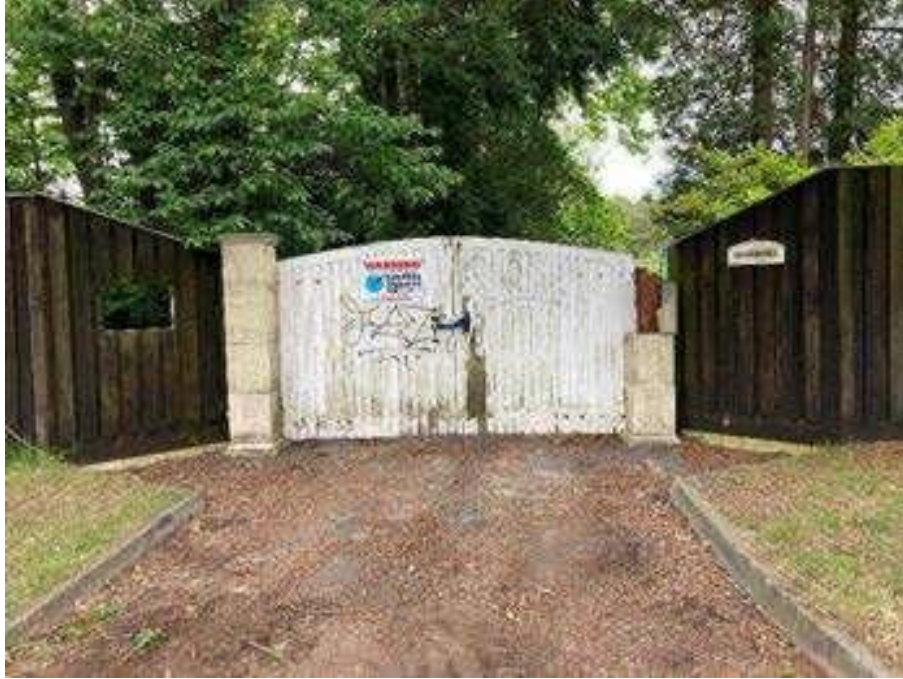
Photograph 1- Access gate from Moorhill Road, facing east.

At the time of the site walkover the site was accessed via a private tarmac road which was noted from visual inspection to be in good condition. The site was secured by two (2no.) wooden gates with concrete pillars at this access point from Moorhill Road (Photograph 1). The wooden gates were secured by key padlocks. The remainder of the site was bordered by wooden fencing.

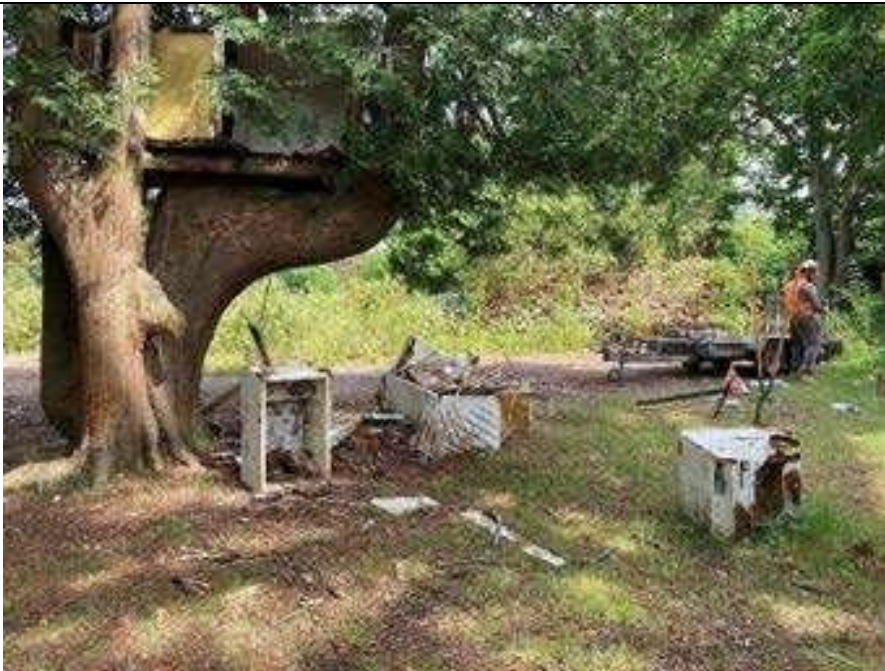
Photograph 2- Fridge appliances on the western boundary. Facing southeast.

Within the north-western corner of the site presumed fly-tipped waste was noted and comprised three (3no.) disused fridges (Photograph 2). Within the centre of the site was an approximately 10.00m x 3.00m x 2.00m pile of presumed demolition rubble (Photograph 3) which is presumed to be from the demolition of the former residential house evident on historical mapping. The demolition rubble contained glass, brick, concrete, and metal and was overgrown with grass.

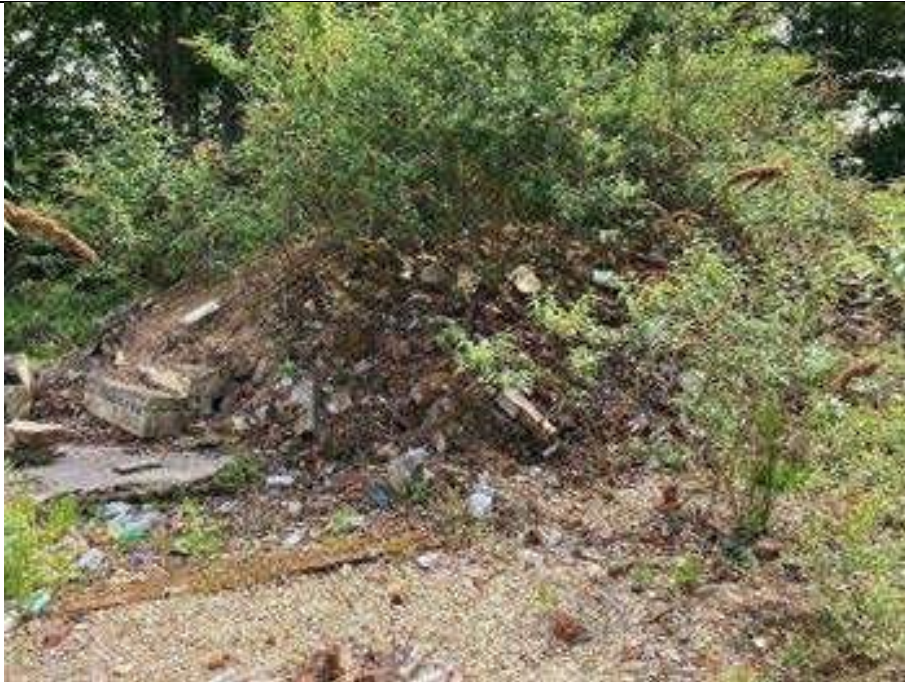
Photograph 3- Waste storage containing demolition rubble from previous residential house. Facing south.

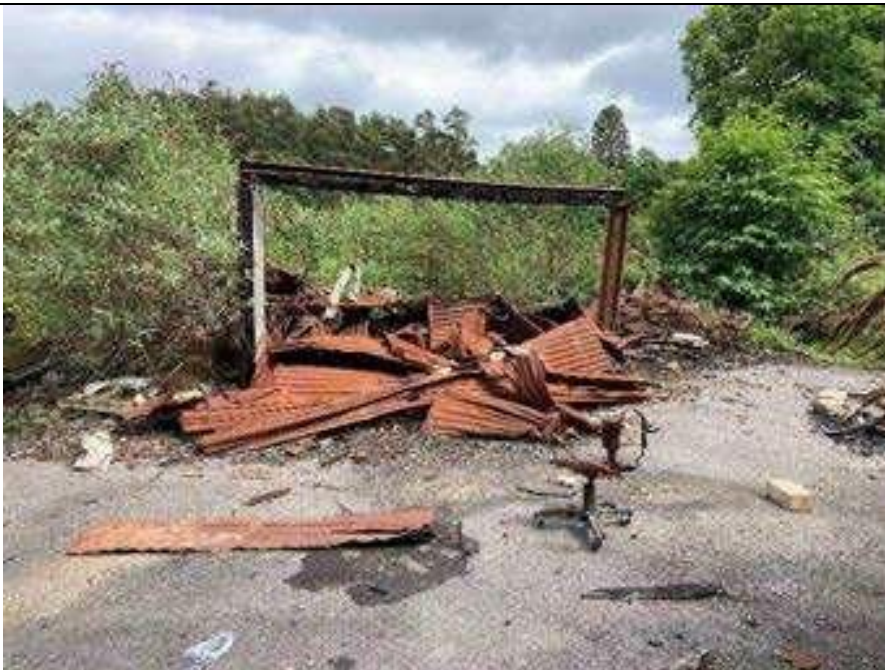
In the centre of the northern extent of the site was a stockpile of metal (Photograph 4). This was rusted, and staining was noted on the hardcore tarmac floor from previous burning. The pile of metal contained metal racking, corrugated iron roofing approximately 5.00m x 2.00m x 2.00m in size.

Photograph 4- Waste storage containing metal. Facing East.

In the centre of the northern extent of the site was a stockpile of metal (Photograph 4). This was rusted, and staining was noted on the hardcore tarmac floor from previous burning. The pile of metal contained metal racking, corrugated iron roofing approximately 5.00x2.00x2.00m.

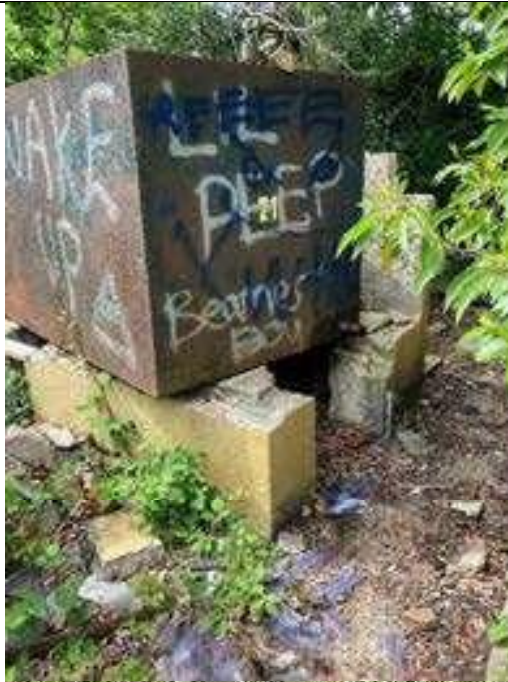
On the north western boundary was a rusted green above ground storage tank (AST) tank (Photograph 5) measuring approximately 1.50m x 1.50m x 1.50m. There was no visual evidence of leaking or staining on the floor, however a tar like substance (Photograph 6) was noted within the

Photograph 5- Rusted Green tank in the northeast of the site. Facing North

In the northern extent of the site was a green above ground storage tank (Photograph 5) approximately 1.50x1.50x1.50m. There was no visual evidence that the tank was leaking and no staining on the floor, however a tar like substance was noted with the pipe exiting the tank.

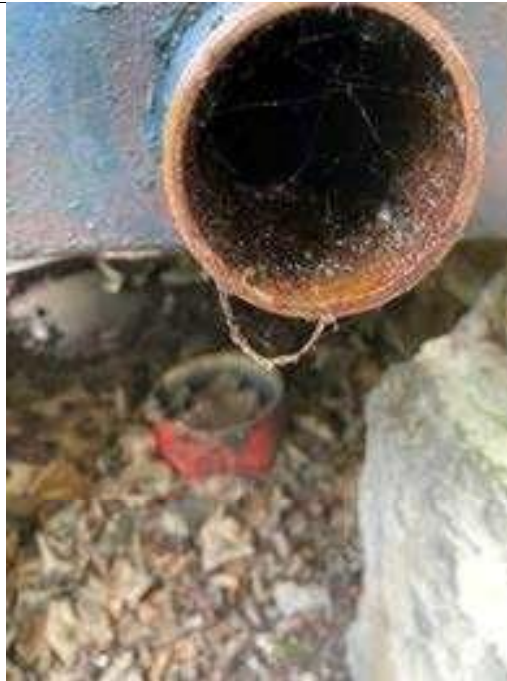
pipe exiting the tank. A concrete covered reservoir was also noted in the neighbouring site to the north, which ran the length of the northern boundary, which was identified as such on contemporary OS mapping.

Photograph 6- Tar Substance within pipe of rusted green tank on northern boundary. Facing west.

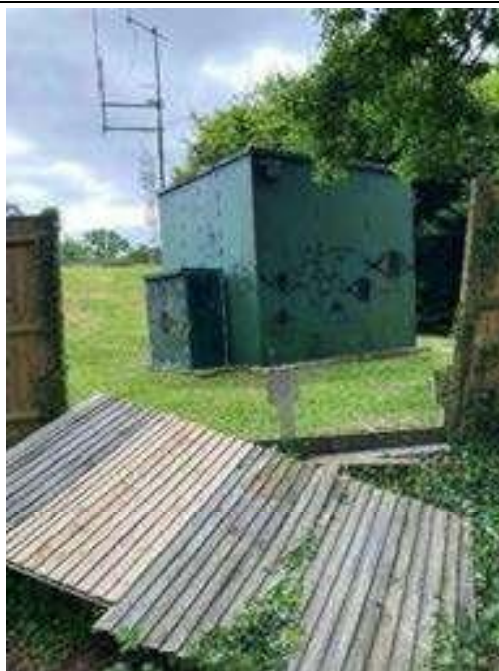
The site boundary was noted to be surrounded on all sides with wooden panelled fencing. One fence panel had fallen down on the southern boundary, which showed a mound associated with a covered reservoir located to the south and identified as such on contemporary OS mapping. Adjacent to the southern boundary was a control building associated with the reservoir with attached aerials presumed for a telemetry system (Photograph 7).

Photograph 7- Electrical substation on the southern boundary of the site, within neighbouring property.  
Facing South.
