# **SITE AT HAMBLE AEROSTRUCTURES – DEVELOTEC DESIGN & BUILD LTD**

## **Contaminated Land Desk Study & Intrusive Investigation Report**

**JUNE 2022**

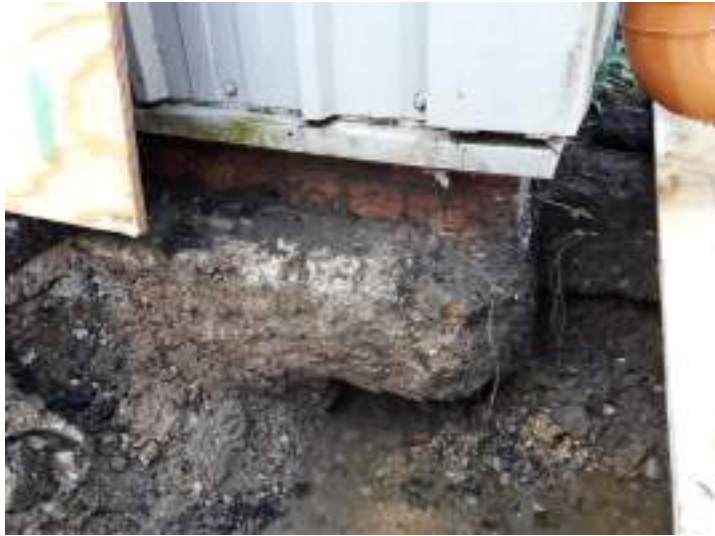
**Figure 6 – Foundation Excavation – TP12/FE12 (Drawing No. 22-83228/04)**

Photo 1: Image of TP12/FE12.

The Client requested information regarding existing foundations and confirmation on the founding strata for the existing storage facility. ACS collected a photo record of the existing structure and foundations and undertook foundation excavation drawings where appropriate. Only one foundation excavation drawing was undertaken for the Site due to the structure of the existing building.

The foundation excavation drawing from TP12 is included as Figure 6.

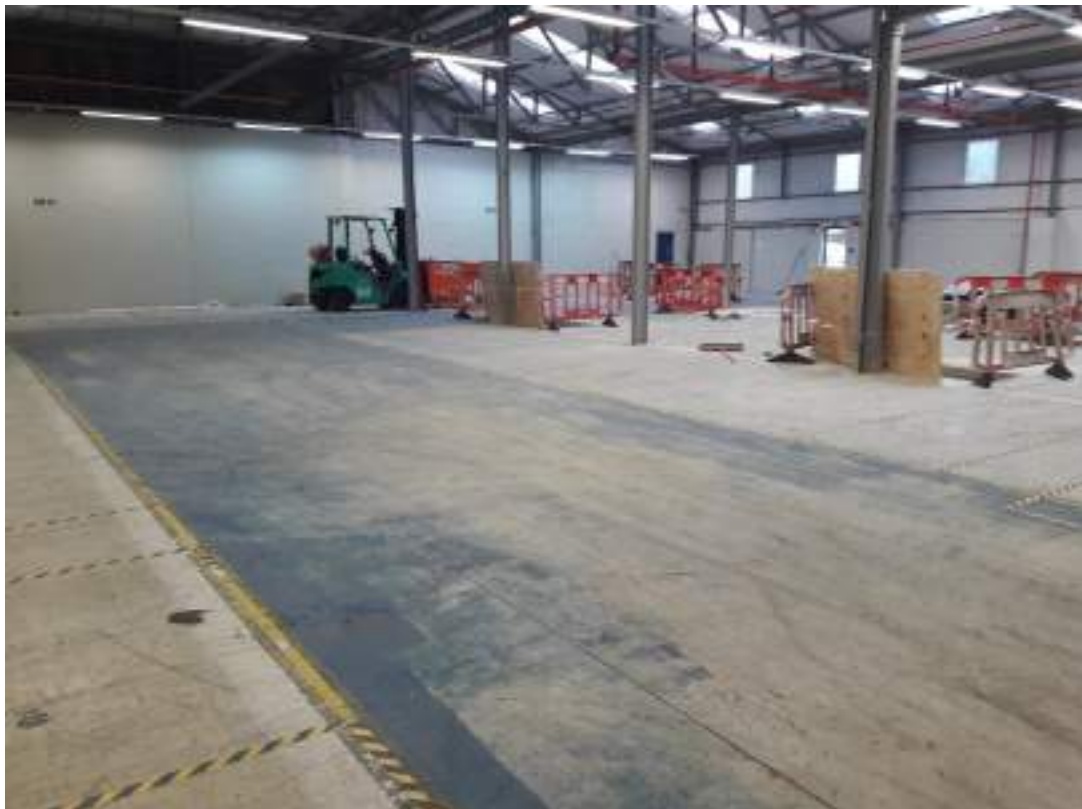
Photo 2: Image of internal commercial building.

The existing commercial building has a concrete slab (Photo 2) covering the surface of the building with a concrete slab also (Photo 3) covering the external northwest section of the Site. The commercial building was empty with only construction materials noted associated with the trial pit works (Photo 2).

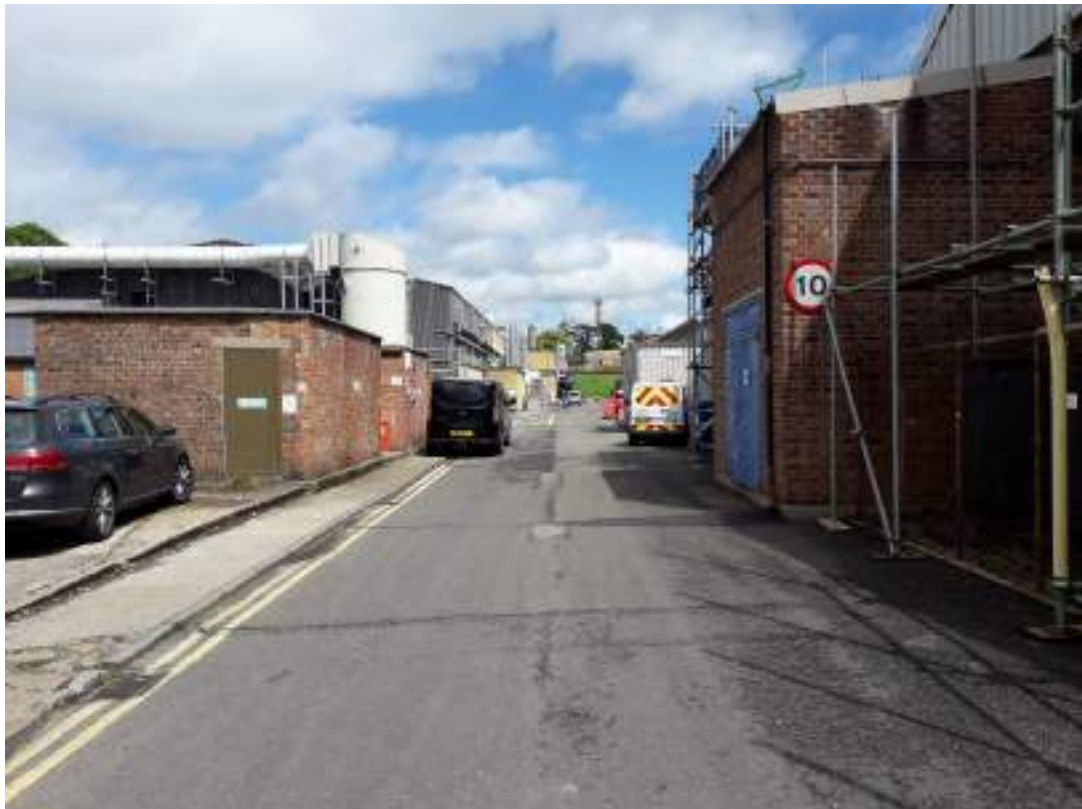
Photo 3: Image access road marking north west boundary of Site. Note the paint stores in the left of image.

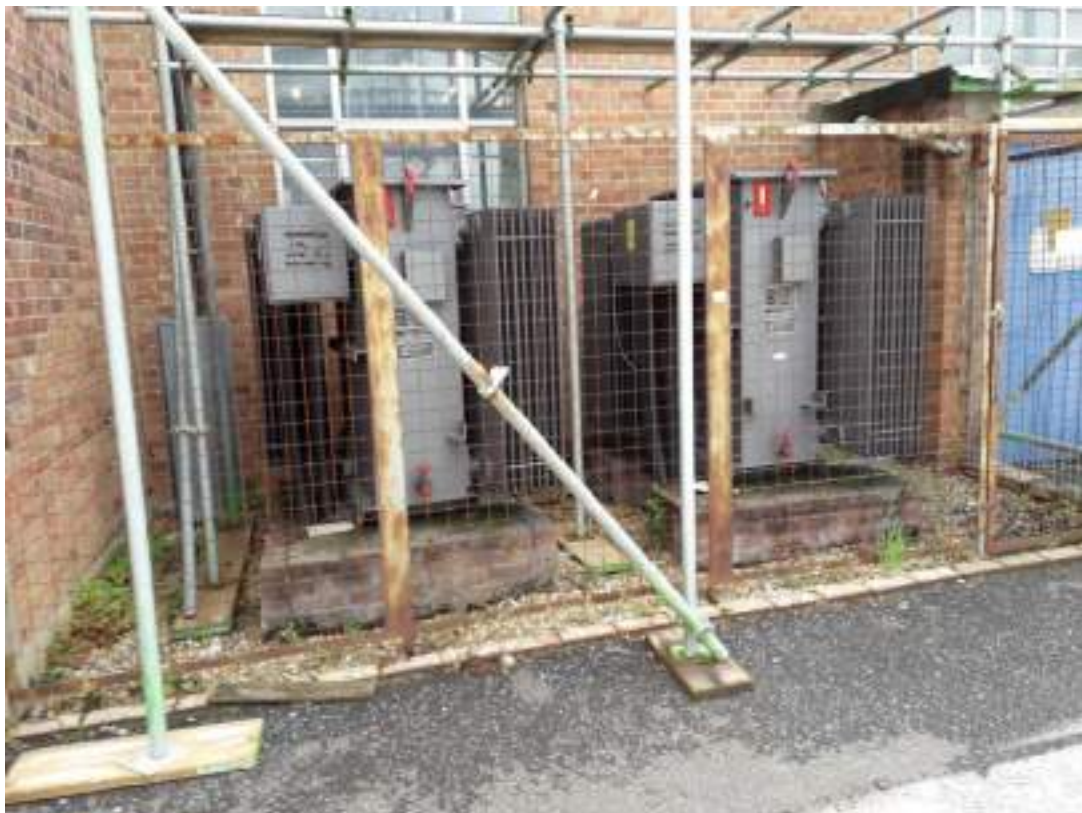
Photo 6: Image of electricity sub-station 15m west of the Site.

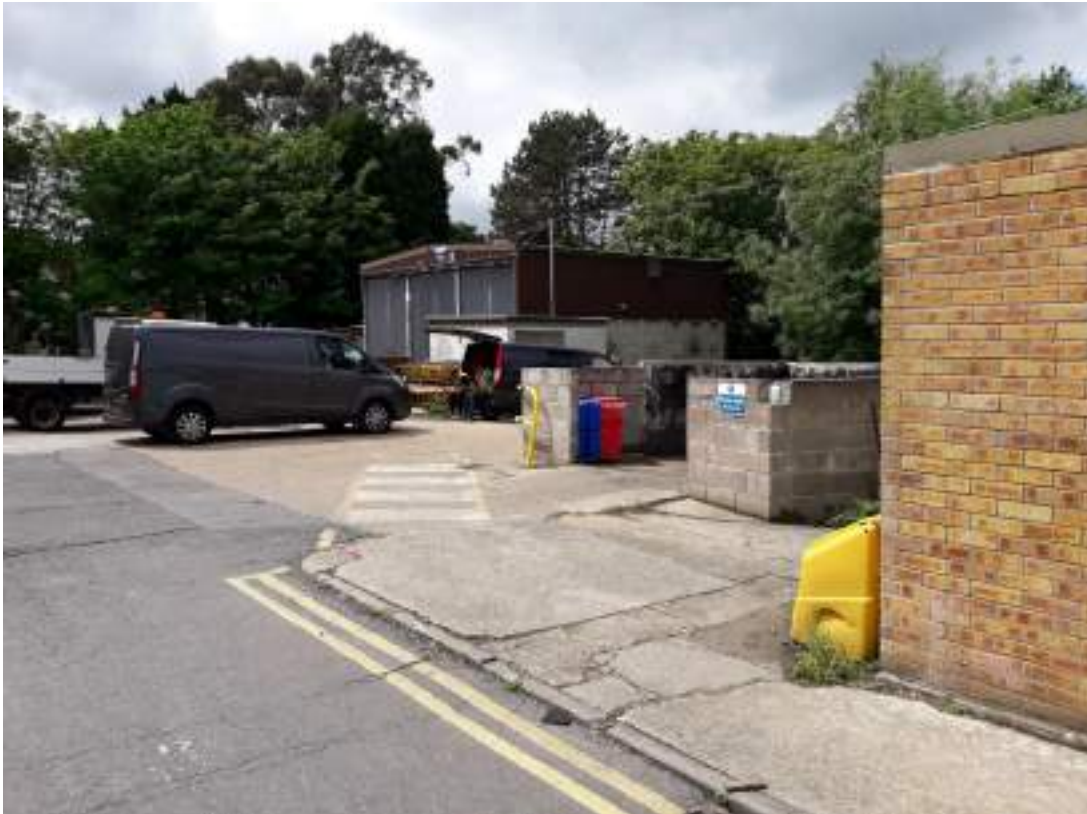
Photo 7: Image of wash off area.

The area surrounding the Site was associated with the commercial/industrial use of the entire larger site. The area to the northwest of the access road was occupied by various buildings and structures. Two buildings were denoted paint store (Photo 3) with buildings further to the northwest associated with the sprinkler system (Photo 4). A large tank was also present that contained the water for the sprinkler system (Photo 5). An electricity sub-station was located approximately 15m west of the site (Photo 6). A wash off area was also noted approximately 35m west of the Site (Photo 7). ACS was told that the wash off area had an interceptor.

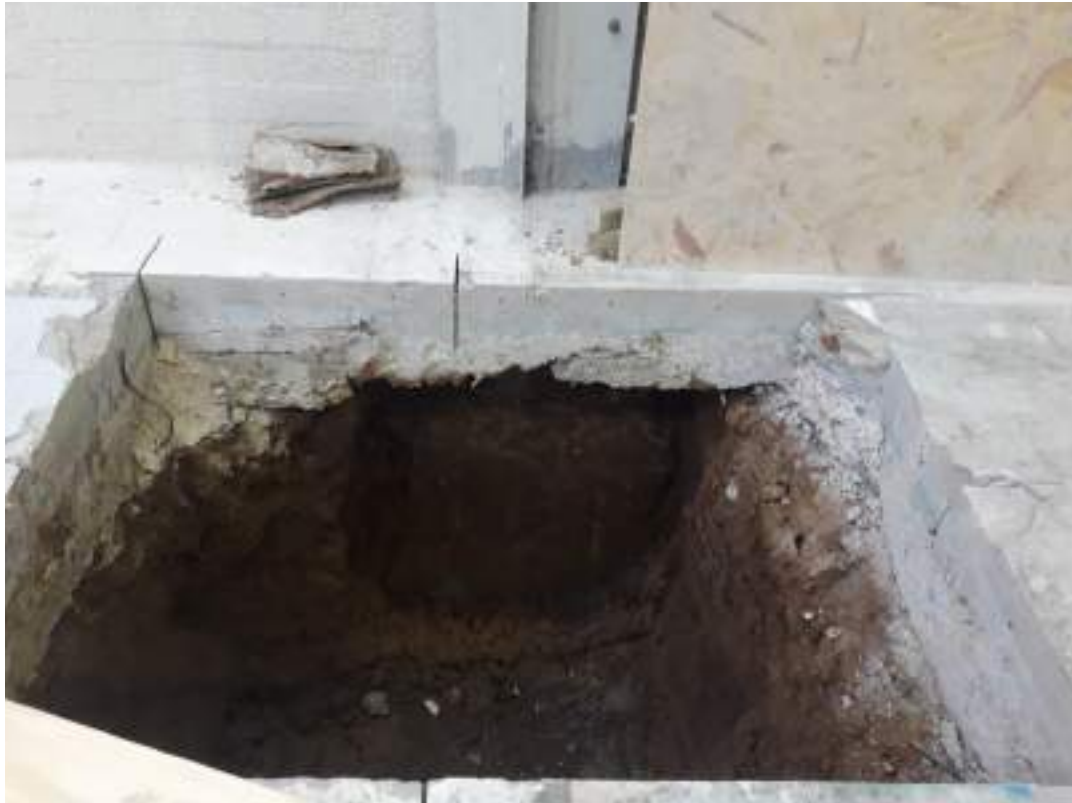
Photo 1: Image of TP01. Note the pile underlying the steel 0.70m wide. Base of pile unknown.

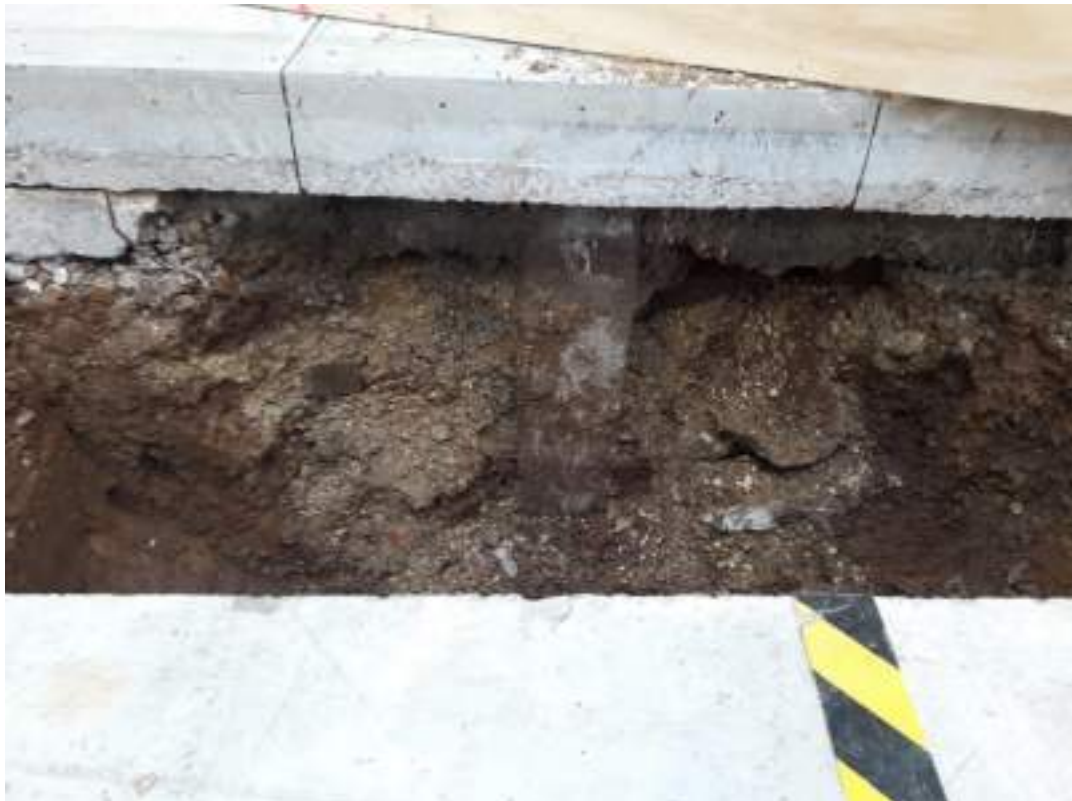
Photo 2: Image of TP02. Note the pile underlying the steel beam 0.20m wide. Base of pile unknown.

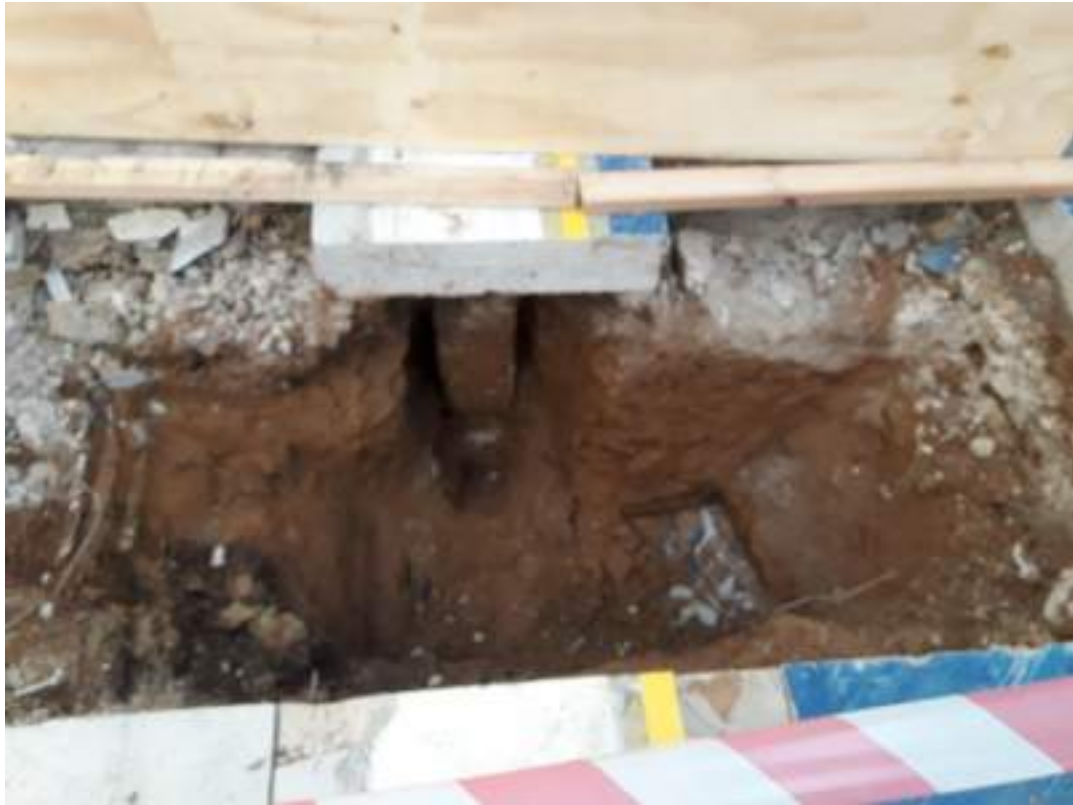
Photo 3: Image of TP03. Note the pile underlying the steel beam 0.20m wide. Base of pile unknown.

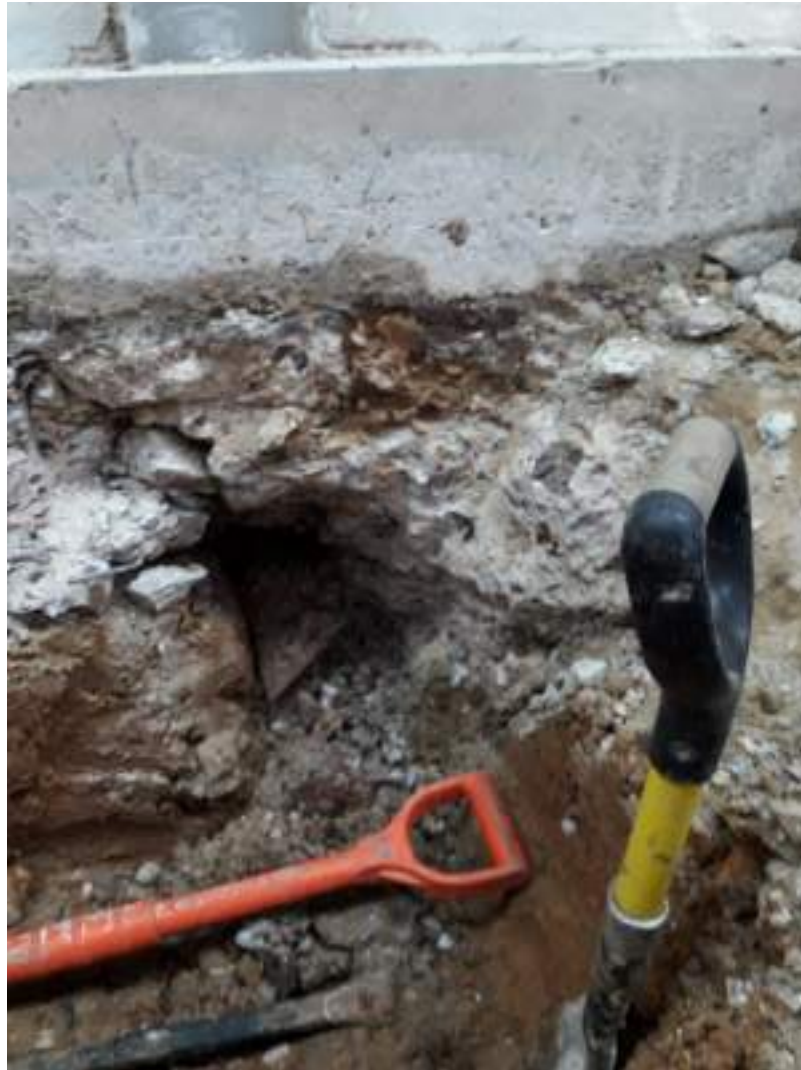
Photo 5: Image of TP04. Note the steel penetrating through the concrete and protruding out of the base of the concrete.

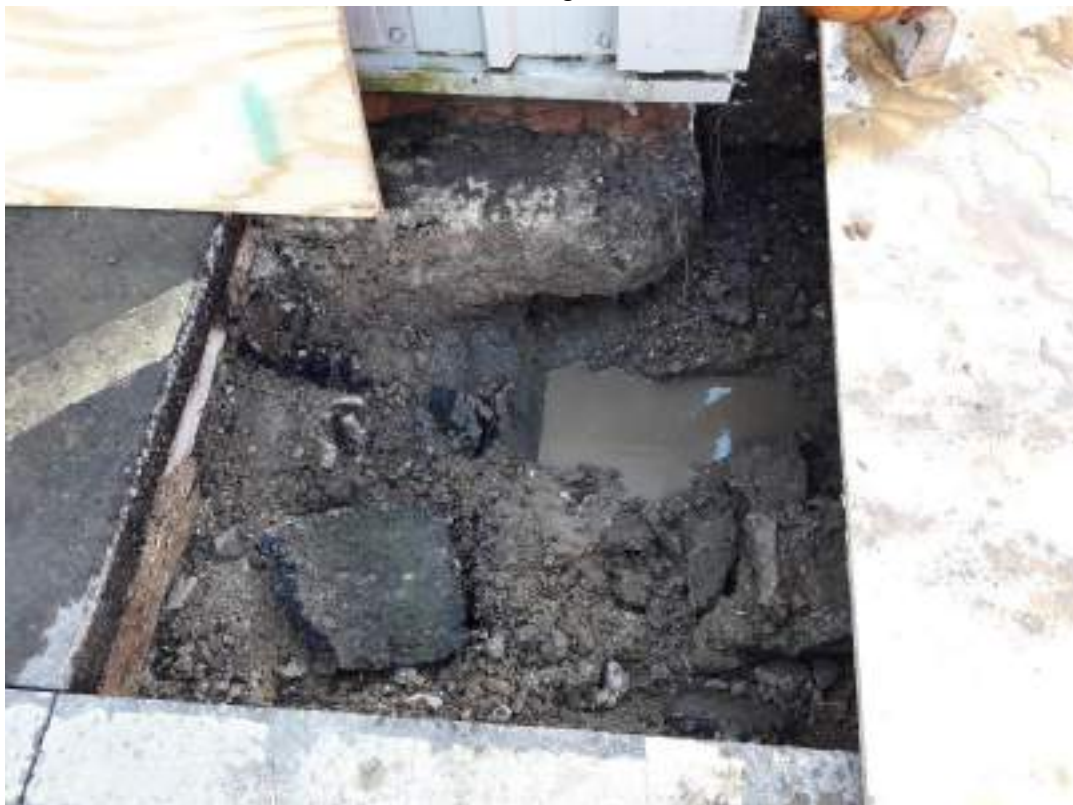
Photo 14: Image of TP12.

Hardstanding comprising concrete was encountered within all the trial pits proven from ground level to depths between 0.15mbgl and 0.55mbgl. One unit of Bound Macadam was noted in TP12/FE12 overlying the concrete.

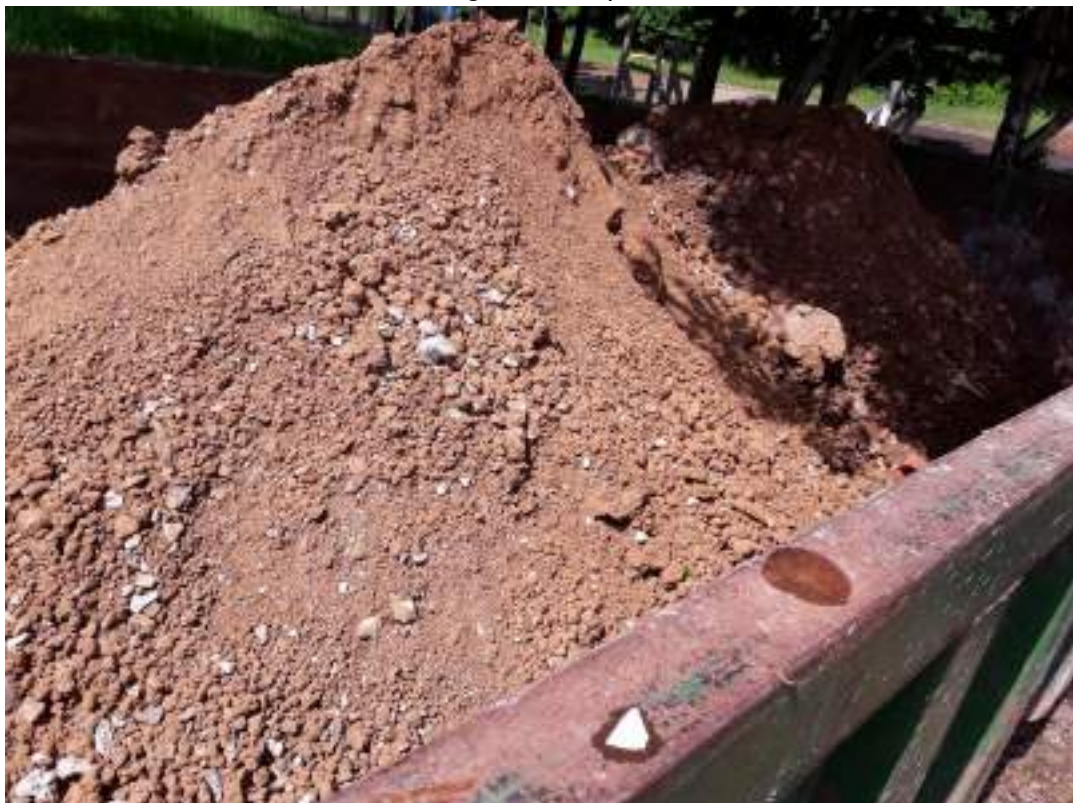
Photo 16: Image of soils within skip containing cement board.

Table 6 summarises the strata encountered during the intrusive investigation. No visual evidence of heavy metals or hydrocarbon contamination was observed in any of the exploratory holes on the Site. However, evidence of cement cladding (potentially asbestos containing material) was noted within the soils in a skip located on Site and within shallow soils underlying the concrete slab in TP01 and TP02. Full details are provided in the exploratory hole logs included as Appendix J.
