**Desk study and preliminary risk assessment report**

**Cockpit Barn, Knowle Lane, Horton Heath**

Alderbury Homes Ltd

July 2021

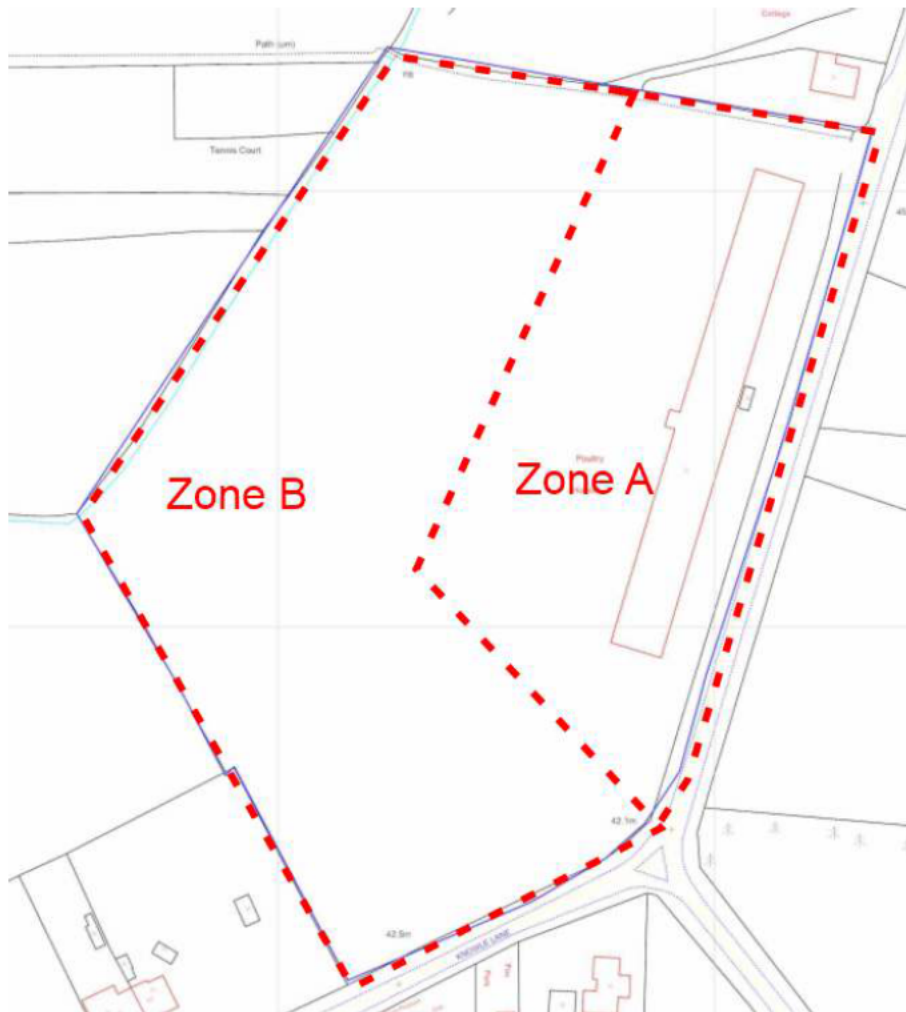
**Figure 2: Delineation of Zone A and Zone B**

There are no plans currently available for the proposed development, although it has been specified that the residential use will be limited to the area of the existing poultry house and the surrounding area (Zone A as defined below in Figure 2).

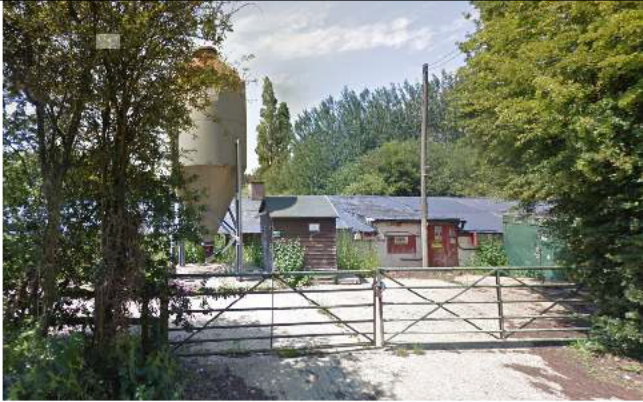
| Zone A | |
|---|---|
| Entrance from Knowle Lane | |

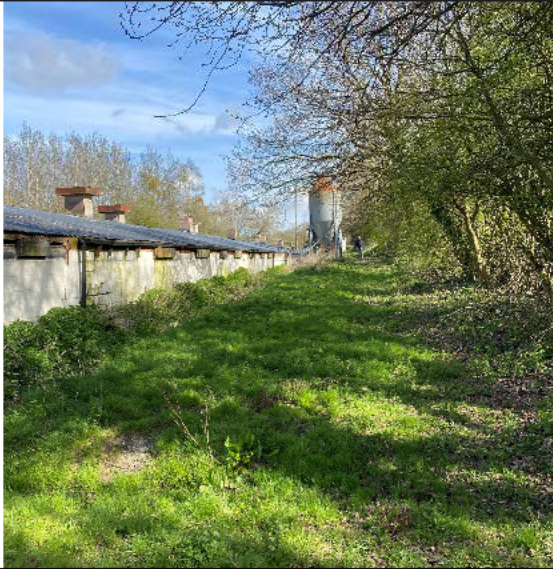
| Zone A | | |
|---|--|---|
| Eastern boundary of the site.<br>Raised bank to the east<br>which reduces to the south,<br>separating site from Knowle<br>Lane | | |

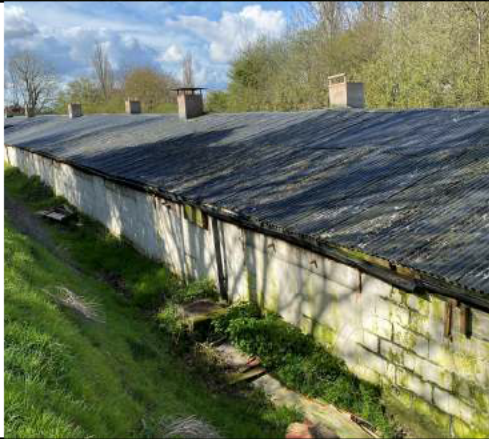
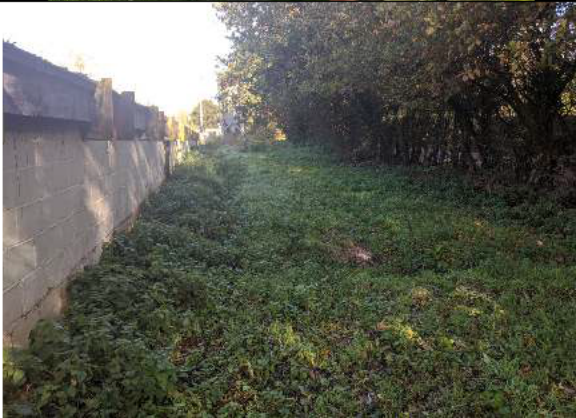
| Zone A | | |
|---|--|---|
| Eastern side of poultry house | | |
| Eastern side of poultry house | | |

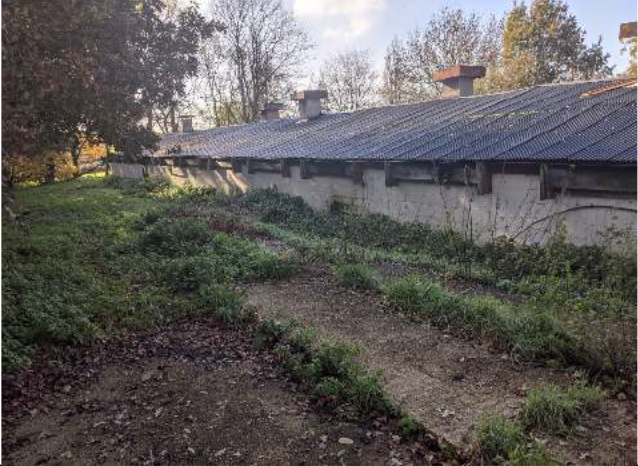
| Zone A | |
|---|---|
| Eastern side of poultry house looking south | |

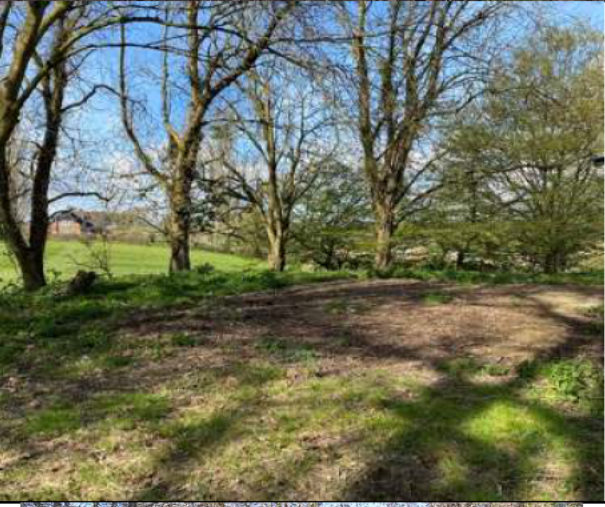
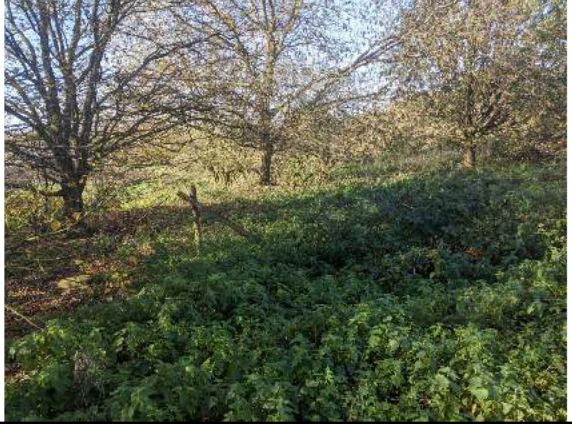
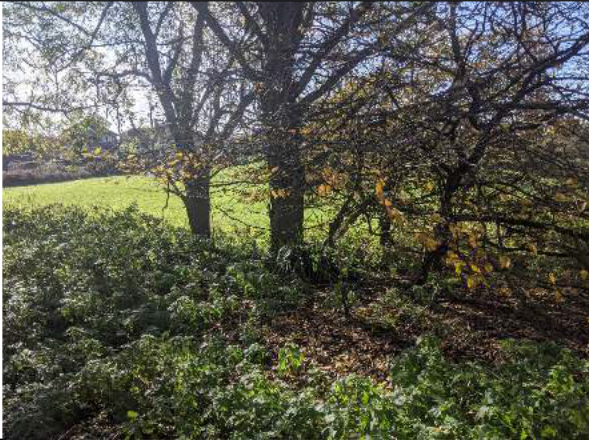
| Zone A | |
|---|---|
| The western area of Zone A with boundary to Zone B | |
| As above | |

| Zone A | | |
|---|--|---|
| As above | | |

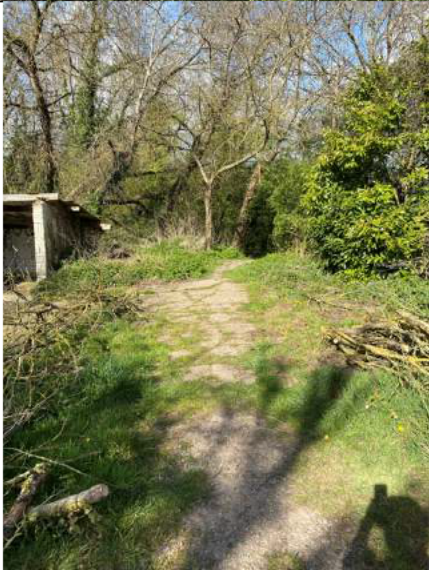
| Zone A | | |
|---|--|---|
| Public footpath running along northern boundary of the site, looking east to west. | | |

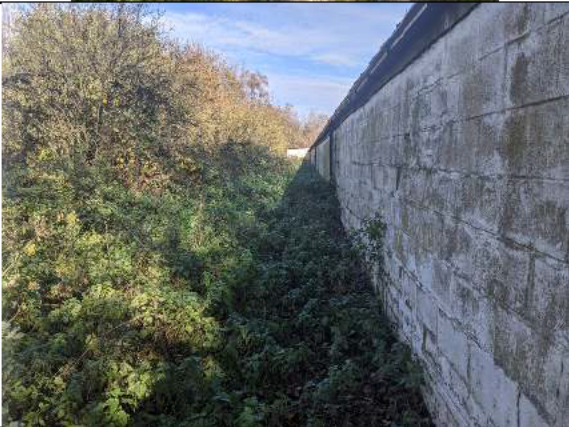
| Zone A | | |
|---|--|---|
| Western side of poultry house at southern end looking north | | |

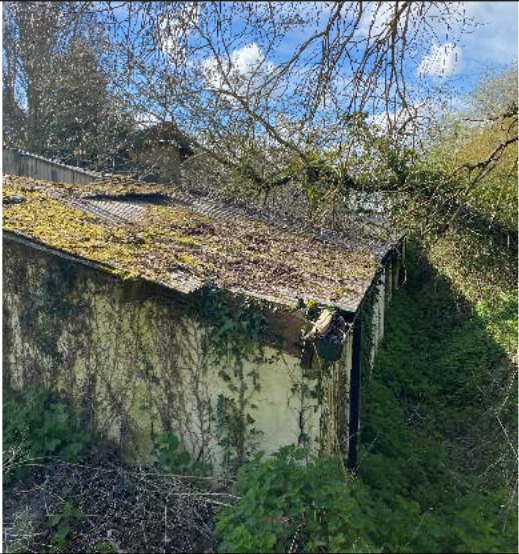
| Zone A | |
|---|---|
| Western side of poultry house from northern end | |

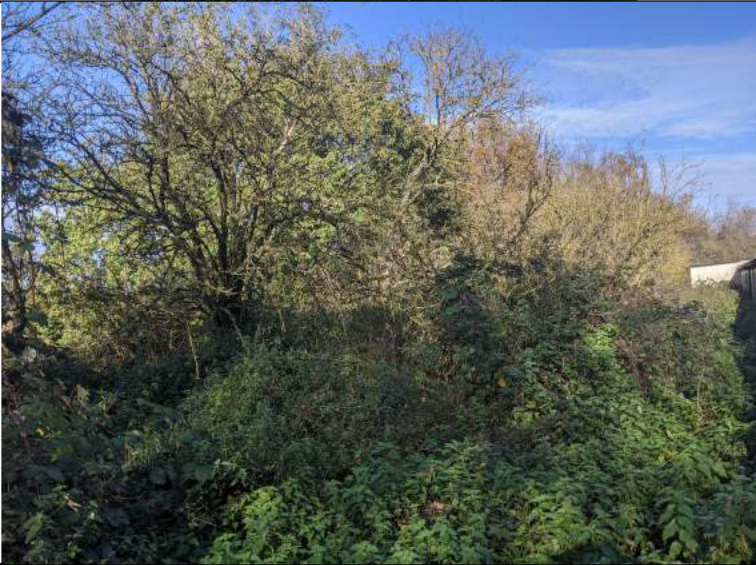
| Zone A | |
|---|---|
| Trees immediately west of poultry house | |

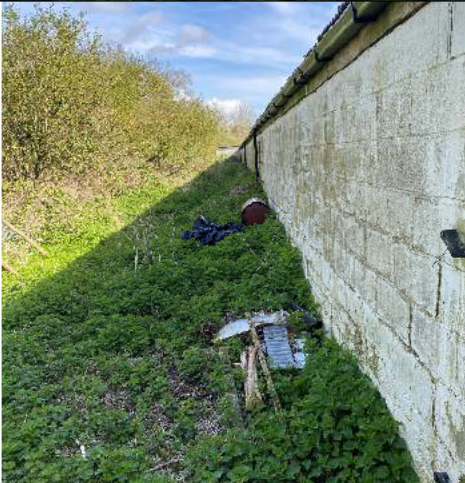
| Zone A | |
|---|---|
| Western side of poultry house. Discarded material includes asbestos cement roof sheet, metal storage drum, metal, plastic and wood | |

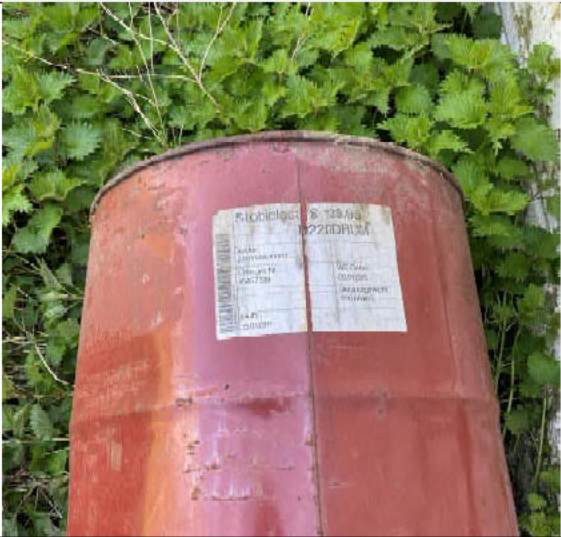
| Zone A | | |
|---|--|---|
| Discarded metal storage drum. Contents identified as Stobielast 133.95 which is a binder for safety surfacing and is generally used in children's play areas. Advised used to coat and bind asbestos cement roofing material. | | |

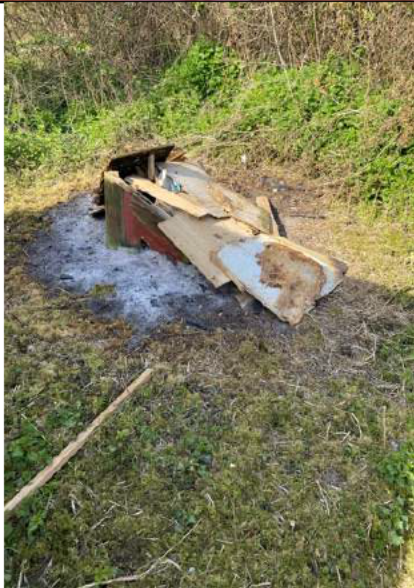
| Zone A | | |
|---|--|---|
| Area used for bonfires towards the centre of the west side of the poultry house | | |

It is also recommended that the identified stacks of debris and bonfire residue are removed, and the locations clearly marked. Shallow soil samples should be obtained from these locations.

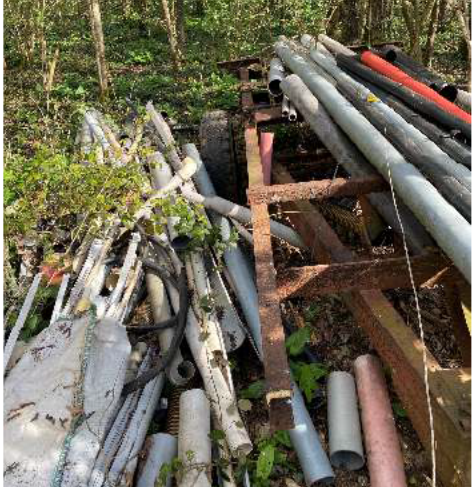
| Zone A | | |
|---|--|---|
| Discarded materials in the central north of Zone A. | | |

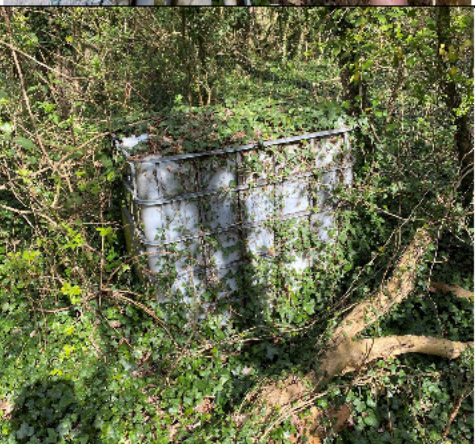
| Zone A | | |
|---|--|---|
| Upside down intermediate bulk container (IBC). No contents noted and previous contents unknown – advised possibly to transport cleaning chemicals | | |

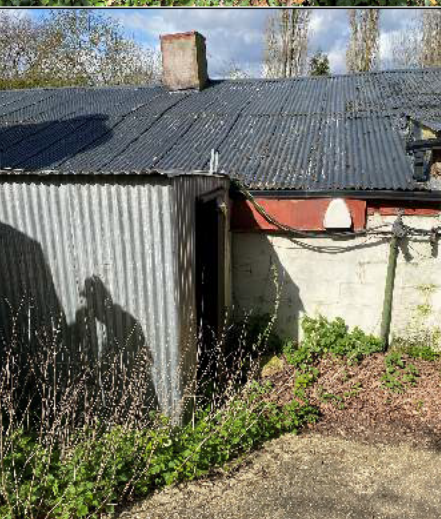
| Zone A | | |
|---|--|---|
| Corrugated metal covered storage area towards the centre of the east side of poultry house, immediately south of entrance | | |

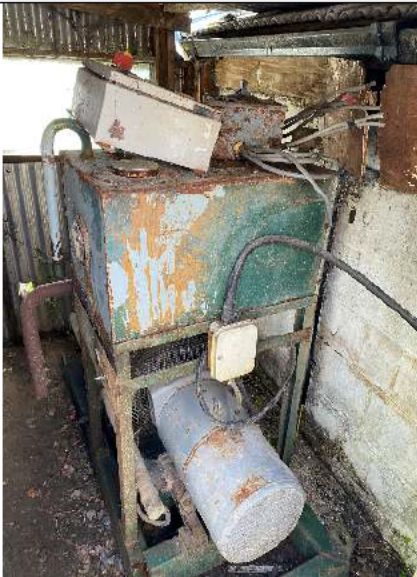
| Zone A | |
|---|---|
| Machinery within corrugated metal covered area, identified as back-up generator with fuel storage. Concrete slab to floor, attached directly to block wall of poultry house | |

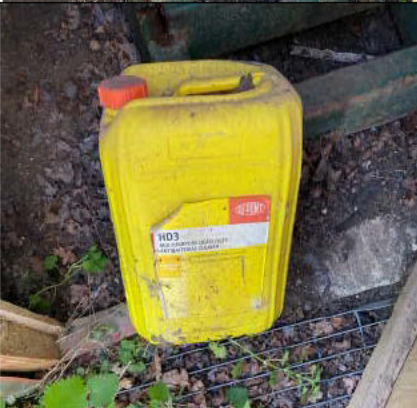
| Zone A | |
|---|---|
| Storage container found in corrugated metal covered area. Identified as multipurpose heavy duty antibacterial cleaner | |

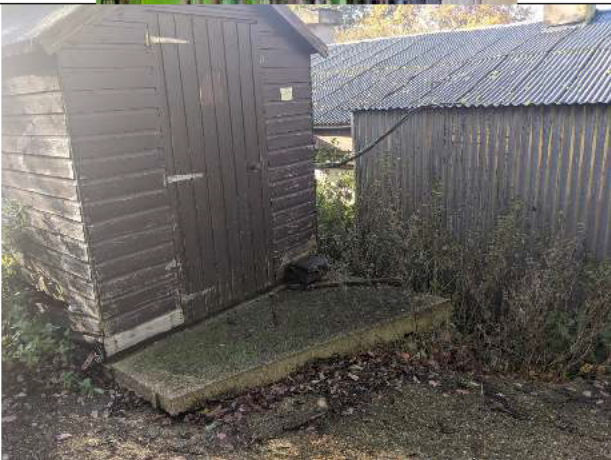
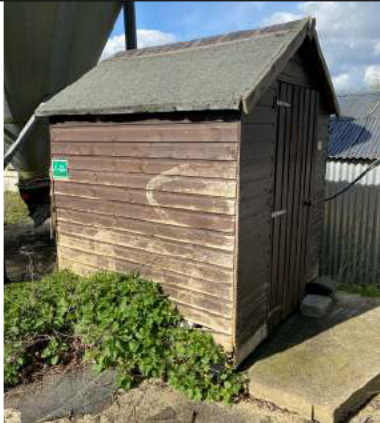
| Zone A | |
|---|---|
| Wooden shed to the southeast of corrugated metal covered storage area, with silo to rear | |

| Zone A | | |
|---|--|---|
| As above | | |

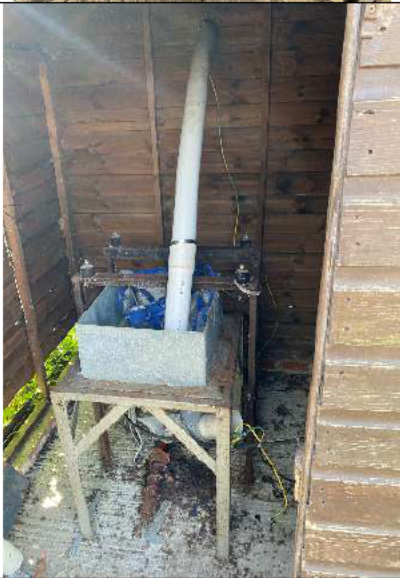
| Zone A | | |
|---|--|---|
| Inside of wooden shed, a hopper used to transfer grain from the silo to the poultry house. The grain falls from the silo into the hopper, where augers drive the grain up to the roof of the poultry house to be automatically distributed to the feeders (Archimedes screw principle) driven by an electric motor. Concrete floor to shed. | | |

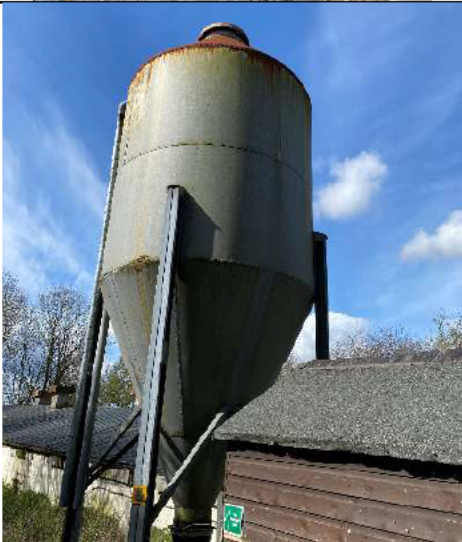
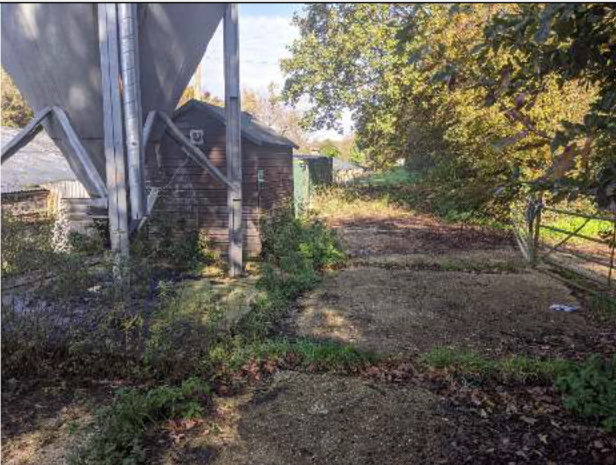
| Zone A | | |
|---|--|---|
| Silo | | |

| Zone A | |
|---|---|
| As above | |

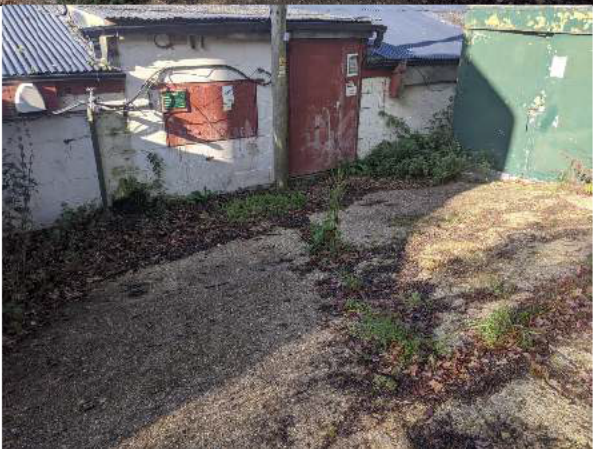
| Zone A | |
|---|---|
| Entrance to poultry house central on the eastern side, empty lorry container to the north | |

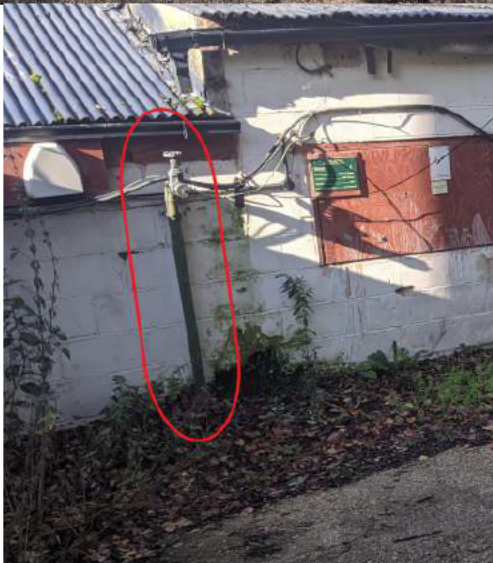
| Zone A | |
|---|---|
| Fuel filler point for tanker delivery | |

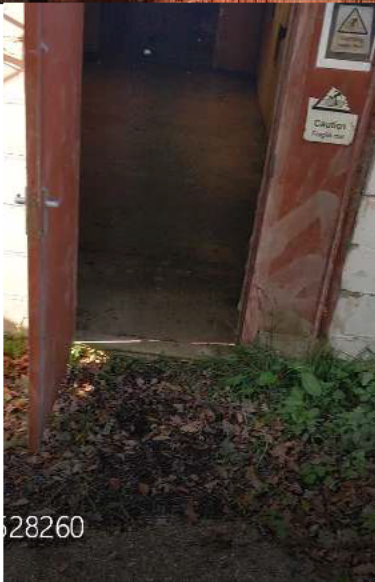
| Zone A | |
|---|---|
| Entrance to poultry house | |

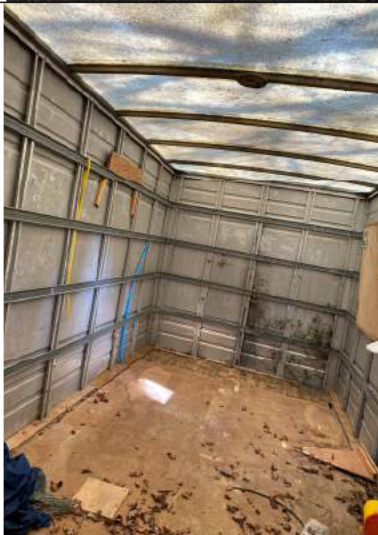
| Zone A | |
|---|---|
| Inside empty lorry container | |

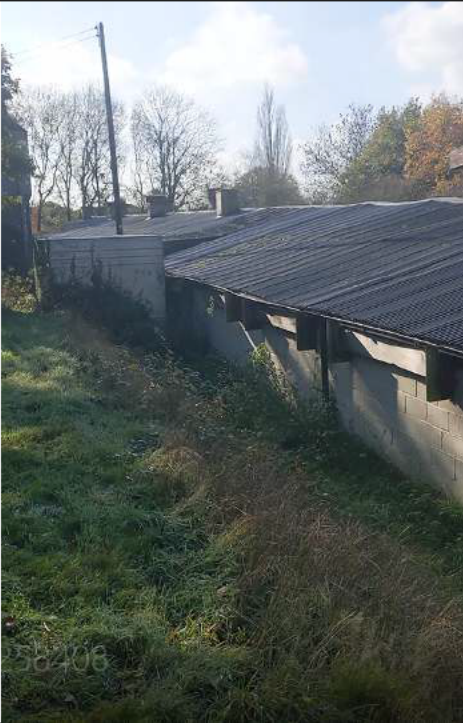
| Zone A | | |
|---|--|---|
| Rear of lorry container | | |

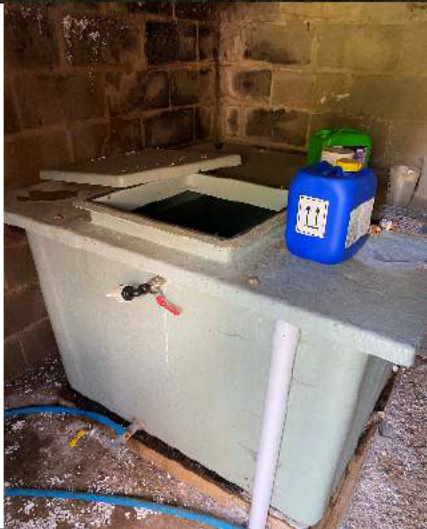
| Zone A | | |
|---|--|---|
| Block-built external structure on central western side of poultry house. Currently containing a tank used to deliver antibiotics and water to chickens. Previously contained fuel storage tank. Concrete to floor | | |

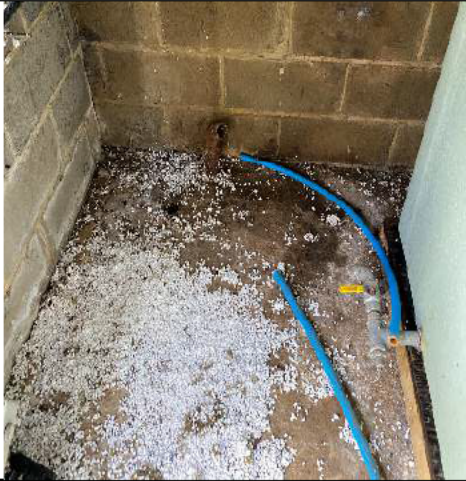
| Zone A | | |
|---|--|---|
| <p>Pipework through wall from historic fuel tank, adjacent to current antibiotic and water tank. This reportedly leads beneath the centre of the poultry house to join up with the tanker delivery point at the eastern entrance. The debris on the floor is polystyrene.</p> | | |

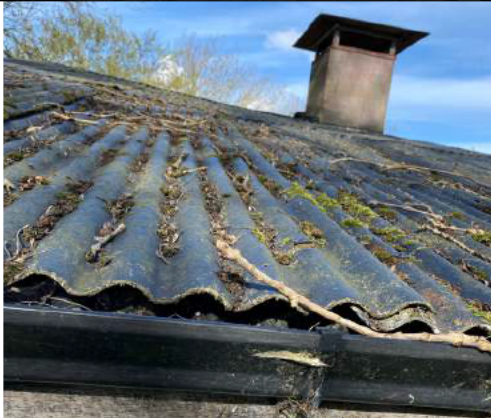
| Zone A | | |
|---|--|---|
| <p>Asbestos cement roof sheets on poultry house</p> | | |

It is recommended that a preliminary targeted and general site coverage intrusive investigation is undertaken, to be supervised by an appropriately qualified and experienced engineer. Additionally, an asbestos survey should be undertaken on the structures.

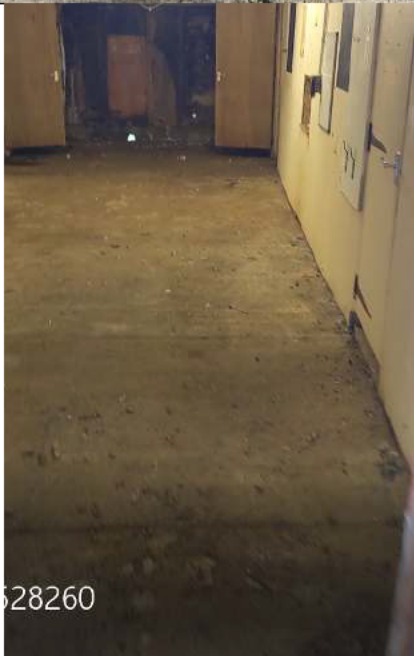
| Zone A | | |
|---|--|---|
| <p>Central area as viewed from the entrance door, bisects the poultry house east to west.</p> | | |

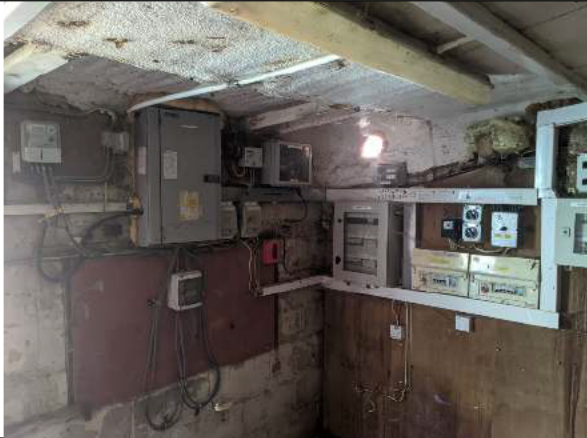
| Zone A | |
|---|---|
| Electrical controls immediately left inside entrance. | |

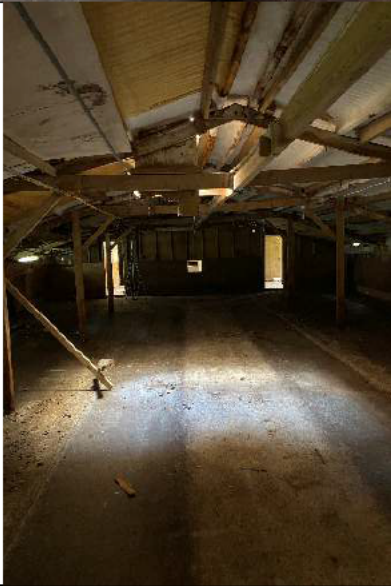
| Zone A | |
|---|---|
| Inside of northern section of chicken shed, looking south | |

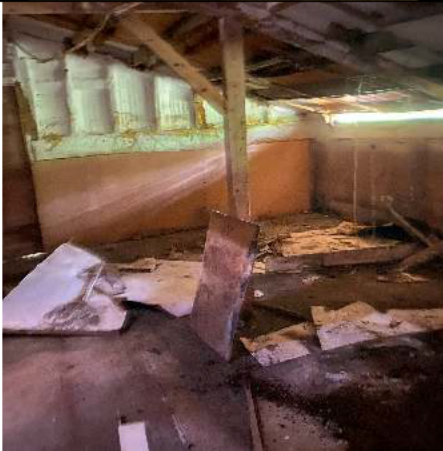
| Zone A | |
|---|---|
| Torn down roof and side panels in northern section of chicken shed | |

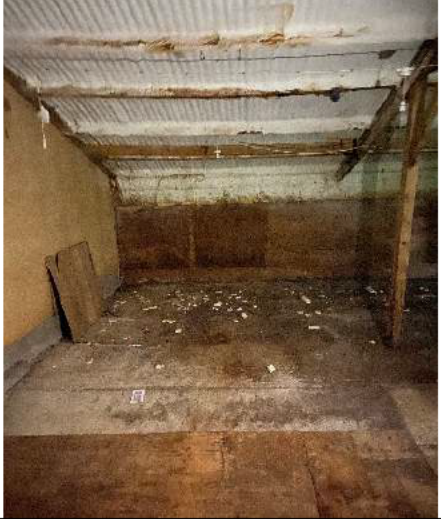
| Zone A | | |
|---|--|---|
| Inside of southern portion of chicken shed | | |

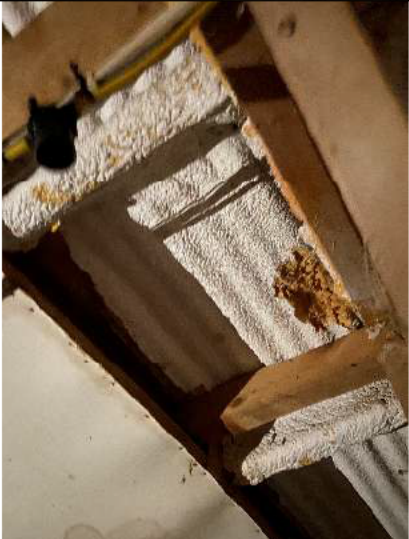
| Zone A | | |
|---|--|---|
| Damaged asbestos cement in chicken shed roofing. Roofing material coated with binding agent. | | |

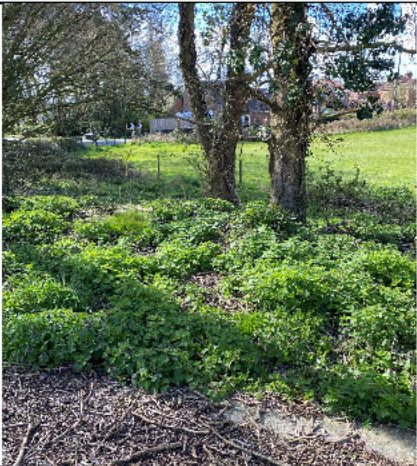
| <b>Site walkover photographs and commentary – Zone B</b> | | |
|---|--|---|
| <p>Western edge of A towards southern boundary of B. Piece of asbestos cement roofing on ground, no additional pieces in the vicinity.</p> | | |

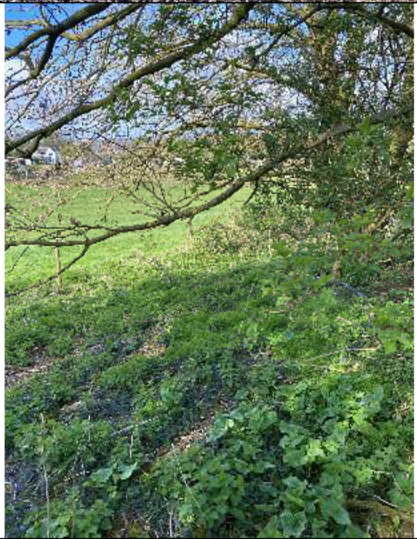
| <b>Site walkover photographs and commentary – Zone B</b> | | |
|---|--|---|
| <p>Slope and change in levels from A towards B looking west</p> | | |

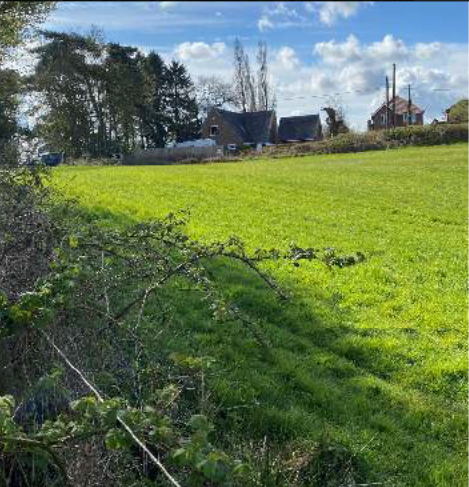
| <b>Site walkover photographs and commentary – Zone B</b> | | |
|---|--|---|
| <p>View south between boundary of A (left) and B (right)</p> | | |

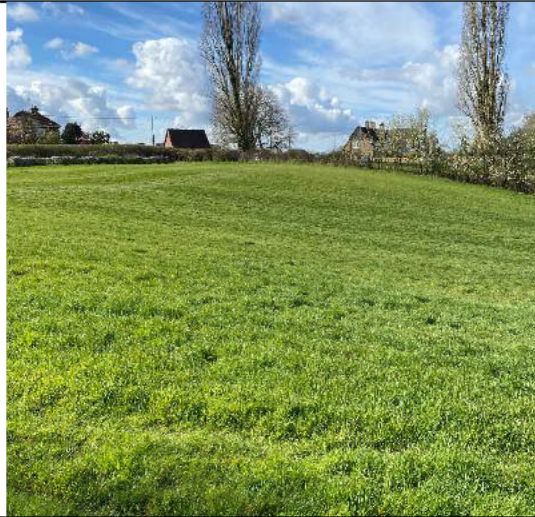
View towards south/southwest corner of the site

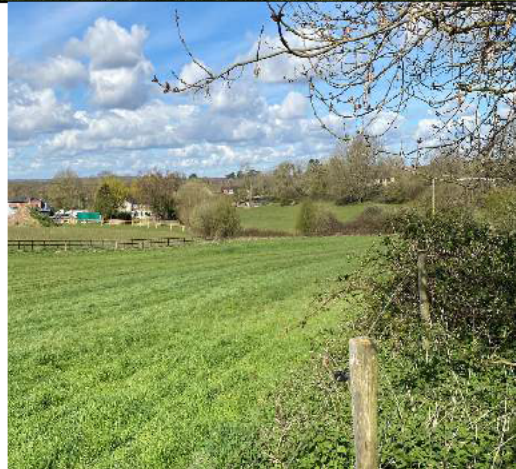
View toward the west boundary of the site, with the site and area sloping down towards the northwest

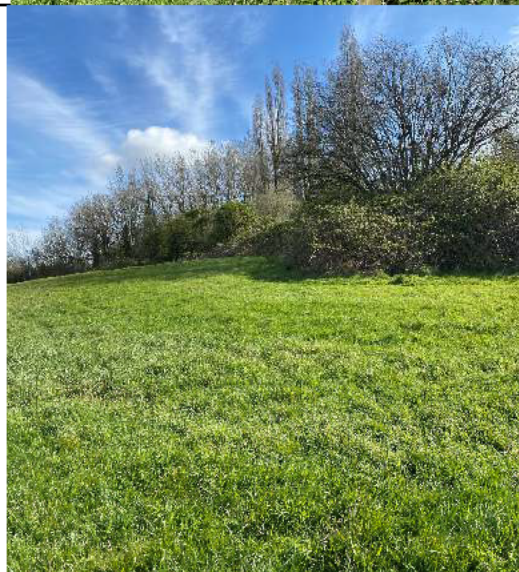
View from B towards western boundary of A. Also, the area suspected of manure/waste poured from the higher ground of A onto the lower ground of B.

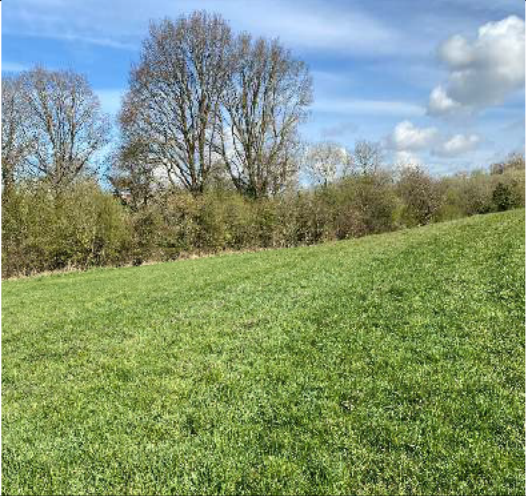
| Site walkover photographs and commentary – Zone B | |
|---|---|
| North boundary of the site | |

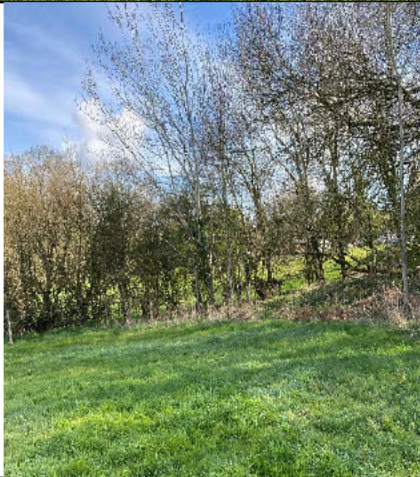
| Site walkover photographs and commentary – Zone B | |
|---|---|
| North boundary of site looking towards the public footpath | |

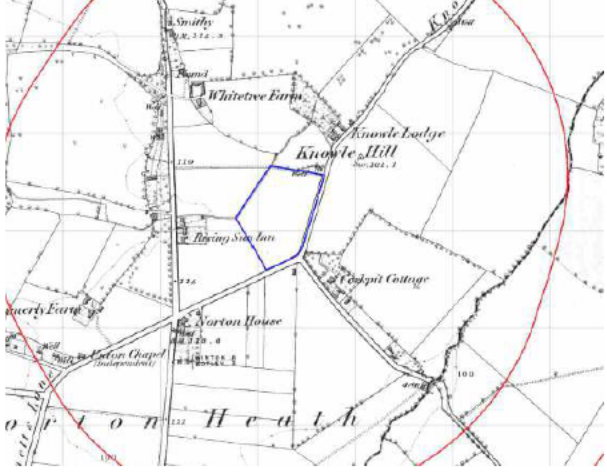
| Commentary | Extracts from historic maps |
|---|---|
| <p>c. 1868 1:10,560</p> <p>The site is open agricultural, surrounded in the main by open agricultural, with limited development in the vicinity. Knowle Lane (then Knowlehill Lane) is present on its current day route. No indication of potentially contaminative sources/activities with the exception of a Smithy 500m north, and farming.</p> | |

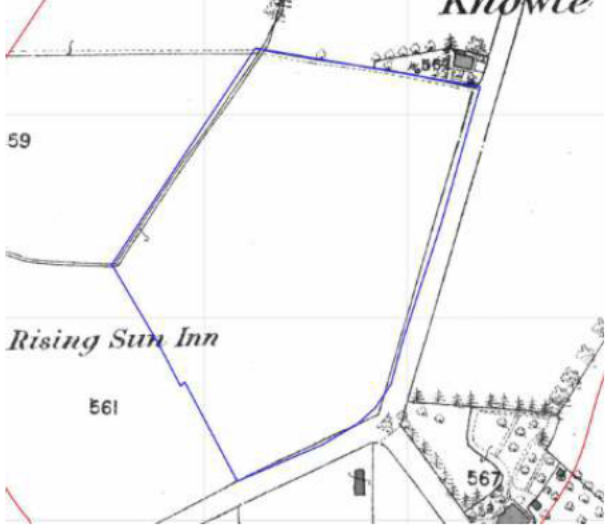
| Commentary | Extracts from historic maps |
|---|---|
| <p>c. 1869 1:2,500</p> <p>Larger scale shows site is clear of any features.</p> | |

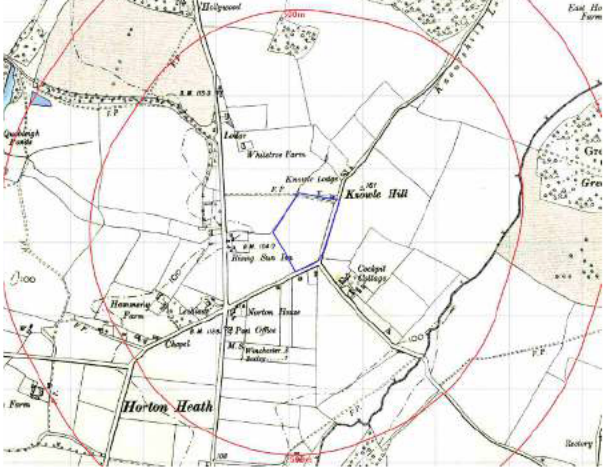
| Commentary | Extracts from historic maps |
|---|---|
| <p>c. 1888 1:10,560</p> <p>Additional development has occurred to the immediate south of the site in the form of residential and Post Office. The Smithy is no longer shown and the only potentially contaminative usage that can be identified is farming.</p> | |

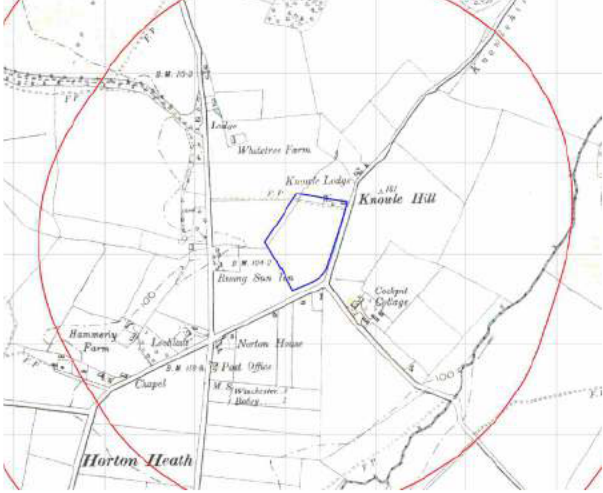
| Commentary | Extracts from historic maps |
|---|---|
| <p>c. 1895 1:10,560</p> <p>No significant changes</p> | |

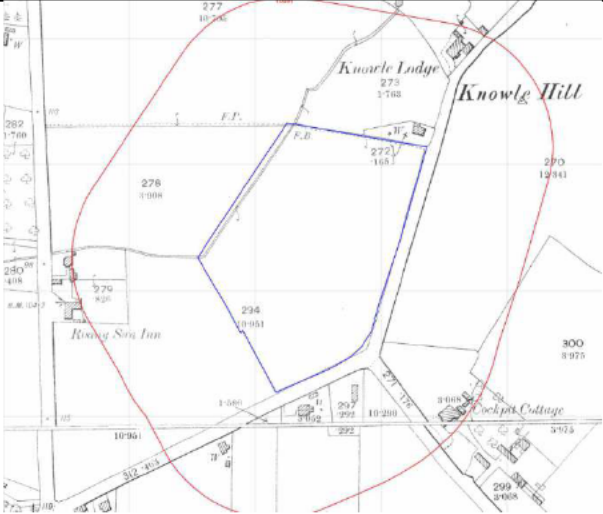
| Commentary | Extracts from historic maps |
|---|---|
| <p>c. 1897 1:2,500</p> <p>The site remains clear of any features.</p> | |

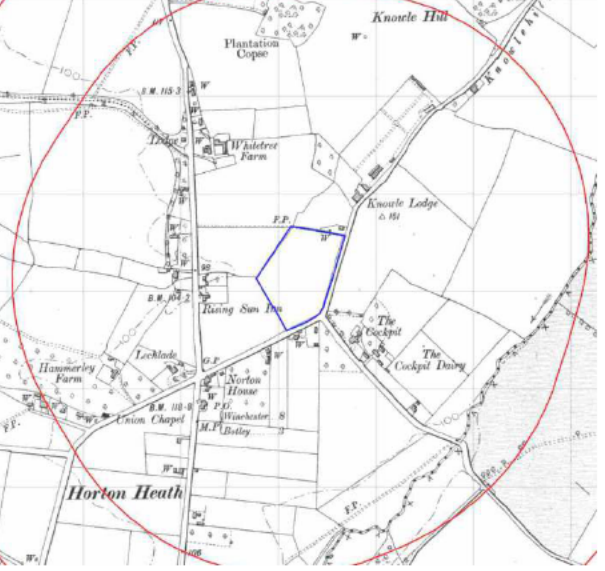
| Commentary | Extracts from historic maps |
|---|---|
| <p>c. 1908 1:10,560</p> <p>Additional development has occurred in the area, including Cockpit Cottage being added to in the form of Cockpit Dairy. No evidence of potentially contaminative activities with the exception of farming.</p> | |

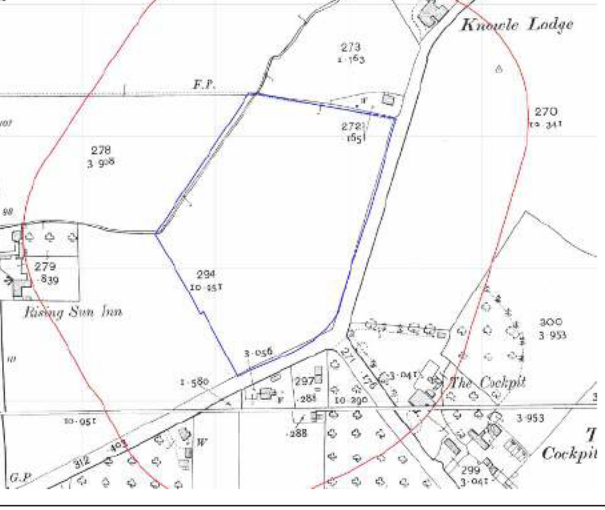
| Commentary | Extracts from historic maps |
|---|---|
| <p>c. 1909 1:2,500</p> <p>The site remains clear of any features.</p> | |

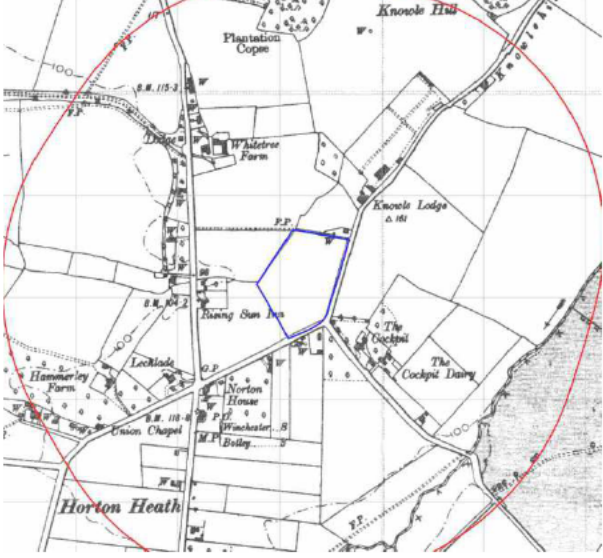
| Commentary | Extracts from historic maps |
|---|---|
| <p>c. 1938 1:10,560<br/>No significant changes.</p> | |

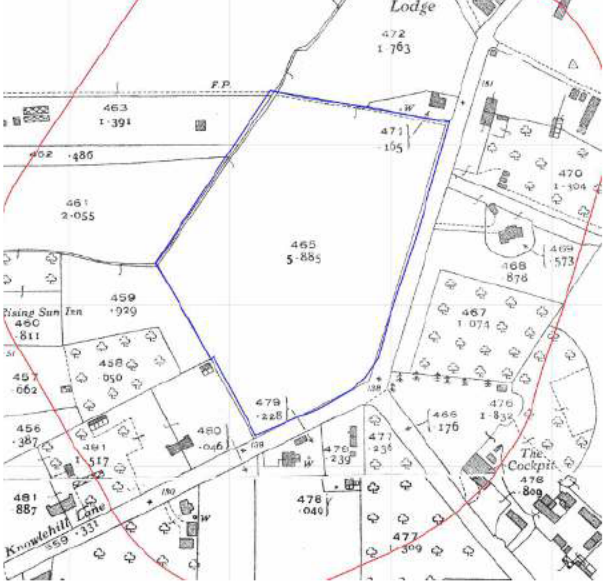
| Commentary | Extracts from historic maps |
|---|---|
| <p>c. 1939 1:2,500<br/>The site remains clear of any features.</p> | |

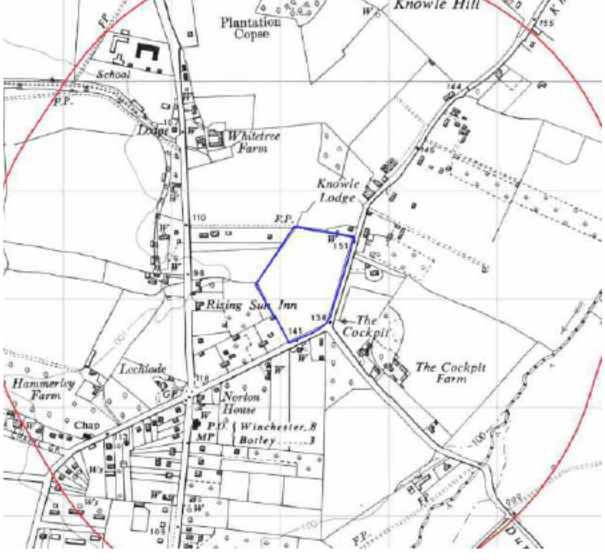
| Commentary | Extracts from historic maps |
|---|---|
| <p>c. 1957 1:10,560<br/>Significant additional development in the vicinity of the site, including residential immediately to the west. Cockpit Dairy is now denoted Cockpit Farm. No evidence of potentially contaminative activities within 500m of the site with the exception of farming.</p> | |

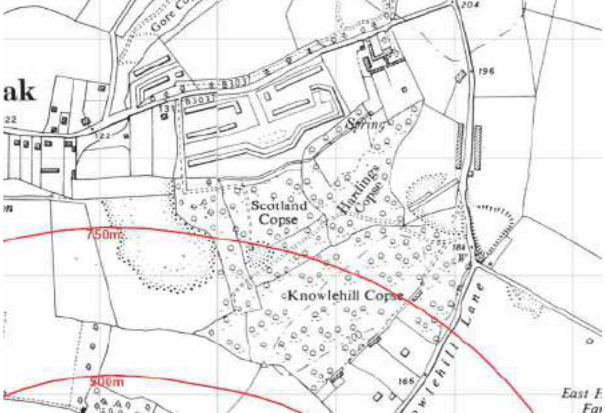
| Commentary | Extracts from historic maps |
|---|---|
| <p>c. 1957 1:10,560<br/>700m to the north of the site extensive sand extraction activities are occurring.</p> | |

The area of sand extraction identified 700m to the north is described in detail within a desk study report and a subsequent intrusive investigation report provided by Eastleigh Borough Council as follows:

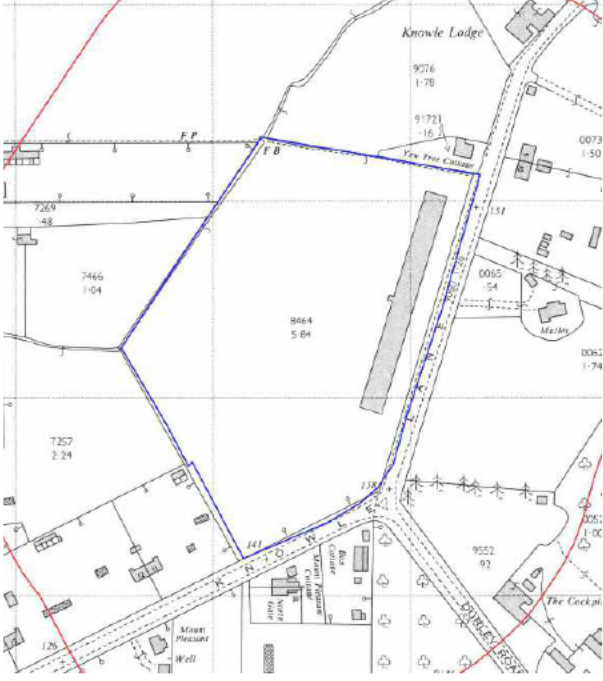
| Commentary | Extracts from historic maps |
|---|---|
| <p>c. 1962 1:2,500</p> <p>The poultry house has been constructed in its current day layout.</p> | |

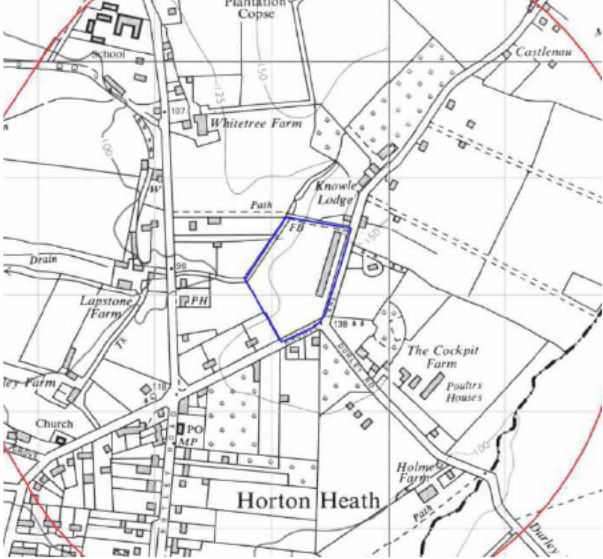
| Commentary | Extracts from historic maps |
|---|---|
| <p>c. 1968 1:10,560</p> <p>No significant changes within 500m of the site.</p> | |

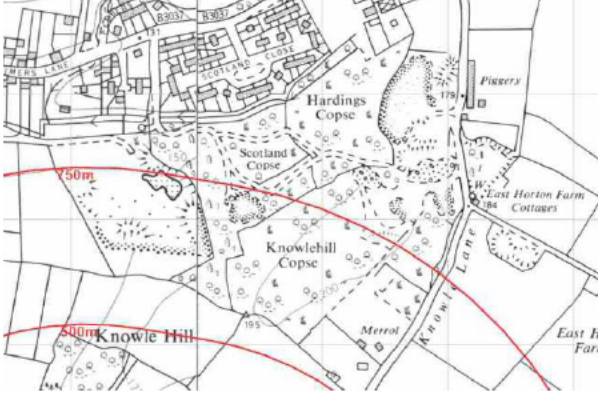
| Commentary | Extracts from historic maps |
|---|---|
| <p>c. 1968 1:10,560<br/>Sand extraction to the north is more extensive, extending to within 650m of the site boundary</p> | |

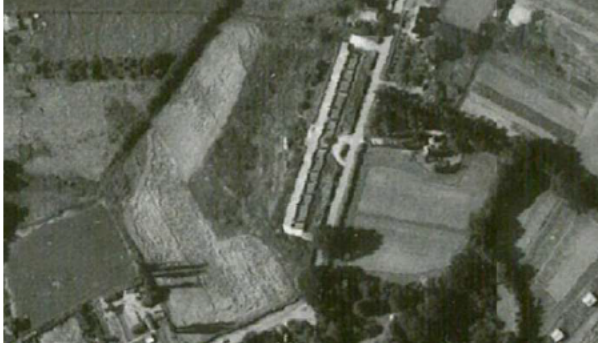
| Commentary | Extracts from historic maps |
|---|---|
| <p>c. 1970s aerial photograph courtesy of EBC<br/>It can be seen that the site and ground cover is as it is in the current day. Grassland to the west, the poultry house to the east, and an area of rough vegetation between the two.</p> | |

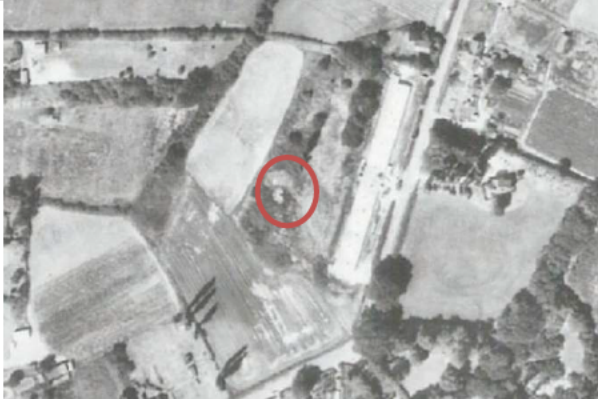
| Commentary | Extracts from historic maps |
|---|---|
| <p>c. 1979-1984 aerial photograph courtesy of EBC<br/>As above, with the exception of some potential ground disturbance within the area of rough vegetation.</p> | |

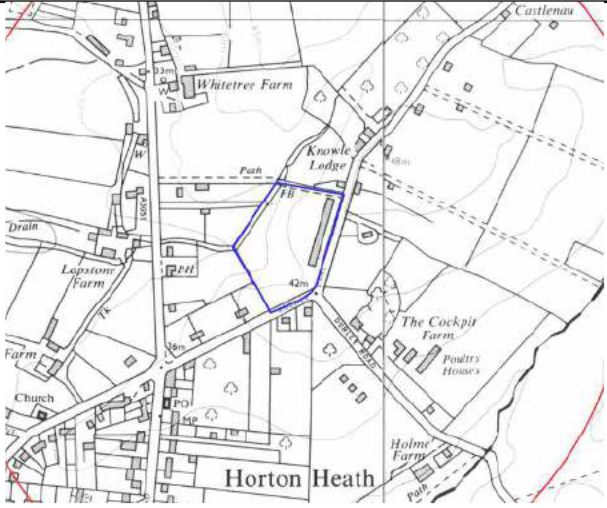
| Commentary | Extracts from historic maps |
|---|---|
| <p>c. 1985 1:10,000<br/>No significant changes.</p> | |

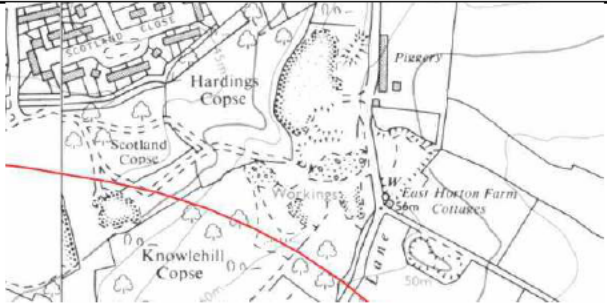
| Commentary | Extracts from historic maps |
|---|---|
| <p>c. 1985 1:10,000<br/>Some evidence of continued works to the far north of the site</p> | |

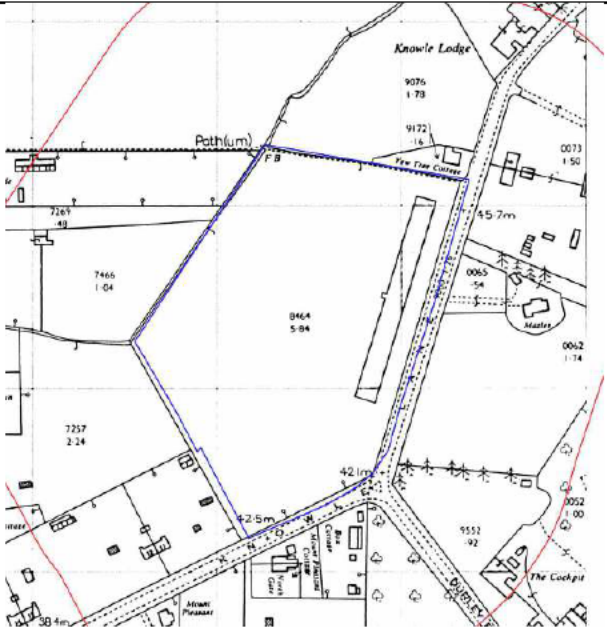
| Commentary | Extracts from historic maps |
|---|---|
| <p>c. 1985 1:2,500<br/>No significant changes.</p> | |

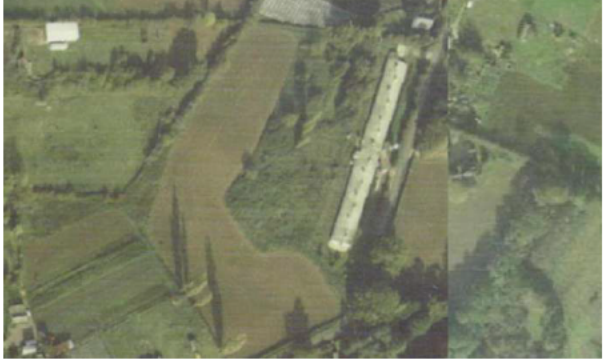
| Commentary | Extracts from historic maps |
|---|---|
| <p>c. 1989 aerial photograph courtesy of EBC</p> <p>No significant changes. Some additional structures on the eastern face of the poultry house.</p> | |

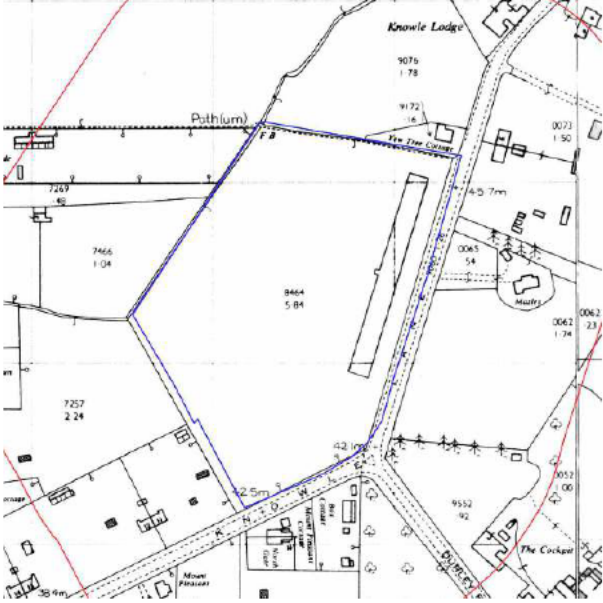
| Commentary | Extracts from historic maps |
|---|---|
| <p>c.1989 1:2,500</p> <p>No significant changes.</p> | |

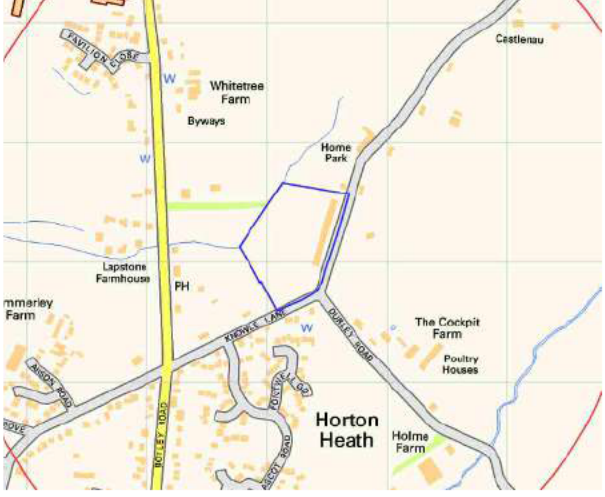
| Commentary | Extracts from historic maps |
|---|---|
| <p>c. 2001 1:10,000<br/>No significant changes.</p> | |

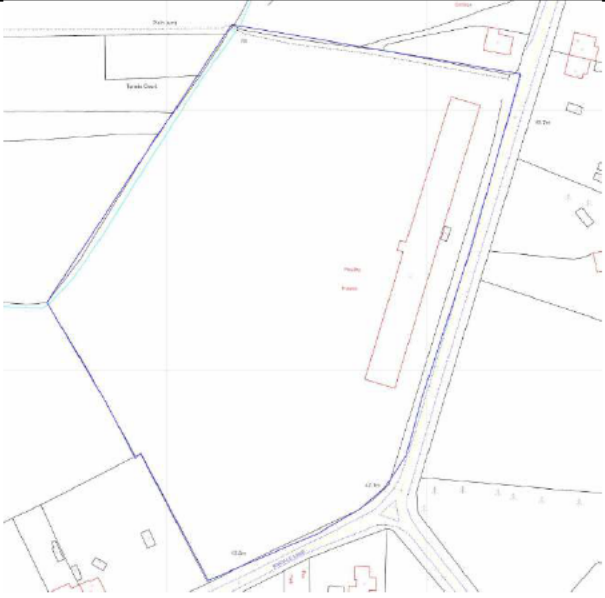
| Commentary | Extracts from historic maps |
|---|---|
| <p>c. 2003 1:1,250<br/>No significant changes.</p> | |

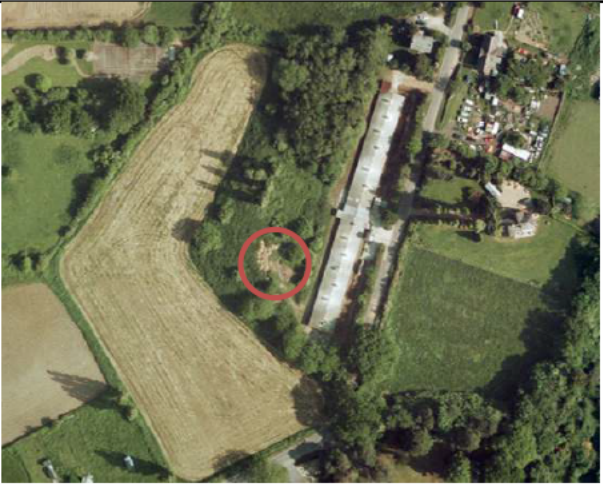
| Commentary | Extracts from historic maps |
|---|---|
| <p>c. 2005 aerial photograph courtesy of EBC</p> <p>No significant changes. The area of potential disturbed ground is reduced in size.</p> | |
