**Desk study and preliminary risk assessment report**

**Cockpit Barn, Knowle Lane, Horton Heath**

Alderbury Homes Ltd

July 2021

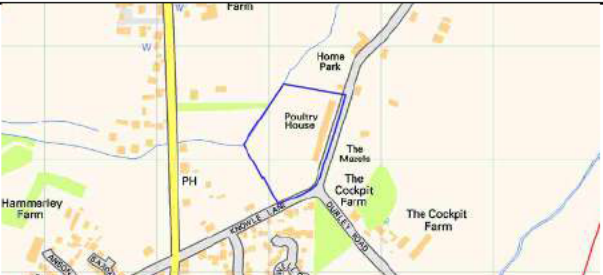
| Commentary | Extracts from historic maps |
|---|---|
| <p>c. 2010 1:10,000</p> <p>No significant changes.</p> | |

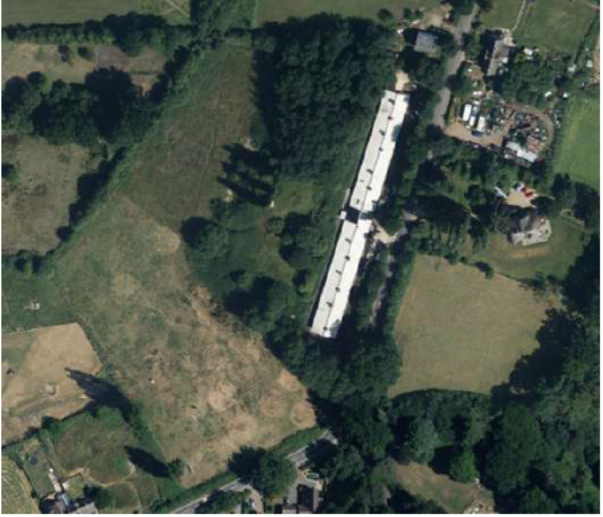
| Commentary | Extracts from historic maps |
|---|---|
| <p>c. 2013 aerial photograph courtesy of EBC</p> <p>No significant changes.</p> | |

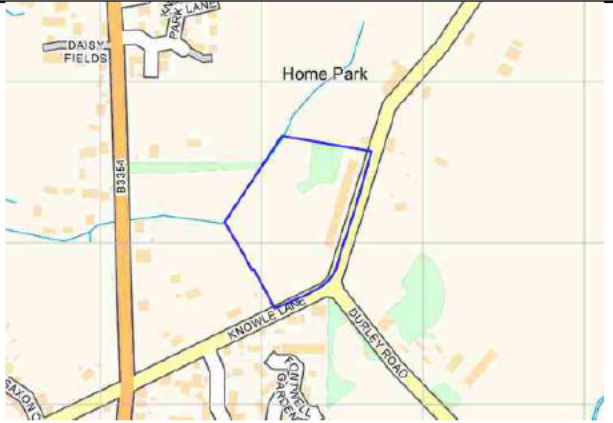
| Commentary | Extracts from historic maps |
|---|---|
| <p>c. 2021 1:10,000<br/>No significant changes.</p> | |

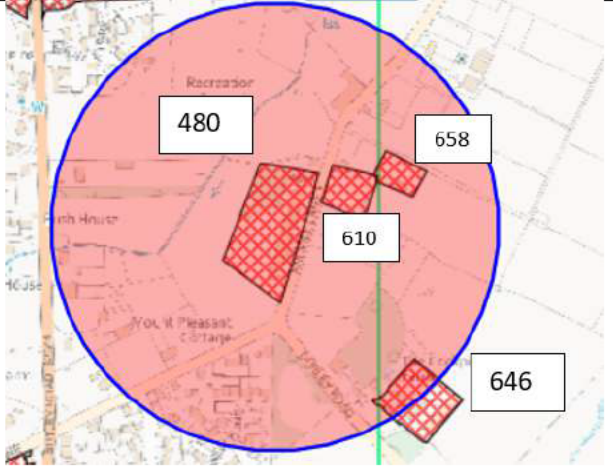
| Commentary | Extracts from historic maps |
|---|---|
| <p>Extract from Eastleigh Borough Council Environmental Services geographical information service</p> <p>480 – the site - identified 'of interest' due to application to convert poultry house to residential usage in 2008</p> <p>610 – land at 10 Knowle Lane – identified 'of interest' due to the presence of multiple vehicles</p> <p>658 – land to the rear of 10 Knowle Lane – identified 'of interest' due to the presence of multiple vehicles</p> <p>646 – Cockpit Farm – identified 'of interest' due to farm usage</p> | |

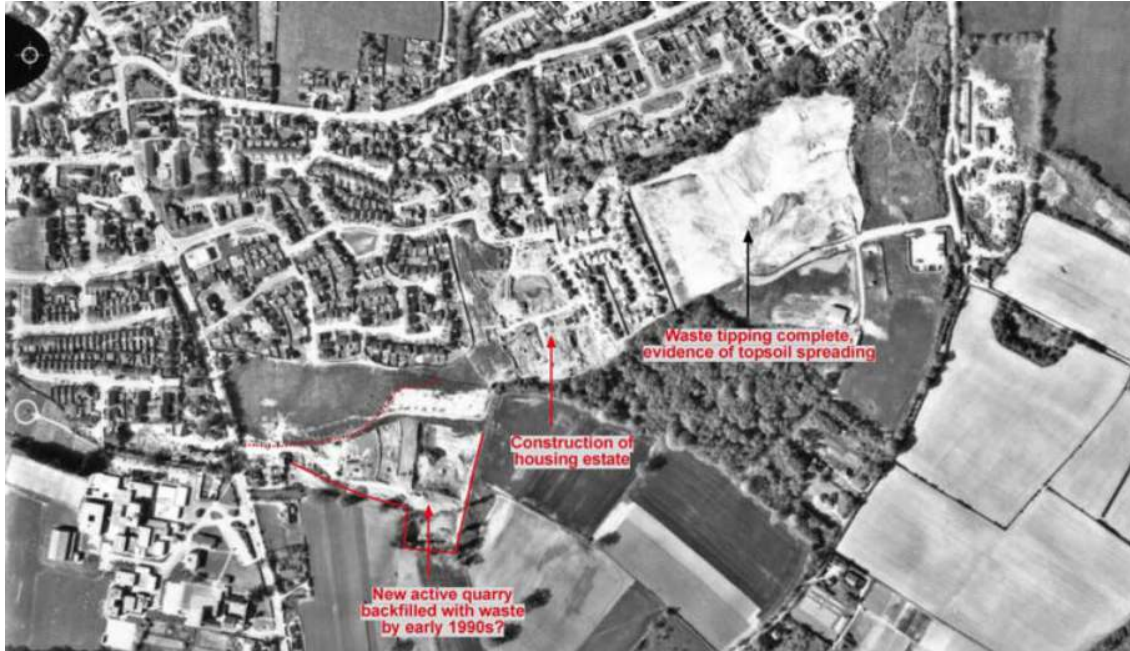
**Figure 4: Extract from Review of archival information Fair Oak Landfill Complex**

The reports identify that the area to the north was subjected to significant sand extraction and subsequent landfilling activities. An extract from the desk study report presented below as Figure 4 identifies that the area of landfilling closest to the site (approximately 650m to the north) was backfilled by the early 1990s.

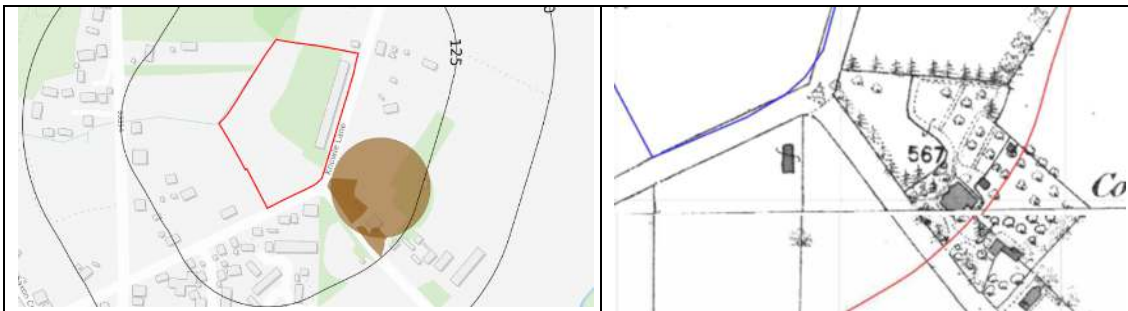
**Figure 5: Extract from Groundsure report identifying two potential refuse heaps identified on 1868 map**

The Groundsure report identifies two refuse heaps on the 1868 edition map to the east and southeast of the site at distances of 10m and 76m respectively. The location of these features as presented within the Groundsure report is shown in Figure 5 below, with an extract from the 1869 larger scale map for comparison.

It is evident that there are no such features present, and as such this will not be considered further within this report.

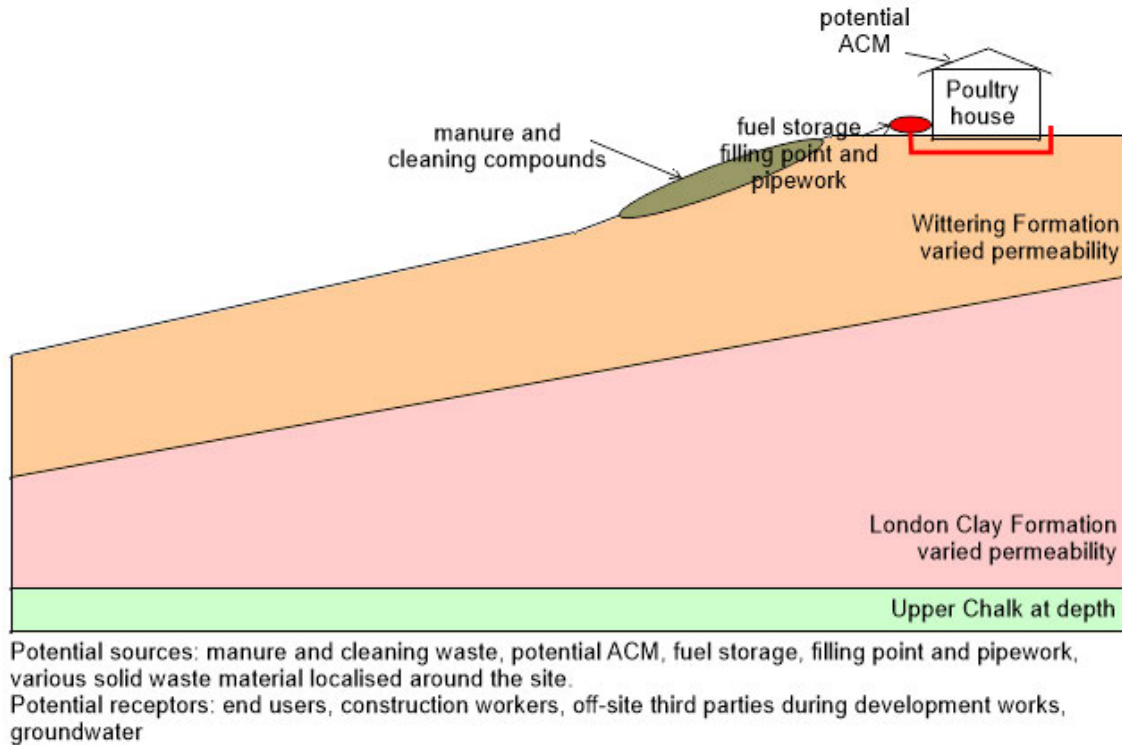
**Figure 6: Simplistic ground model**

A simplistic ground model of the site based on the information presented above is illustrated in Figure 6 below.

In summary, potential sources of contamination have been identified in the form of potentially contaminated shallow soils, representative of an unknown risk to construction workers, off-site third parties and end users via direct contact, inhalation or ingestion. In addition, there is the potential for shallow groundwater within the underlying soils (variable permeability) to have been impacted.

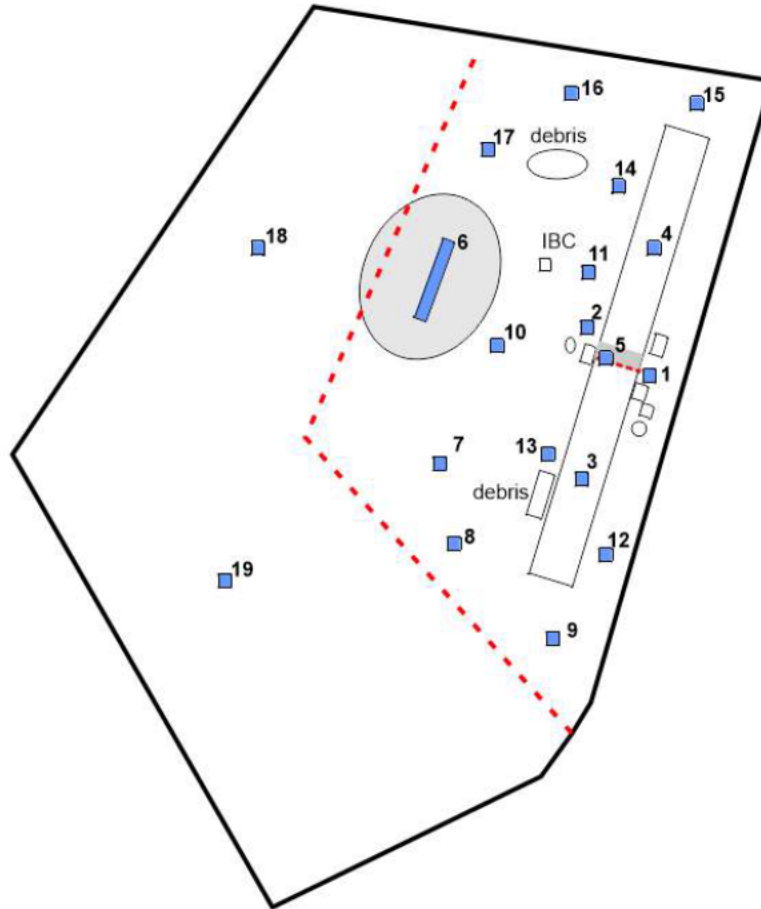
**Figure 7: Approximate recommended locations for trial pits**

It is recommended that an intrusive site investigation is undertaken comprising trial pitting to achieve general coverage and to target potential contaminated soils. Approximate locations are presented in Figure 7 below, and the recommended depth/location choice presented in Table 4.
