# DRAINAGE STRATEGY

QUEENS VIEW, NETLEY

Project No. AAL307

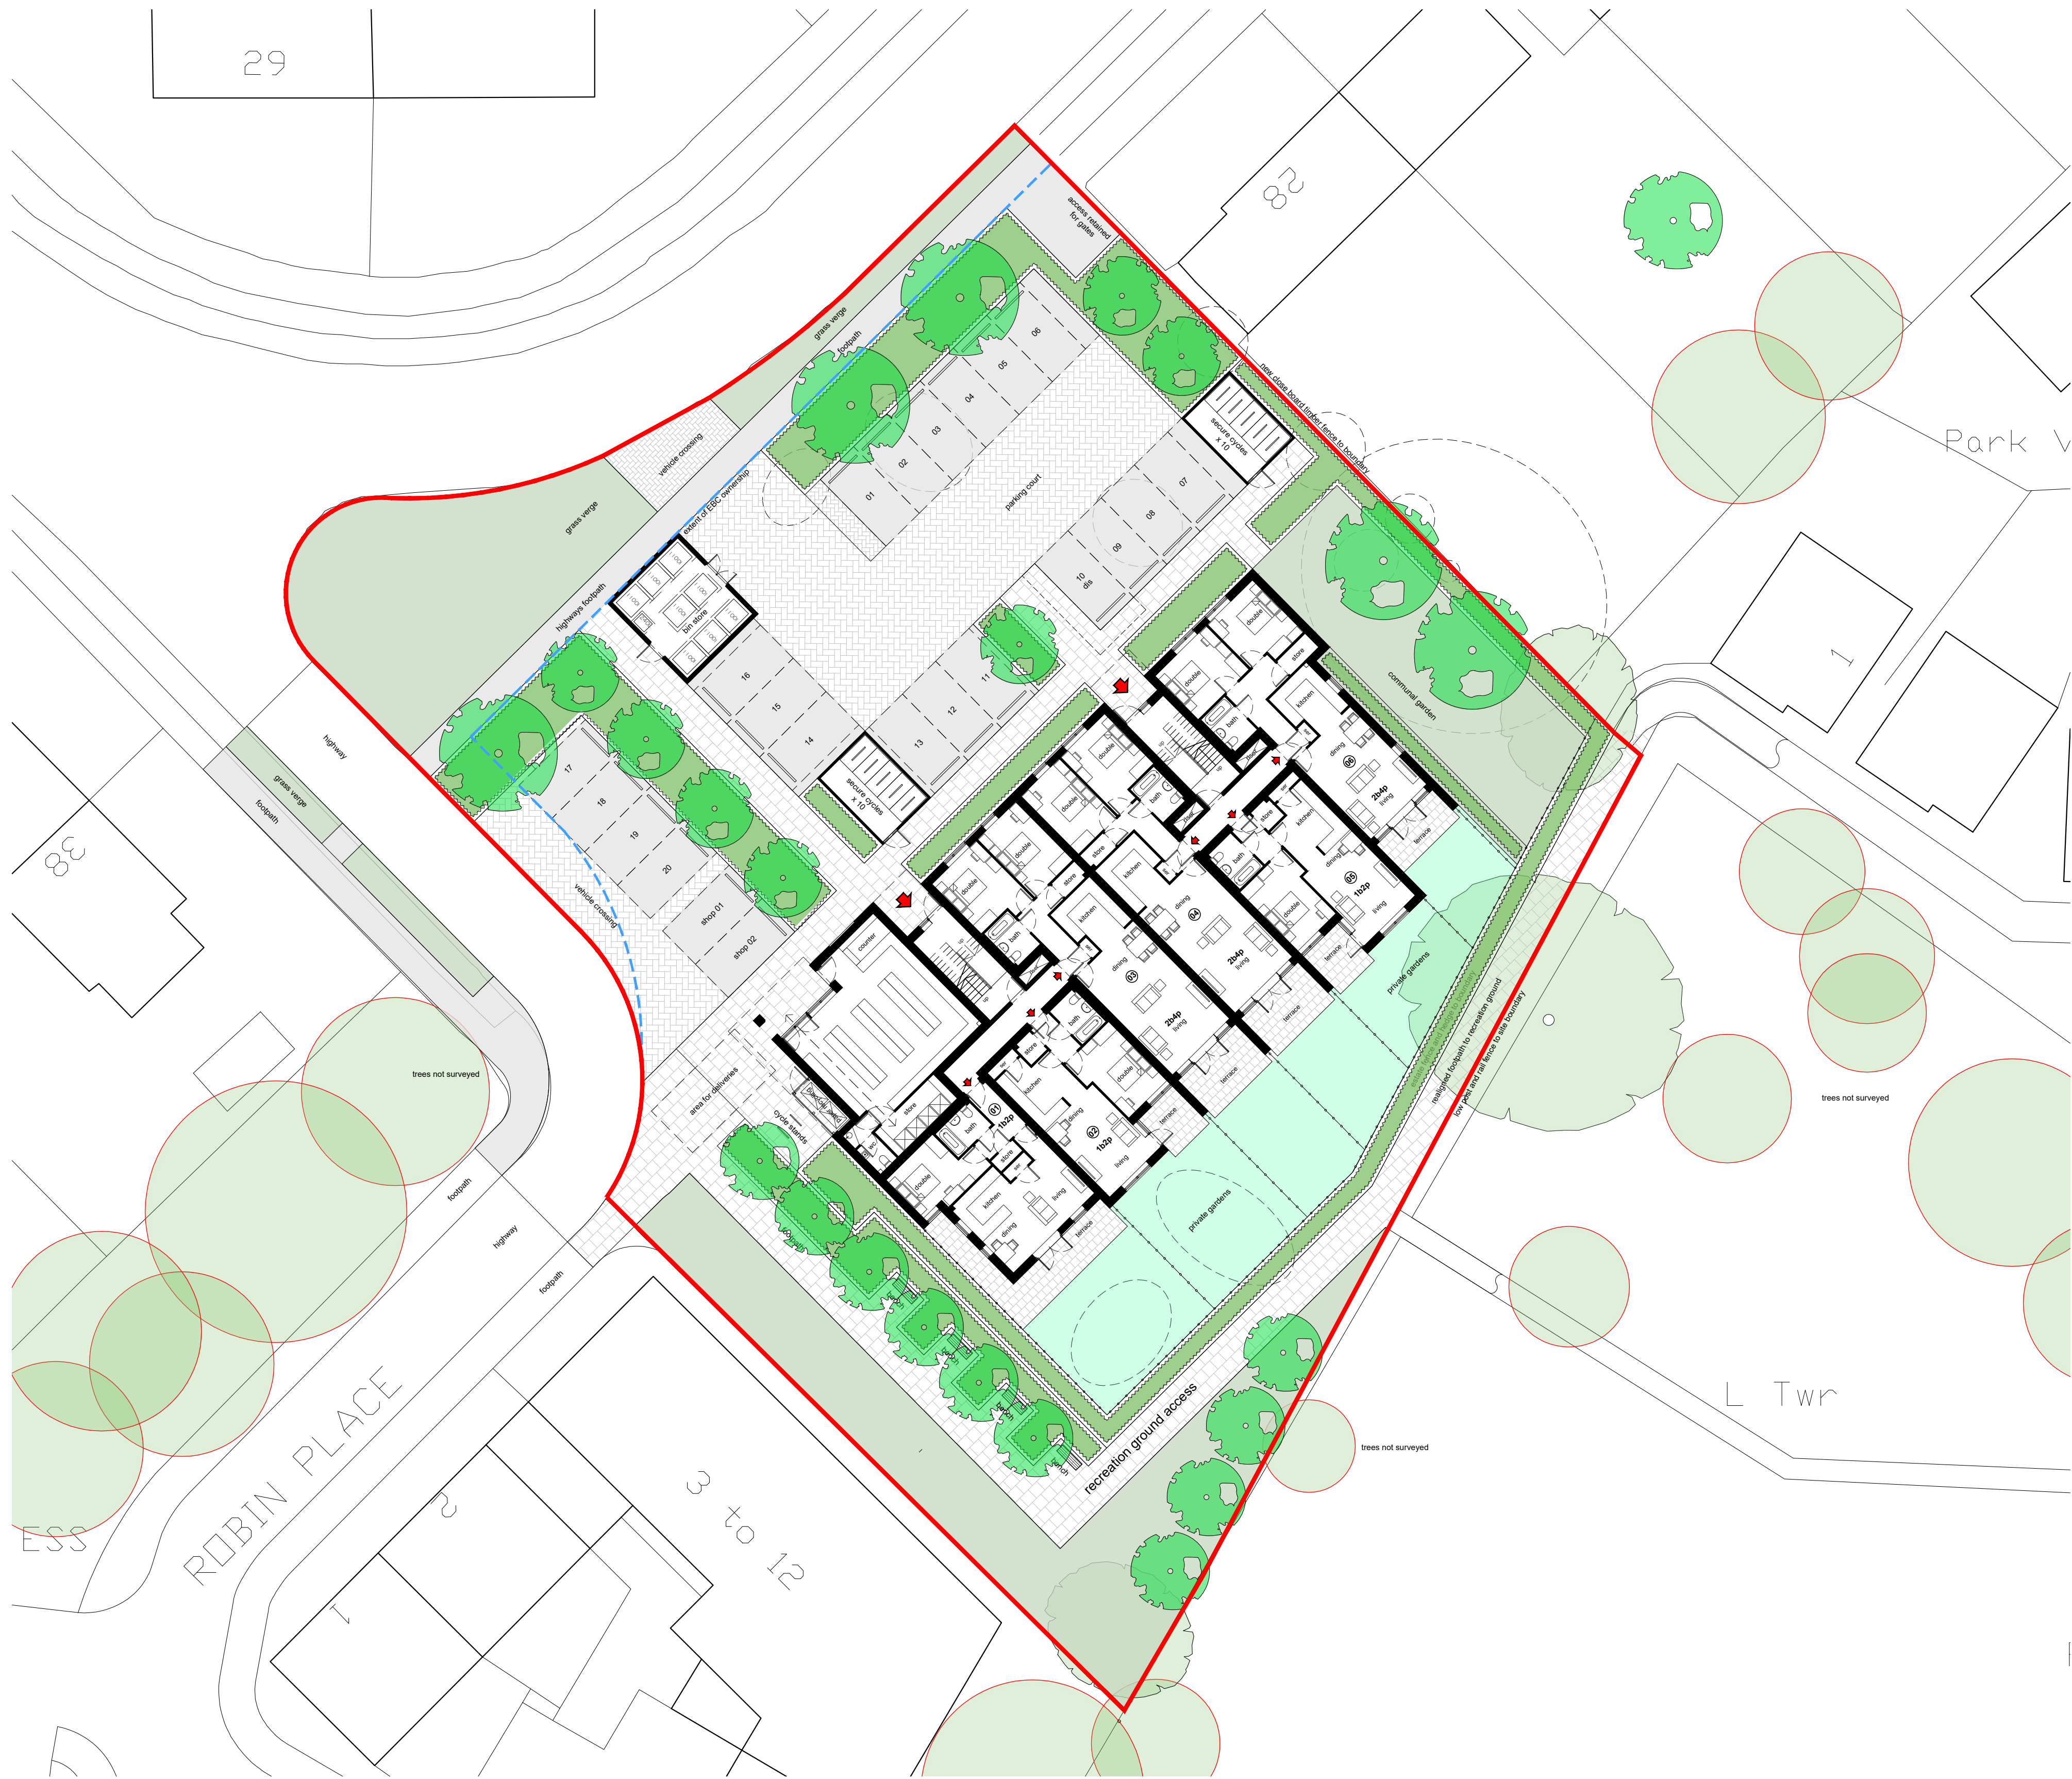
### Proposed Masterplan

Arch Associates Limited have been commissioned by Eastleigh Borough Council to prepare the Foul and Surface Water Drainage Strategy to accompany the planning application at Queens View, Netley. The proposed development includes demolition of the existing structures to make way for a new build residential scheme of 18 apartments.

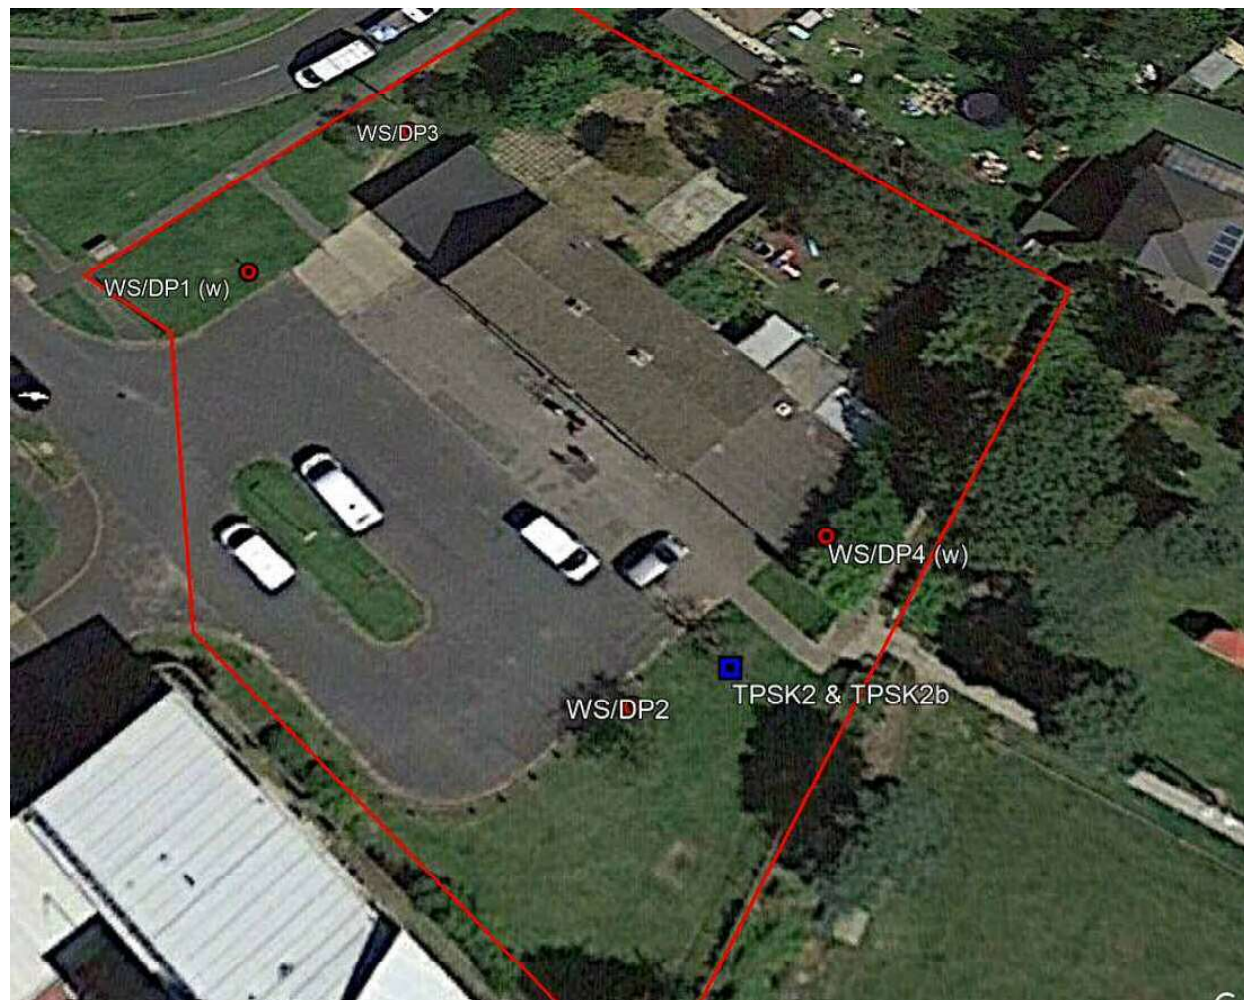
**Figure 3 – Exploratory Hole Plan**

- Service clearance of proposed test hole locations
- 4No. window sample boreholes to a maximum depth of 3.00m bgl (WS1 to WS4)
- 4No. dynamic probes (DPSH) to a maximum depth of 6.00m bgl (DP1 to DP4), adjacent and prior to the drilling of the relevant window sample boreholes
- Installation of wells in two (2No.) of the boreholes (WS1 and WS4), to allow groundwater/ground-gas monitoring on three (3No.) occasions
- 3No. machine excavated trial pits (TPSK1, TPSK2 and TPSK2b) to 1.20m, 2.50m and 1.50m bgl respectively, to allow infiltration testing in accordance with BRE365
- Geotechnical laboratory testing
- Chemical laboratory analysis

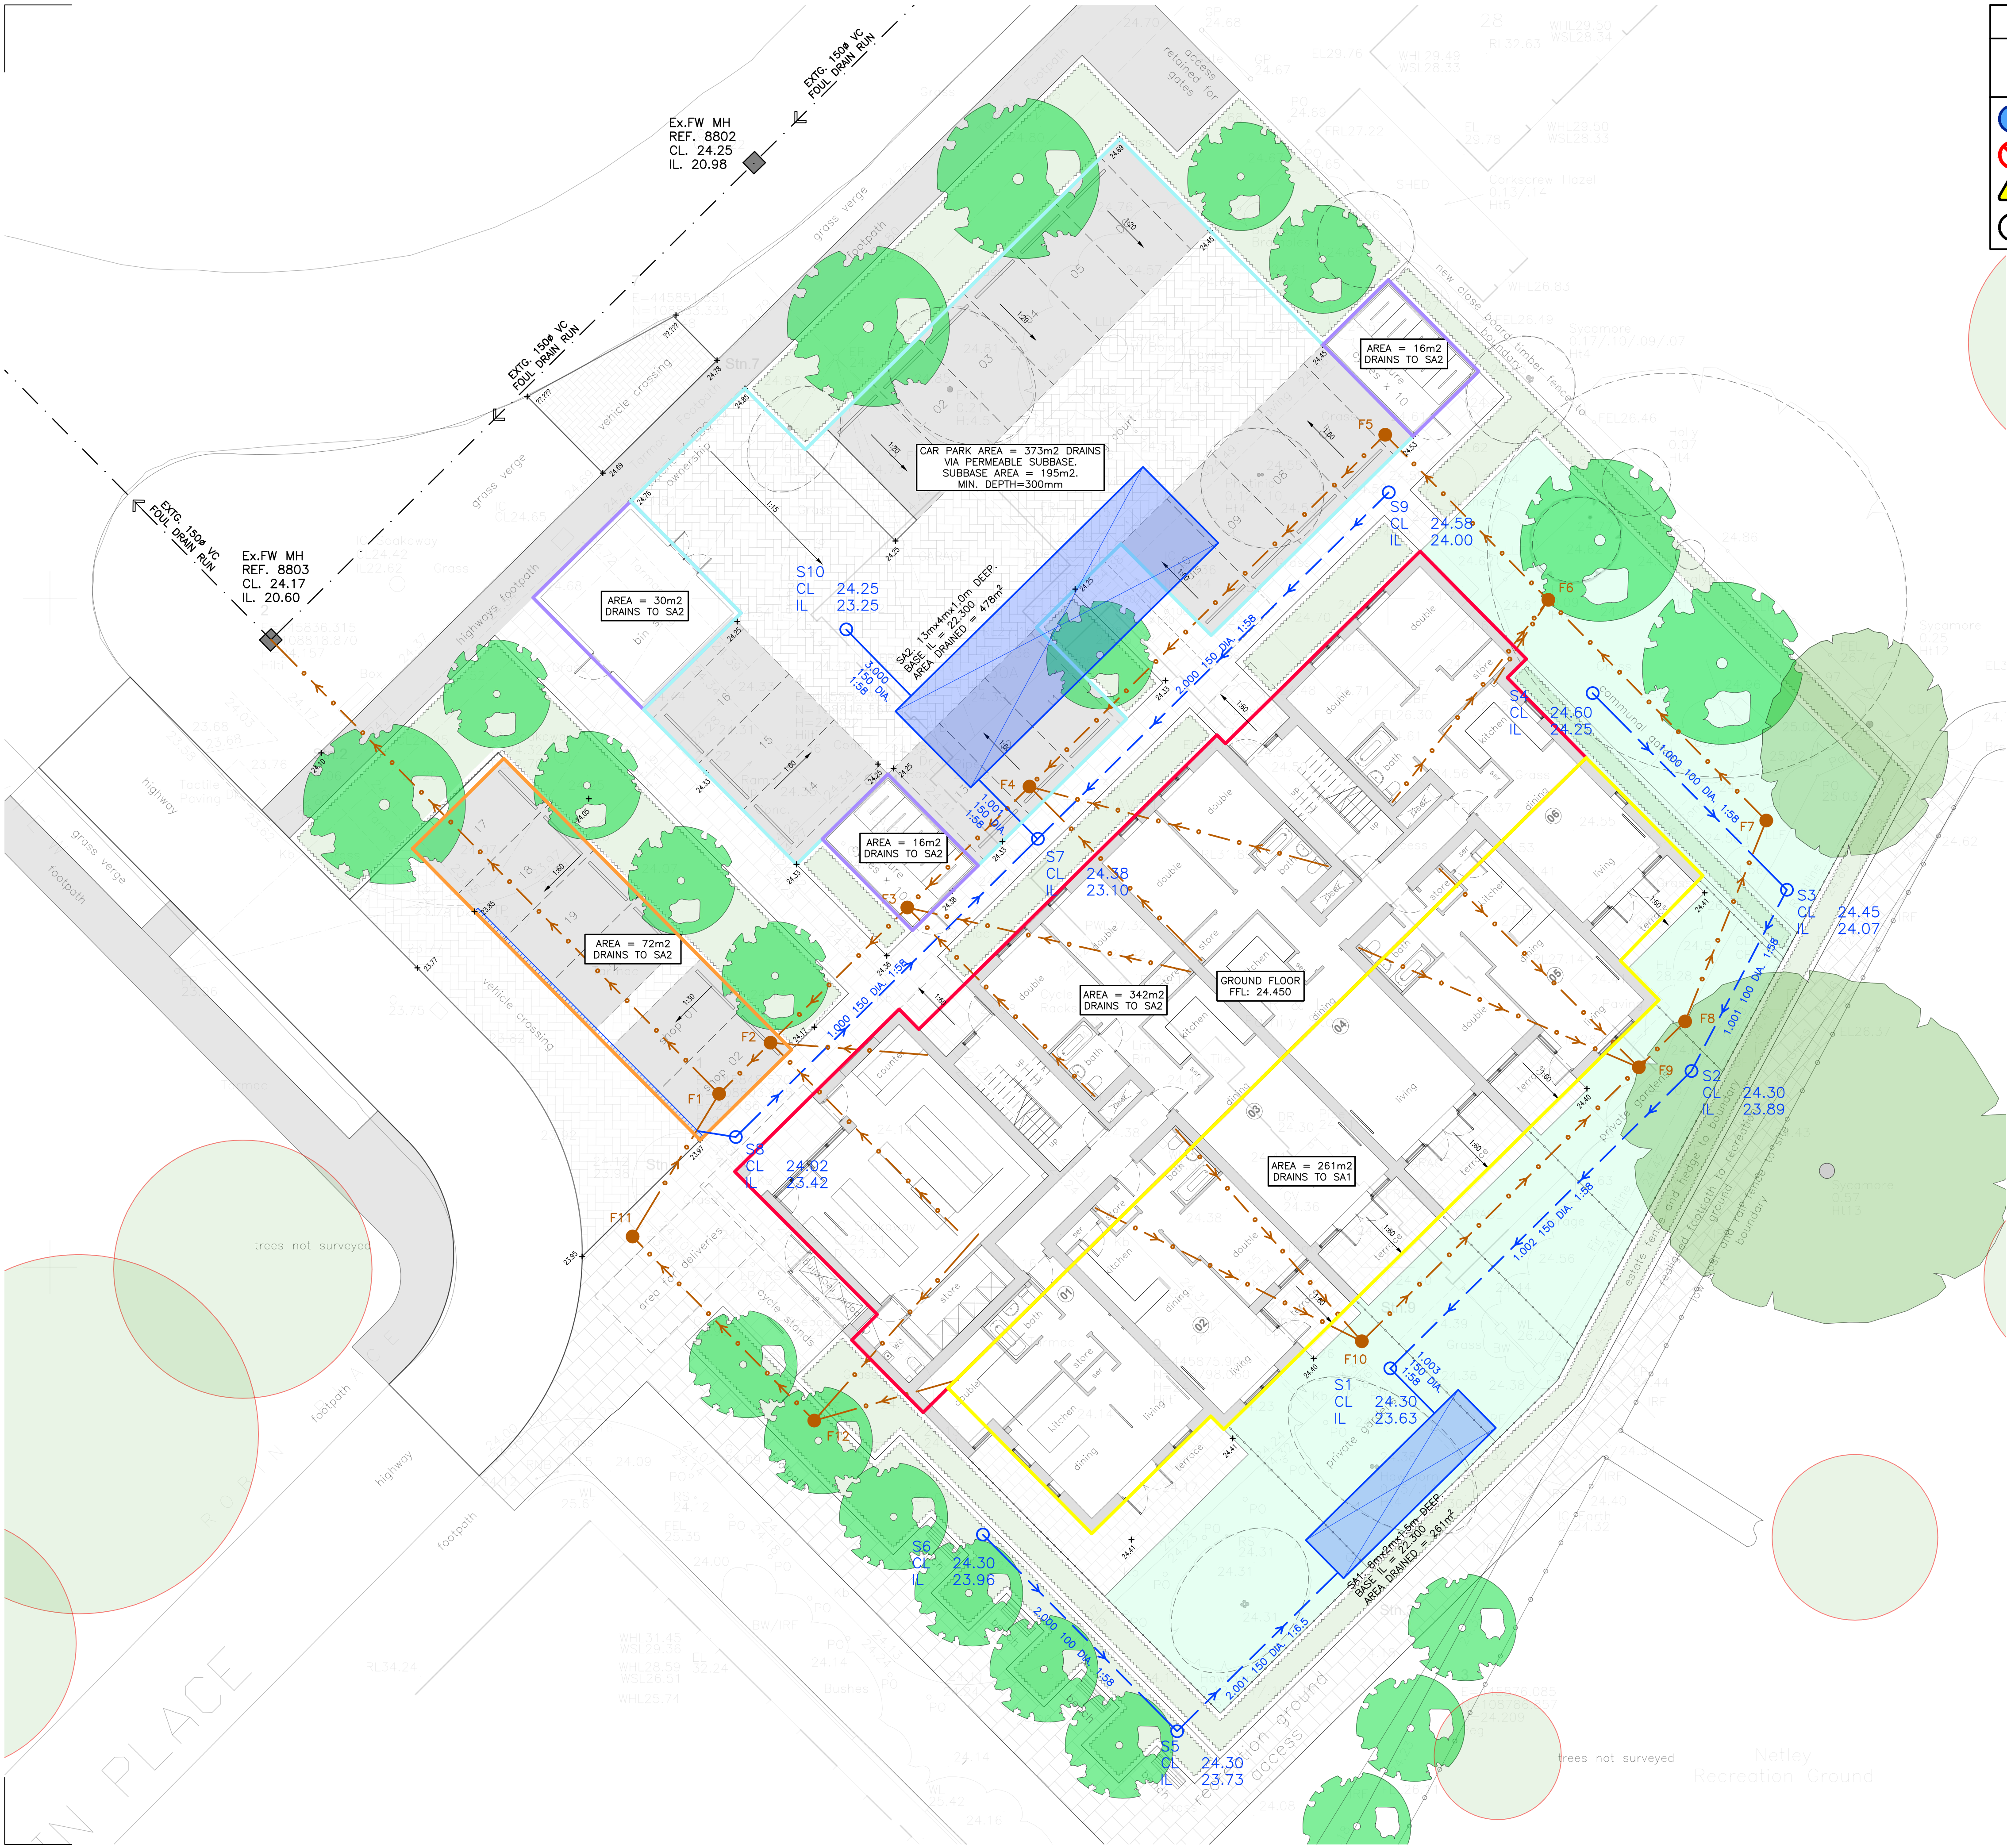
| Drawing title | |
|---|---|
| AAL307 - AAL-00-XX-DR-S-5001-P02 | |

Based on available information, infiltration to ground is proposed for this development. Run-off from the roof areas and small parking area to the south of the site will be directed into buried crate soakaways, while external hard landscaping will infiltrate to ground via the use of permeable paving and porous subbase.

Given the topography of the site, exceedance flows would naturally flow downhill towards the southern boundary, at which point it will discharge onto Castle Road. Refer to Appendix 5.
