**GROUND INVESTIGATION REPORT**

**ONE HORTON HEATH – FIRST RESIDENTIAL PARCEL,**

**EASTLEIGH BOROUGH COUNCIL**

| Reference: | GE18771-GIRv4.0-JUL22 |

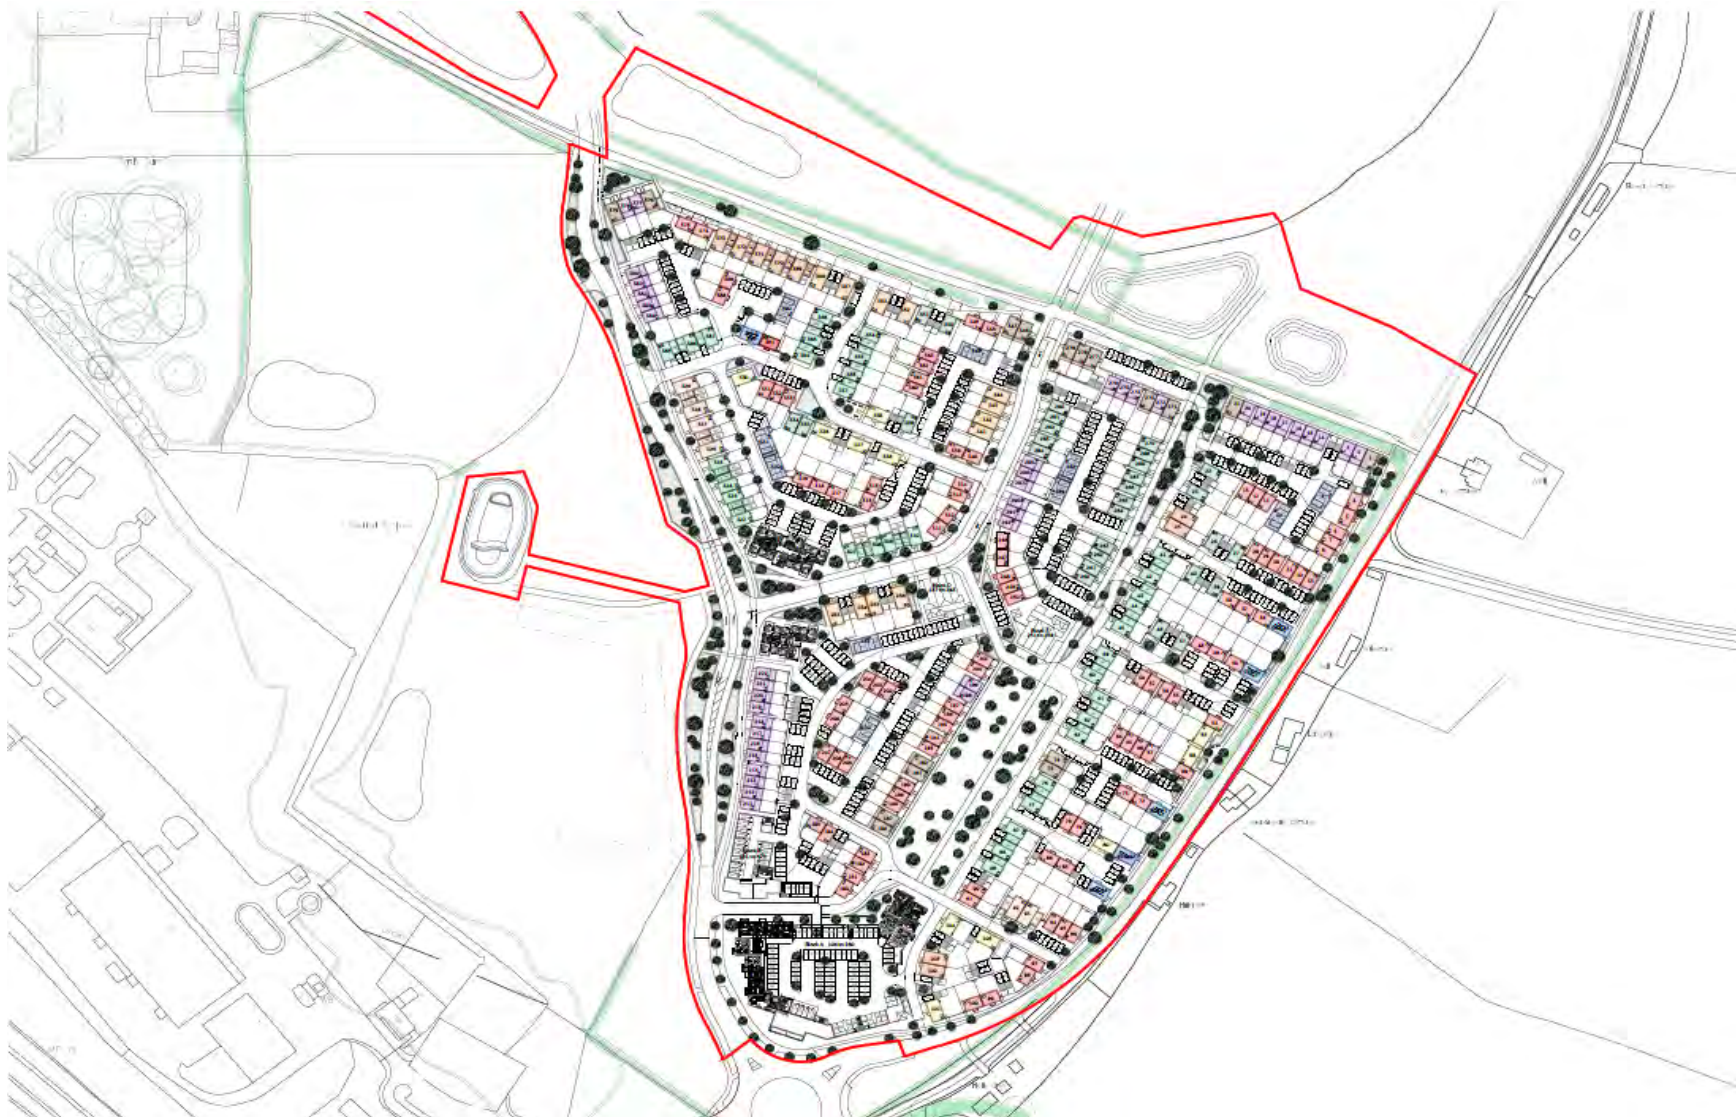
| <b>Project:</b> | One Horton Heath - First Residential Parcel | | | <b>Title</b> | Proposed Site Layout | |

Adjacent land uses were noted to comprise farmland and a solar farm to the north, Chalcroft industrial estate to the south and west, and residential uses to the south and east. Figure 1 presents the site's location and Figure 2 presents the site plan.

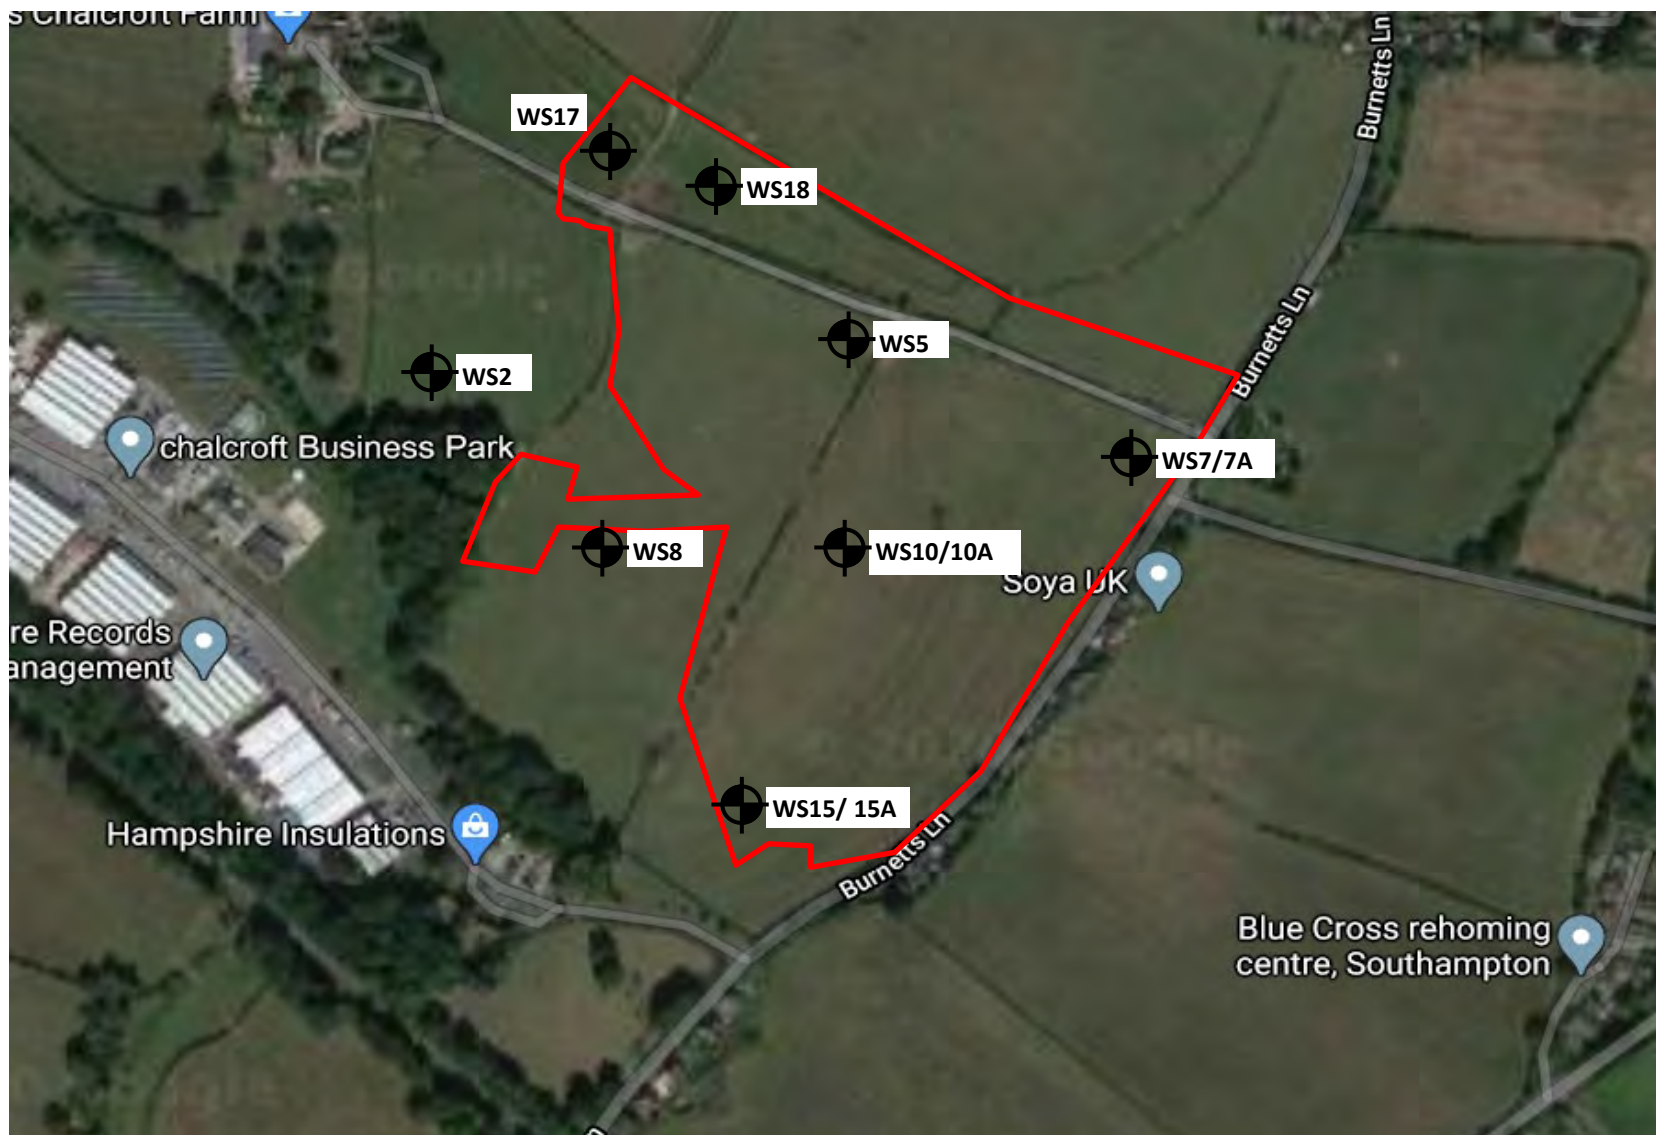
| <b>Project:</b> | One Horton Heath - First Residential Parcel | | | <b>Title</b> | Groundwater Monitoring Wells | |
