# Land at Horton Heath Eastleigh, Hampshire

## *Heritage Desk-Based Assessment*

CA Project: 770834

CA Report: 18560

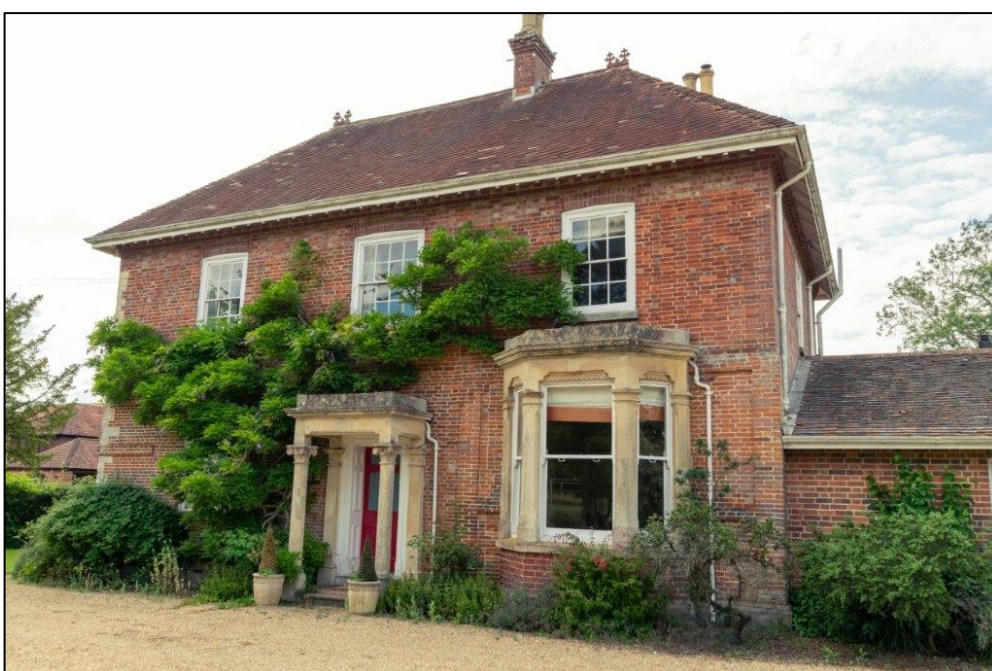
**Photograph 7**

sashes in exposed frames (Photograph 7). With the exception of the bay windows, the sashes lack any horns, pre-dating 1830 in design, and most retain historic glass.

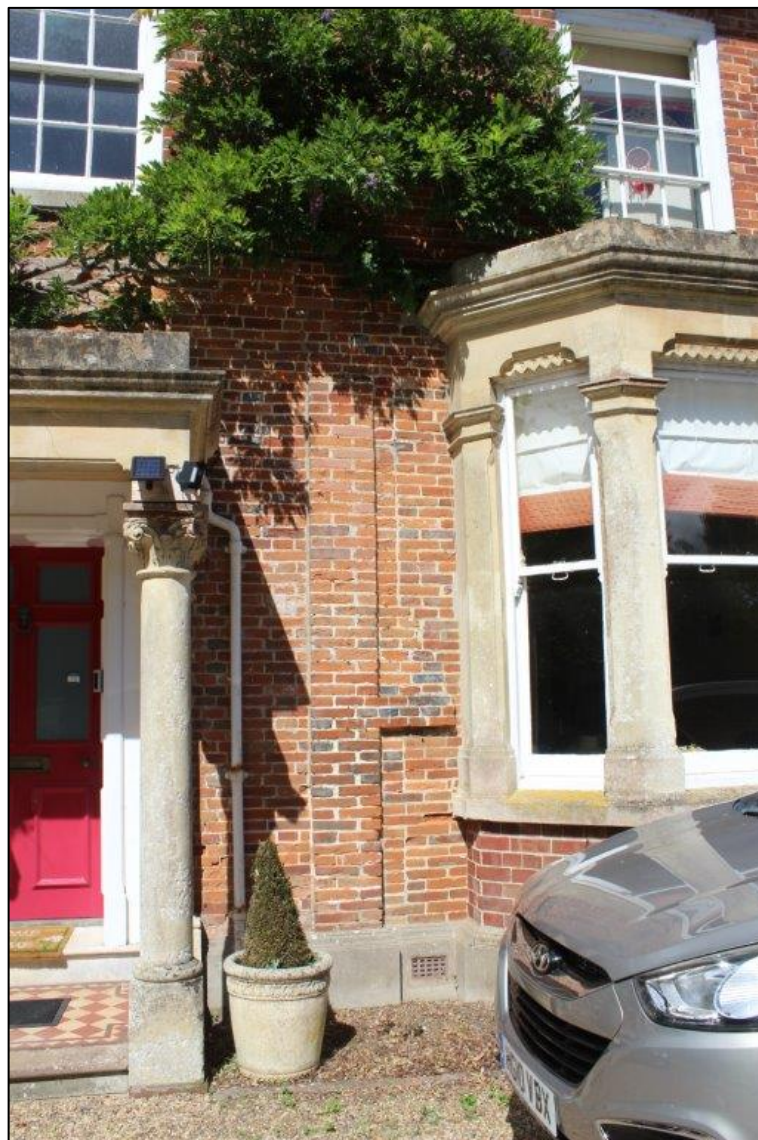
**Photograph 8**      **Detail of east (front) elevation**

- 5.22. Notably, there is a straight joint between the entrance door and the bay window which corresponds with one of the areas of reworking and strengthening (Photograph 8). Proportionally, this location may correspond with the end of the building depicted on the 1825 enclosure map (Map 7), and its possible some of the earlier fabric survived from this building and was reworked into the new wing. This also corresponds with the location of a chimney which bears no relation to the current ground floor plan, but is retained above (see Figs. 7 and 8 and discussion below at 5.50).

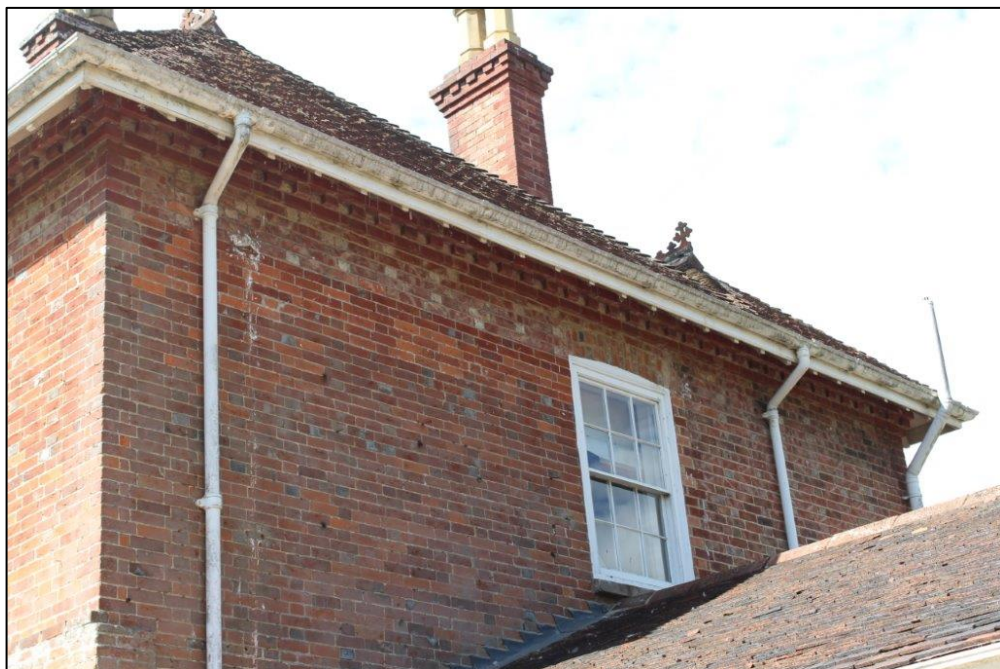
**Photograph 9**                      **North elevation of east wing**

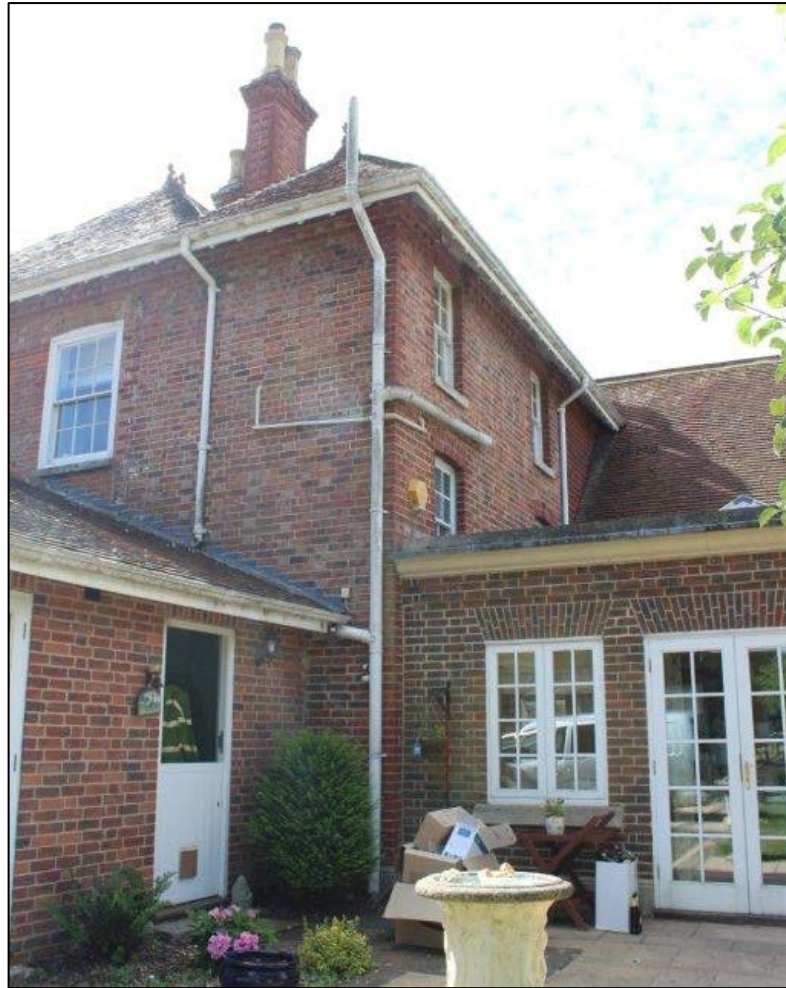
**Photograph 10**      **Narrower, rearward extension to east wing**

- 5.25. The narrow rearward extension dates to the late-19th century. It is of lesser height, but in the same style, and has clearly been constructed over the roof of the south wing (Photograph 10).
- 5.26. The lower portions of the north elevation are visible within the single-storey garage which was added in the late-20th century. Where it was visible, the wall appears to be in English garden wall bond, with a three-course band above a section of vertical brickwork, approximating a large lintel though not very high off the ground (Photograph 11). The stone plinth was also visible at low level.

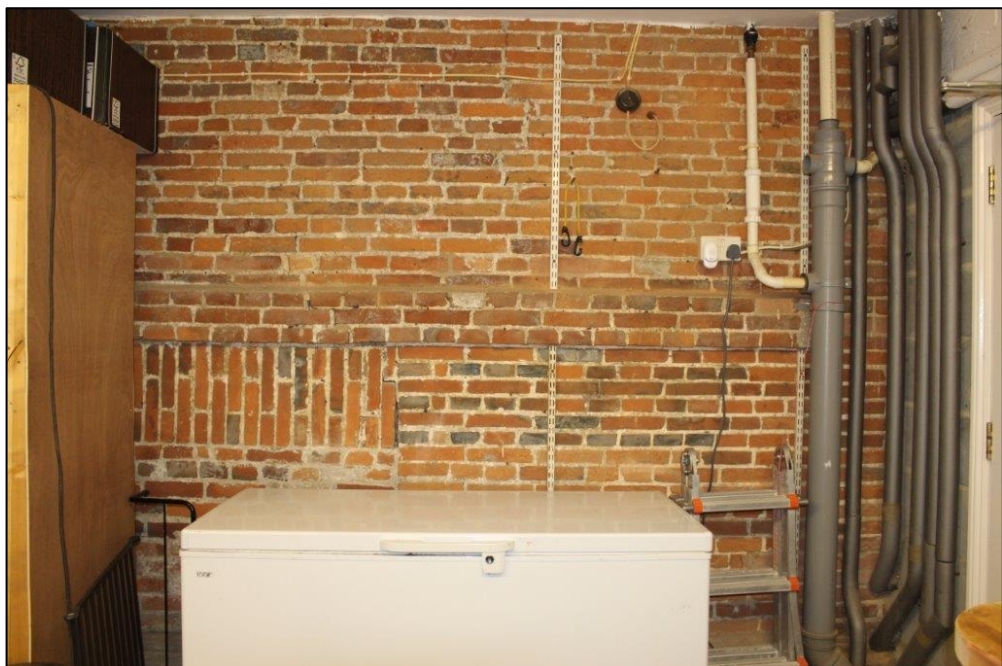
**Photograph 11**      **Narrower, rearward extension to east wing**

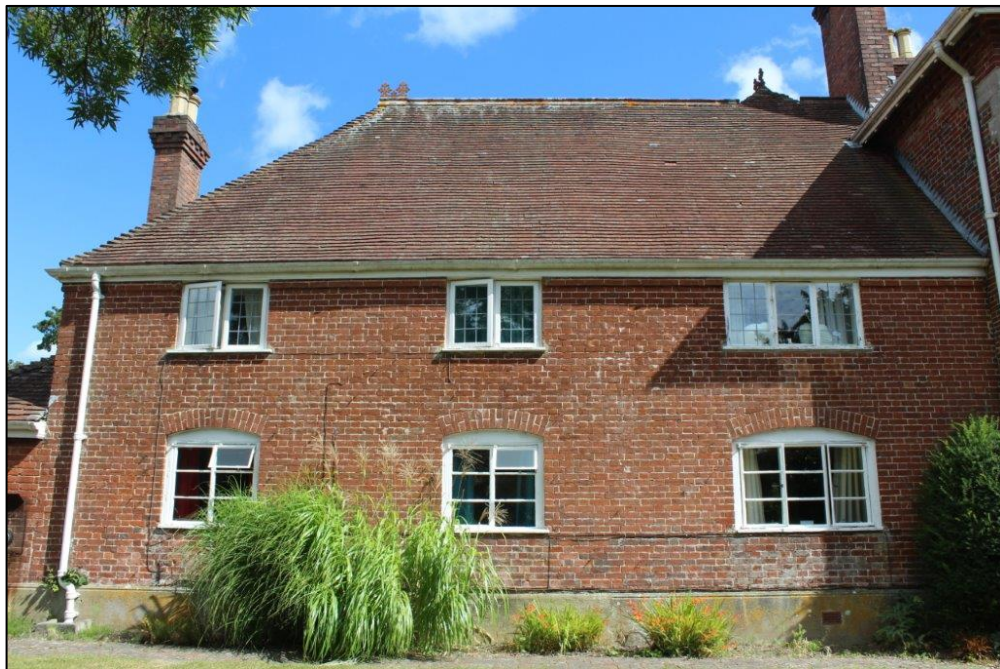
**Photograph 12**      **Principal elevation on south wing**

5.28. The older, south wing has a more understated polite appearance. It is constructed in Flemish Bond characteristic of the 18th century, with a politely composed elevation to the south under a steeply pitched tiled roof featuring Victorian ridges (Photograph 12). Characteristic of Flemish bond brickwork, queen closures mark the apertures of the windows, but curiously do not appear to carry on below the windows. In the absence of any other obvious scarring, it is therefore presumed that the earlier building also fronted east, or possibly north, based on the paths indicated by the enclosure map. Some of the later detailing, such as the bath stone plinth, has been carried over from the east wing, to create a more cohesive appearance.

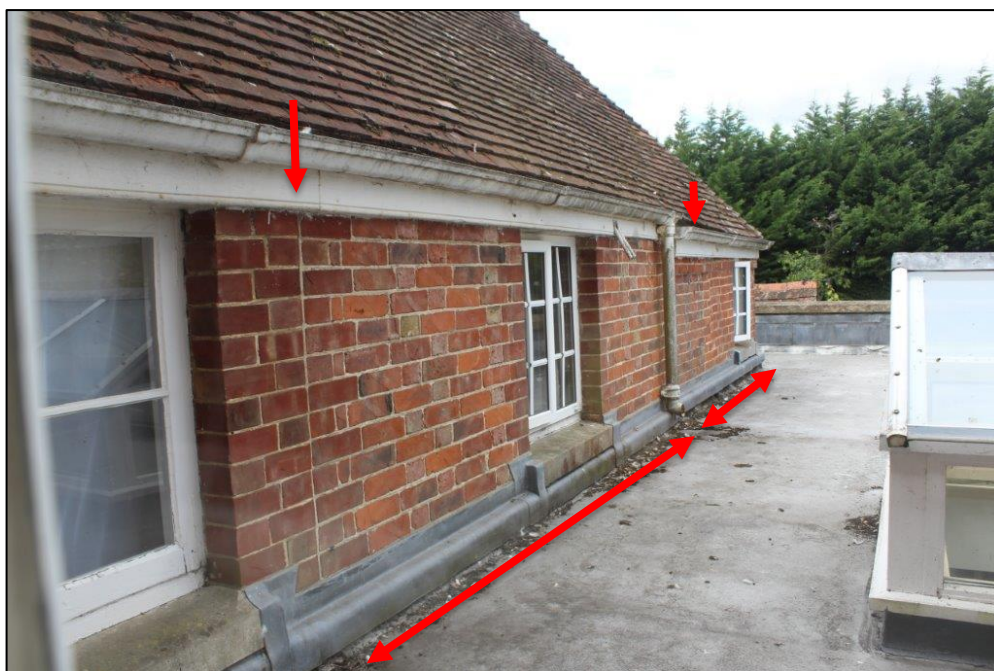
**Photograph 13**      **Rear (north) elevation of south wing**

5.30. All of the other elevations have been obscured by later additions, thereby limiting understanding of this element to some degree. Only the upper portions of the north elevation are visible from the upper floor windows. This suggests three different build periods for the north elevation, indicated by straight joints in the brickwork (Photograph 13). However, the brickwork itself varies from the south elevation in its mottled colour and texture, and is at least partly in Monk Bond corresponding with the later-19th century elements, suggesting that it has been rebuilt (possibly in phases). The two windows to the west end have been replaced with double-glazed units with applied glazing bars, but the remaining traditional window is a split pane timber casement. Despite the later extensions, the historic envelope survives internally at ground floor, with two windows (now internal), both of which are multi-pane sashes. The larger, western one is a 6/6 sash with horns and appears historic, though it is unclear if it is in an original position as none of the fabric of the wall is visible.

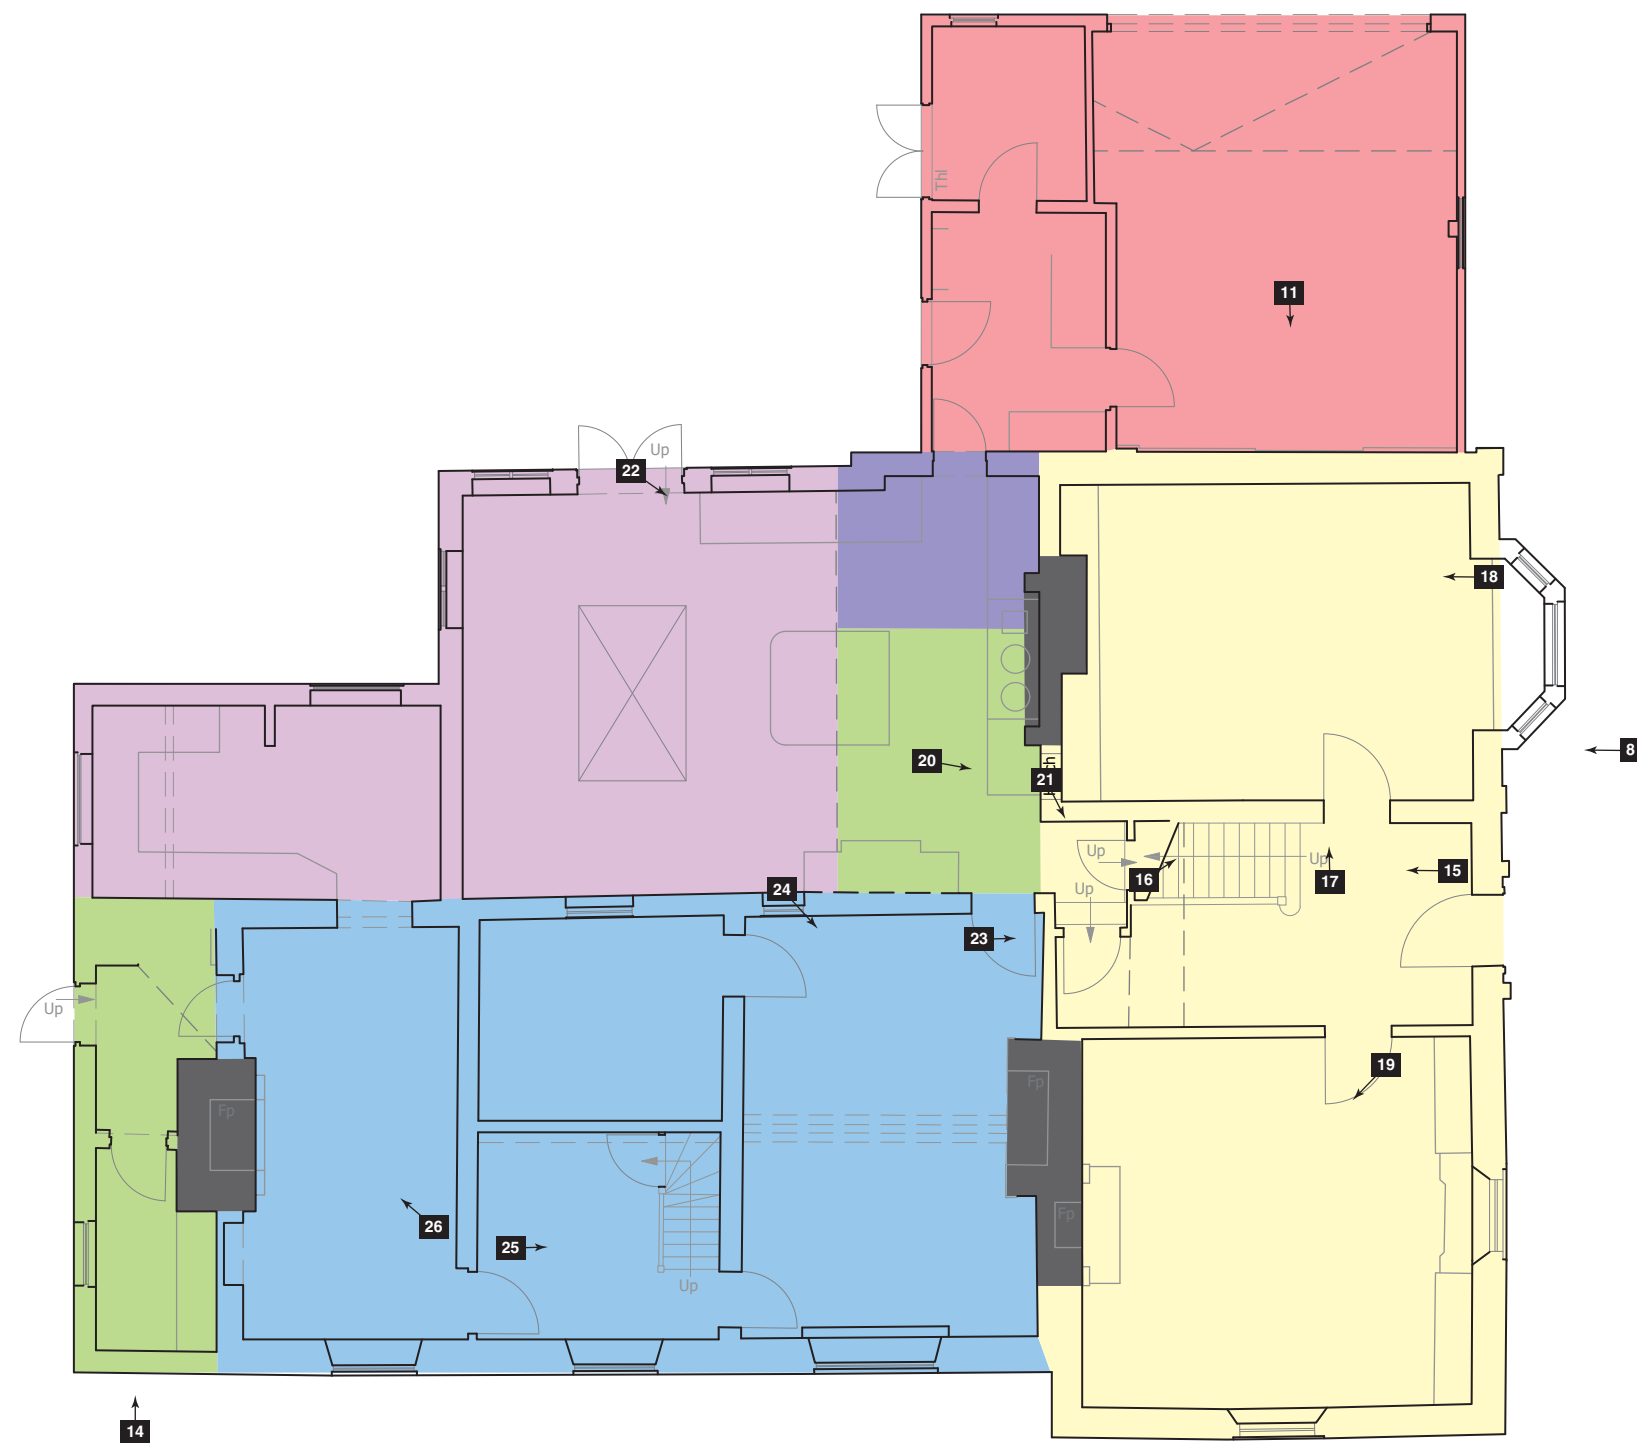
| DRAWN BY AO<br>CHECKED BY DJB<br>APPROVED BY HH | PROJECT NO. 770834<br>DATE 30/10/2020<br>SCALE@A3 1:100 | FIGURE NO.<br><b>7</b> |

Ground Floor

- 5.51. In the southern room, the chimney is on the western wall, where it shares the large stack with the south wing (Photograph 35). Although this wall is flush, there were distinct breaks in the skirting boards and a vent indicating the fireplace position. The wall at the junction between the south and east wings is particularly thick (Figure 8), with four flues in the chimney.

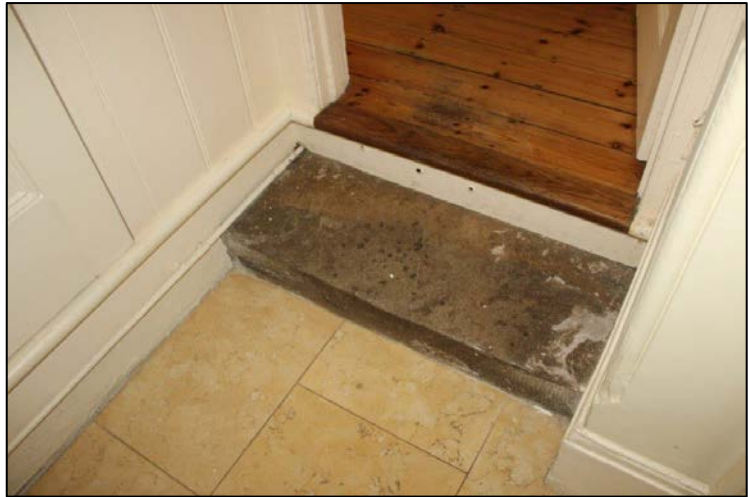
**Photographs 20 and 21**  
entrance hall

**Historic details in the kitchen, at the threshold with the**

- 5.37. From the entrance hall, a four-panelled door (but with the same high-status architraves) discreetly tucked beneath the stair leads into the rest of the 19th century extension beyond and facilitates access to the ground floor of the older 18th century wing. Although the extent of the historic addition remains legible by virtue of the downstand and step in the external (north) wall, the small space has been opened out into the extension of c. 2000. The high-status and polite detailing has been meticulously recreated in this space, though it was likely more modest in character historically. There are few genuinely historic features legible within the space, apart from the understair cupboard with a four panelled door and bead-boarding, and the worn stone step on the threshold from the hallway (Photographs 20 and 21).

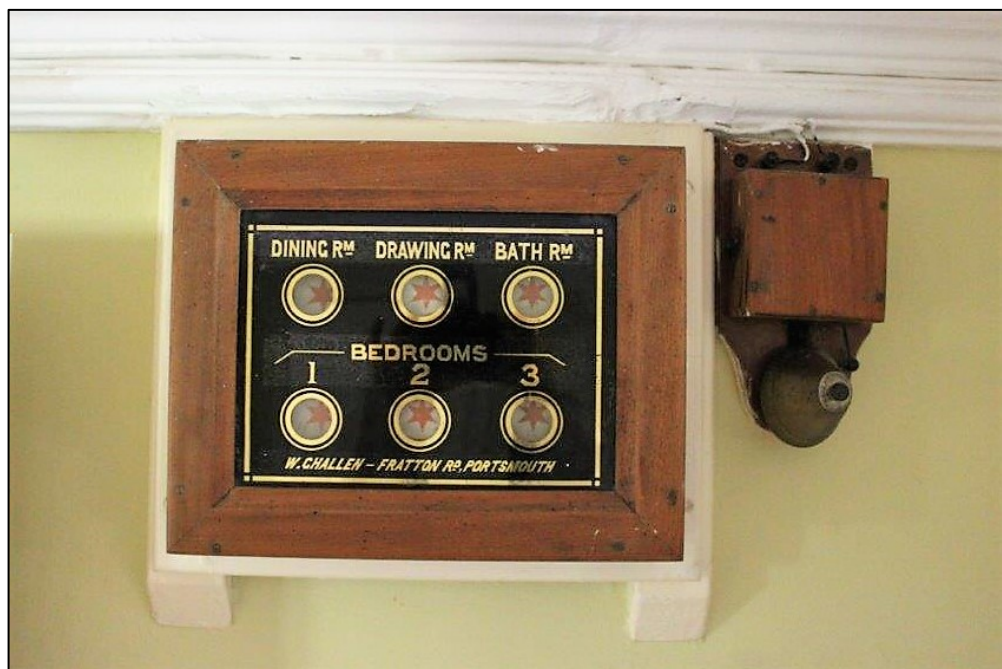
**Photograph 23**      **Service call box in the older wing**

- 5.41. Supporting this theory, the service call box remains mounted on the wall in the main space (Photograph 23), possibly the historic kitchen but today a secondary sitting room. The box has bells for the Dining Room and Drawing Room at ground floor, and the upper-floor bedrooms, all within the late-19th century wing, as well as an unknown 'bathroom'. This has been produced locally, by W. Challen of Fratton in Portsmouth.

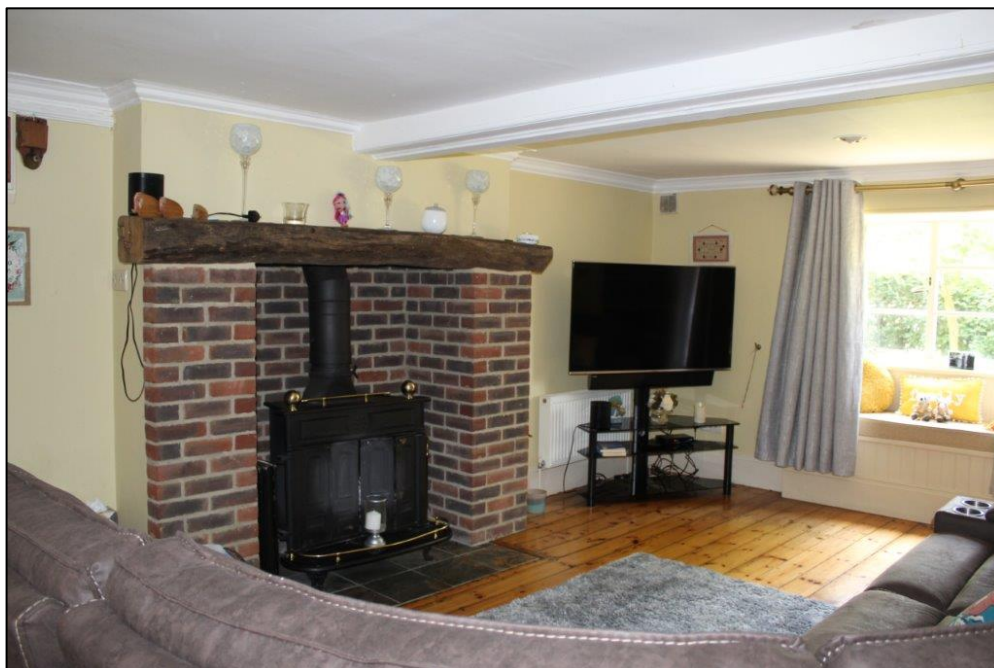
**Photograph 24**      **Rebuilt fireplace in the older wing**

- 5.42. This main space features a spine beam supported on its eastern end by the chimney breast, which has been rebuilt in brickwork to match that found in the opposing room, with a tiled hearth and reused piece of timber as a mantle (Photograph 24). A timber board mounted on the landing of the stair is inscribed with 'Christopher Earle Anno Dom 1661' which is said to date a beam in the older wing, presumably this beam (Course & Moore, 1985). This board also carries the inscription of 'A.V. Maybury 1897', who was likely the patron of the late-19th century enlargements. The beam has been boxed out and is painted, so reveals very little of interest. The window

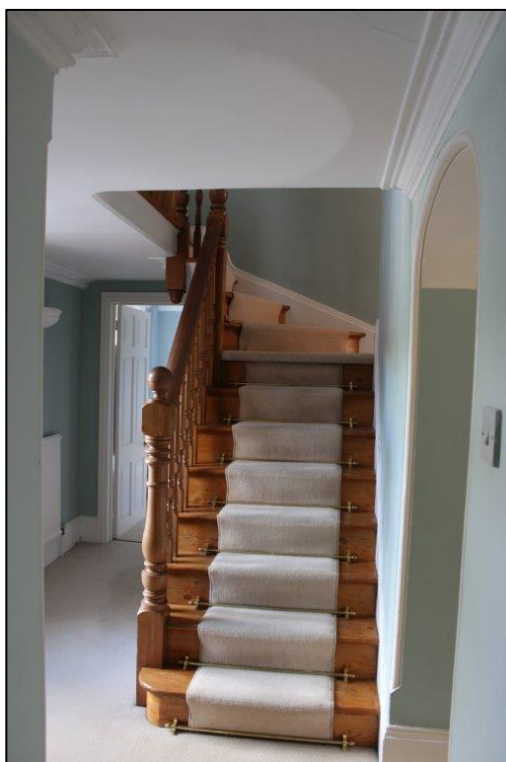
**Photographs 31 and 32**

**Stairwell and mezzanine in the Victorian addition**

- 5.48. The detail on both of the stairs is the same, suggesting they are contemporary. Observations from the exterior suggested that raising of the roof and the extension to the rear were undertaken as two separate events, and it is unclear what the stair arrangement may have been within the east wing prior to the addition to the rear which today facilitates access to the northern bedroom.

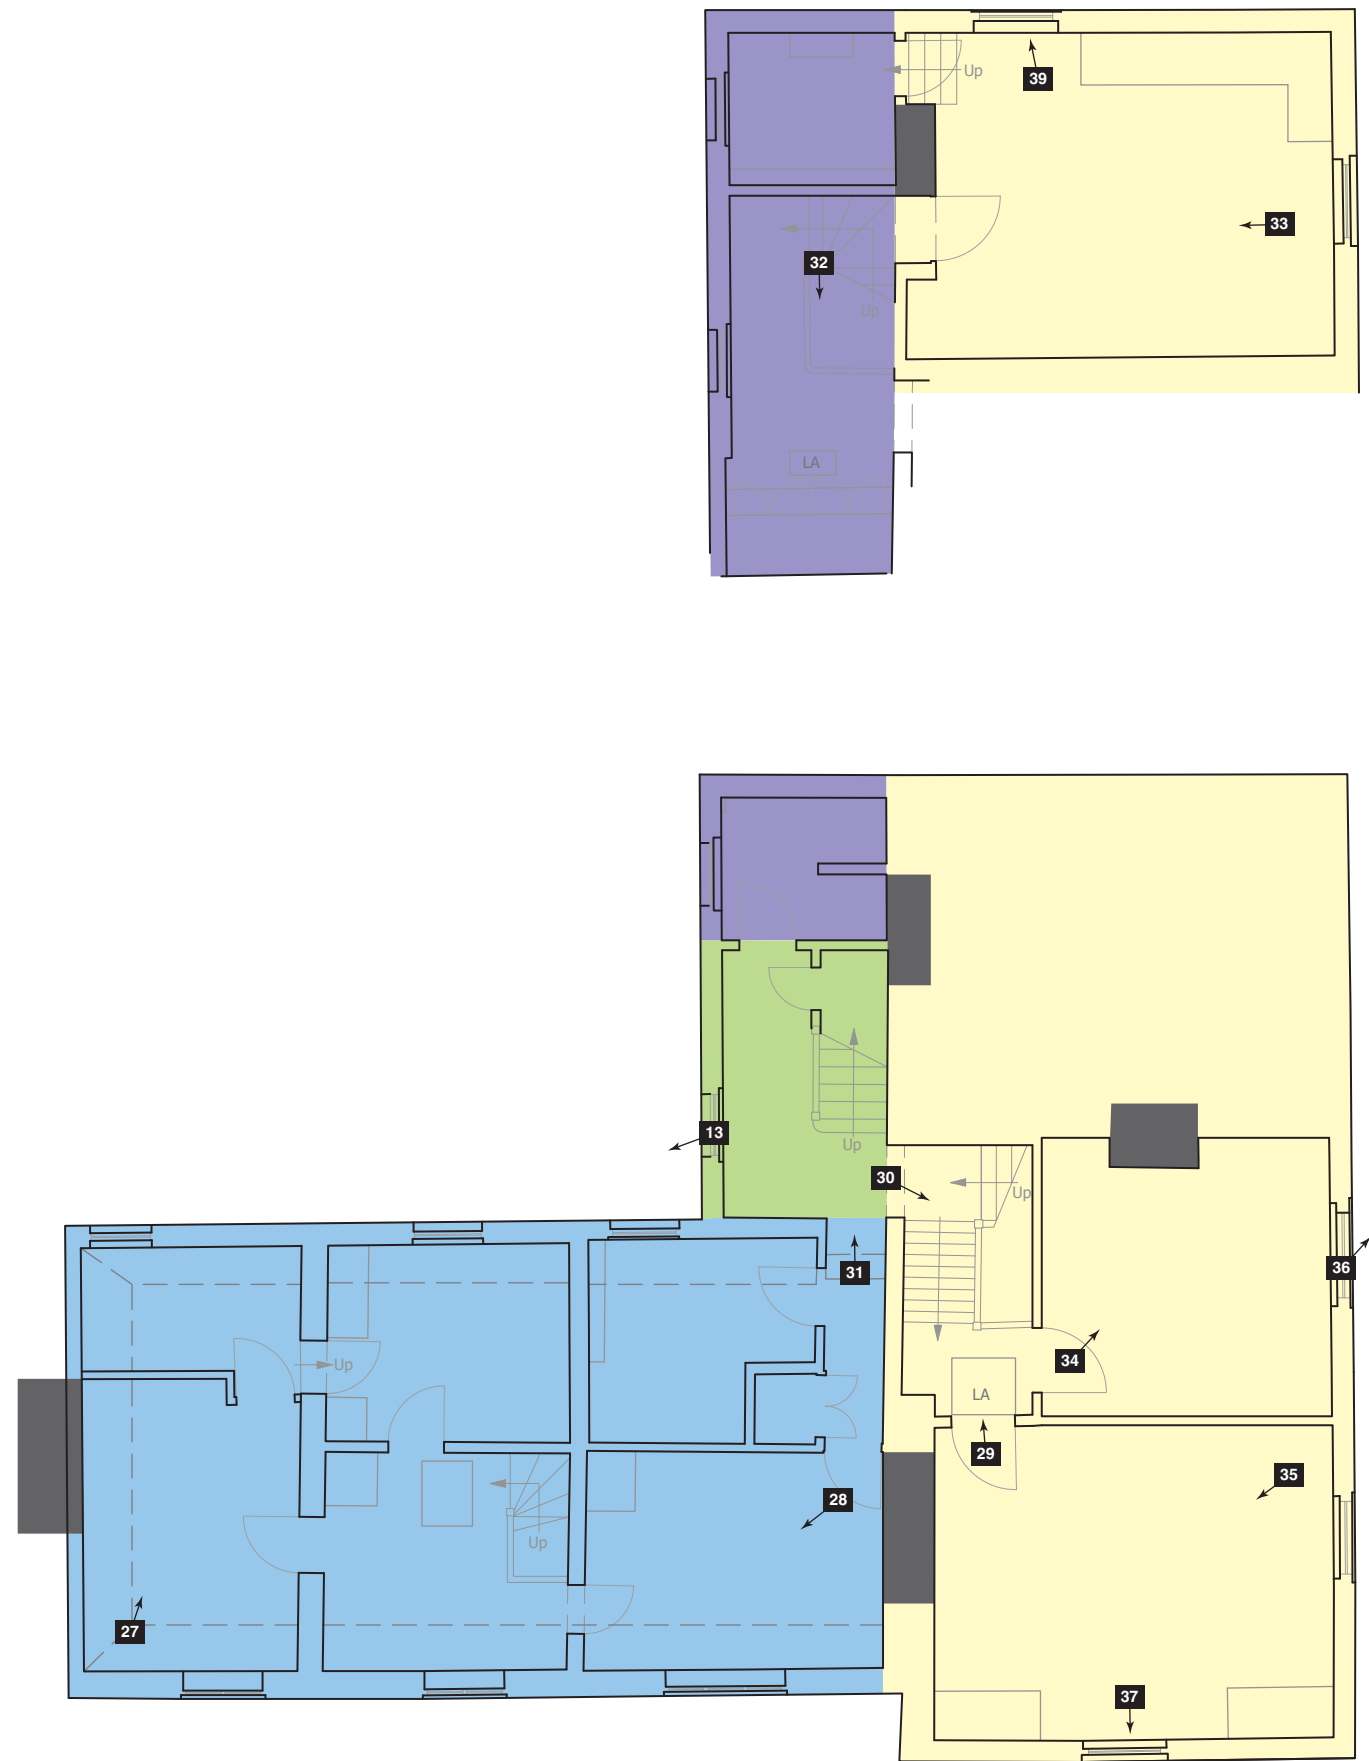
Upper Floors

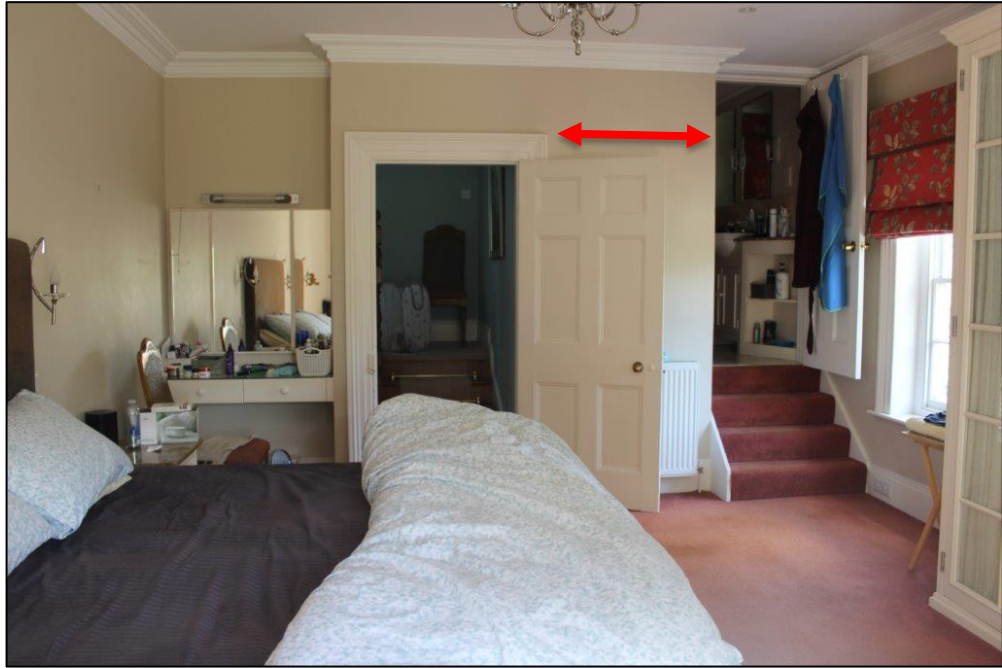
**Photograph 33**View west in the northern bedroom (presumed flue location identified)

- 5.49. All of the bedrooms in the east wing retain their timber joinery, including doors and architraves, skirting boards, picture rails and sash windows, and have plaster covings to the ceilings. The northern bedroom is distinct in that it has an en-suite (stacked over the shared bathroom within the later addition) which is reached via a short flight of stairs from within the bedroom (Photograph 33).

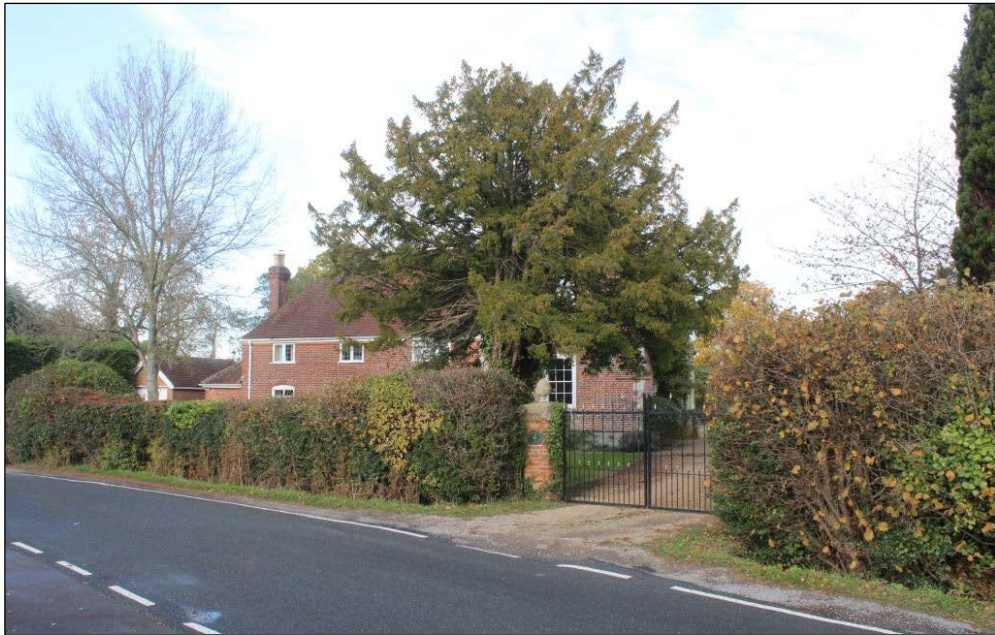
**Photograph 40**      **Firtree Farm from Firtree Lane (looking north-west)**

- 5.61. Due to the narrow width of Firtree Lane, high hedges and curve of the road, views of the Listed Building are generally glimpsed and focused on the older, more informal south elevation which is largely screened at ground level by intervening vegetation. Only a sense of the building's polite appearance and large gardens can be understood from Firtree Lane, largely by virtue of the decorative gate and piers (Photograph 40), though the use of similarly style gates at Victoria House has undermined this to some extent (Photograph 4 above).
