DEMOLITION ASBESTOS SURVEY  
TO  
BISHOPSTOKE MEMORIAL HALL,  
17 RIVERSIDE,  
BISHOPSTOKE,  
EASTLEIGH,  
HAMPSHIRE  
SO50 6LQ  
ON BEHALF OF  
EASTLEIGH BOROUGH COUNCIL

A demolition asbestos survey was carried out to Bishopstoke Memorial Hall, 17 Riverside, Bishopstoke, Eastleigh, Hampshire, SO50 6LQ

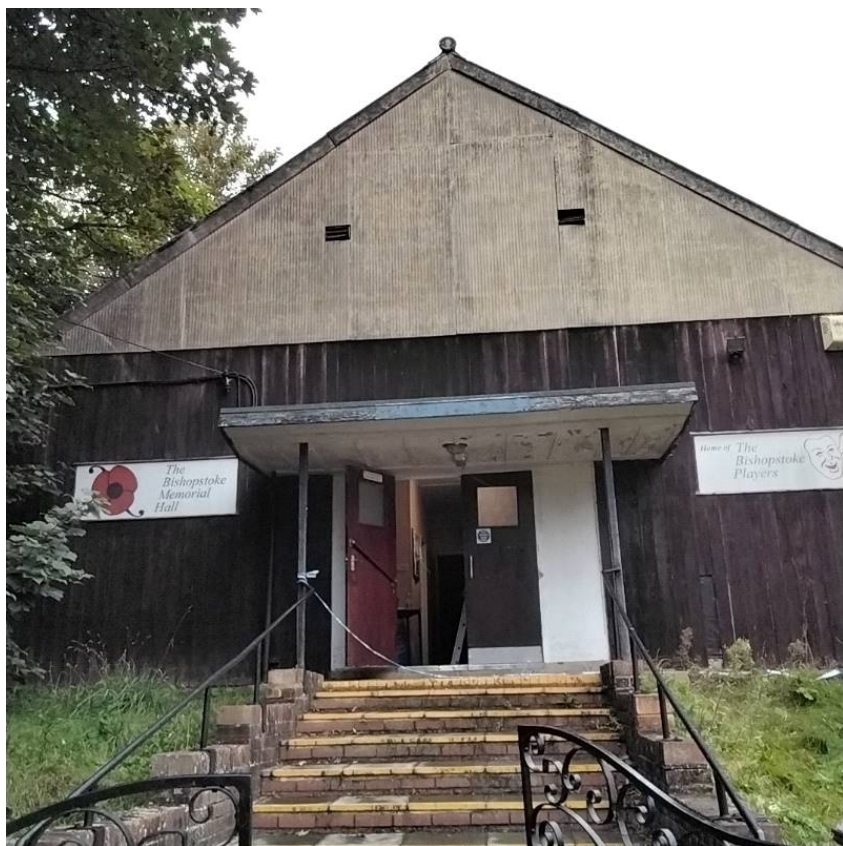
Externally the building is constructed of brick and wooden walls, profile cement roof sheets, cement soffit boards, downpipes and gutterings, hardboard and modern bitumen felt forming entrance canopy, putty to metal windows.

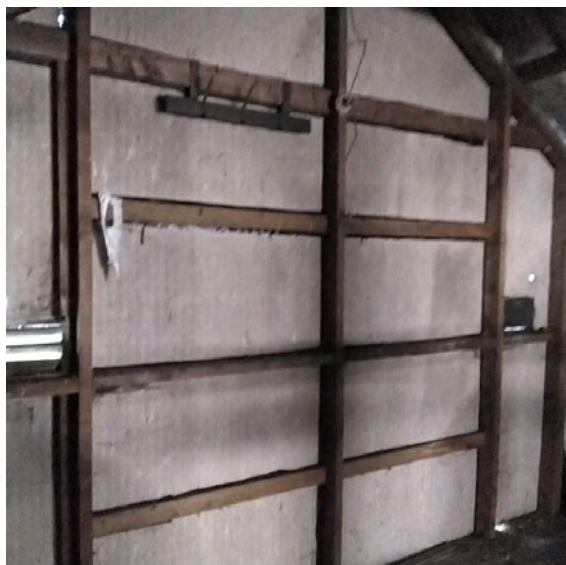
Sample 21: Mezzanine. Storage Area. Cement panels to front and rear gable ends

| SAMPLE NUMBER | SAMPLE DESCRIPTION | PRODUCT TYPE | ACTION REQUIRED |
|---|---|---|---|
| Sample 21 | Mezzanine Storage Area, Cement panels to front and rear gable ends | Asbestos Cement | Removal of non-licensed ACMs (Remove (non-licensed)) |

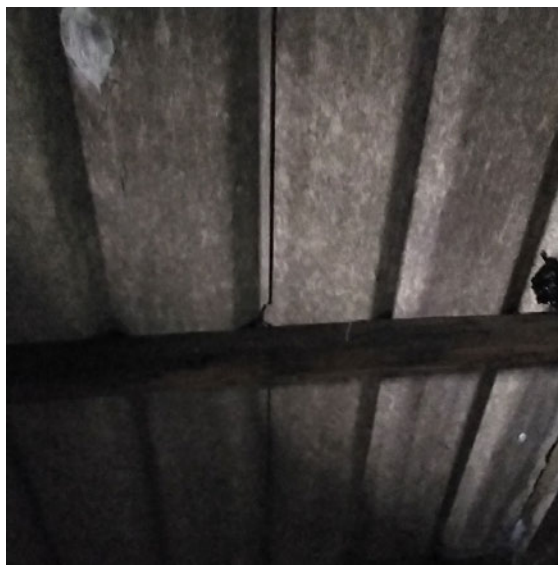
Sample 22: External. Exterior. Profile cement roof sheets sampled internally.

| SAMPLE NUMBER | SAMPLE DESCRIPTION | PRODUCT TYPE | ACTION REQUIRED |
|---|---|---|---|
| Sample 22 | External Exterior, Profile cement roof sheets sampled internally. | Asbestos Cement | Removal of non-licensed ACMs (Remove (non-licensed)) |

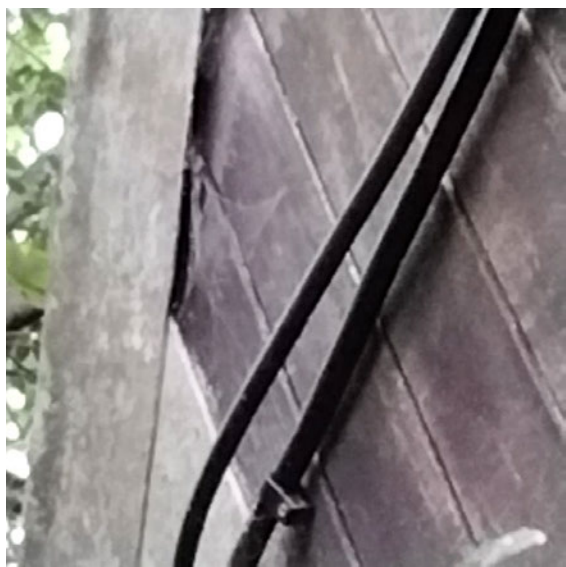
Ref. Sample 22: External. Exterior. Cement roof edging boards

| SAMPLE NUMBER | SAMPLE DESCRIPTION | PRODUCT TYPE | ACTION REQUIRED |
|---|---|---|---|
| Ref. Sample 22 | External Exterior, Cement roof edging boards | Asbestos Cement | Removal of non-licensed ACMs (Remove (non-licensed)) |

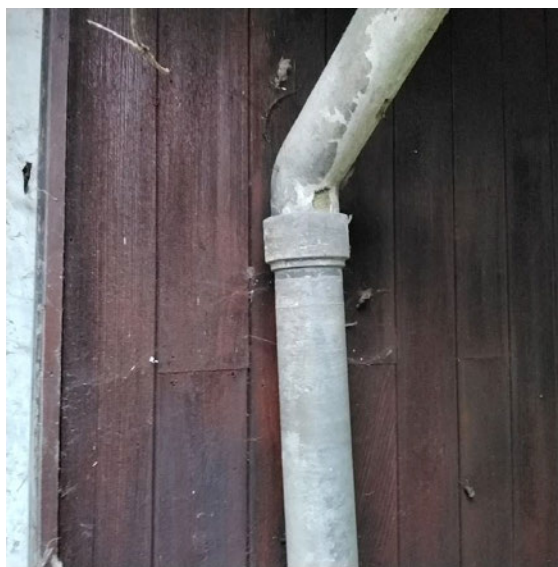
Sample 23: External. Exterior. Cement downpipes around perimeter

| SAMPLE NUMBER | SAMPLE DESCRIPTION | PRODUCT TYPE | ACTION REQUIRED |
|---|---|---|---|
| Sample 23 | External Exterior, Cement downpipes around perimeter | Asbestos Cement | Removal of non-licensed ACMs (Remove (non-licensed)) |

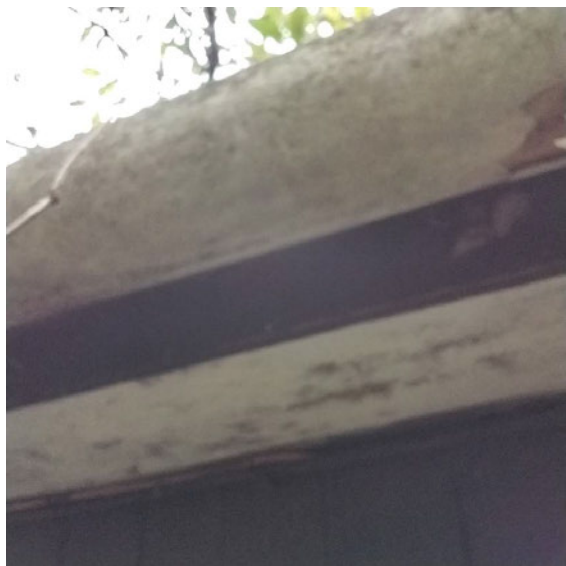
Sample 24: External. Exterior. Cement gutterings around perimeter

| SAMPLE NUMBER | SAMPLE DESCRIPTION | PRODUCT TYPE | ACTION REQUIRED |
|---|---|---|---|
| Sample 24 | External Exterior, Cement gutterings around perimeter | Asbestos Cement | Removal of non-licensed ACMs (Remove (non-licensed)) |

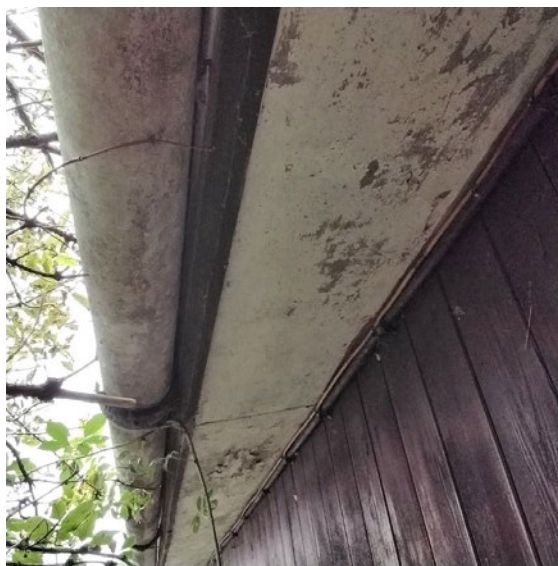
Sample 25: External. Exterior. Cement soffit boards around perimeter

| SAMPLE NUMBER | SAMPLE DESCRIPTION | PRODUCT TYPE | ACTION REQUIRED |
|---|---|---|---|
| Sample 25 | External Exterior, Cement soffit boards around perimeter | Asbestos Cement | Removal of non-licensed ACMs (Remove (non-licensed)) |
