Phase 1 & 2 bat surveys

**95 Lakewood Road**

**Chandler's Ford**

Survey and report by: Vesper Conservation & Ecology Limited

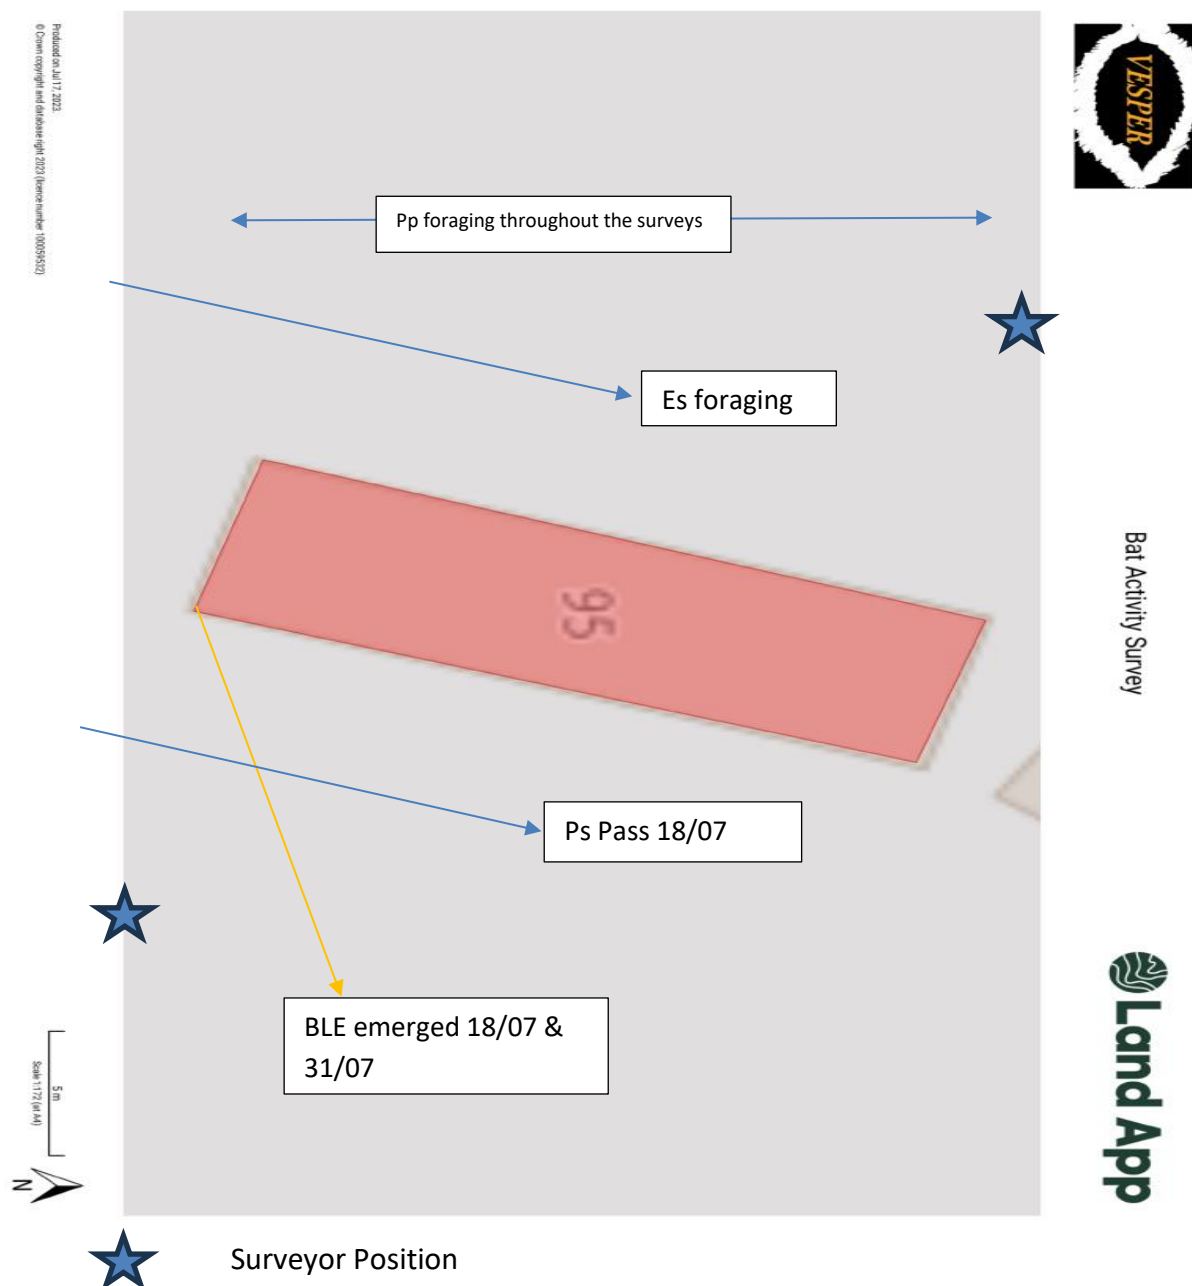
**Figure 1: Dusk Surveys summary map (for the activity surveys 18/07/23 and 31/07/23)**

3.4 During the first dusk survey (18/07/23) 4 species were recorded (Soprano and Common pipistrelle, Serotine and Brown Long eared bats). 1 X Brown Long eared bat was seen emerging from the single storey extension from the hip on the southeastern end. (See Figure 1) (Peter Allan, Suzie Melhuish)

3.5 During the second dusk survey (31/07/23) 3 Species of bat were recorded (Common pipistrelle, Long-eared and Serotine bats). 1 x Brown long eared bat was seen emerging from the hip of the single storey extension at the southeastern end. (See Figure 1) (Rob West, Peter Allan)

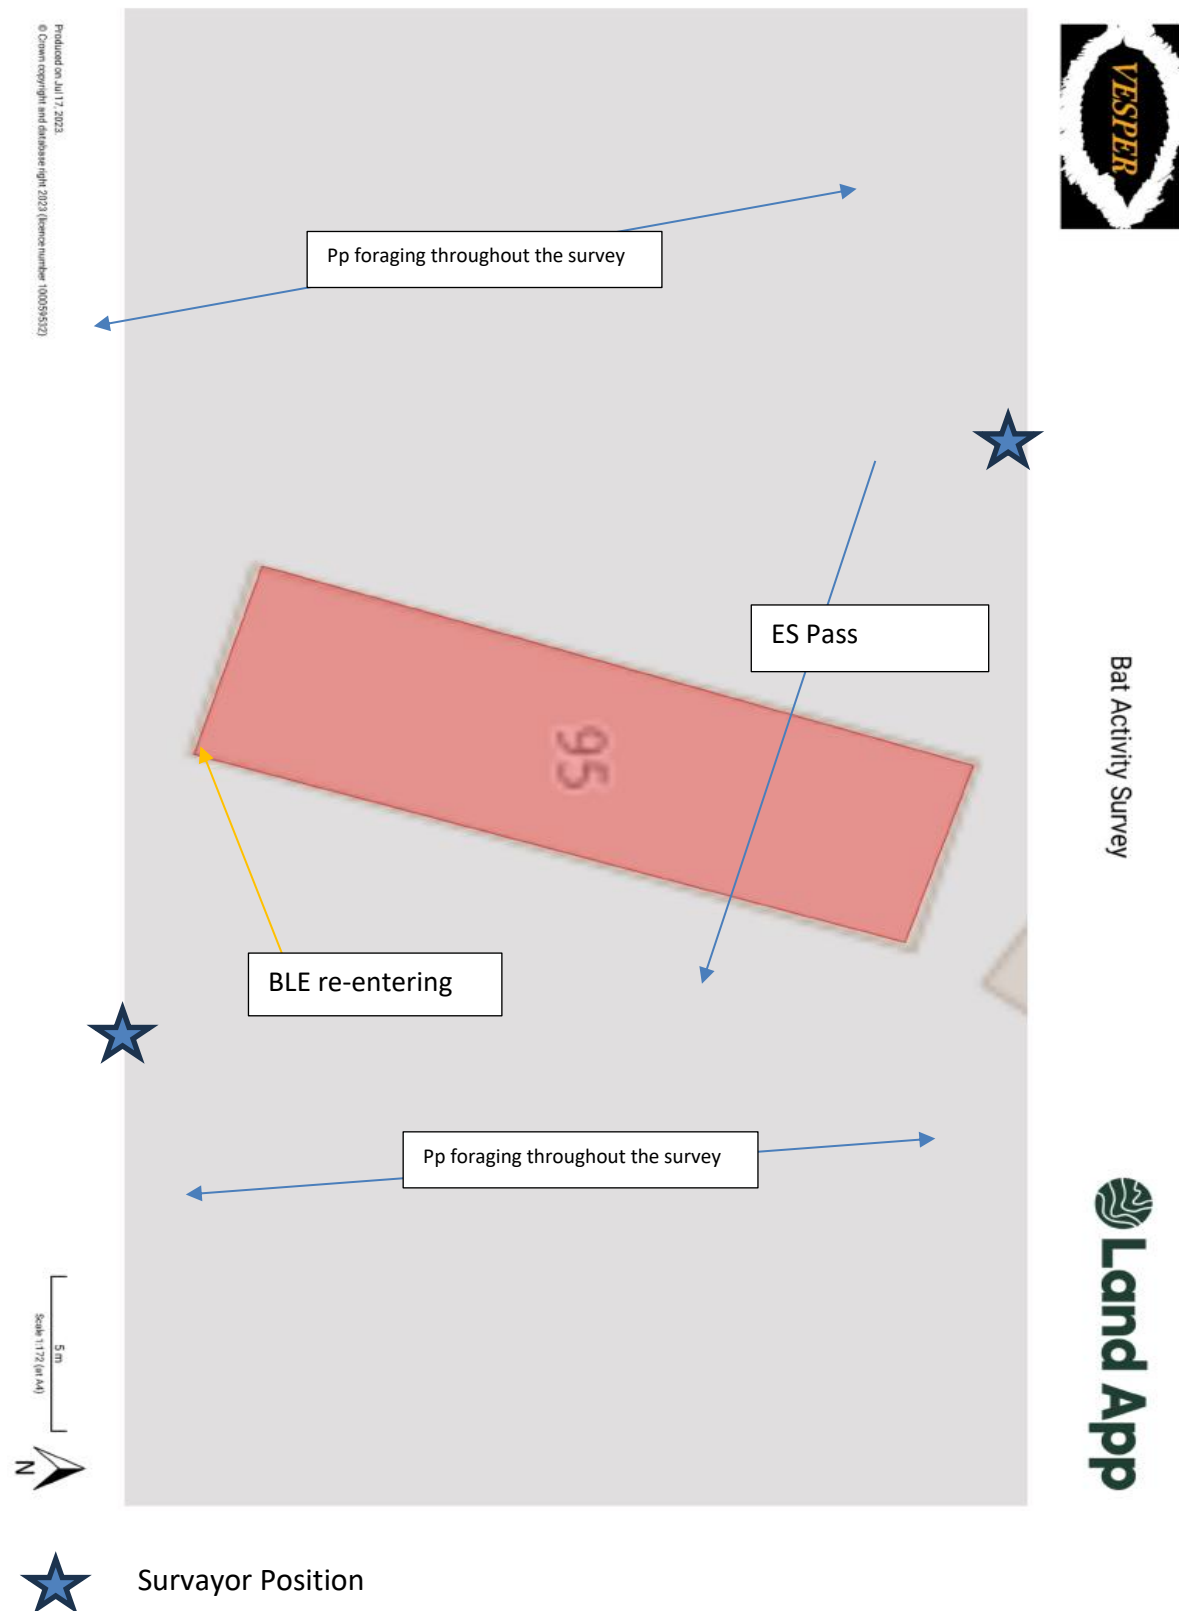
**Figure 2: Dawn Survey summary map (for the activity survey 14/08/23)**

3.6 During the dawn survey (14/08/23) 3 species were recorded (Common pipistrelle, Serotine and Brown Long eared bats). 1 x Brown Long eared bat was seen re-entering the building into a gap in the hip tiles on the single storey extension at the southeastern end of the building. (See figure 2). (Rob West, Peter Allan)

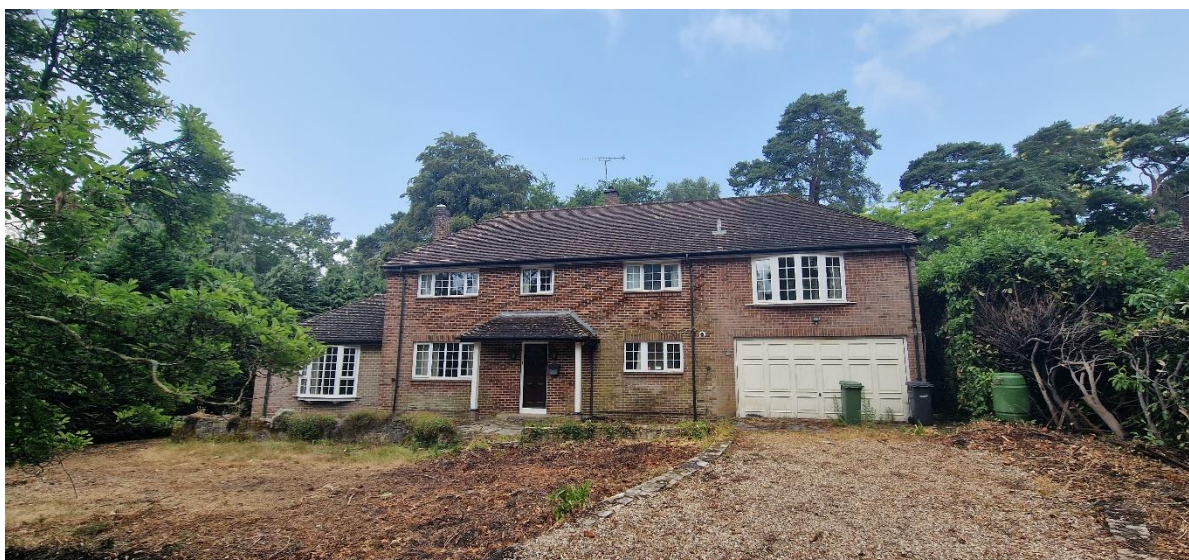
**Picture 1:** The eastern elevation

- 2.6 There are gaps on all the elevations; eaves consist of mostly tight-fitting barge boards but there are gaps on all aspects of the building. All the tile verges are tight on the house the single storey side extension has a single gap.

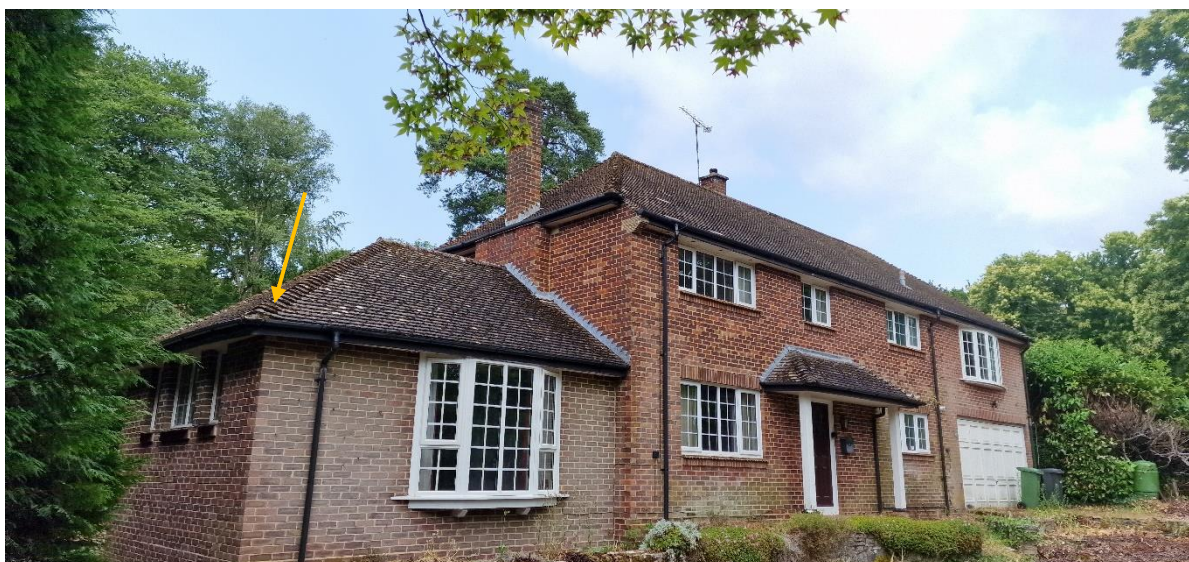
**Picture 3:** Showing southeastern area where bats were seen emerging.

- 3.11 The activity surveys showed that 1 species of bat are using the building as a roost, the roost entry point is a gap in the hip tiles on the single storey extension. The proposed work will affect one of the entry points and therefore, to carry out the proposed works, a suitable mitigation strategy needs to be developed. A Protected Species Licence (PSL) in respect of bats will also be required to carry out any works affecting the bat roost. This will require an application to Natural England and can only be applied for after the grant of planning permission, as a copy will need to go with the license application.

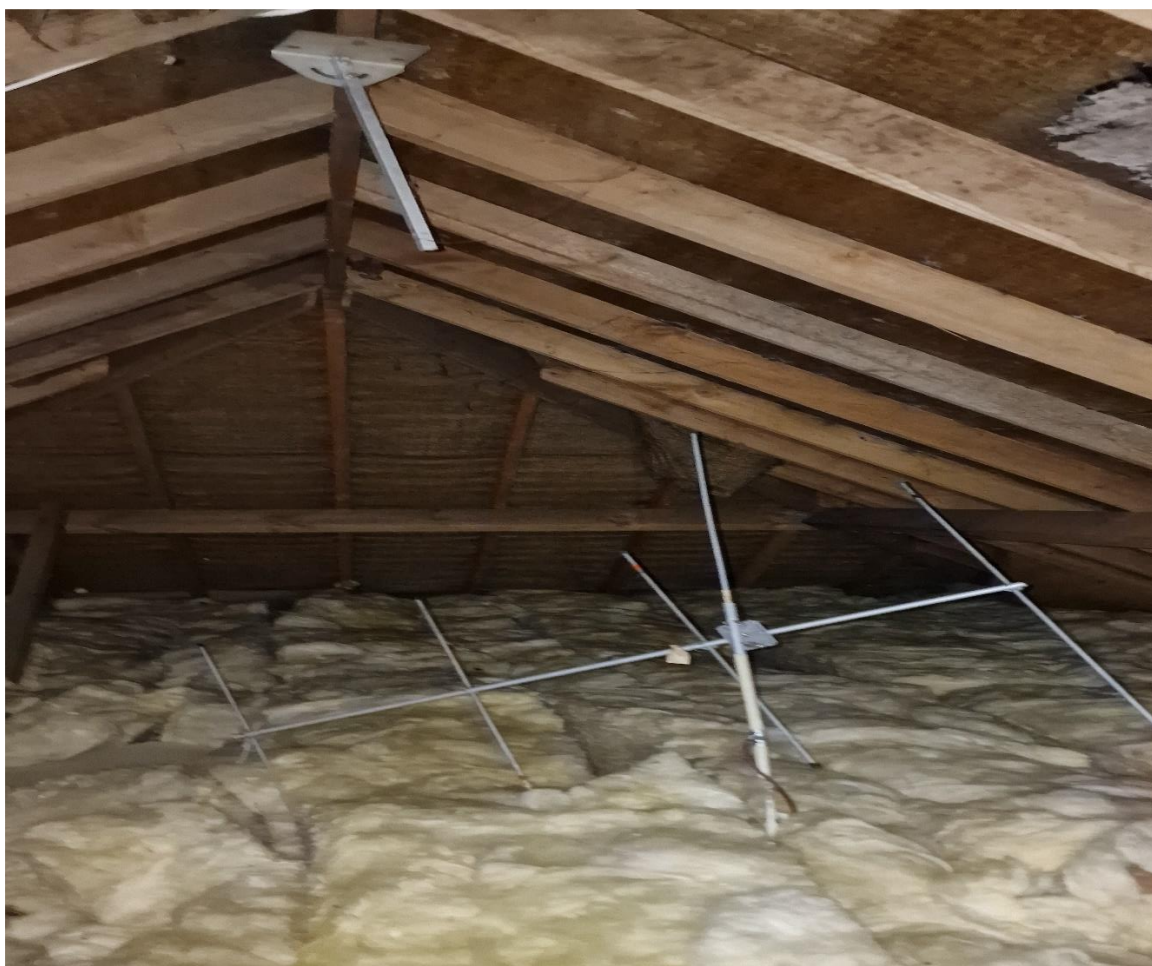
**Picture 4:** Showing the internal roof structure.

- 2.8 There is a single roof space that cover the whole of the main house, the single storey extension has no roof space. Access to the loft space was good throughout.
- 2.9 The roof floor is covered with a thick layer of insulation which goes right into the eaves. There are no obvious gaps or holes that allow light into the roof space.
- 2.10 The tiles are backed with bitumen felt, this is in good condition with no gaps or holes that would allow bats to ingress into the roof void.
- 2.11 The floor of this roof was covered in thick glass fibre insulation and there were boards to walk on throughout.
- 2.12 There were no physical signs of bats within the roof, there were also no other signs of rodents or birds in the roof void.
