**GROUND INVESTIGATION REPORT**

**HOLLY TREE FARM,**

**MADDOXFORD LANE,**

**BOORLEY GREEN, HAMPSHIRE,**

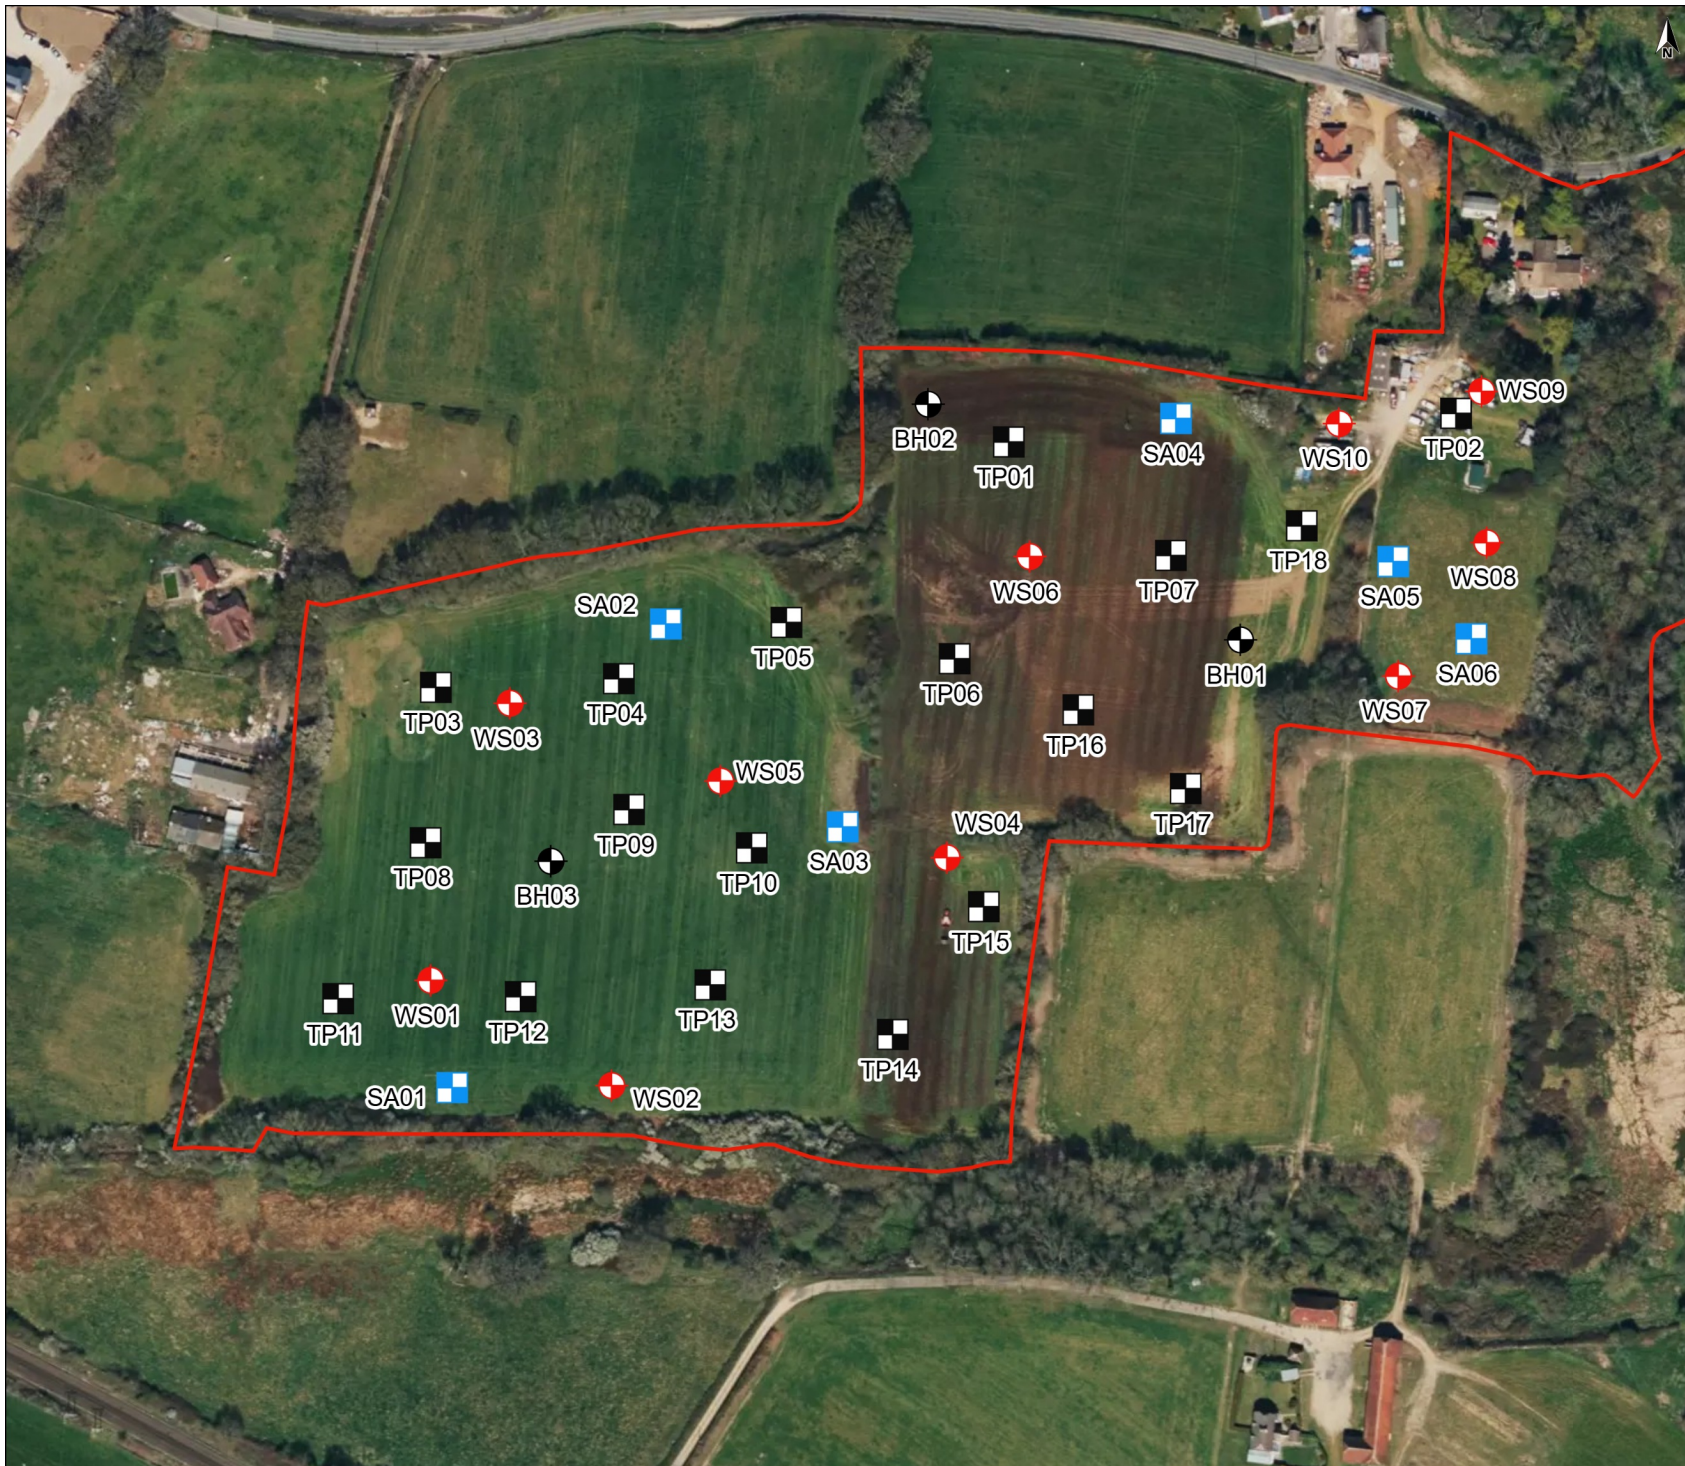
- Legend**
- Site Boundary (Holly Tree Farm)
  - Cable Percussive Boreholes
  - Monitoring Wells
  - Soakage Testing
  - Trial Pits

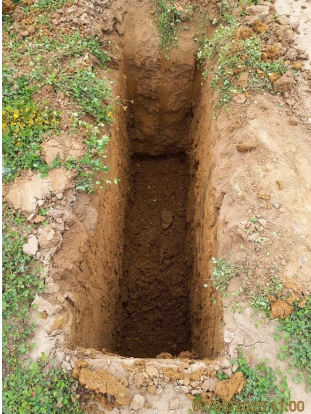
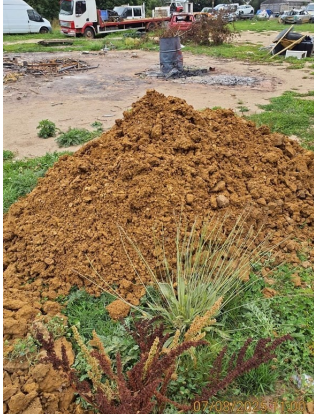
| PhotofPit | | | | | PhotofSpoil | | | | |

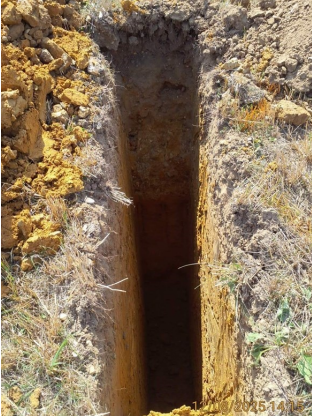
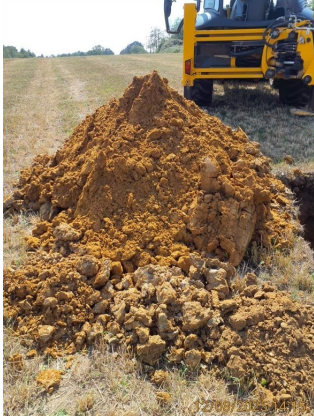
| | | | | | | End of Trial Pit at 3.00m | | | |
| Final Depth: | 3.00m | | | | <br>PhotoofPit | | | | |
| Groundwater not encountered | | | | | | | | | |
