**Main Investigation Report**

**Samsons Gym, 237 Chamberlayne Road,  
Eastleigh, Hampshire SO50 5JB**

**Eastleigh Borough Council**

**Reference: I9I92/MIR RevI02  
November 2025**

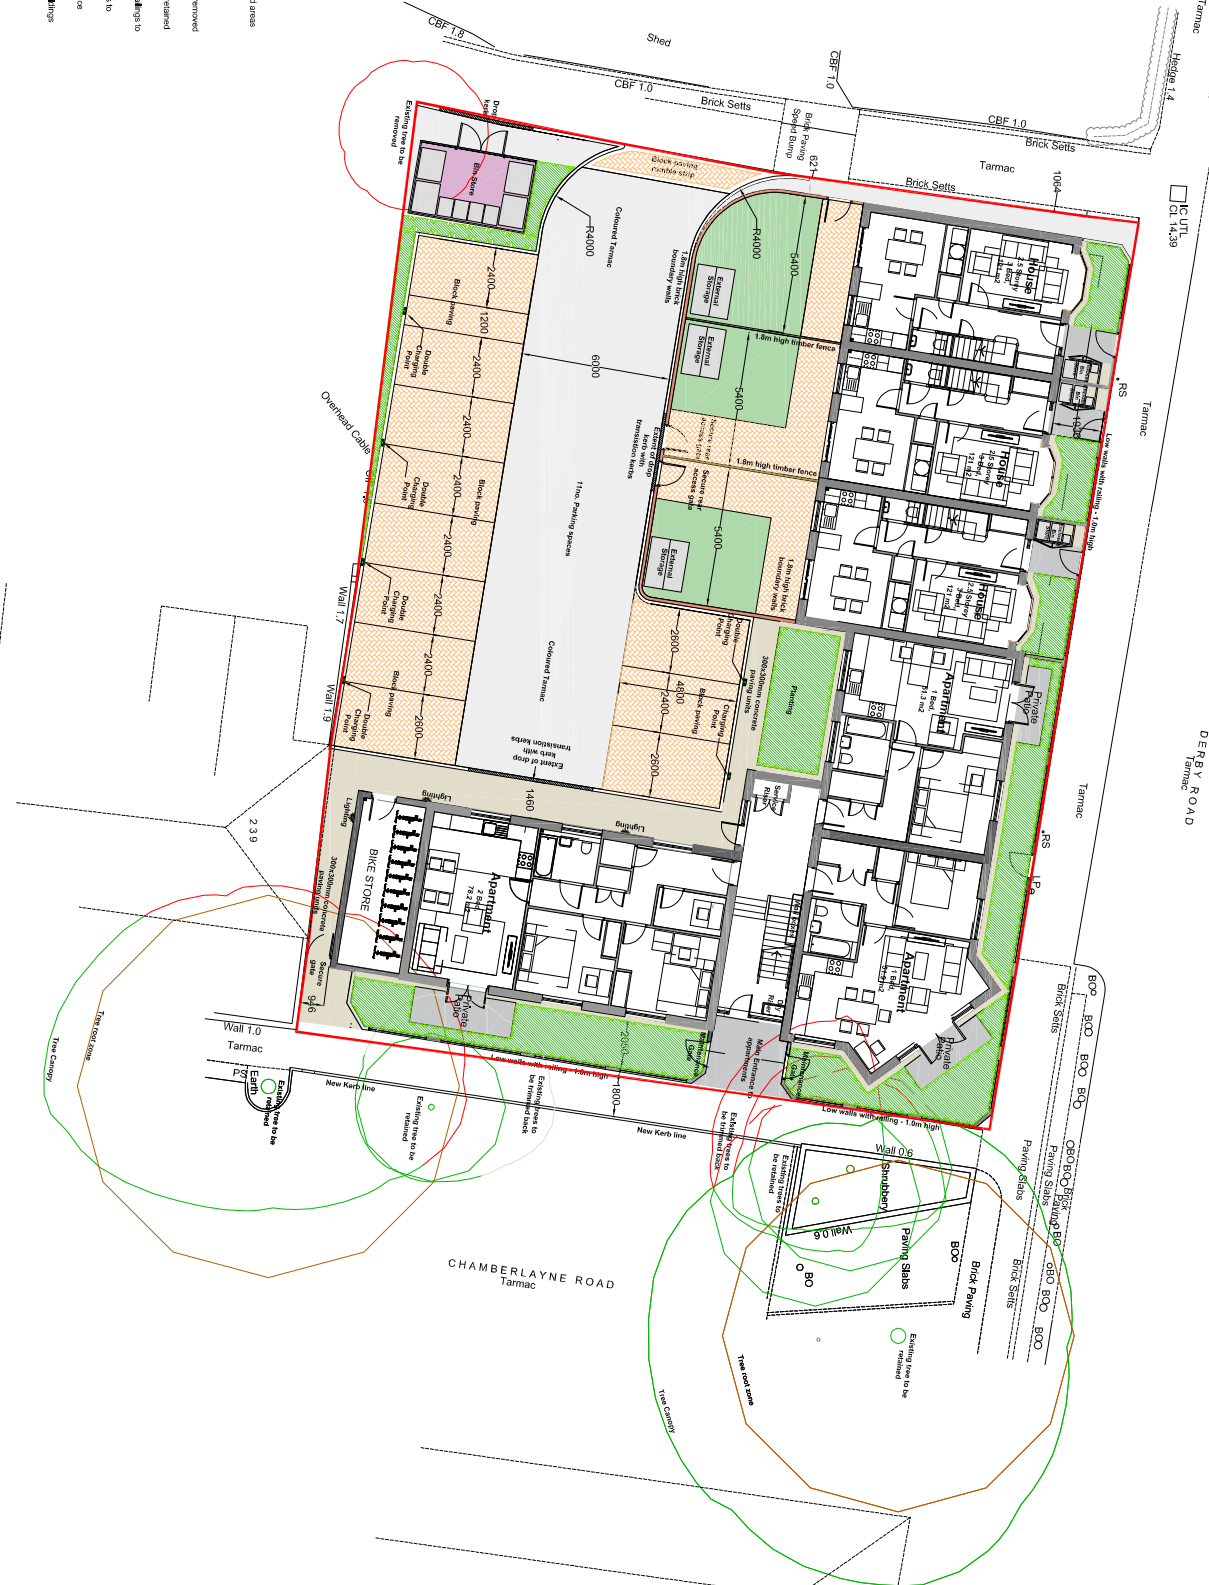
# PROPOSED SITE PLAN

The proposal comprises the construction of three 2.5-storey terraced houses, alongside a three-storey apartment building comprising nine residential units. The development includes public open space or domestic gardens and provision for car parking spaces adjacent to the terraced row. In compiling this report reliance was placed on drawings listed in the Commission Section and recommendations apply only to this scheme. Any changes require consultation with Soils Limited. Soils Limited must be notified about any change or deviation from the scheme outlined.
