# **92 Pine Road, Chandler's Ford**

## Preliminary Roost Assessment

18th March 2026

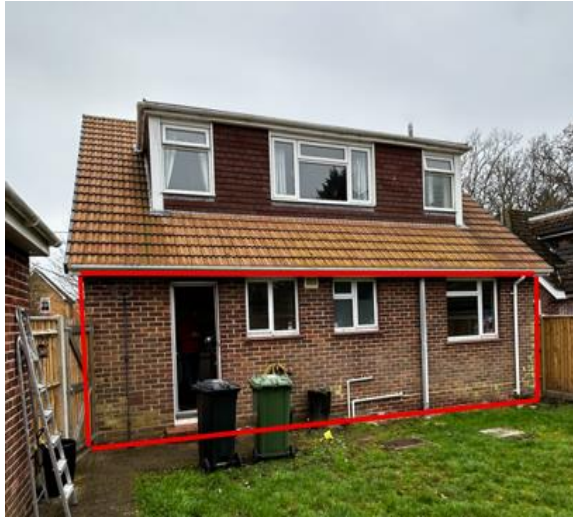
Photo 1 – Building 1 rear view where works are proposed.

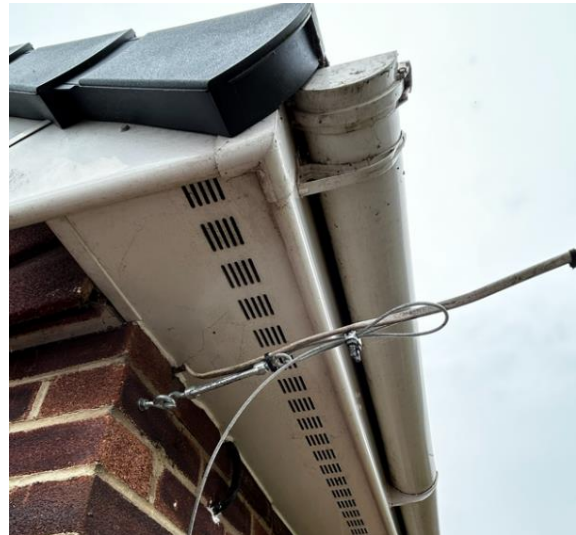
| | <p>windows to the front and rear elevations. A cross-hipped roof was present over the single-storey front porch, which also incorporated a small flat-roofed extension to the side. The pitched roof sections were clad in machine made interlocking concrete tiles incorporating tight fitting verge tiles. The eaves were enclosed with close fitting uPVC soffits and fascias, and the Dorner windows clad in a heavy-duty bitumen type felt. The walls of the building were constructed from brick with machine made concrete tile cladding on the walls of the dormer sections and down to roof line level at each gable end.</p> <p>No PRF were recorded.<br/>No evidence of bats was recorded externally.</p> | <p>works are planned were not internally accessible.<br/>No PRF were recorded &amp; no evidence of bats was recorded internally.</p> |

Photo 2 – Building 1 external view of close-fitting soffits & verge tiles.

| Building 1 –<br>92 Pine<br>Road | <b>NEGLIGIBLE</b> | <ul style="list-style-type: none"> <li>No PRF recorded in the roof and wall cladding</li> <li>No evidence of bats recorded externally or internally</li> </ul> | No further survey work required. |

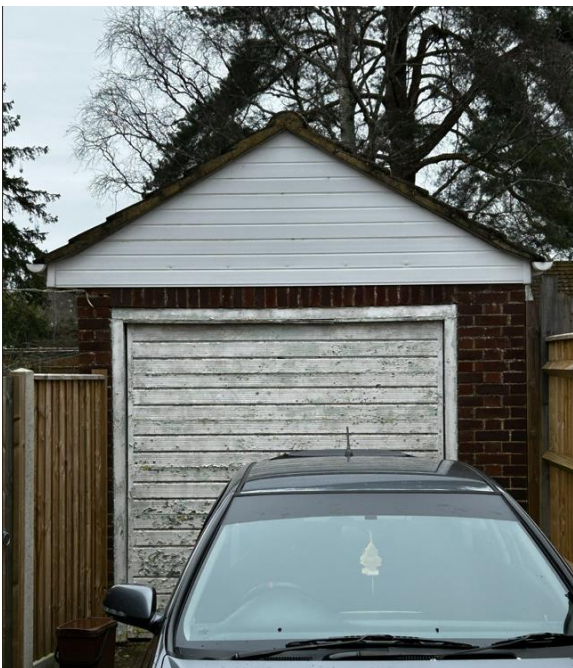
| Building 2 – 92 Pine Road Garage | <p>The building roof was of a gable-ended, dual-pitched design<br/>The pitched roof sections were clad in machine made interlocking concrete tiles<br/>The walls of the building were constructed from brick with horizontal wooden cladding down to roof line level at each gable end.<br/>No PRF were recorded.</p> <p>No evidence of bats was recorded externally.</p> | <p>The underside of the roof was open, fully visible, and well maintained. The roof was constructed using breathable roofing membrane over wooden beams and rafters, and the fabric was found to be in good condition with no PRF recorded.</p> <p>The building was primarily used for storage, including the rafters. No evidence of bats was found inside the building.</p> |

Photo 3 – Building 2 external view of detached garage.

| Building 1 –<br>92 Pine<br>Road<br>Garage. | <b>NEGLIGIBLE</b> | <ul style="list-style-type: none"> <li>No PRF recorded in the roof and wall cladding</li> <li>No evidence of bats recorded externally or internally</li> </ul> | No further survey work required. |

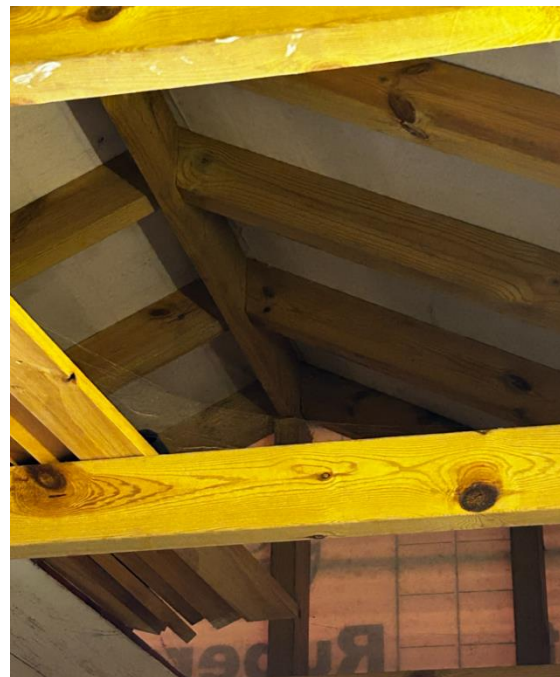
Photo 4 – Building 2 internal view of garage, roof underside.
