# 5 Forest Road, Chandlers Ford, Southampton, SO53 1NA

## Preliminary Roost Assessment (PRA)

Date: 15/05/26

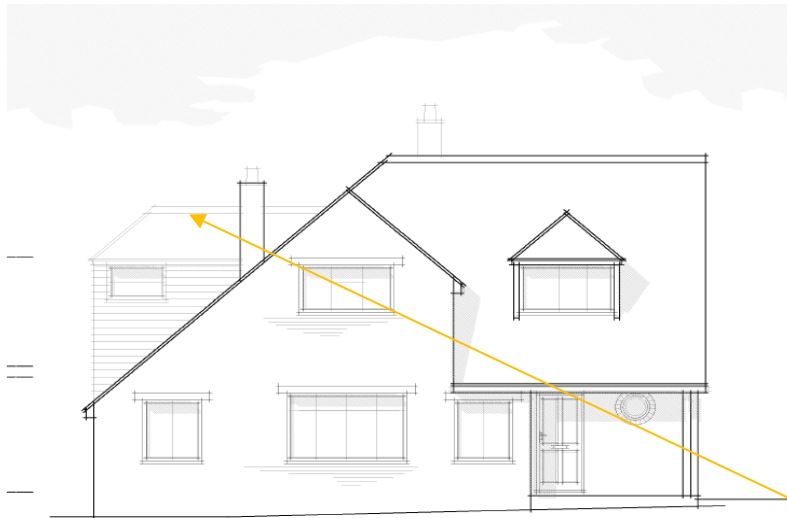
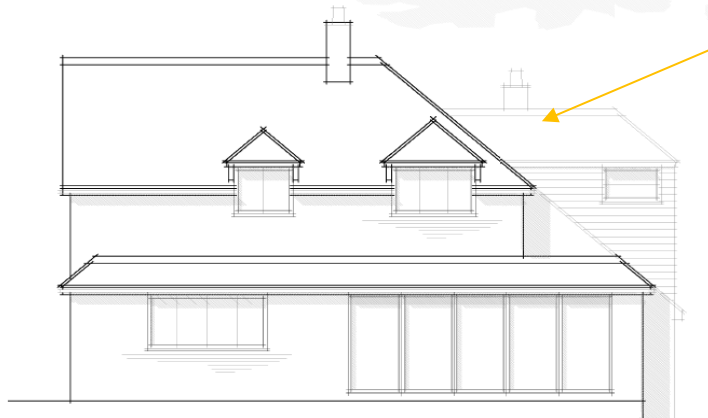
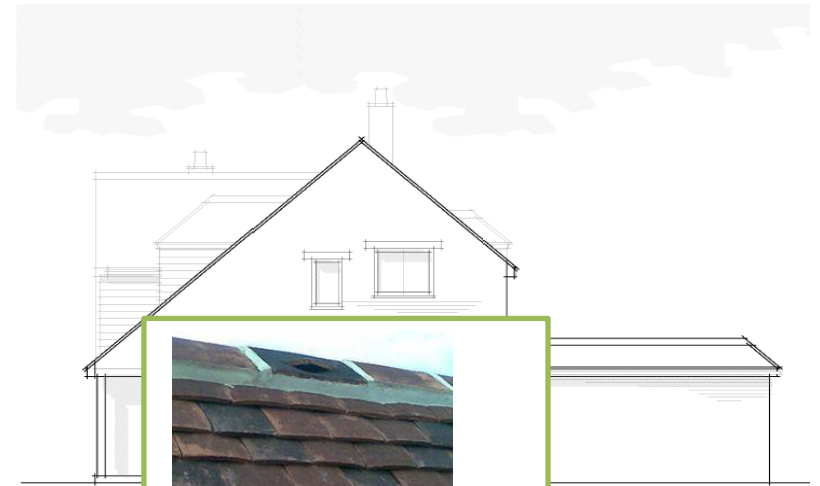
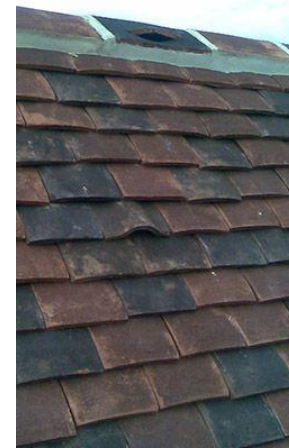
**Figure 1: Showing the proposed biodiversity enhancements**

**Roof access tiles with  
 bitumen felt underneath**

paragraph 187(d). As a proportionate biodiversity enhancement for this building, and not as mitigation for an identified bat roost, it is recommended that **two roof access tiles with bitumen felt behind** are installed on suitable elevations of the westernmost dormer, at a height and aspect appropriate for bat use, and retained thereafter as part of the completed development, as shown in Figure 1 below.

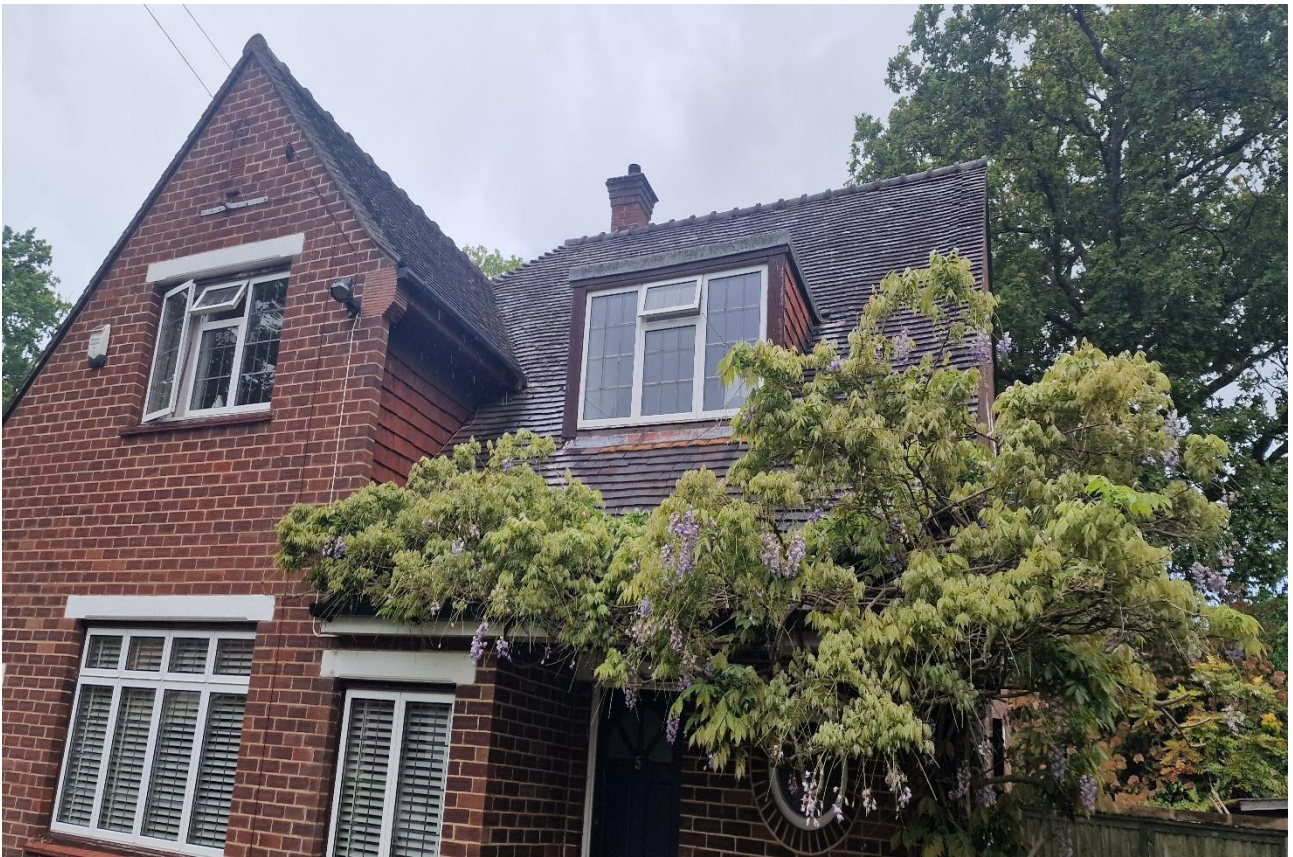
**Picture 1:** The front elevation

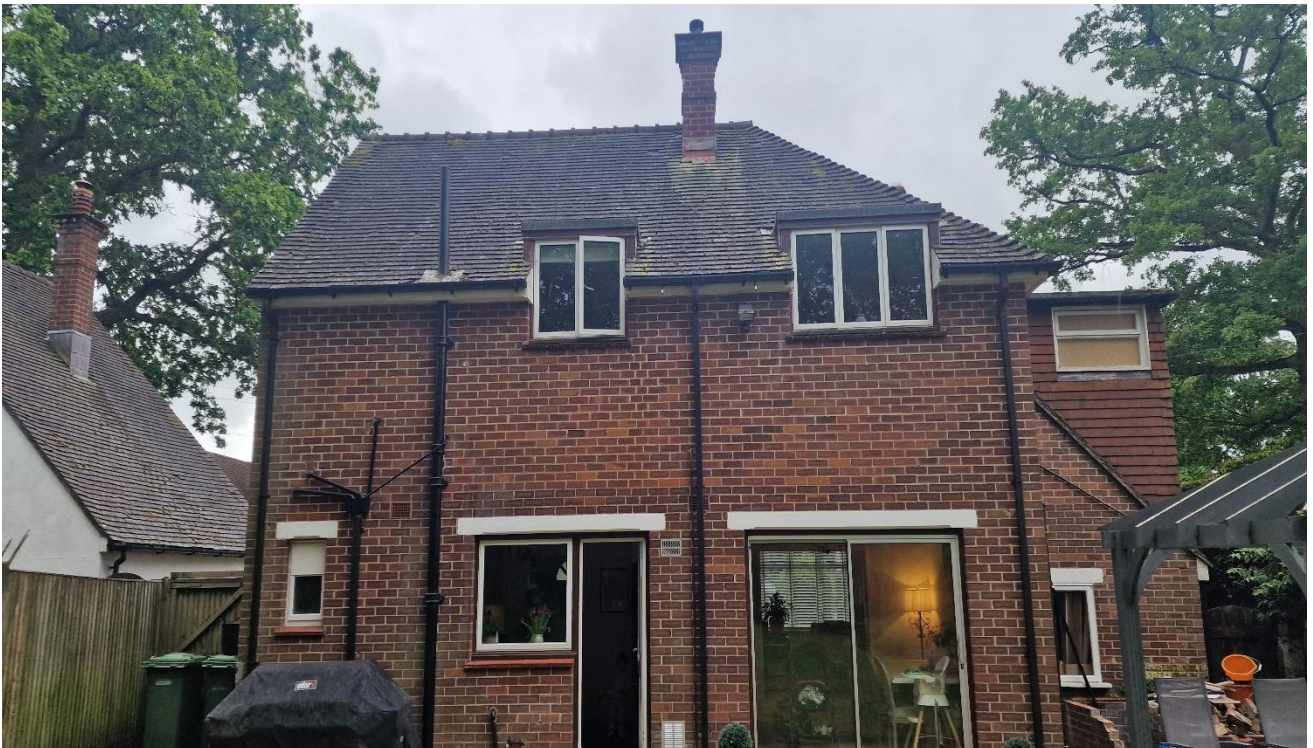
- 2.4 A small number of broken tiles were noted near the chimney stack on the rear elevation. These were inspected from ground level using binoculars and a high-powered torch and, on the basis of the views obtained, were not considered to create features of a size, depth or condition suitable for bat roosting. In addition, these tiles are sufficiently distant from the proposed works that they would not be directly affected.

**Picture 2:** Showing the rear elevation

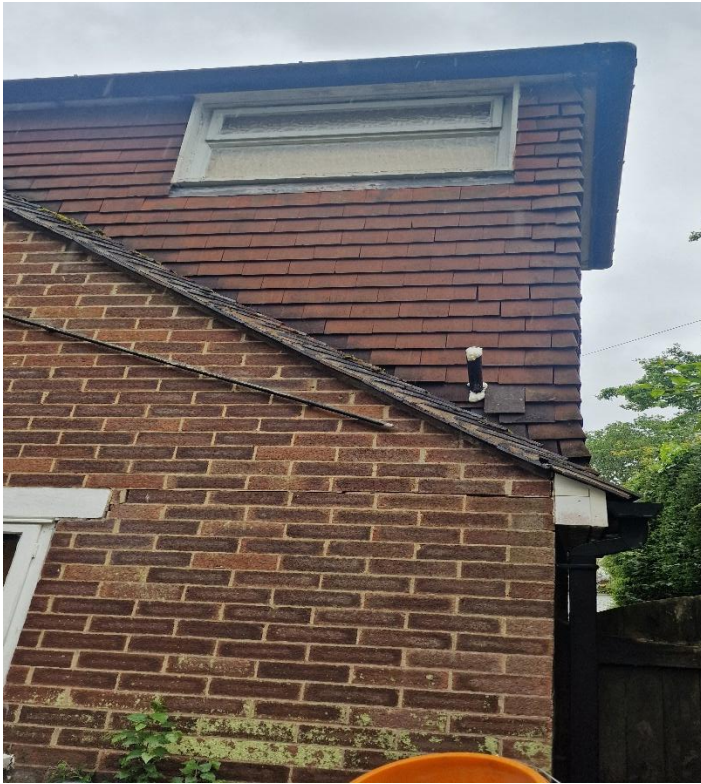
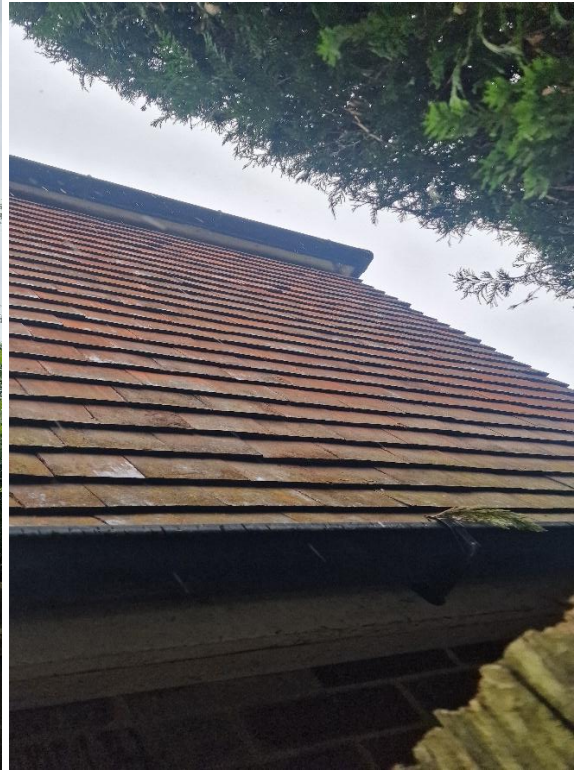
would allow access into the building fabric. There are two dormer windows on the rear elevation; these do not have hanging tiles, and both have flat bitumen roofs in good condition, with bargeboards that were tight and showed no obvious gaps or holes. The dormer window on the western elevation has a similar flat roof, also in good condition and without gaps. This dormer includes tile hanging, and although a small number of minor gaps were noted at the corner tiles, close inspection using torches and an endoscope confirmed that these were too limited in size and extent to provide suitable roosting features for bats or access into the building fabric. Accordingly, these areas are considered unsuitable for bat roosting at the time of survey.

**Picture 3:** Showing the tile hanging on the western dormer

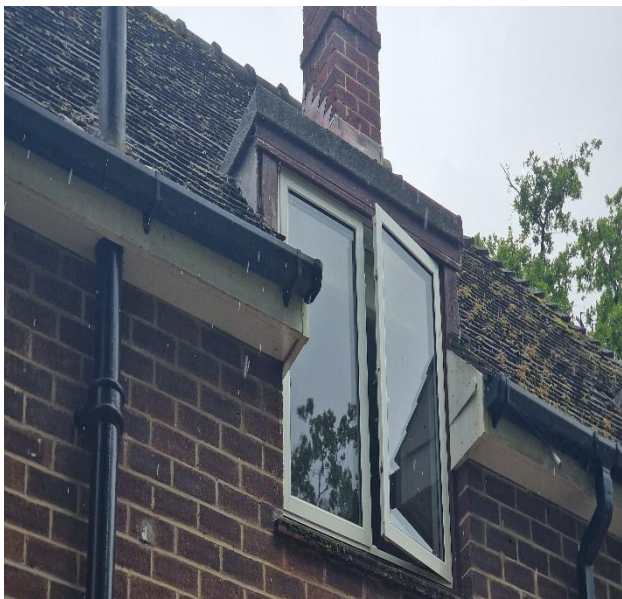
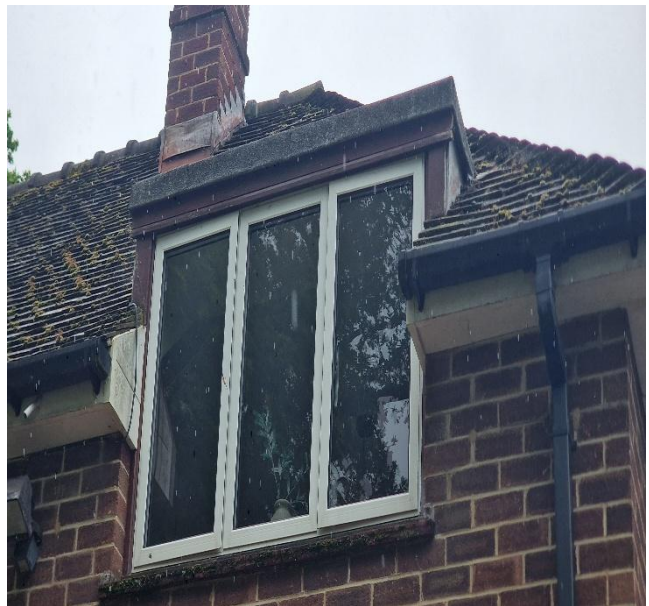
**Picture 4:** Showing the dormers on the rear of the property

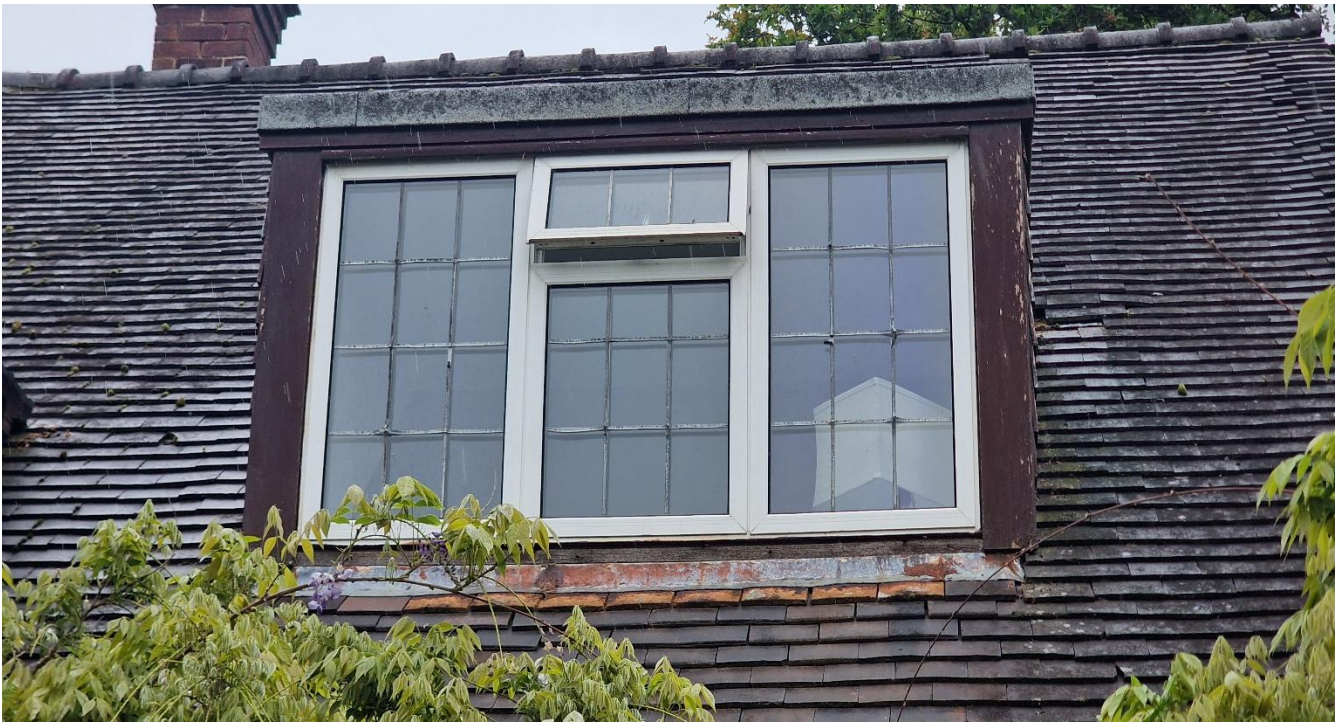
- 2.8 The buildings soffit boxes and the eaves are tight, with no obvious gaps or holes that would allow ingress into the building.
- 2.9 The building has four dormer-style windows. The front dormer has a flat bitumen felt roof, which was in good condition and appeared tight, with no gaps. It also has tile hanging, which was likewise found to be tight, with no obvious gaps or holes that

**Picture 5:** Showing the front dormer window

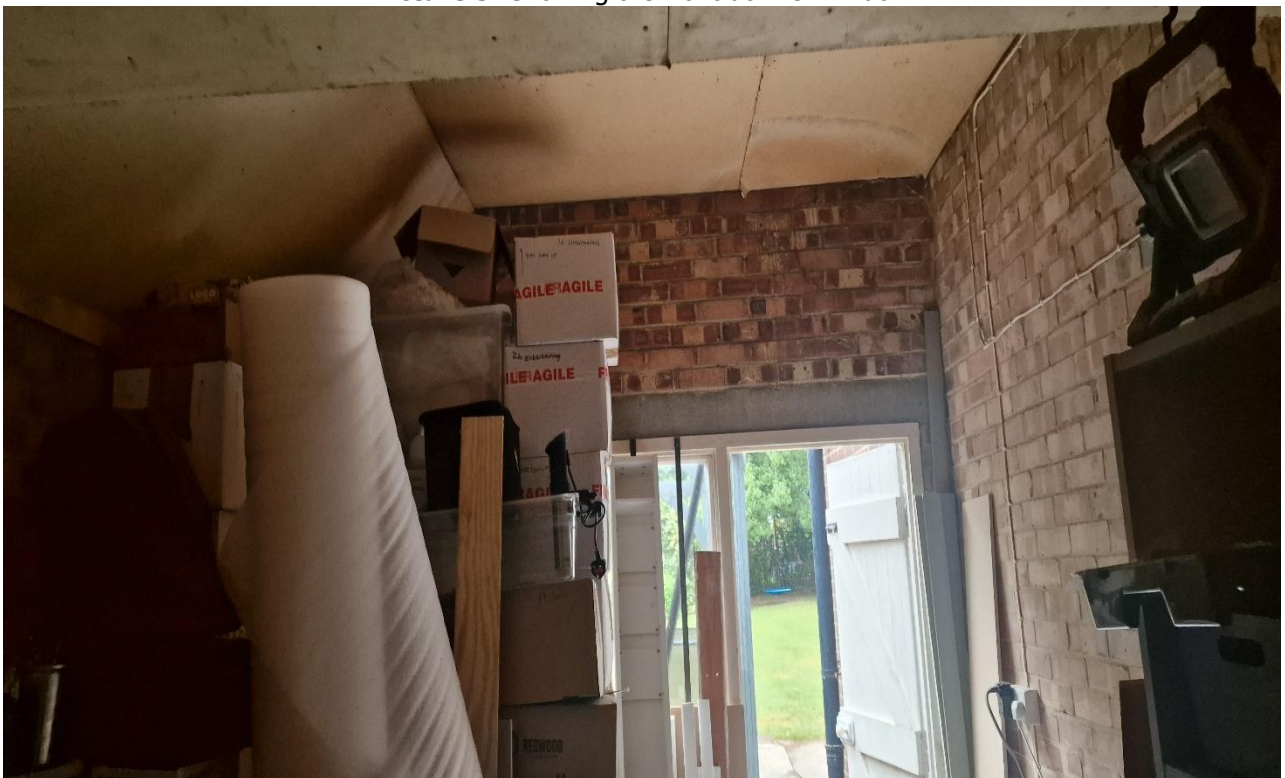
- 2.17 The integral garage has no roof void and is open to the underside of the roof tiles. As such, it does not provide a suitable enclosed roosting space for bats.

**Picture 6:** Showing the internal structure of the integral garage

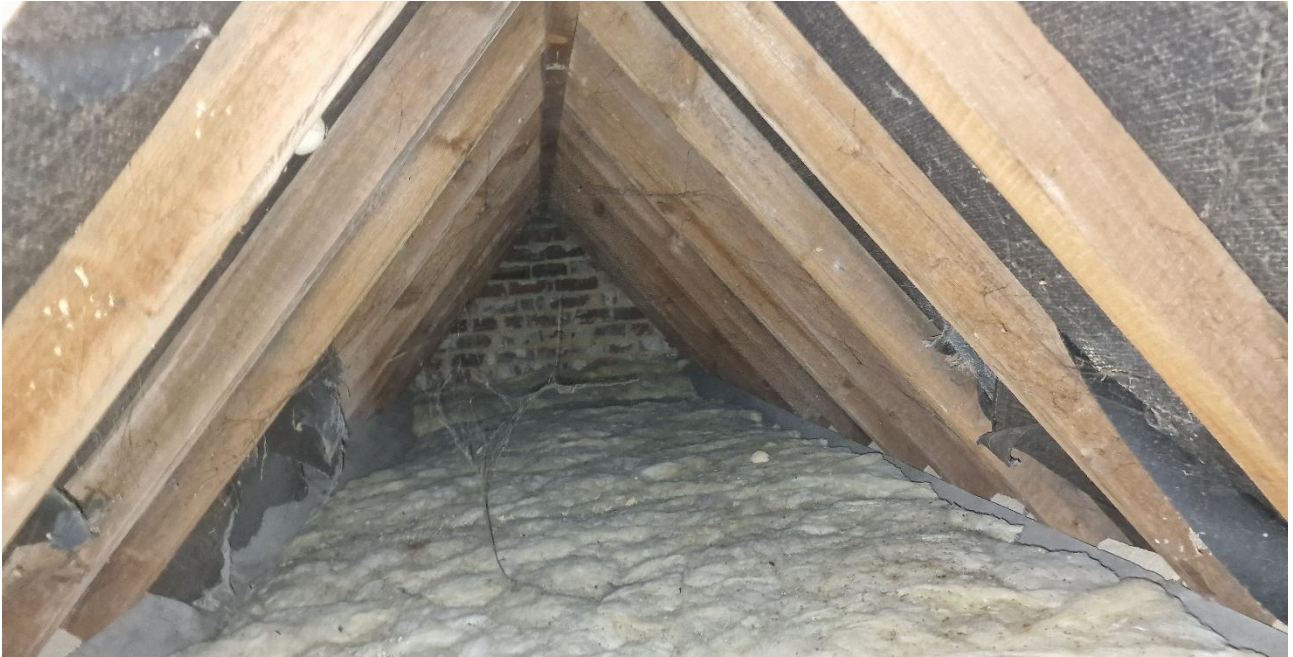
- 2.12 The underside of the roof tiles is lined with bitumen felt, which was in good condition, with no obvious gaps or holes that would allow bat access.

- 2.13 The roof void has a ridge height of approximately 1.8m and a single ridge beam running east-west. Cobwebbing along the ridge beam indicated that this area had not been disturbed for some time.

- 2.14 A thick layer of insulation was present across the joists and extended into the eaves. No signs of light penetration or air movement were detected within the roof void. These conditions reduce the suitability of the space for use by roosting bats.

- 2.15 The chimney breast passing through the roof void showed no obvious gaps leading to the exterior.
- 2.16 No physical evidence of bats was recorded within the roof void. Signs of rodent activity were present, but there was no evidence of wasp nests or bird activity. On the basis of the features observed internally, this area is considered unsuitable for bat roosting at the time of survey.

**Picture 7:** Showing the roof void
