# 3 Merdon Close, Chandlers Ford SO53 1EF

## Preliminary Roost Assessment (PRA)

Date: 10/04/26

Vesper Conservation & Ecology Limited  
13 Chilbolton Down  
Crawley  
Stockbridge  
Hampshire  
SO20 6BU

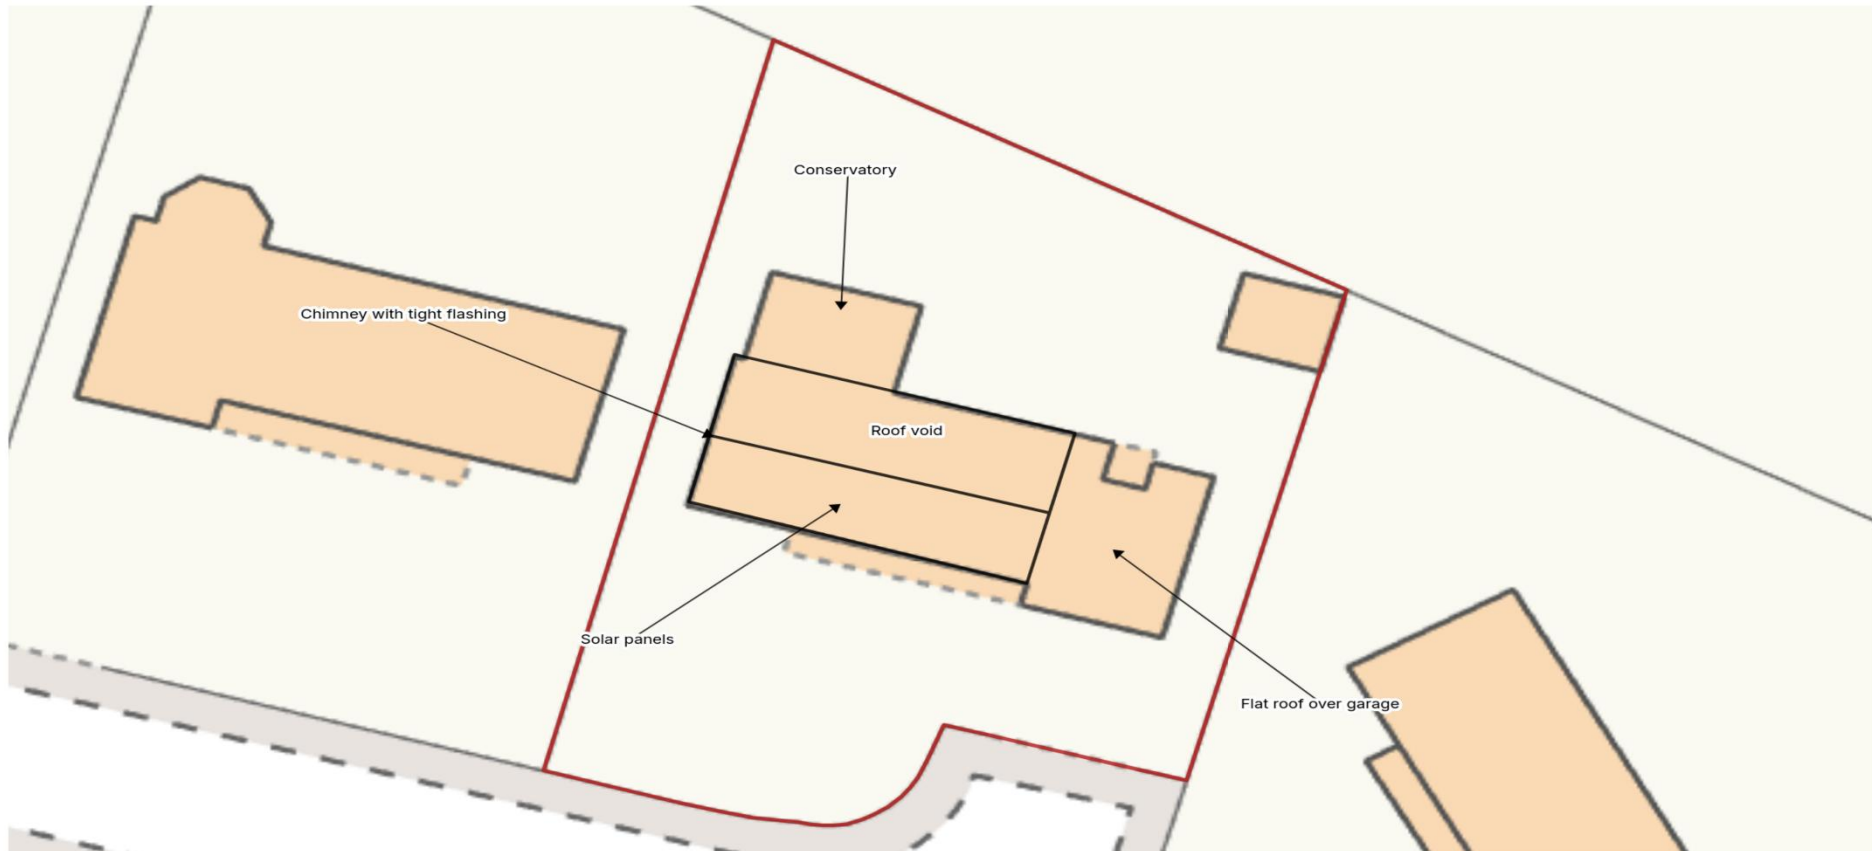
**Figure 1:** Showing the results of the PRA

- 2.2 The building is brick-built structure that is detached and sits within its own grounds it has an attached double garage and a rear conservatory (Figure 1). The property has well maintained front and rear gardens with hard standing parking area.

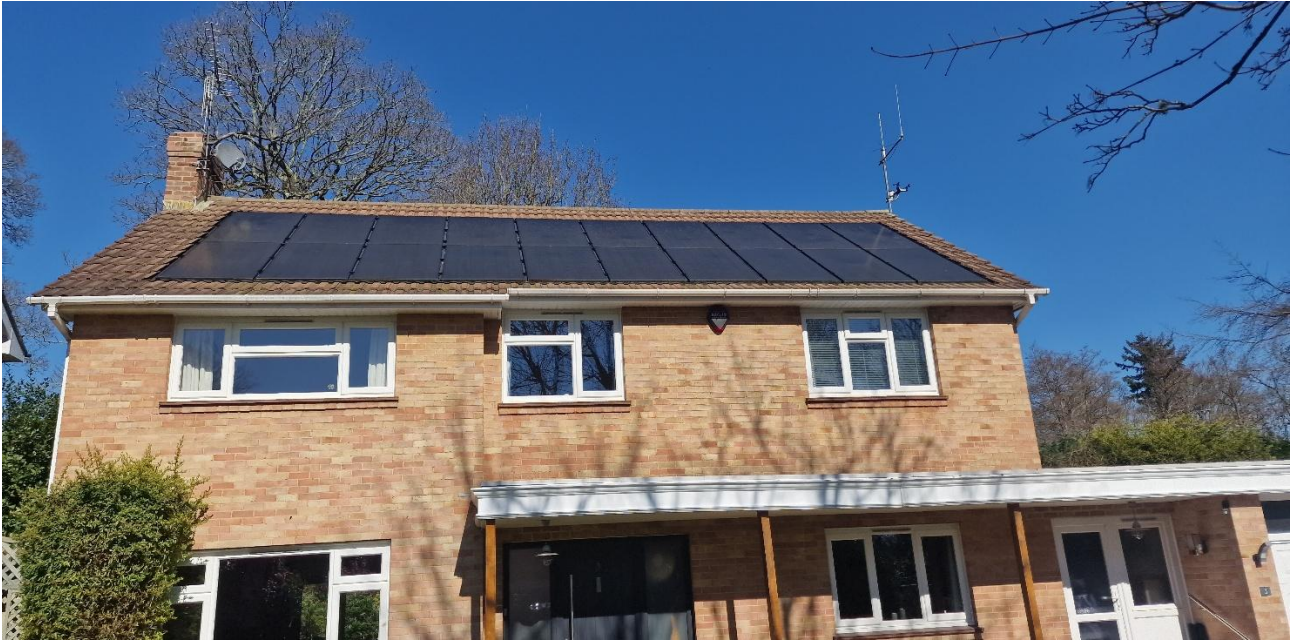
**Picture 1:** The front elevation

- 2.3 The roof on the main house is tight fitting interlocking tiles; the tile bed is in good order with no holes or gaps that would allow ingress. The front elevation of the building has tight fitting flush solar panels; there are no obvious gaps or holes around the panels that would allow ingress.

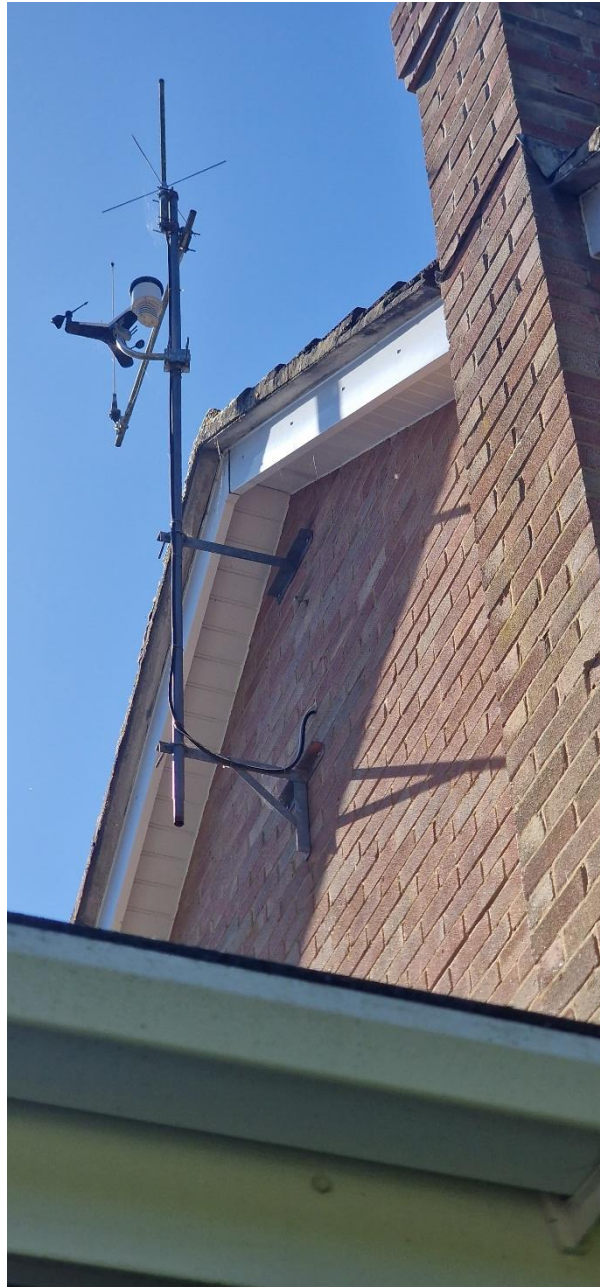
**Picture 5:** Showing the eaves at the eastern end

- 2.6 The eaves on all of the buildings are constructed from UPVC plastic, they are tight with no obvious gaps or holes that would allow ingress into any of the buildings.

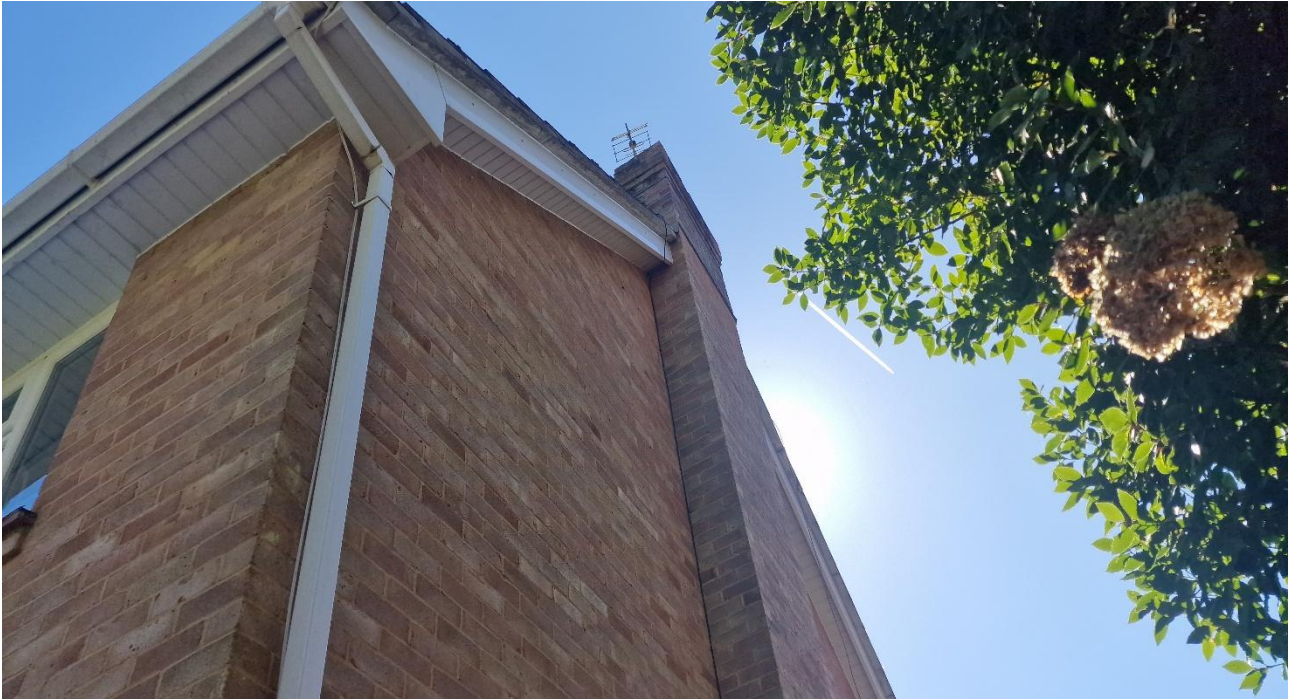
**Picture 6:** Showing the gable wall of the western elevation

- 2.4 The ridges is made from the same material and there are no obvious gaps or holes that would allow ingress into the building.
- 2.5 The tiles verges on the building is tight with no missing pugging and no obvious gaps or holes that would allow ingress into the building.

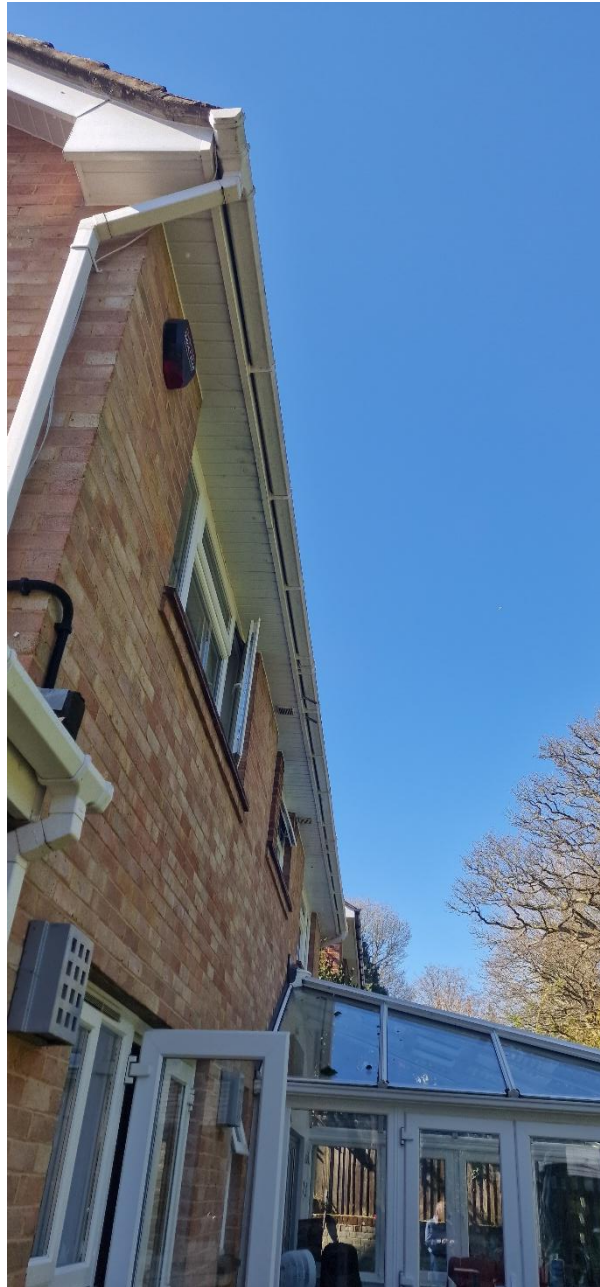
**Picture 7:** Showing the eaves and conservatory

- 2.7 The garage has a flat roof and a rear conservatory; these are tight with no obvious gaps or holes that would allow ingress into the building's materials.

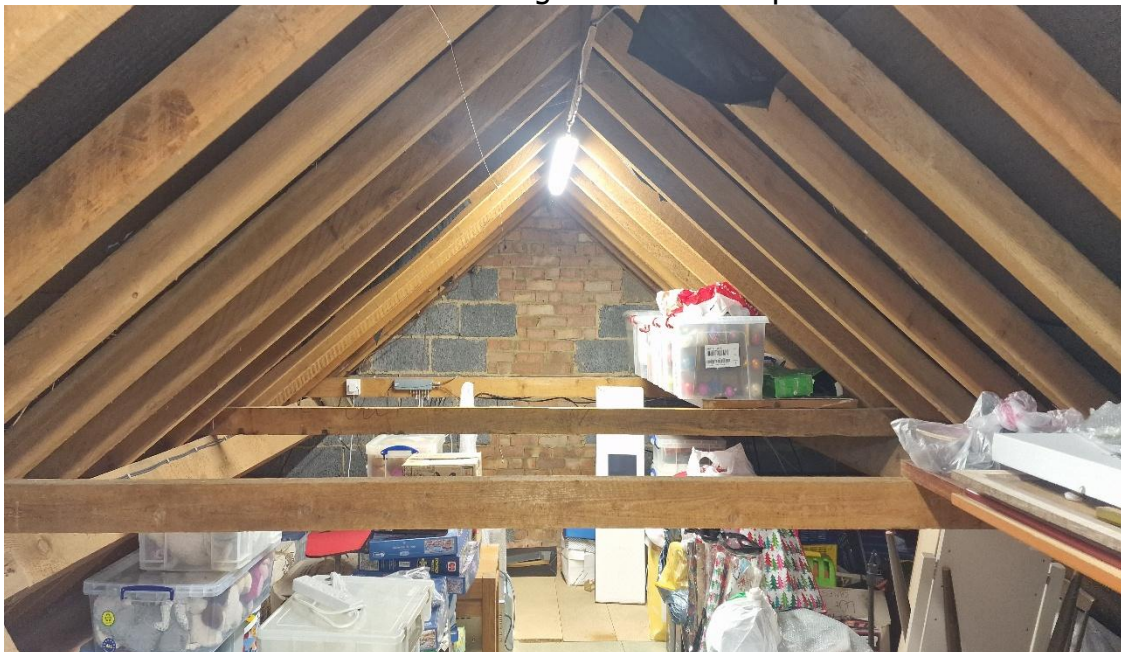
**Picture 10:** Showing the internal structure of the roof void

- 2.9 The garage buildings have no loft void. The main house has a roof void that cover the whole of the house.
- 2.10 Access was good throughout this space with the areas been part boarded; the floor of the roof void has glass fibre insulation throughout. The insulation goes into the eaves; there is no obvious light or draft within the roof void.
- 2.11 The tiles are backed with bitumen felt, the felt is in good order with no obvious gaps or holes that would allow ingress into the building.
- 2.12 There is a single ridge beam that traverses the roof east to west, the roof is clean with limited amounts of cobwebbing.
- 2.13 There are no physical signs of bats within the roof void at the time of the survey, there are also no signs of bird rodent activity.
