**Main Investigation Report**

at  
**Primary School, Sports Facilities, & Allotments, Burnetts Lane,  
Hampshire SO50 7QB**

for  
**Eastleigh Borough Council**

**Reference: 22177/MIR Rev 1.02  
June 2026**

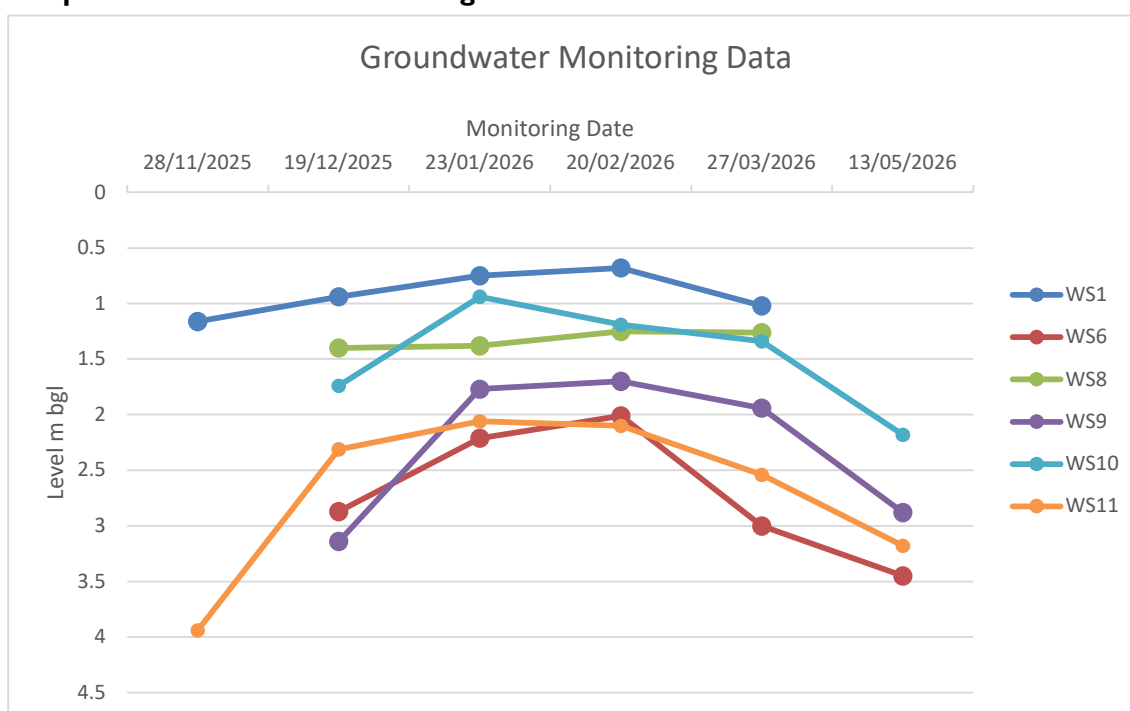
**Graph 1. Groundwater Monitoring Data**

Groundwater levels generally peaked in January or February, in line with expected seasonal trends, and reflecting the high rainfall through both months. Levels dropped significantly through the spring, again reflecting the relatively low rainfall noted.

Groundwater was encountered within six exploratory holes (CP1, WS1, WS8, WS9, WS10, WS11) and was struck at depths ranging between 3.00m bgl and 3.70m bgl. Soils were observed to be moist around 2.40m bgl in TP1.

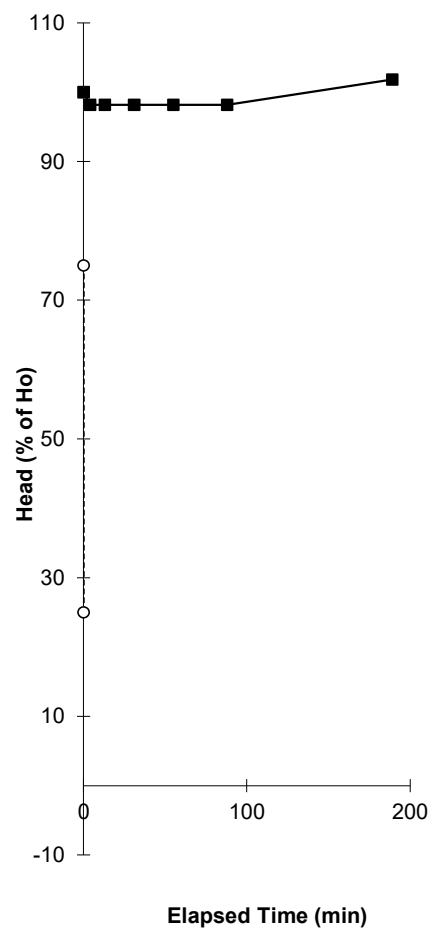
Negligible infiltration achieved onsite prior to groundwater level rising. Infiltration rate not calculable.

A single test was carried out in TPSA1 to TPSA5, but 75% drainage was not reached in any tests undertaken onsite. Infiltration rates were not calculable due to negligible infiltration. Groundwater rose within TPSA1, potentially due to surface water run-off from waterlogged topsoil.

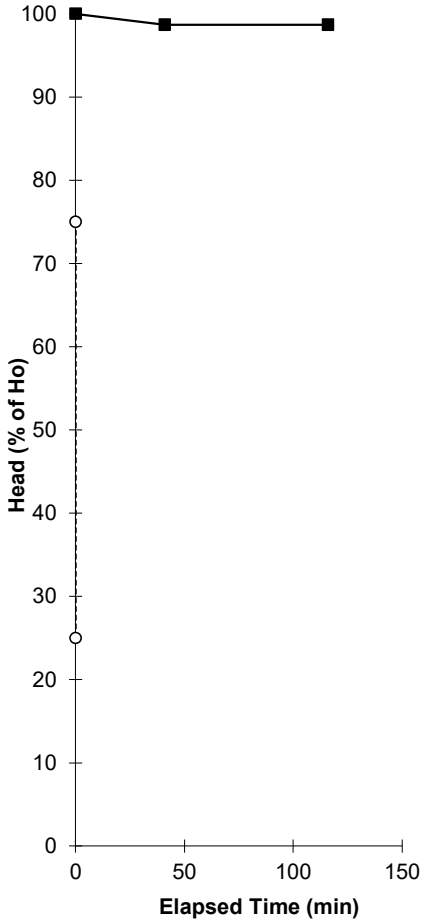
Negligible infiltration achieved onsite. Infiltration rate not calculable.
