# **Surface Water Drainage Strategy**

One Horton Heath

Primary School, Sports Facilities &  
Allotments

Document Ref: 332613072-STN-01-RP-C-000002

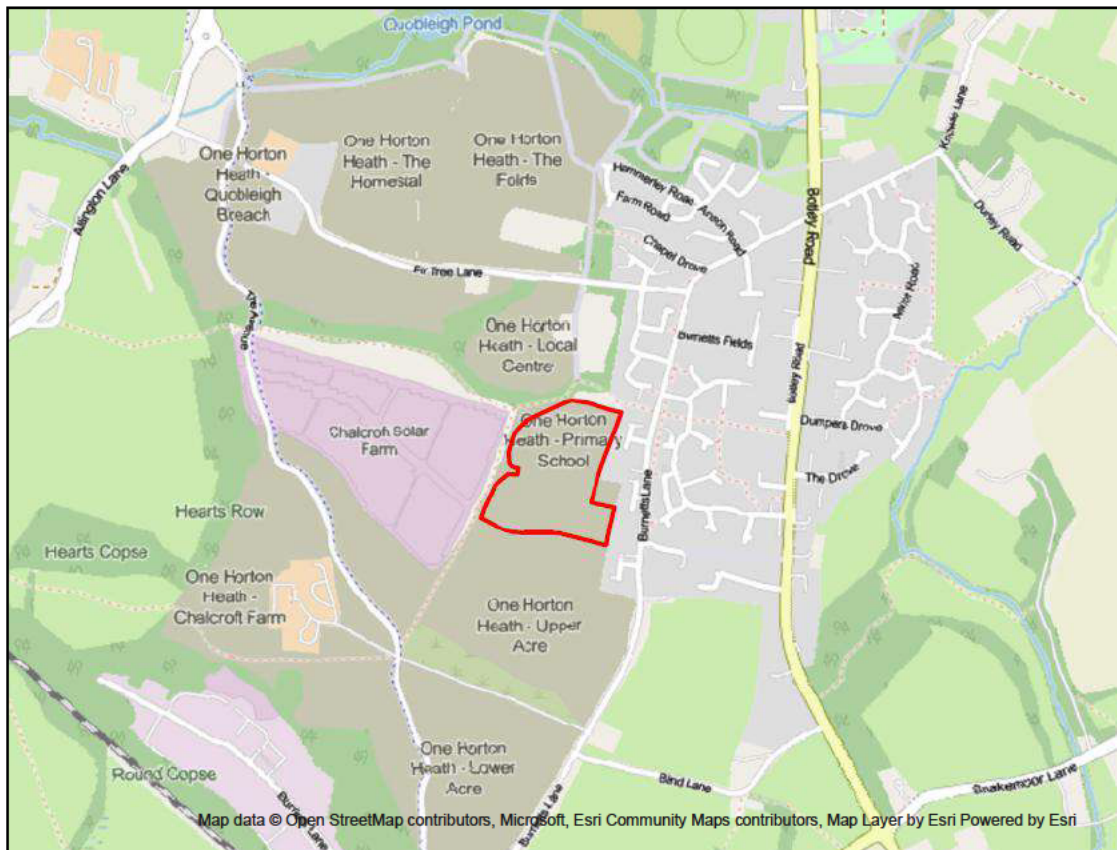
**Figure 1 - Site Location Plan**

- 2.1.4 The Primary School development site is 5.9ha in size and situated on land to the west of Burnetts Lane, Eastleigh, SO30 2HH, which is part of the One Horton Heath major mixed-use development.

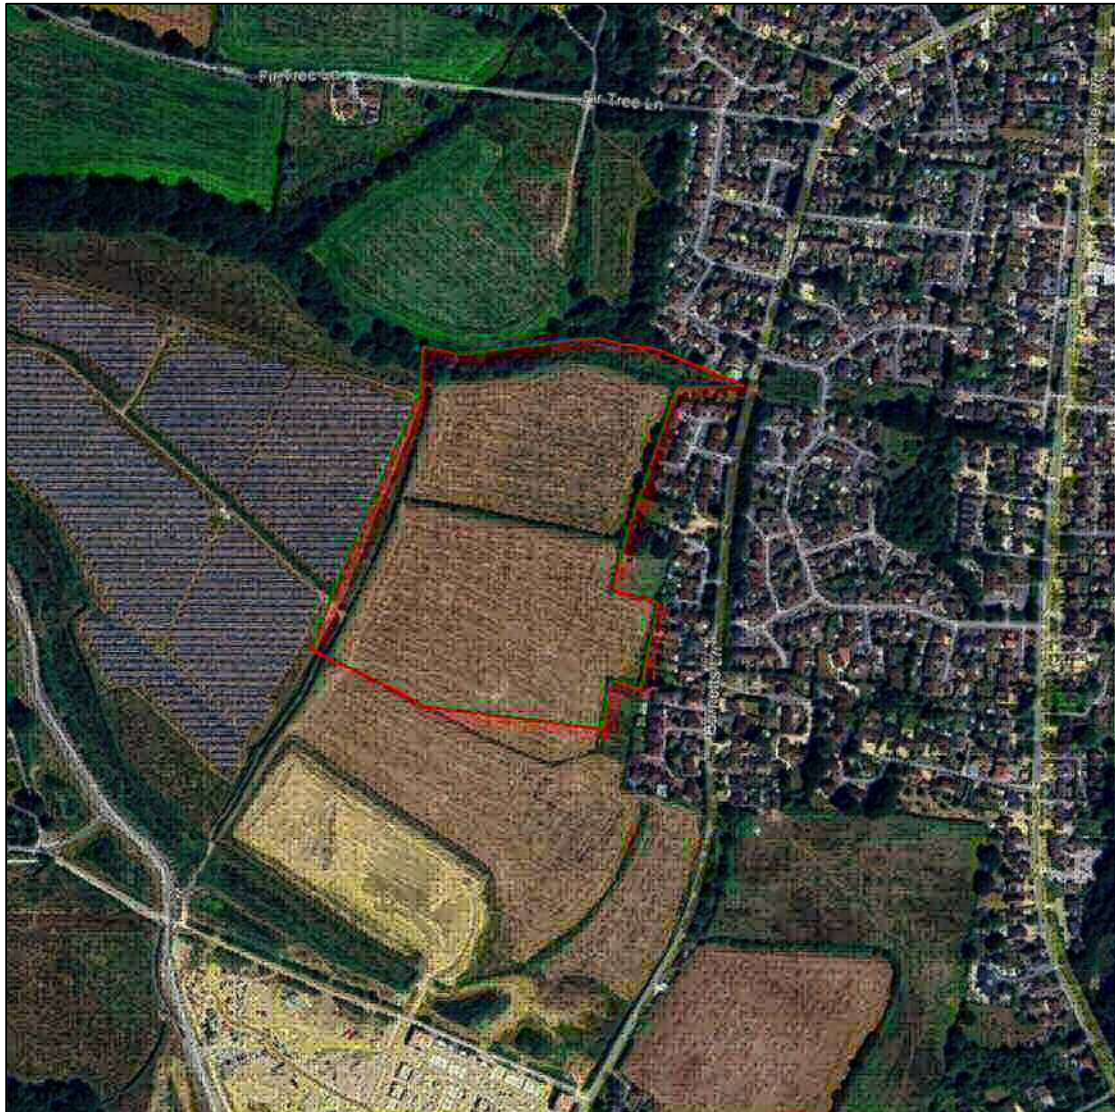
**Figure 1 – Site Location Map**

All exploratory hole locations have been presented in Figure 1.

The site location plan is given in Figure 1. An aerial photograph of the site and its close environs has been included in Figure 2.
