# Biodiversity Net Gain Report

**Fairport House,  
Lands End Road,  
Lowford,  
Bursledon,  
Eastleigh,  
Hampshire  
SO31 8DN**

**JUNE 2026**

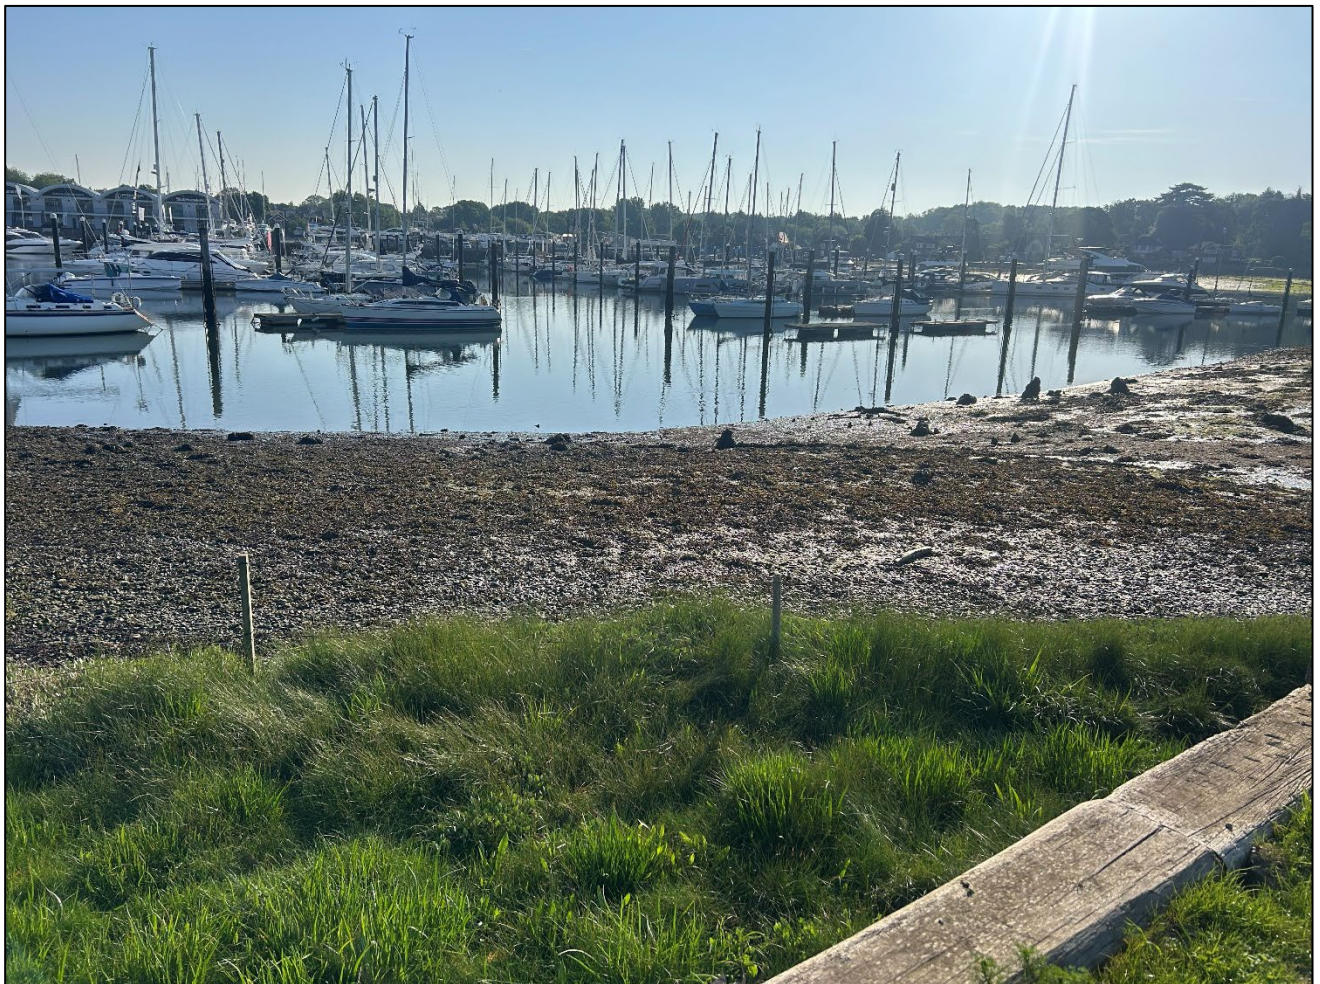
***Figure 2. Baseline Habitat at the Fairport House, the two wooden posts marking the location of the proposed jetty.***

The site was surveyed by Fathom Ecology on 7 May 2026 and comprises approximately 0.2065 ha of habitat, consisting of Atlantic Salt Meadow (0.0113 ha), Intertidal Mudflats and Sandflats (0.1215 ha) and Modified Grassland (0.0737 ha). The site also contains an existing timber sleeper seawall, classified
