# DESIGN & ACCESS STATEMENT

**Re-righting of the right hand column to the front portico and replacement/recovering of the roof structure**

**Reference:** SS-26-14845

9 Greyladies, School Road, Bursledon, Nr Southampton, SO31 8BX

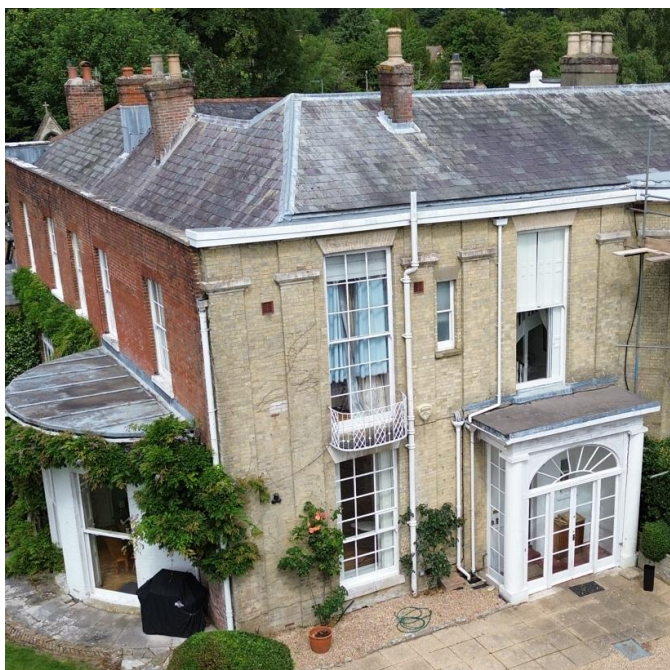
*Front right hand corner of the main property showing the portico (taken by drone on 18.06.26)*

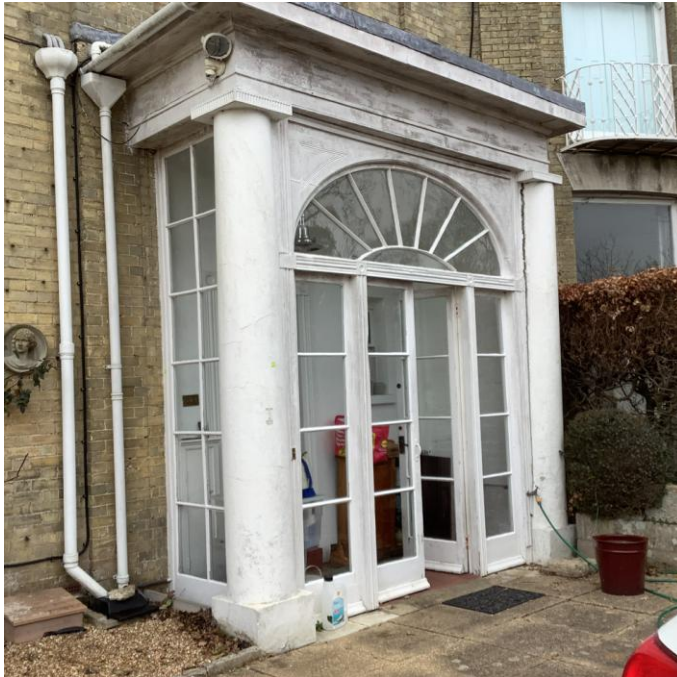
*Photograph taken from the front left of the portico structure (photo taken 06.01.26).*

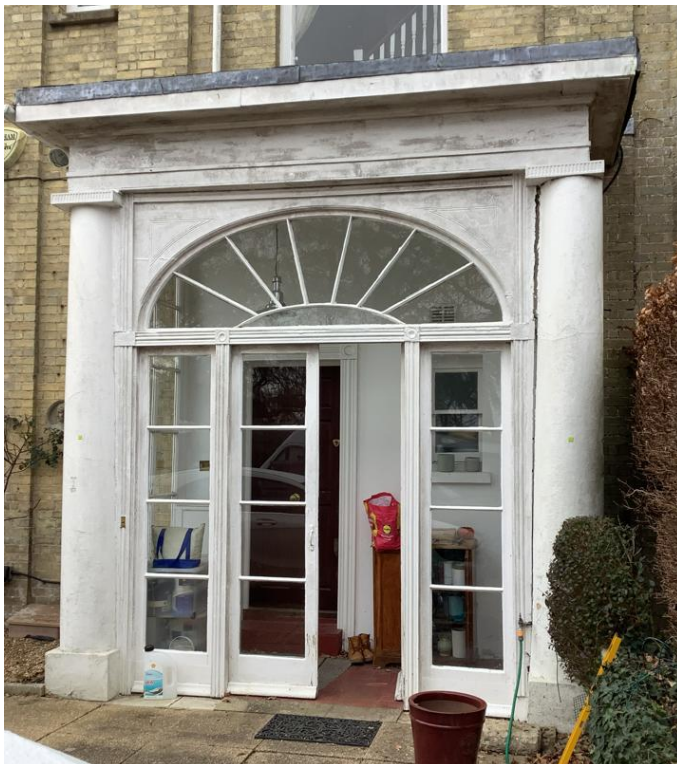
The proposed works comprise of the partial stabilisation of the front portico structure to allow for the re-righting of the right hand column which has tipped away from the structure by approximately 45mm.

The structure has suffered from a combination of clay shrinkage related subsidence exacerbated by nearby vegetation in the form of the adjacent beech hedge, localised leakage from underlying drainage, not helped by the structural pin lacking lateral restraint at roof level.

*Photograph taken of front elevation of portico allowing for the 2 columns to be compared (taken 06.01.26)*

The aim is to take a minimal intervention approach thereby jacking the column back into position and locking it back in place. As such, the disturbance of the historic fabric is minimised as much as is possible.

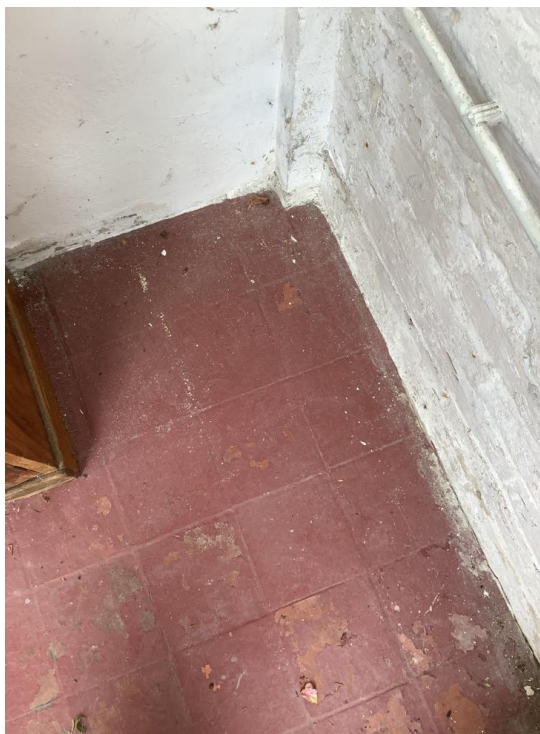
*Looking down at the portico's floor – no gapping where the structure meets the front wall of the main building or to the side privacy brick wall thereby confirming that the dropping of the floor slab is historic (taken 05.06.26)*

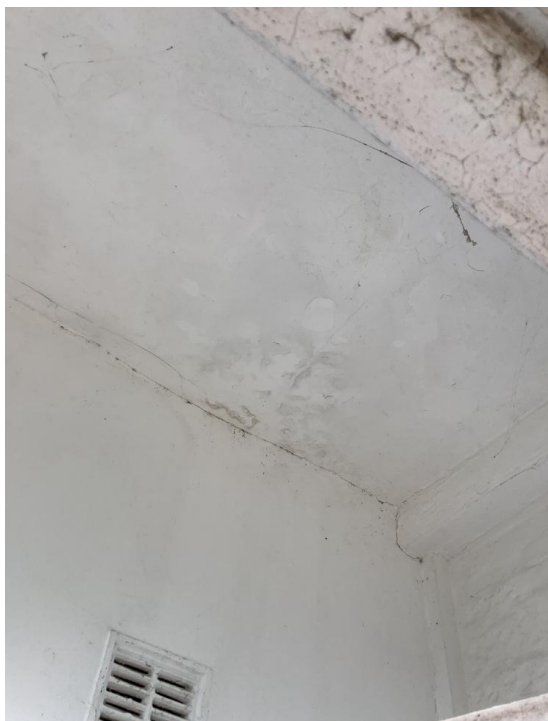
*Water staining to the underside of the ceiling – roof finish is starting to perish suggesting it is at the end of its useful life and as such, needs replacement (taken 05.06.26)*

The roof timbers are expected to be in a poor state of repair, and as such it is proposed that the main structural roof timbers are to be replaced and new felt finish installed, thereby allowing for the structural pin to the column to be locked back into position.

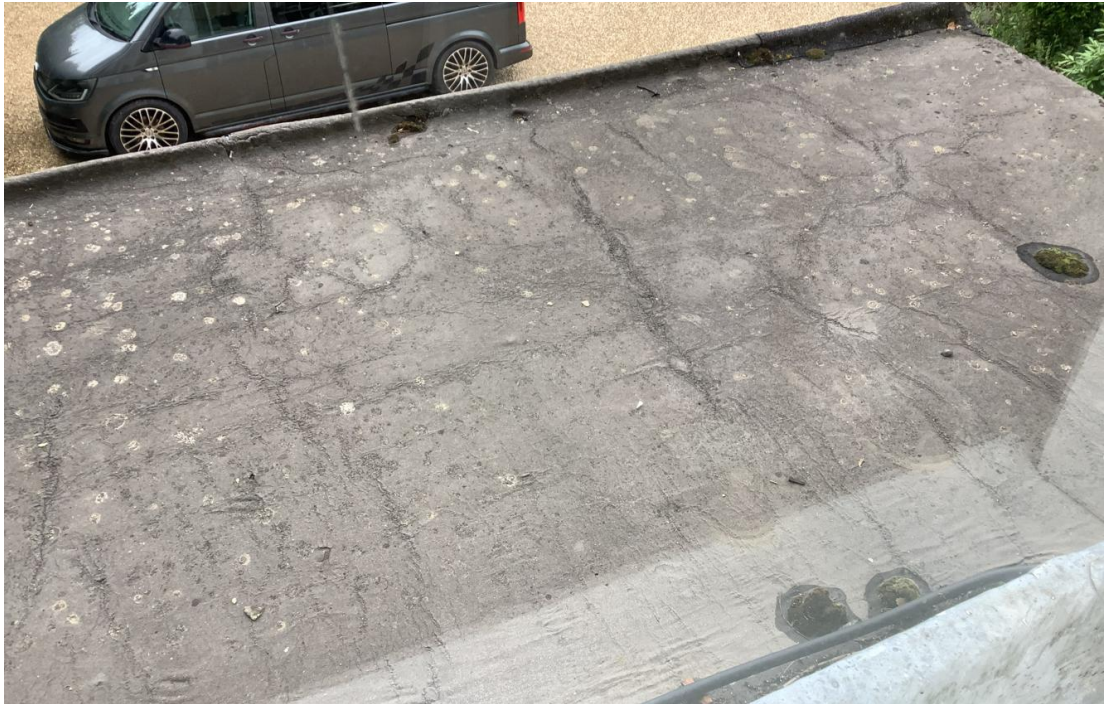
*Perished felting roof to canopy over portico – roof covering needs replacing (taken 05.06.26)*
