## Heritage Statement

9 Greyladies, School Road, Bursledon, Hants SO31 8BX

Figure 1 – view of area of works – front portico structure

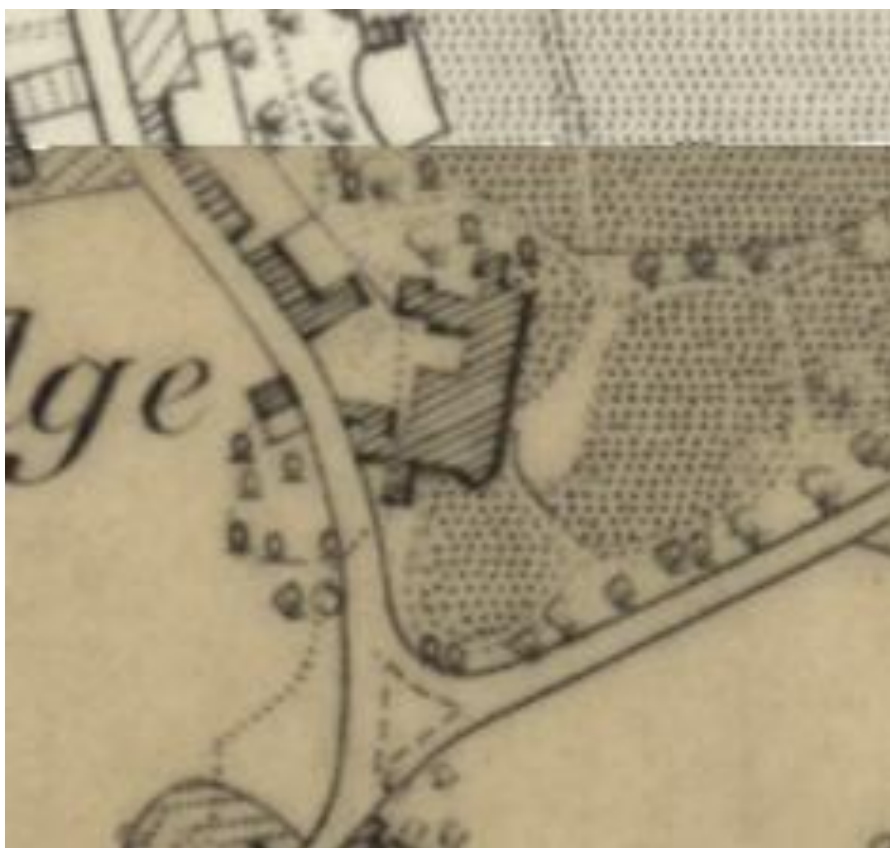
*Figure 3 - Mapping from the early 1800's showing the structure – it demonstrates that the shape of the buildings has predominantly remain unchanged, although the front portico is not shown to the front elevation*

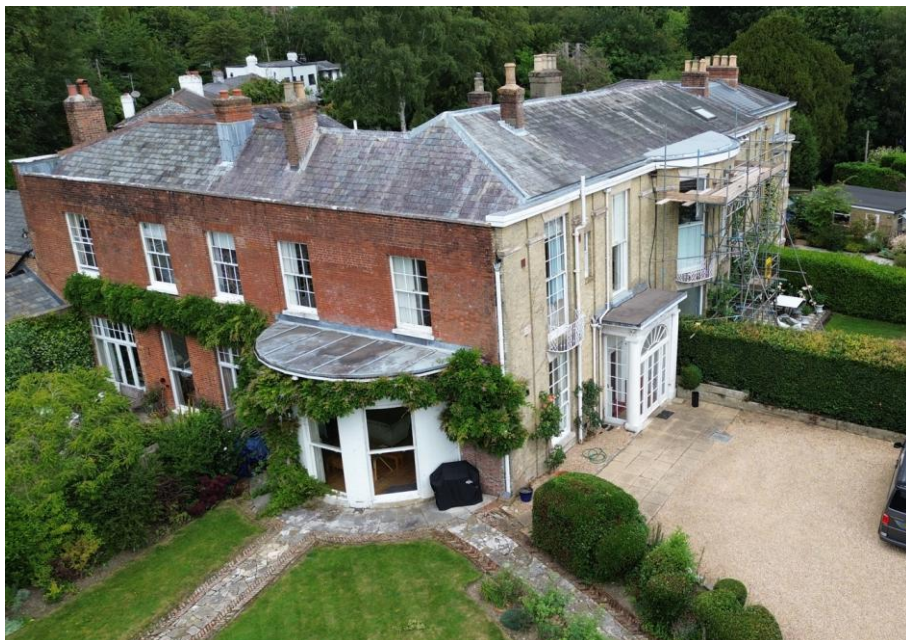
Figure 4 – Recent photo taken by drone (on 18.06.26) of the front left corner of the property

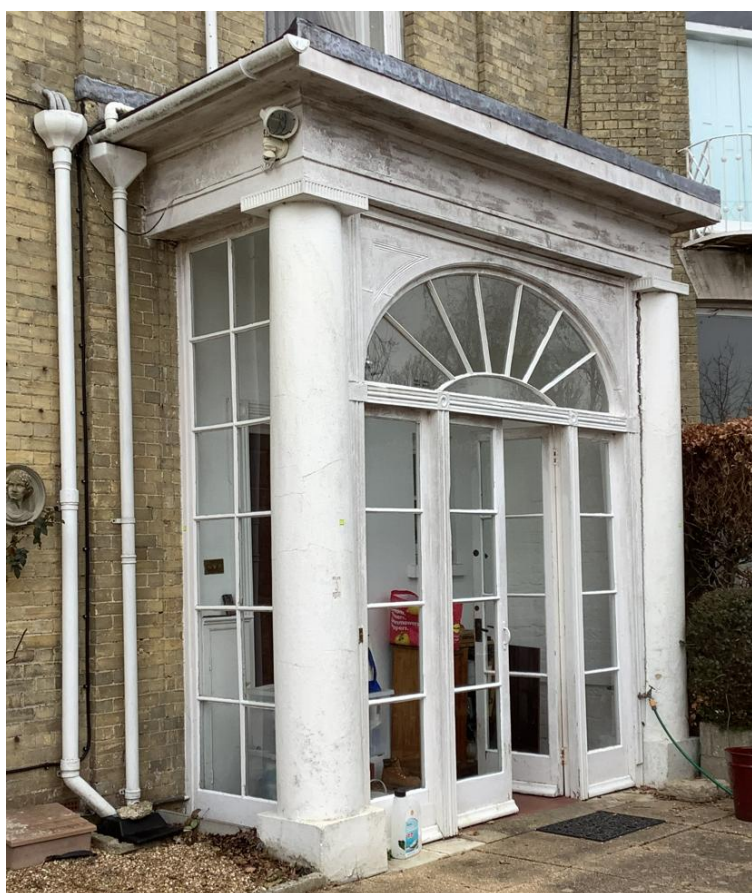
*Figure 5: Photo showing the front portico in question*

*Note – the right hand column is topping away from the main structure*

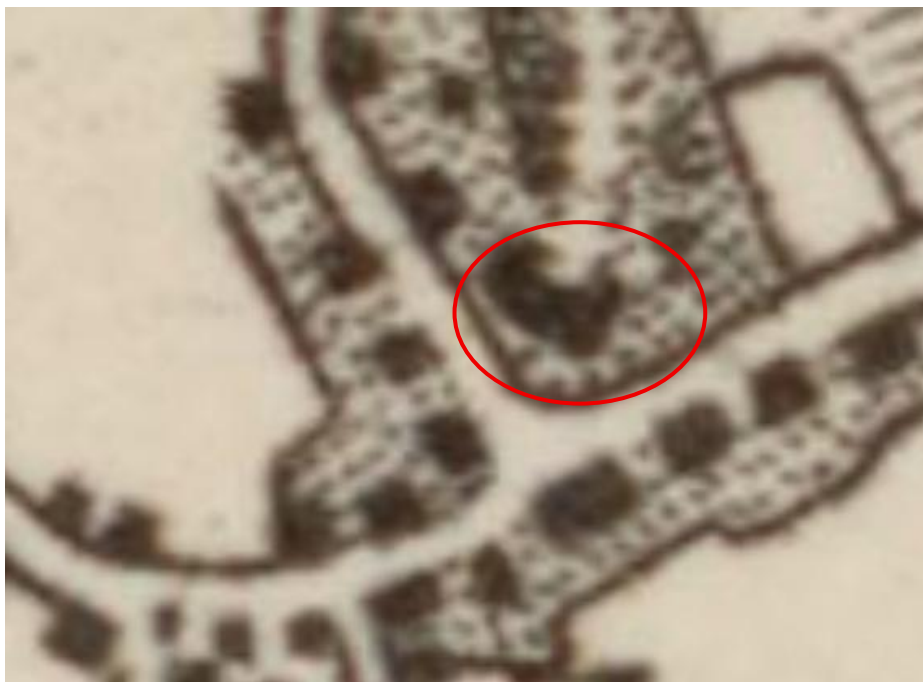
In the late 1700's, the distinct shape of the structure can be seen including for the curved bay structure to the front, however the map below does suggest that the road was once closer to the structure than it now is:

*Figure 6: Historic map dating from 1798*

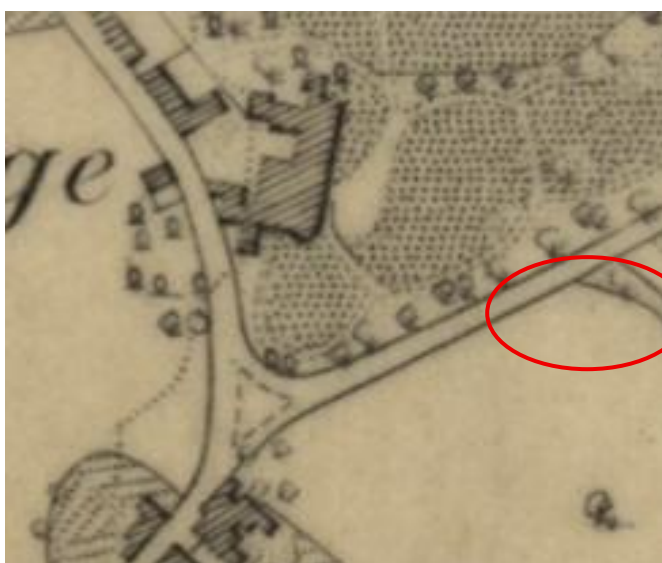
*Figure 7: Map from 1830s-1880s showing a structure on the site but the road now as per 'today'*

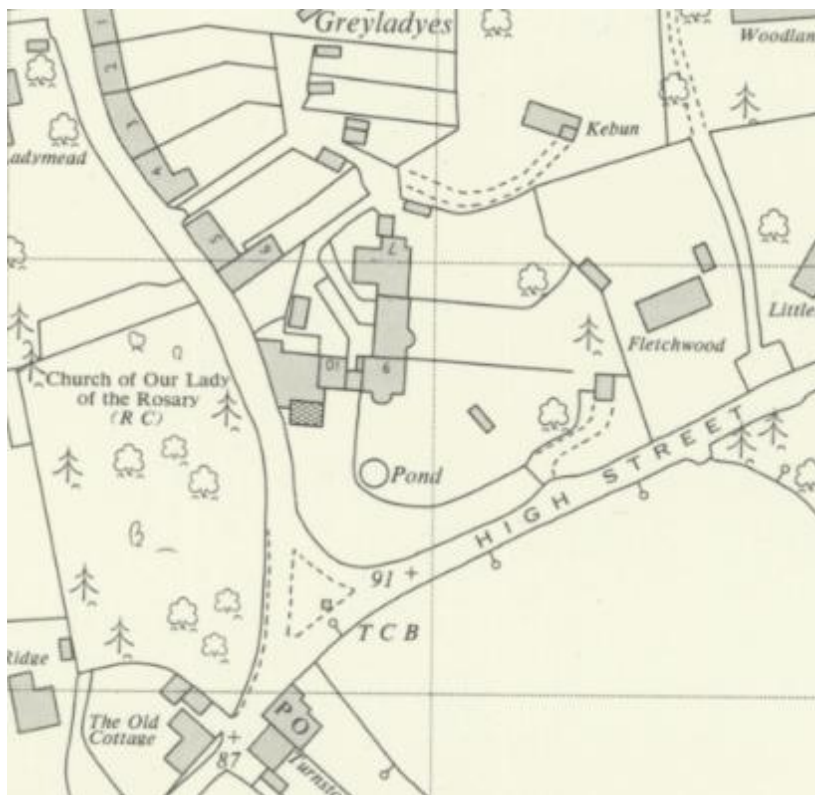
Figure 9: OS Map from 1944-1975 now showing the property sub-divided into the four properties and including the pond within the grounds for No.9

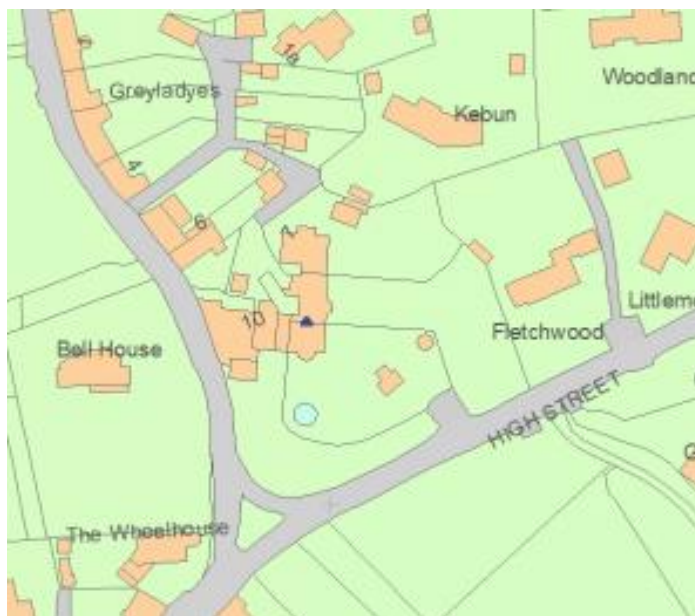
Figure 10: Map taken from English Heritage website showing the current location of the property

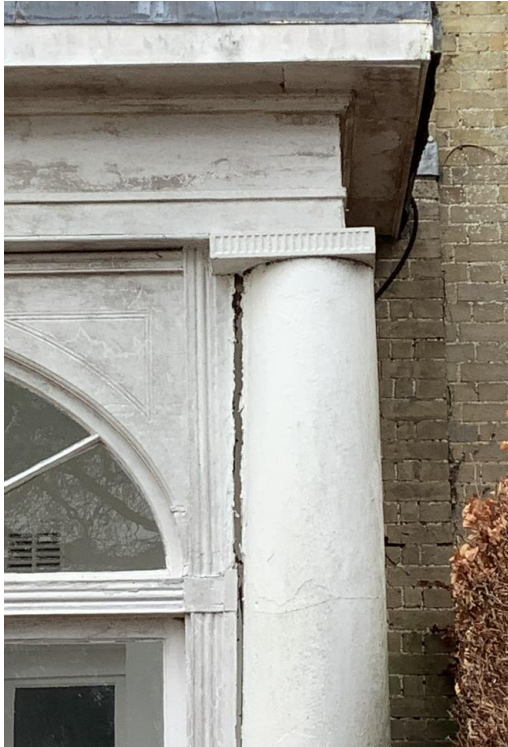
Based on this information and assessment of the structure by an experienced heritage based structural engineer, it is considered that the damage to the portico is due to a combination of localised subsidence related movement to the foot of the column coupled with deterioration of the roof timbers.

It is assumed that the head of the column is held in place by a structural connecting pin from the top of the column into the roof structure. The roofing felt to the canopy is starting to perish and as such we assume that the roofing timbers are compromised thereby resulting in the structural pin not being fully restrained. Localised ground movement has occurred to the foot of the column following the recent warm summers, enough for the base of the column to tip forward. With the lack of

restraint at the top + the fact that the brick privacy wall and front glazing are not tied to the column, the right hand column has tipped away from the structure by approximately 45mm.

Figures 13: Top of right hand column showing movement Externally

To do this, we propose to:

- Install temporary counter-weight to the left of the porch, as no works can be undertaken from the right hand side due to neighbourly disputes.
- Install a timber frame within the portico to keep the structure square
- Install a ratchet strap around the head of the column, tying it back to the counter-weight
- Strip back the felt from the roof to expose the roof timbers
- All rotten roof timbers to be removed – we have allowed to replace all roof timbers, but until it is stripped back we do not know the extent of the works required to the roof. All architraves will be carefully set aside for re-use
- Install one screw-type pile to the front of the right hand column with a jacking head installed
- While jacking off the pile, slowly and carefully operate the ratchet strap thereby re-righting the column

- Lock the column in place by concreting the head connection to the pile at the base, and installing new timbers as required to the roof
- Redecoration to the portico to match existing

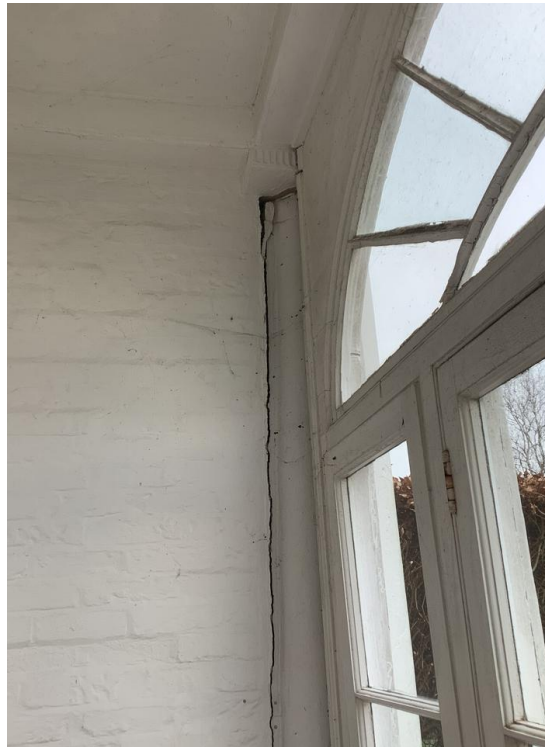
Figure 14 Internally
