# 16 Mill Hill, Botley, Southampton, SO30 2GY

Preliminary Roost Assessment (PRA)  
Bat and Bat Activity Surveys (BAS)

Date: 27/07/26

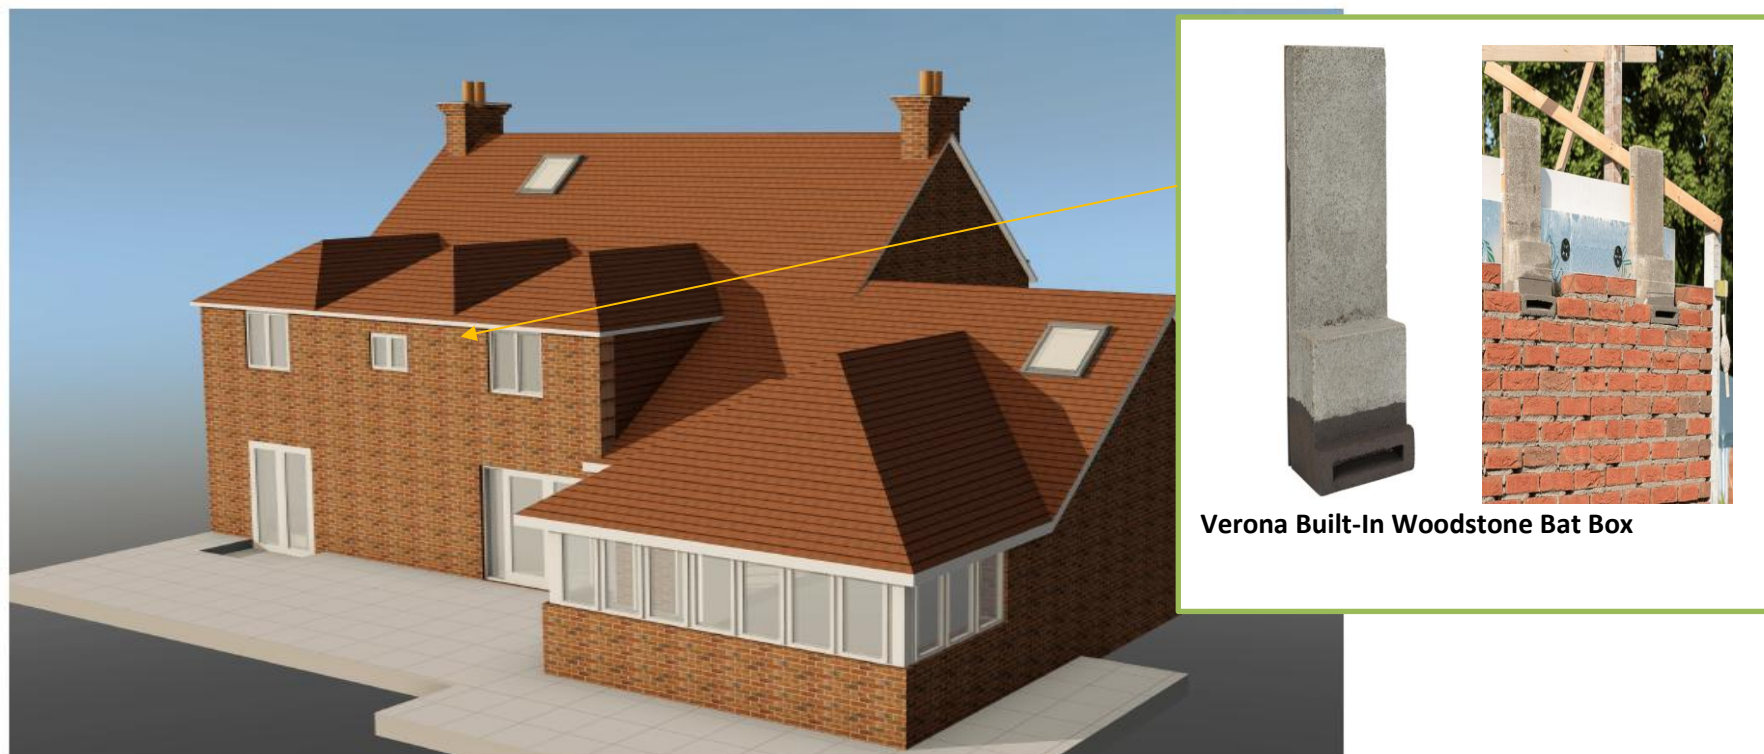
Figure 3: Showing the location of the proposed biodiversity enhancement

- 5.2 One integrated bat box shall be incorporated into the new rear wall of the development as a biodiversity enhancement and to maintain opportunities for roosting bats within the completed scheme. The bat box should be built into the wall fabric at, or as close as practicably possible to, eaves height, and should be positioned on a suitable aspect where it will be sheltered from strong winds and receive some solar gain during the day. The location should avoid direct illumination from external lighting and should remain connected to suitable commuting and foraging habitat within the rear garden and wider landscape.

- 5.3 The integrated bat box should be a proprietary built-in unit suitable for incorporation into masonry or similar wall construction and installed strictly in accordance with the manufacturer's instructions and current Bat Conservation Trust guidance. The entrance slot should remain unobstructed on completion, with no projecting features, dense vegetation, artificial lighting or other obstructions immediately below or in front of the access point.

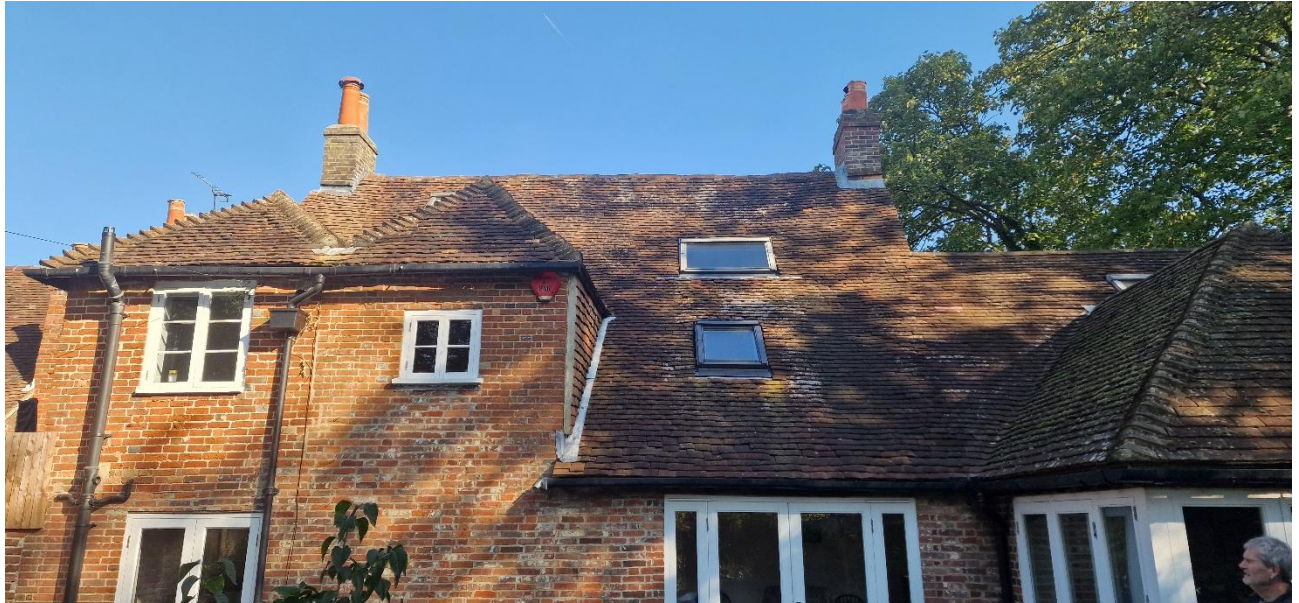
**Picture 1:** The rear elevation and location of the proposed works

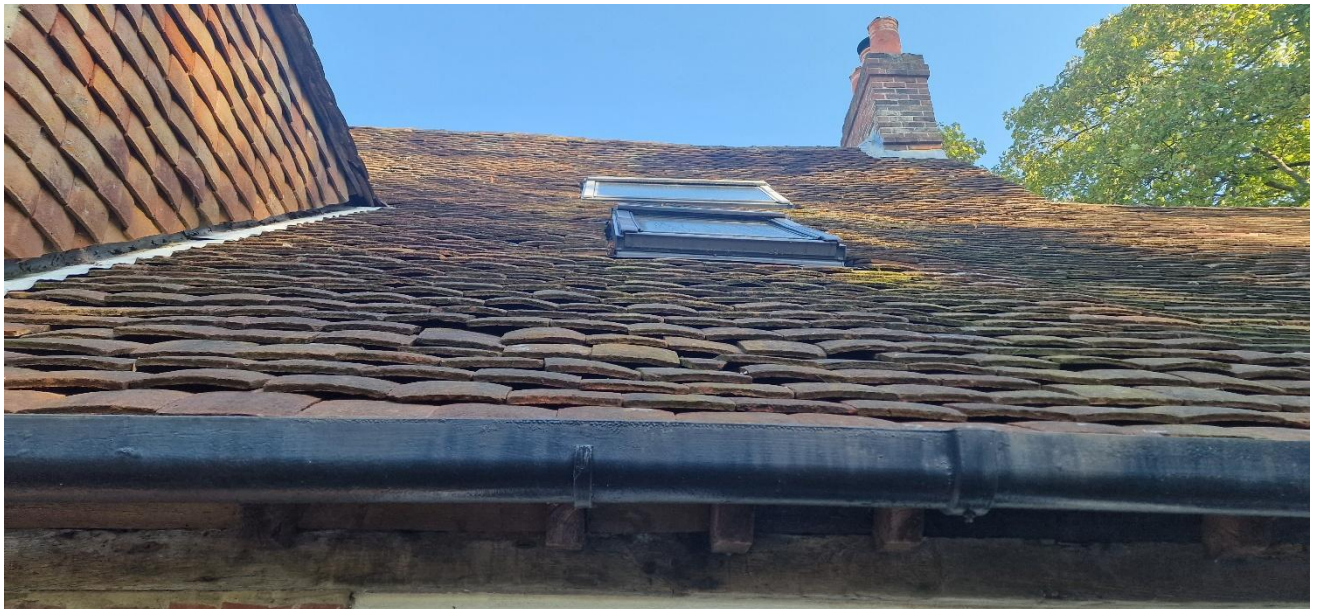
- 2.4 The roof is covered for the most part in handmade clay tiles. These have a profile that could allow bats to enter beyond into the roof or roost behind on the battens. There are areas at the rear where more modern tiles have been used to cover the sunroom and repairs to the main roof.

**Picture 2:** Showing profiles in the tiles that could allow bats to enter

- 4.7 As a precautionary working method, works to the rear dormer, roof tiles and hanging tiles should proceed carefully and under a sensitive soft-strip approach. Tiles and associated roof/dormer materials should be removed by hand where practicable, lifting outwards rather than sliding or levering aggressively. Any crevices, lifted tiles, gaps behind hanging tiles or areas of ridge/mortar bedding should be checked visually as they are exposed. If a bat, or evidence of bats, is discovered at any stage, works must stop immediately in the affected area and advice must be sought from a suitably qualified ecologist. Bats must not be handled by contractors unless there is

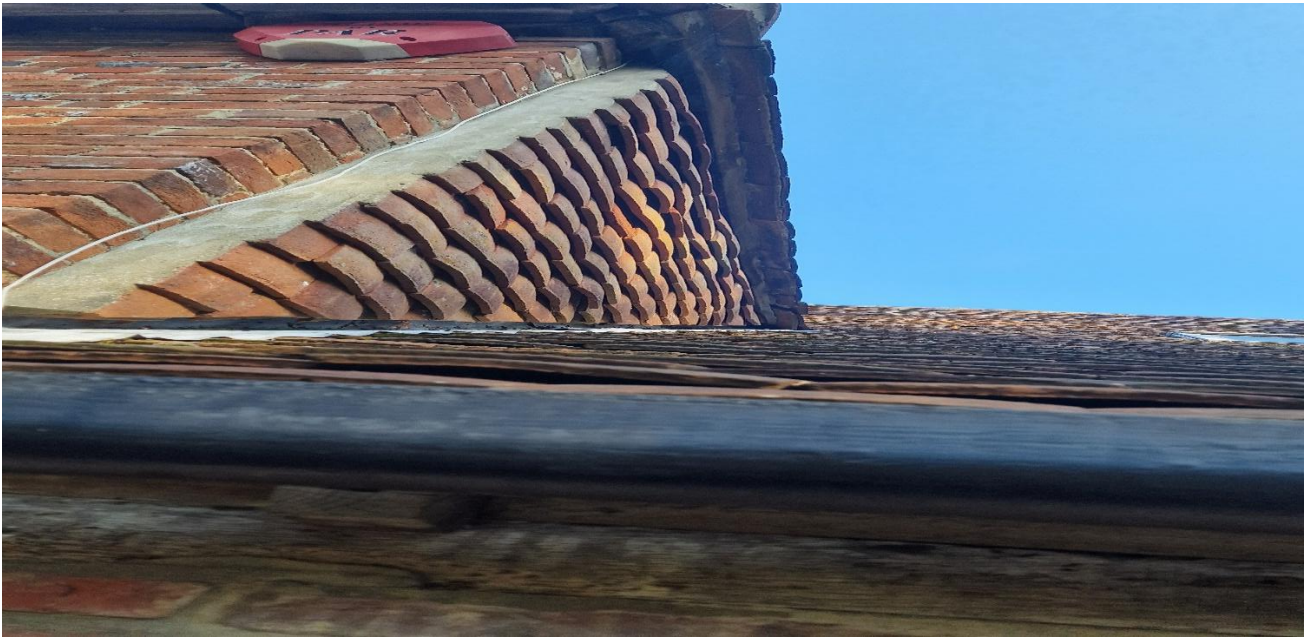
- 2.6 The rear of the building has a double-width dormer. This is covered with the same small tiles, which have numerous gaps and holes. The cheeks of the dormers are covered in tile hanging, and there are gaps throughout the tile beds.

**Picture 3:** Showing existing hanging tiles and gaps within the tile bed.

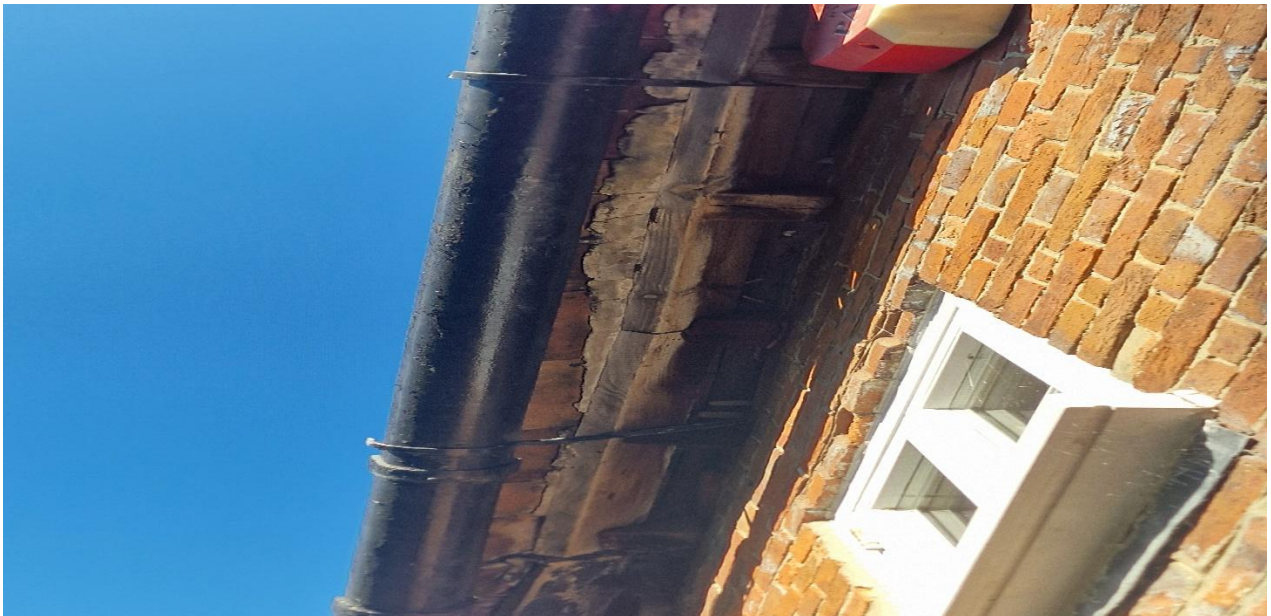
- 2.8 The building has no soffit boxes; the eaves are tight and are constructed with wood that blocks any ingress into the building's fabric.
- 2.9 All the window and door frames are tight fitting, with no obvious holes or gaps that would allow ingress into the fabric of the building.

**Picture 4:** Showing the tight eaves in the location of the proposed works

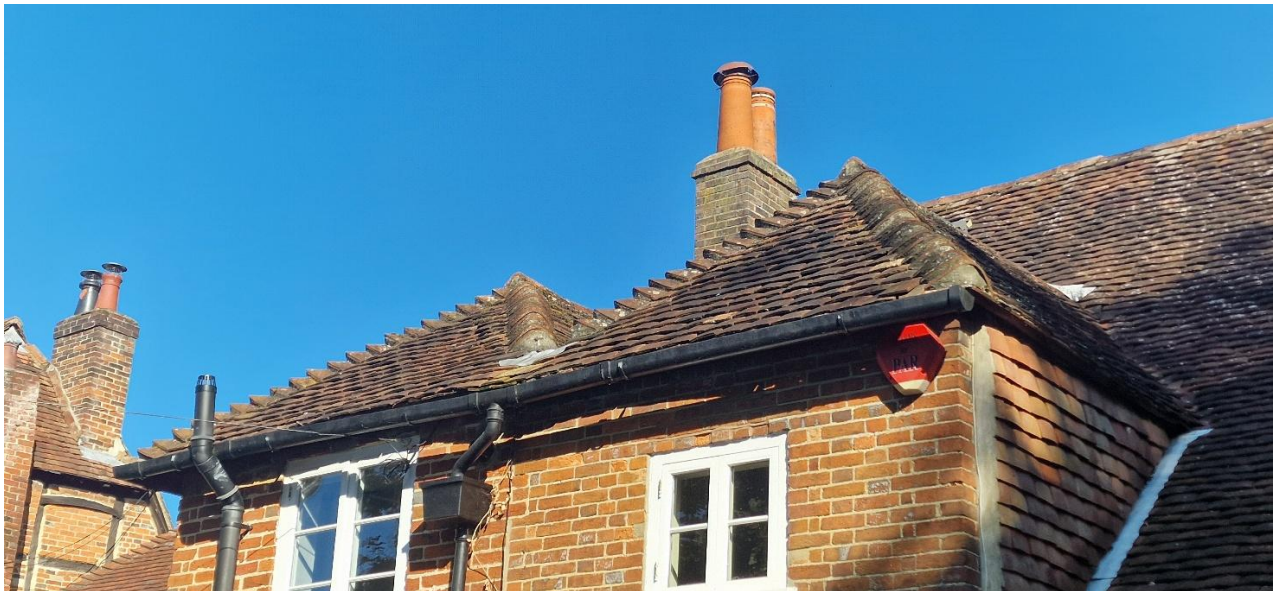
**Picture 5:** Showing the tile bed on the existing double-width dormer

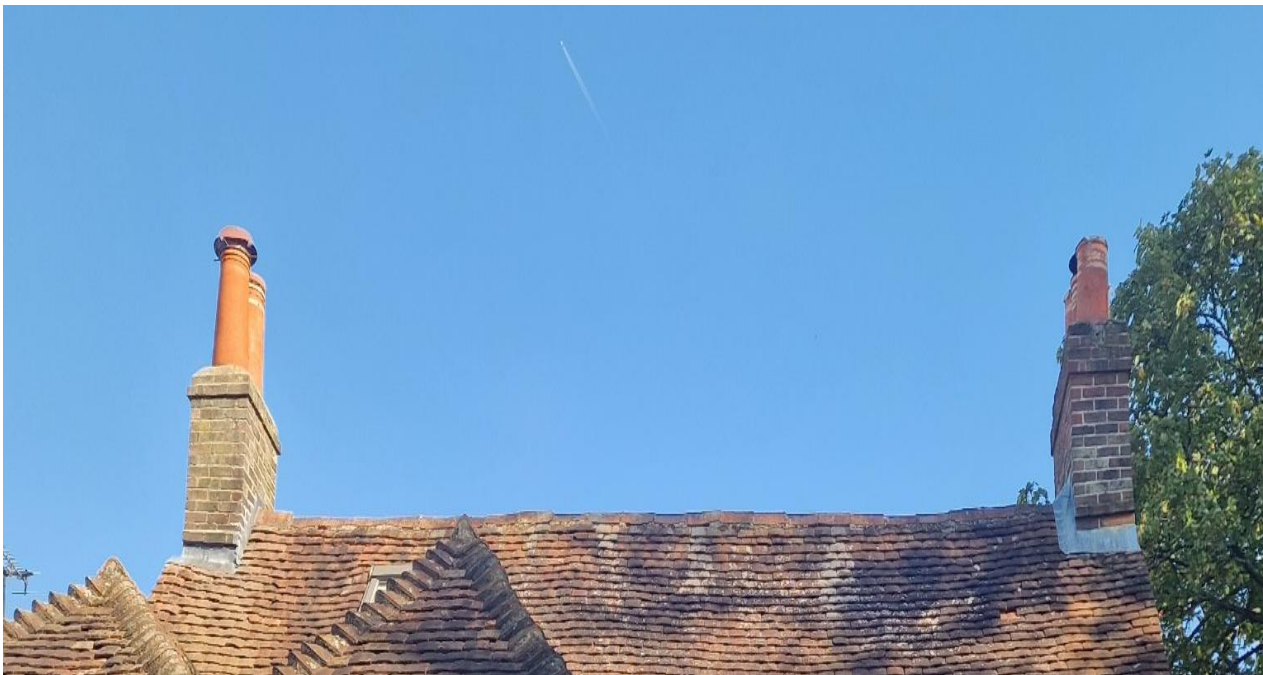
- 2.5 The ridge is made from the same material as the tiles (handmade clay tiles). The ridge has missing pugging along its length that could allow ingress into the building.

**Picture 6:** Showing ridge of the main roof and the gaps in the bedding

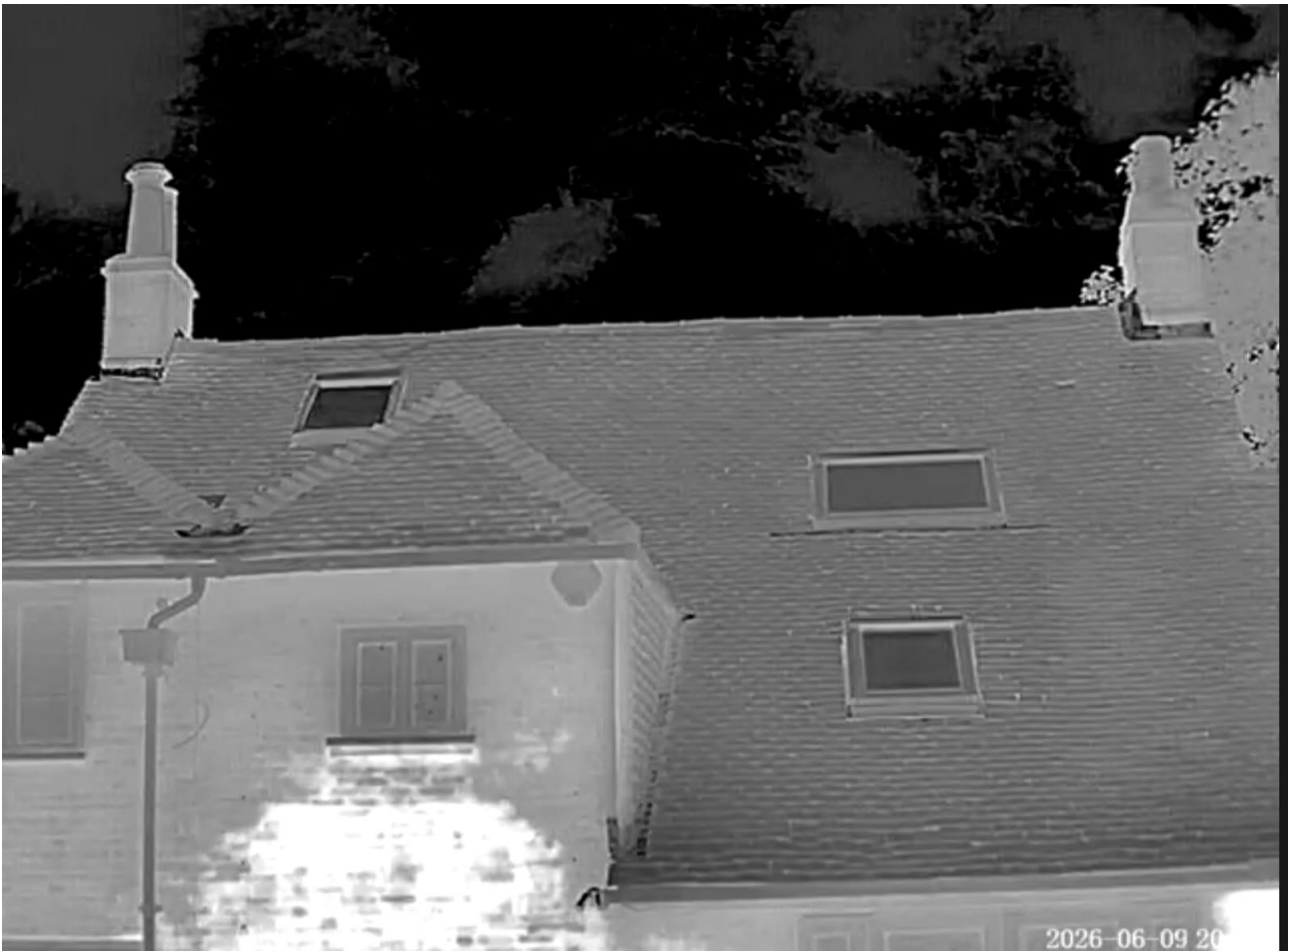
**Picture 7:** Showing the thermal image of the rear of the building

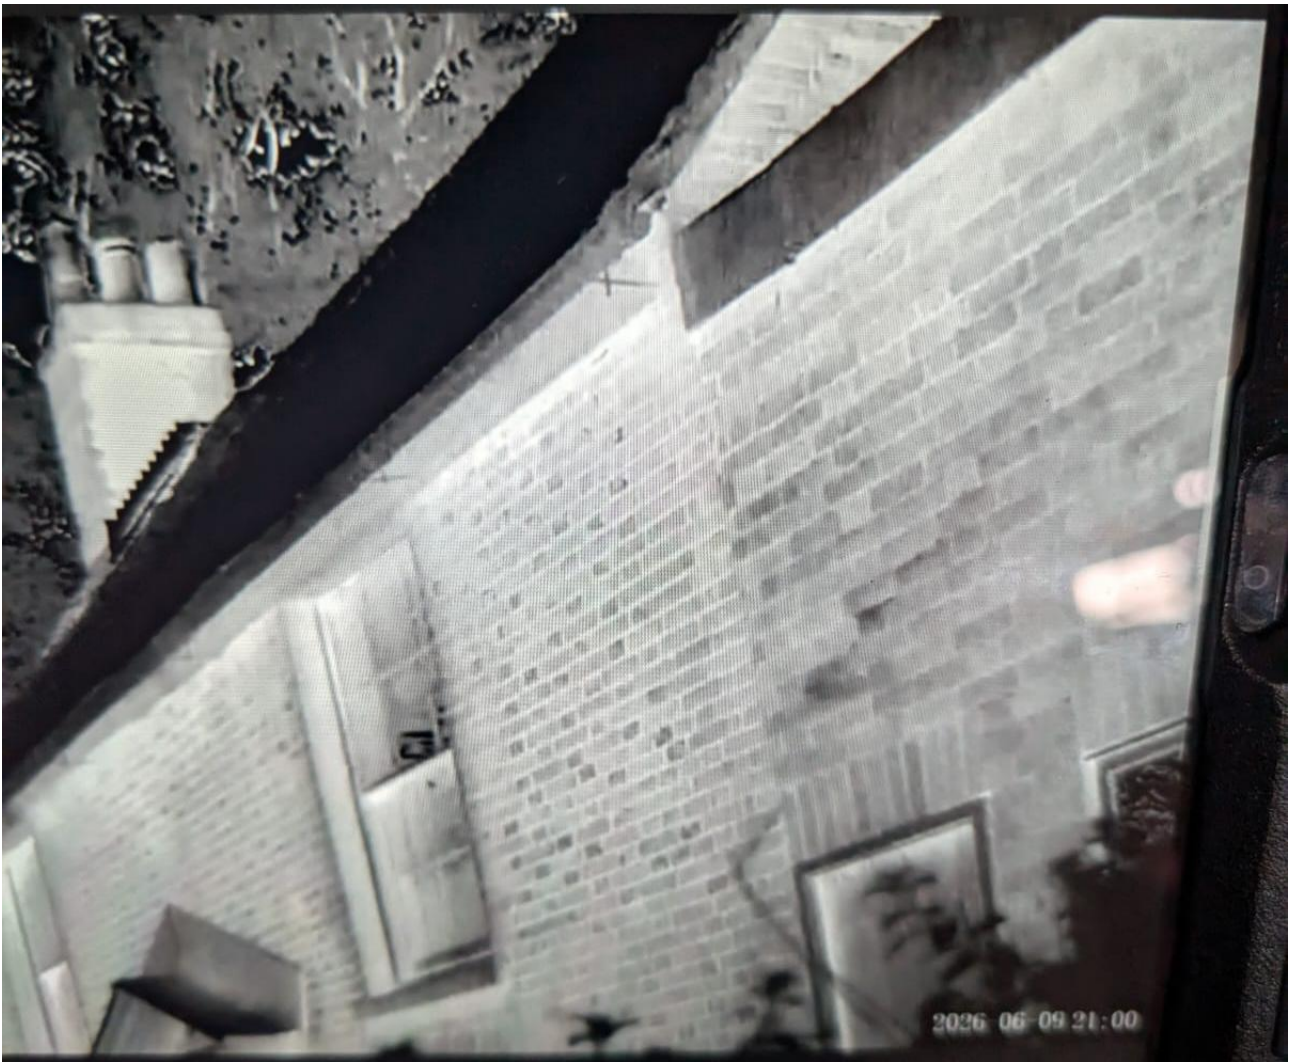
**Picture 8:** Showing the thermal of the front of the building
