# Preliminary Roost Assessment

Portland House, 29 High Street, Botley, SO30 2EA

This report is prepared to inform a planning application with Eastleigh Borough Council- '*Proposed replacement sashes of 19no. sash windows & proposed replacement of 3no. casement windows*'.

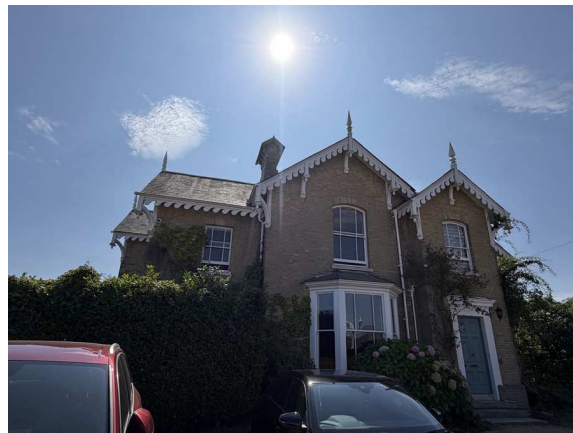
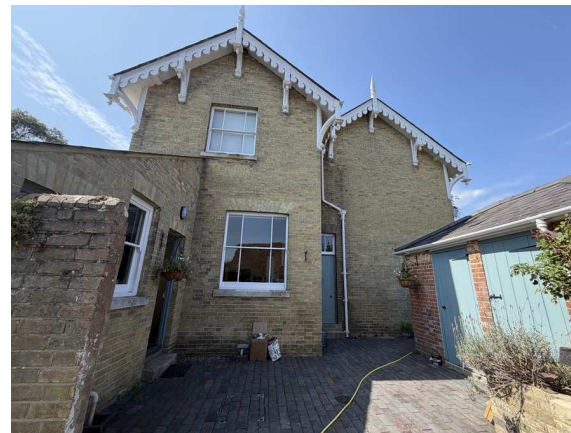
The building is a residential dwelling situated within the site. Its construction and current use as a well-maintained dwelling offer no discernible roosting opportunities for bats, with no accessible voids or suitable crevices present. The building has negligible habitat value.

*Building B1*

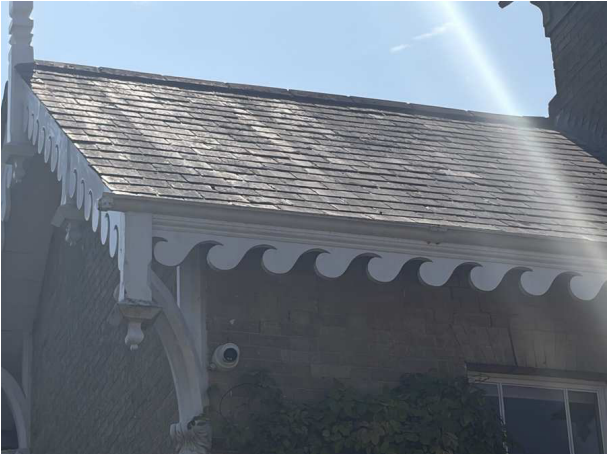
| Feature | Materials/<br>Details | Condition / description / suitability | Photograph |
|---|---|---|---|
| Roof | Slate | <p><b>Condition/description</b></p> <p>The roof appeared in be in good condition throughout with no gaps or missing tiles that could provide roosting opportunities for crevice dwelling bats, or access into the roof structure.</p> <p><b>Suitability/access/evidence of bats</b></p> <p>No suitable roosting features were recorde</p> | <div><p><i>B1 roof</i></p><p><i>B1 roof</i></p></div> |

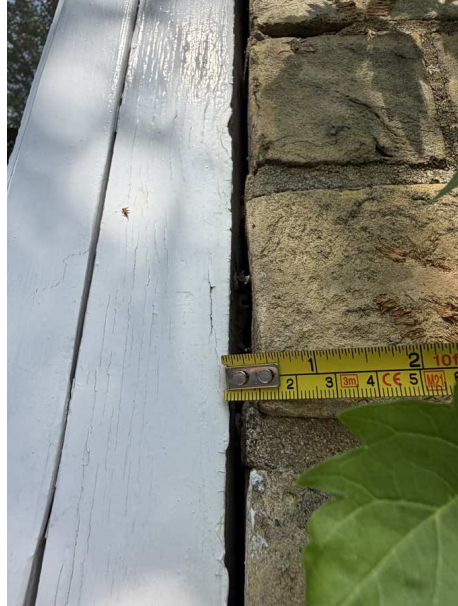
| Windows | Timber | <p><b>Condition/description</b></p> <p>Gaps between the timber frames and the brickwork on window 4 provide crevice roosting opportunities, however on closer inspection, the width and depth of the gaps were deemed too small and unsuitable.</p> <p><b>Suitability/access/evidence of bats</b></p> <p>The gaps around the window are approximately 1 cm wide and 2 cm deep. While bats are capable of accessing relatively small crevices, the limited dimensions of these gaps are considered to provide negligible suitability for use as a bat roost.</p> <p>In particular, the gap has a very limited depth of only 2 cm, meaning that it does not appear to extend sufficiently into the building fabric to provide a substantial, enclosed and suitably sheltered space in which bats could establish a roost. The 1 cm width also provides very restricted access. Consequently, the feature is considered unlikely to provide adequate space for a bat to enter, manoeuvre and establish itself within a secure roosting cavity.</p> <p>The gap is therefore considered unsuitable as a typical crevice roosting feature due to the combination of its narrow 1 cm opening and very limited 2 cm depth, together with its configuration around the window.</p> <p>The area of window 4 hidden by vegetation was inspected at first floor level and no gaps or cracks were observed.</p> <p>No additional evidence of bat use has been identified.</p> | <p><i>B1 window / doors frames and lintels</i></p> |

In the unlikely event that a bat or evidence of bats is discovered during the development all work must stop and a bat licensed ecologist contacted for further advice.

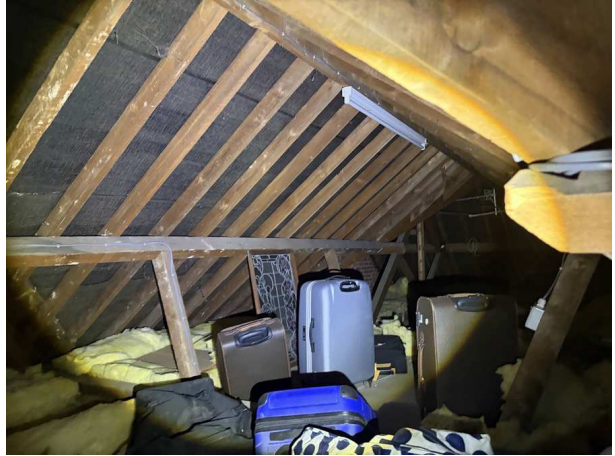
| Internal void 1 | Timber rafters.<br>Bitumen felt lining | <b>Condition/description</b><br>The loft appeared to be well sealed with no signs of natural light entering the loft. The insulation appeared to be in good condition with no tears that could provide access into the loft void.<br><br><b>Suitability/access/evidence of bats</b><br>No evidence of protected species was recorded. | <br><i>B1 internal void 1</i> |

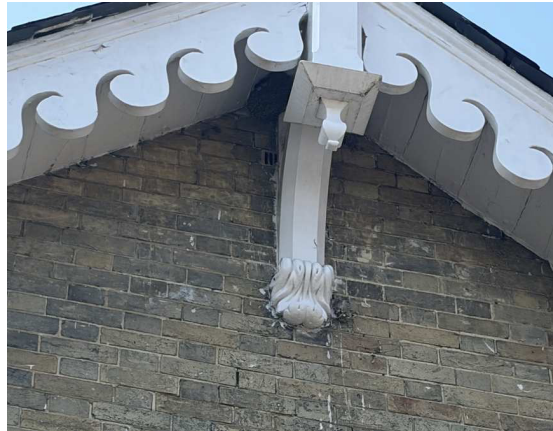
Multiple active House Sparrow nests were observed within the eaves at each gable end of the building. The nests showed evidence of current use and were considered to be active at the time of the survey. As a result, the eaves provide confirmed nesting habitat for breeding birds.

*Active sparrow nest*

The replacement of windows located below the swallow nests could result in the disturbance and subsequent abandonment of active bird nests located above the windows due to be replaced.

Any window replacement located below the active nests should be undertaken outside the period 1st March to 31st August. All active nests will need to be retained until the young have fledged or an ecologist has confirmed the nesting attempt has concluded.

Precautions should be taken with machinery and noise levels when working close to any retained nests so as not to disturb any nearby nesting birds during construction works. At least a 3-5m buffer should be created between any machinery and active nests until the young have fledged or an ecologist has confirmed the nesting attempt has concluded.
