BOTLEY MILL, MILL HILL, BOTLEY, SO30 2GB

## **BAT SURVEY REPORT**

August 2026

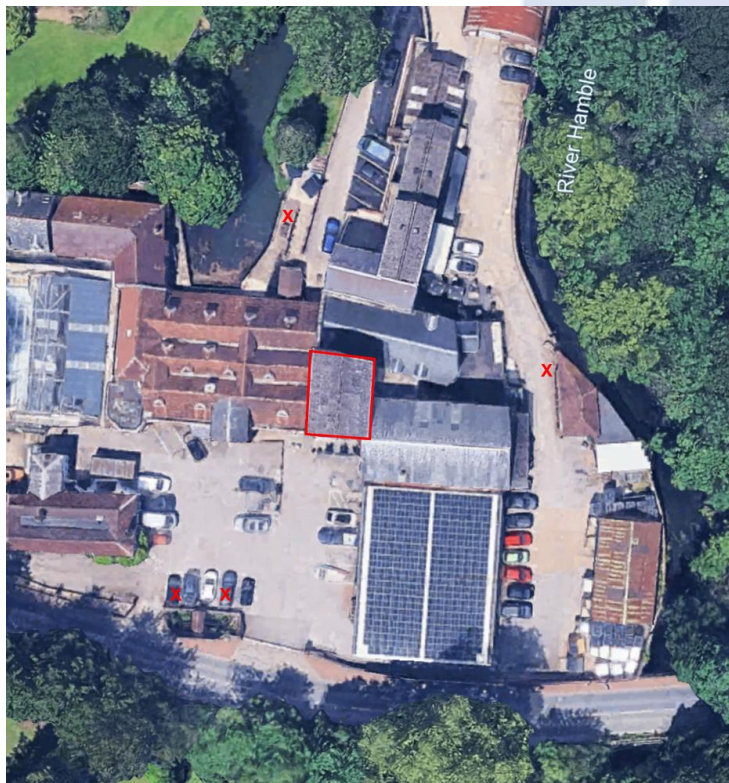
**Figure 2.** Location of surveyors shown with red x with building outlined in red.

- 4.7 During both surveys four surveyors were placed around the site to cover all angles of the building as detailed in Figure 2.

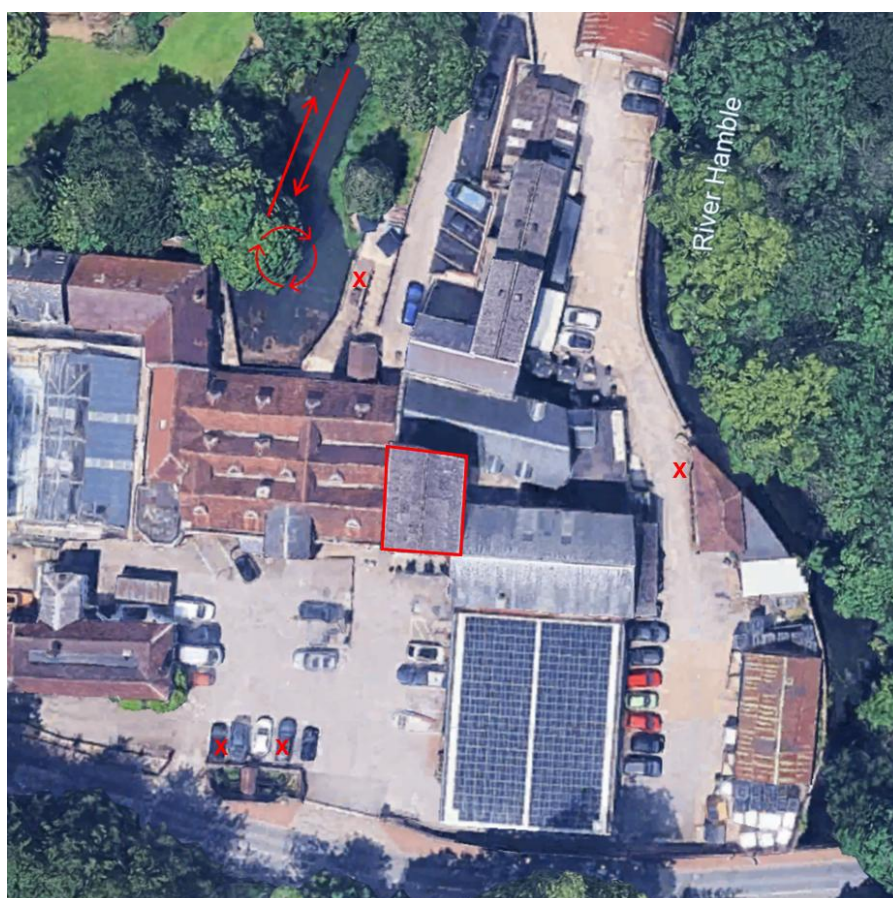
**Figure 4.** Observed activity.

- 4.8 No bats were seen emerging from the building during the first survey. This was confirmed by review of the night vision infrared footage. Overall, very low levels of activity were heard or observed from outside of the building. 8 Common pipistrelle calls, 4 Soprano Pipistrelle calls and 2 Noctule calls were logged on the Echo Touch 2 Pro at the rear (north) of the site.

- 4.11 To the rear of the building views were also limited by existing buildings although the roof was entirely visible. Only four bat calls (Common and Soprano pipistrelle) were heard but not seen between 21:37 and 22:29. A single Noctule was heard not seen at 21:53. At 22:33 a single Soprano pipistrelle was observed foraging over the water to the north (west of the surveyor) for 5 minutes. It then left up the river corridor to the north.

- 4.13 During the first survey all surveyors noted that the site is heavily lit with flood lighting and lower-level lighting. All elevations of the buildings were lit all night, and lighting remains on until morning. Overall, this would be likely to deter bats from using site or entering the building to roost and may explain the very low levels of observed activity.
