BOTLEY MILL, MILL HILL, BOTLEY, SO30 2GB

## PRELIMINARY ROOST ASSESSMENT

June 2026

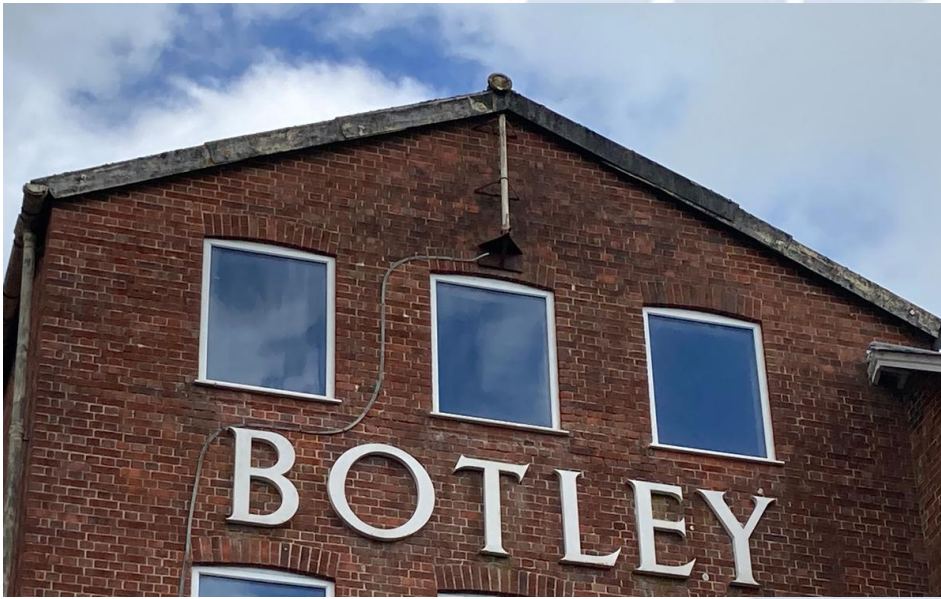
**Figure 4.** Image showing a wide gap beneath the fascia on the front elevation

- 4.7 In the main the front elevation of the building does not offer many Potential Roost Features (PRF's). The windows are well sealed with no gaps around and the brickwork appears sound. However, there is a gap beneath the 1086 signage and it was unclear if the 'BOTLEY MILL FLOUR & FEED' lettering was sealed to the building.
- 4.8 The roof is constructed of corrugated asbestos and is not sealed where it meets the wall face on the front and side elevations. The fascia boards on the front gable leave a gap which allows access into the building and internally air can be seen draughting in through the spaces.

- 5.4 In accordance with current best practice guidance, further presence/absence surveys are recommended prior to the commencement of any works that may affect the identified potential roost features. These surveys should comprise **two dusk emergence surveys** undertaken between May and September. Should rare or significant numbers of bats emerge during these surveys additional survey effort may be required.

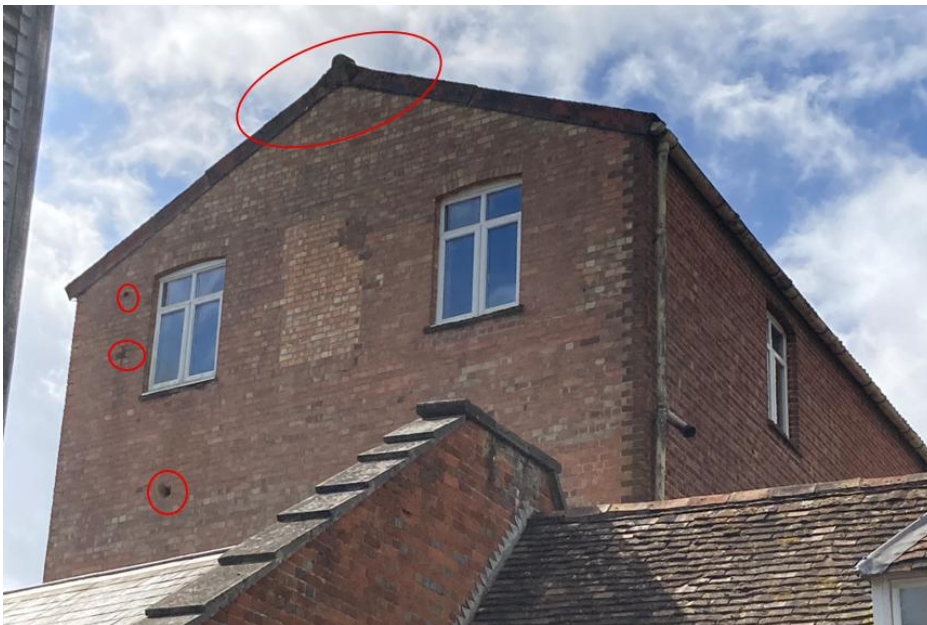
**Figure 5.** Rear elevation PRF's

- 4.9 To the rear elevation the fascias are flush to the building however there are some smaller gaps which could be utilised by crevice roosting species, particularly around the apex of the gable. Some small holes are also visible in the elevation

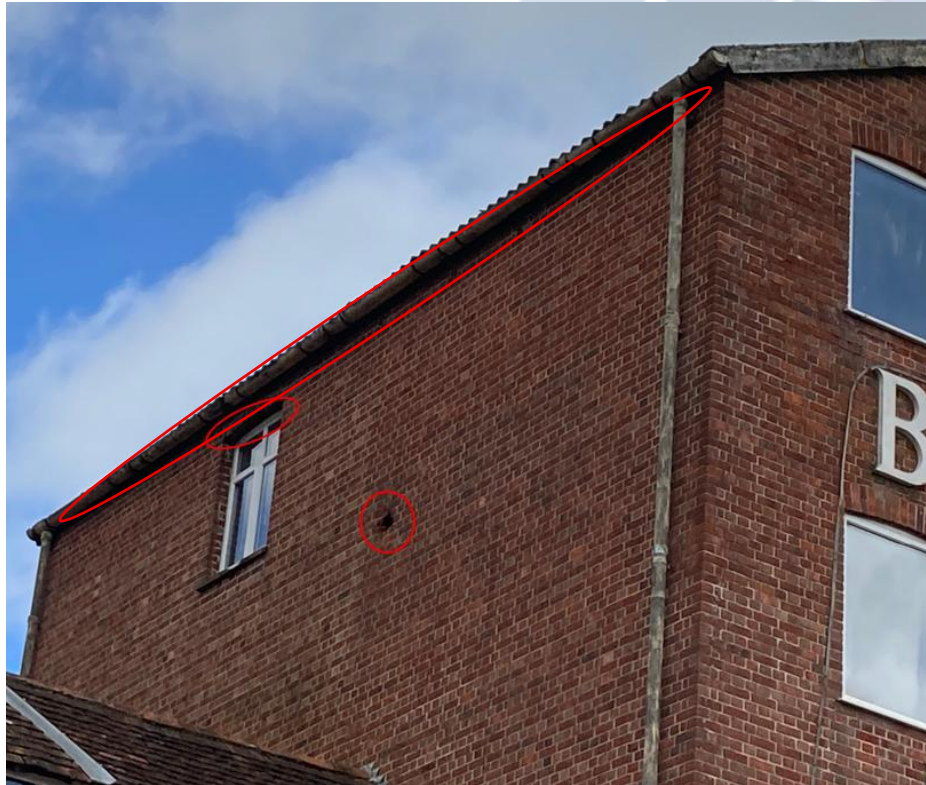
**Figure 6.** Image showing PRFs in the x elevation

- 4.10 As noted at the top floor to the x elevation the corrugated roofing can be seen to overlap the wall. There is also a hole which opens into the building, and there is also some gapping above the top of the window frame.

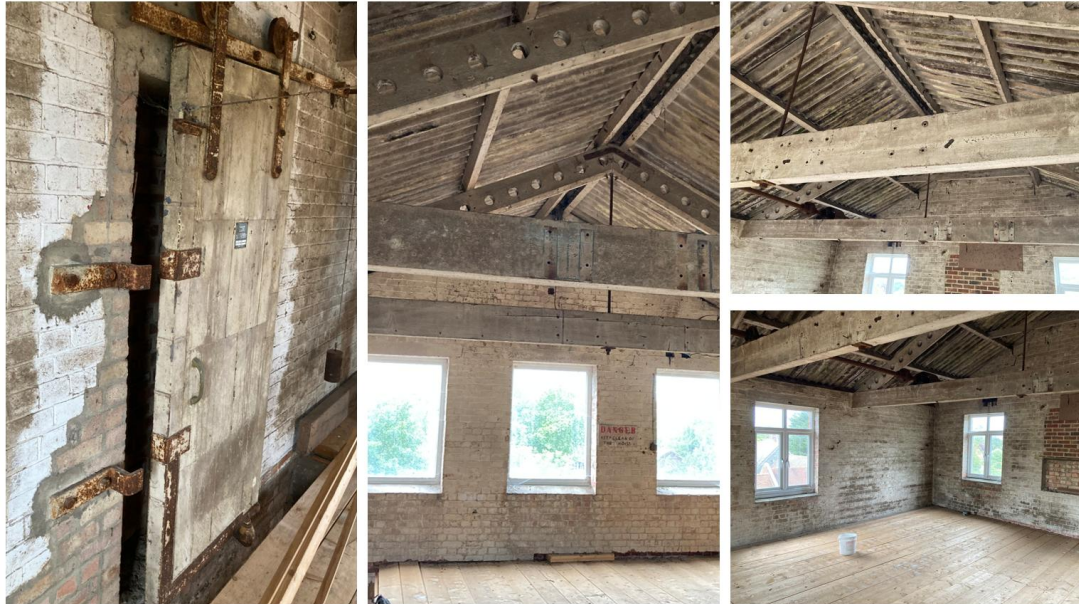
**Figure 7.** Image of the top floor

- 4.11 At the ground floor the space is in part occupied by I086 and to the rear the space is utilised in association with site operations (unspecified). These areas are well used and well lit and would not provide appropriate roost opportunities. However, the upper 4 floors are all unoccupied and do have some roosting potential as detailed below.
- 4.12 The very top floor of the building is highly unlikely to be being utilised by roosting bats. Although there is various access point the top floor is very well lit by the numerous windows. The asbestos roof is not lined and does not gap where it overlaps. The gaps behind the beams are visible and there are no bats in these locations. There are some limited areas such as beyond the now blocked door frame and in some very small gaps in the wall and where the roof meets the wall. In these locations the areas are very draughty

and unlikely to be thermally stable enough for bat roosting. The area was searched for dropping, feeding remains or staining and none was found.

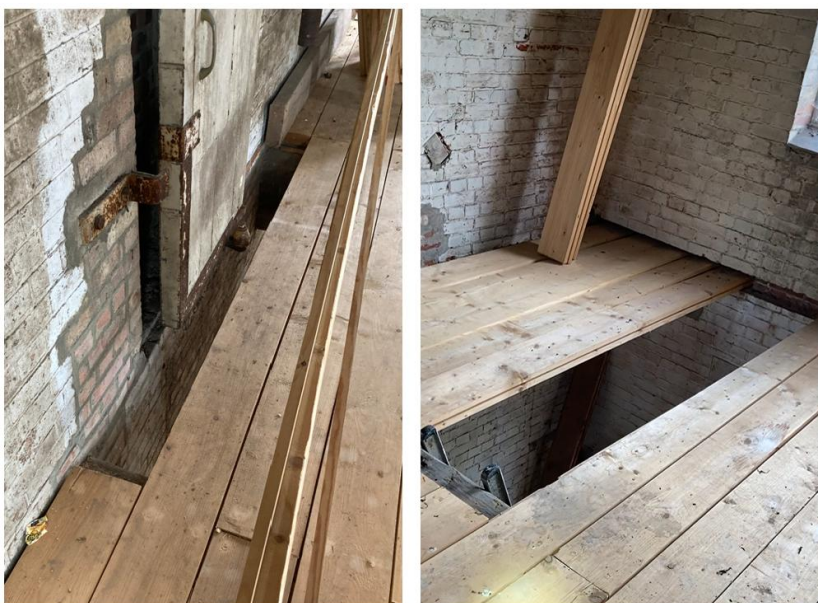
**Figure 8.** Images of the holes through to the floor below.

- 4.13 Although there is no evidence of bats utilising the top floor there are several large holes in the floor which lead into the two floors below. It is possible that any bats accessing from the roof could then be roosting in the floors below.

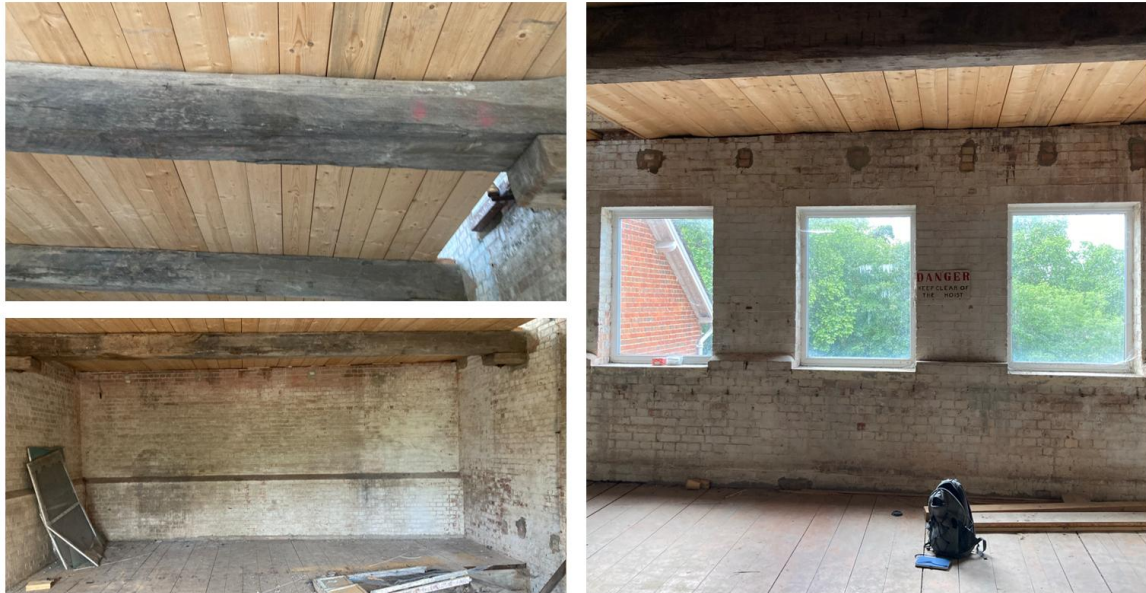
**Figure 9.** Images of the holes through to the floor below

- 4.14 The floor below is still relatively light by virtue of the windows in the front elevation and light from above. There are some slightly darker areas and some gaps beneath the large ceiling beams which may offer limited roosting opportunities. The area was searched for dropping, feeding remains or staining and none was found.

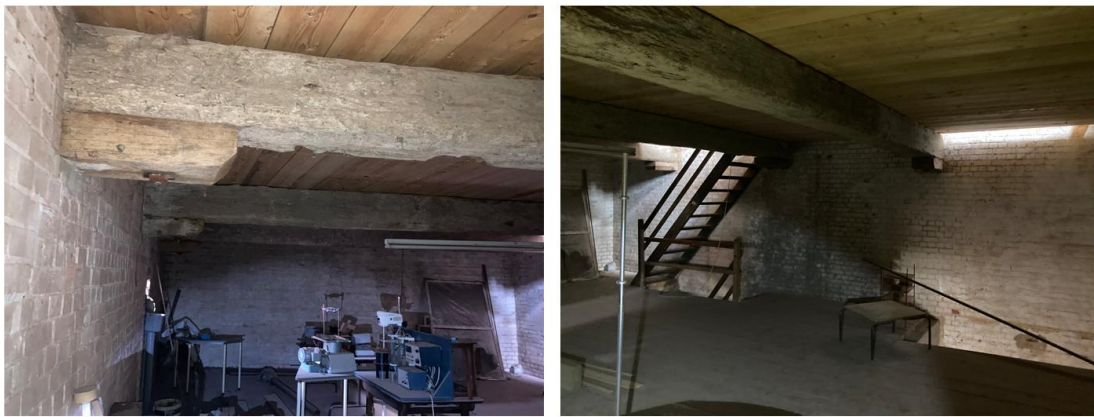
**Figure 10.** Internally lit from upper and lower floors.

- 4.15 The next floor down is significantly darker, and the only light is from the upper and lower floors. The large ceiling beams have some small gaps and there are some limited gaps in the brickwork. This floor contains several pieces of historical paraphernalia relevant to the Mill which have been placed here some time ago. The area was searched for dropping, feeding remains or staining and none was found.

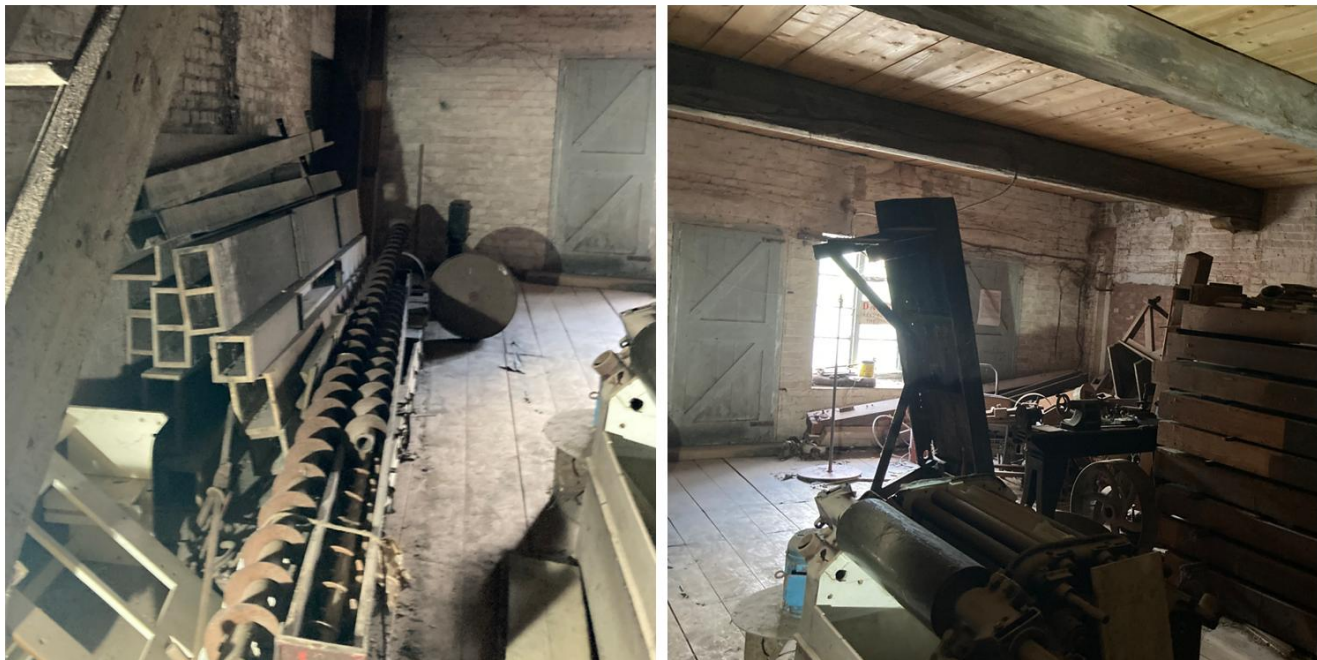
**Figure 11.** Front section.

- 4.16 The next floor down is split into two sections, front and rear which are all open and again all accessible through the building from the roof. There are windows in the front section. Both of these areas are being used for ancillary storage purpose and again the paraphernalia and been in situ for some time. Whilst every effort was made to search these areas this was not entirely possible as it may have result in undue disturbance. These areas were searched for dropping, feeding remains or staining and none was found.
