# Lighting Survey Report

## Boorley Green (Parcels B4 & C6)

### Vistry Group PLC

SLR Project No.: **402.064830.00001**

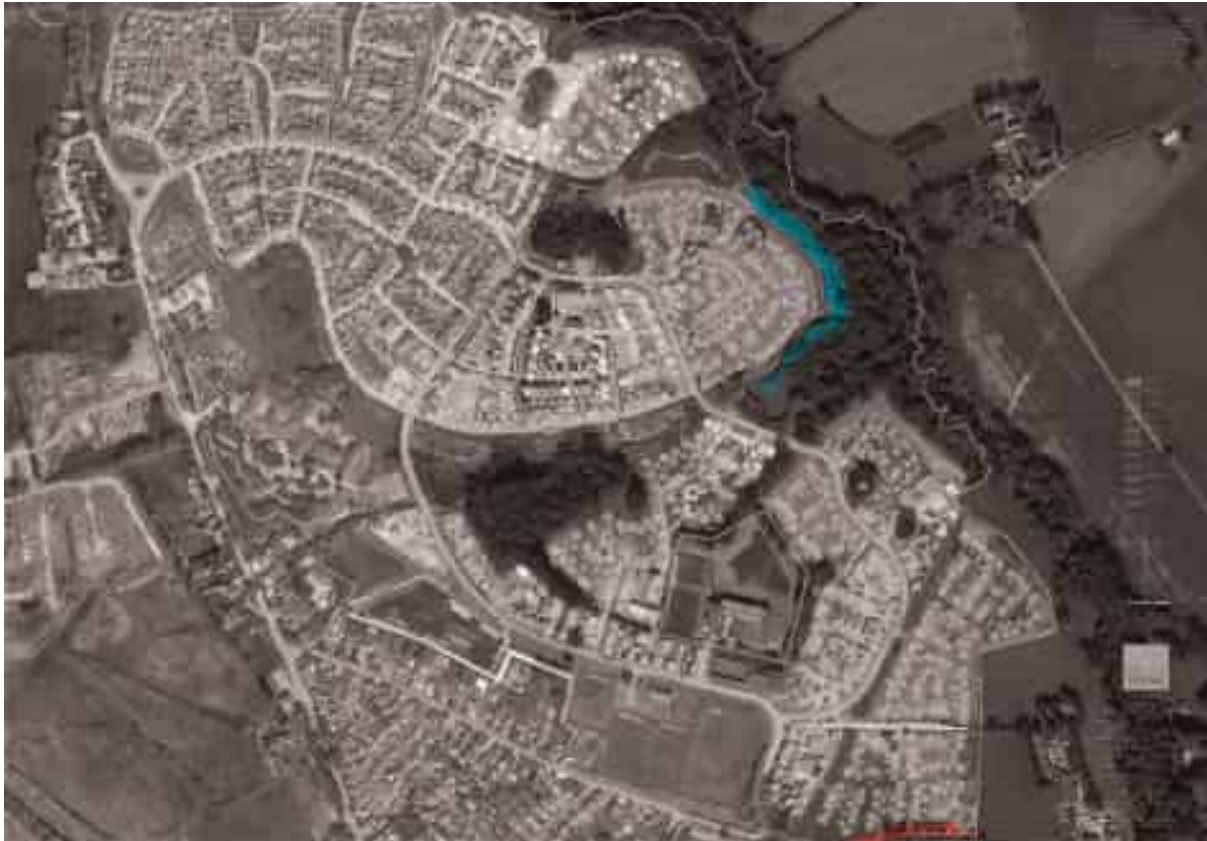
The area highlighted in **Red** represents AoS1 which is the periphery of Parcel C6.

The area highlighted in **Blue** represents AoS2 which is the periphery of Parcel B4.

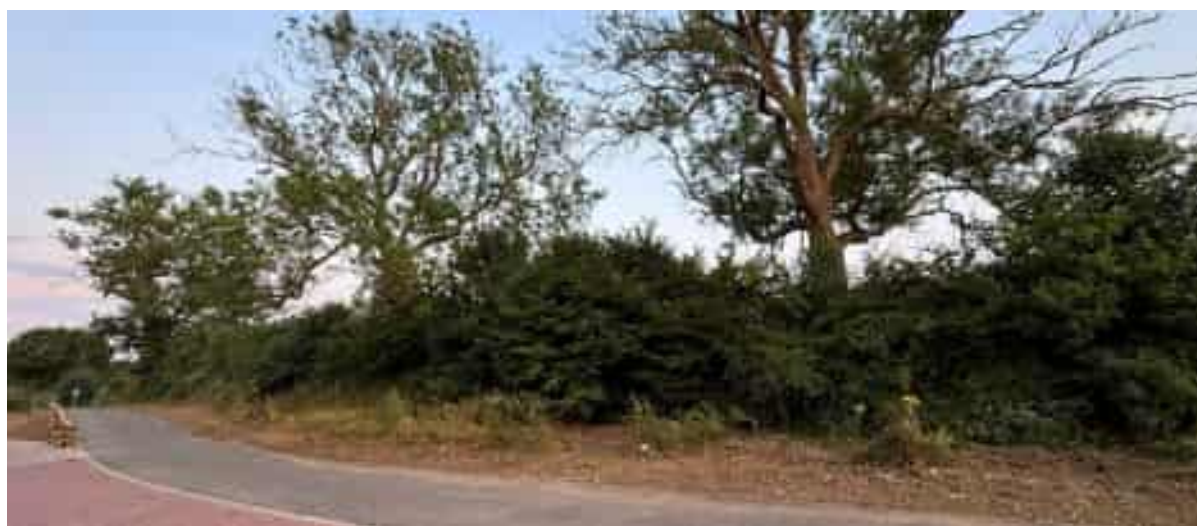
**Figure B: AoS1E East Tree line & Hedgerow South of Oakland Road**

View looking southeast towards the tree line between the development edge and Maddoxford Lane beyond to the south. The tree line consists of a stand of tall mature trees with dense mature hedgerow beneath. This tree line is considered an ecological receptor and potential habitat for light sensitive species such as bats and nesting birds.

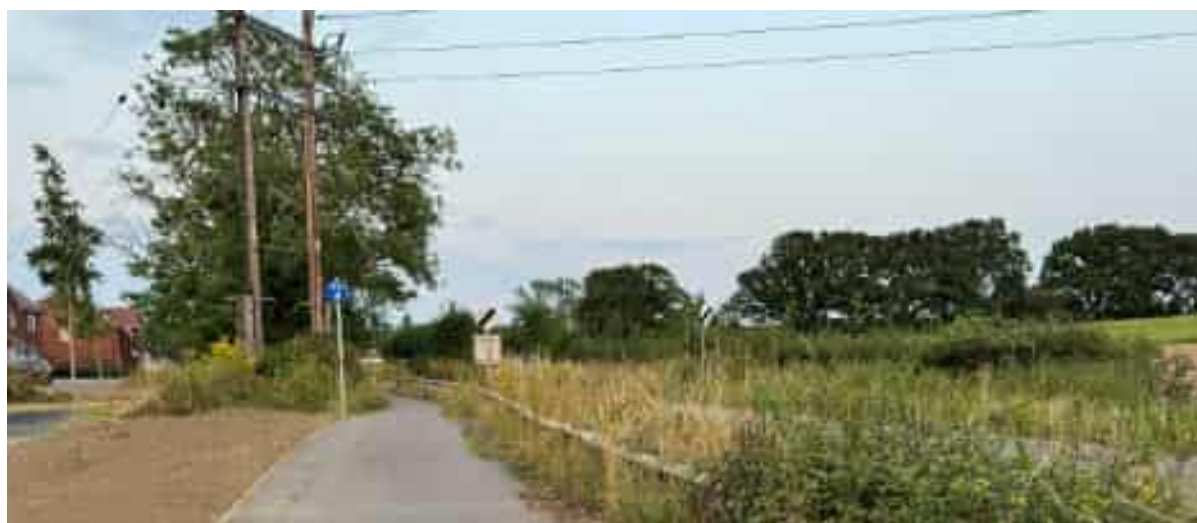
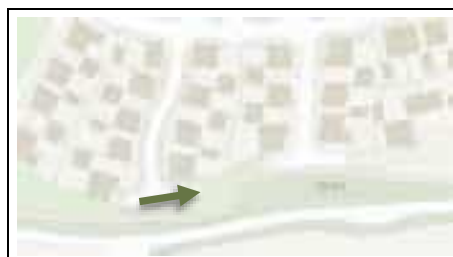
**Figure C: AoS1W West Hedgerow South of Oakland Road**

View looking east towards the tree line and low-level hedgerow between the development edge and Maddoxford Lane. The hedgerow in this area is minimal, no more than 1 metre in height. The tree line and mature hedgerow effectively terminates before the power line columns shown in the left of the image.

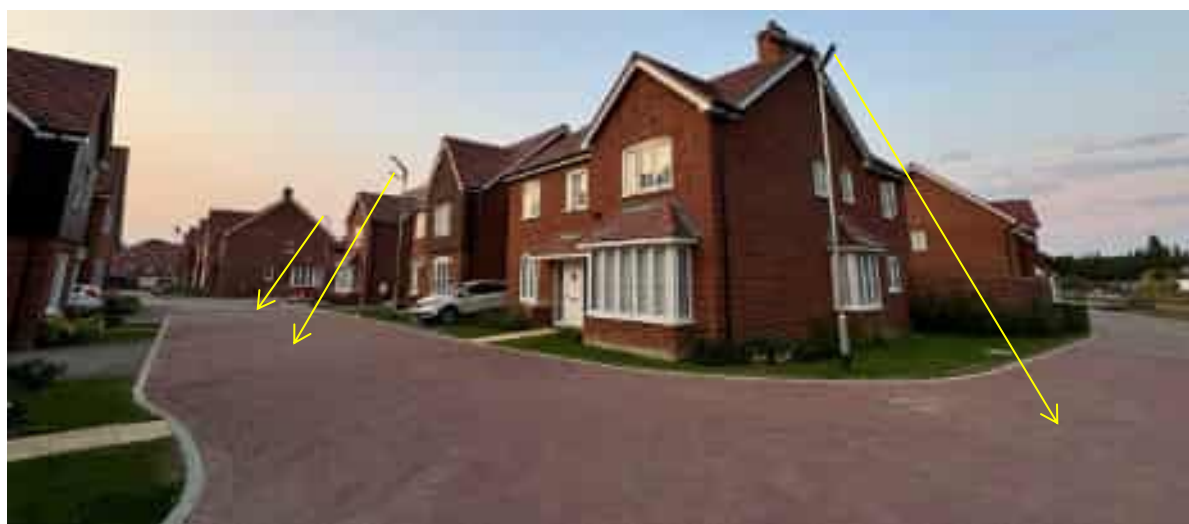
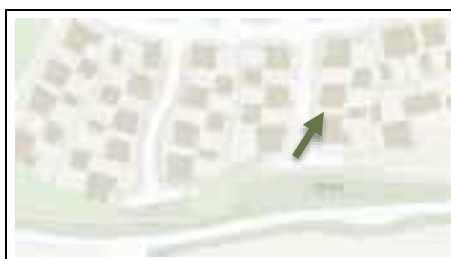
**Figure D: AoS1E East Oakland Road Turning Area - Day**

View looking northeast towards the development from the turning area. The street light column to the turning area is shown in the right of the image. The streetlight is angled upwards at 22° and is oriented towards the tree line at the boundary (marked).

- The application of a front shield to the streetlight in AoS1E East to reduce the projection of light into the tree line at the boundary of the development.
- Adjusting the orientation and angle of tilt of the streetlight in AoS1E East to direct the light away from the tree line.
- Reducing the output of the streetlight in AoS1E East by removing the 'Active' state and using only the reduced output of the fixture by disabling presence detection.
- Removing the streetlight in AoS1E East altogether and leaving the turning area in 'contextual darkness'.

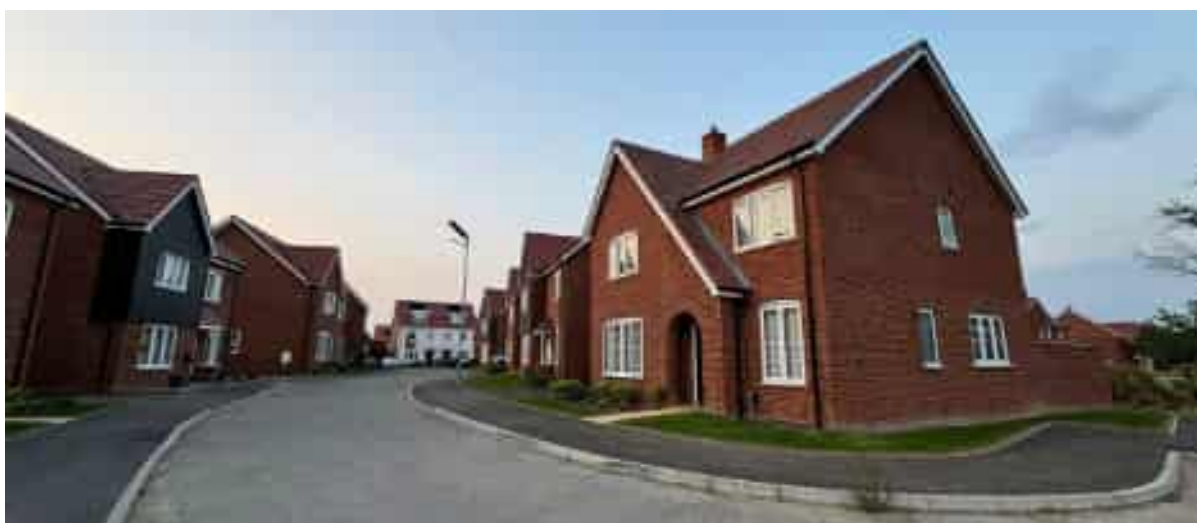
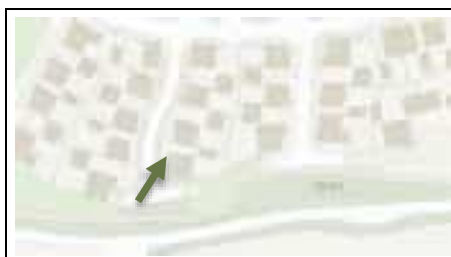
**Figure E: AoS1W West Oakland Road Turning Area - Day**

View looking northeast towards the development from the turning area. One street light column is observed to be installed along this section of Oakland Road although it is not observed to be functional at the time of the survey. The other street light column to the turning area and bollard to the parking bays, both shown on the lighting plans are not installed at the time of the survey.

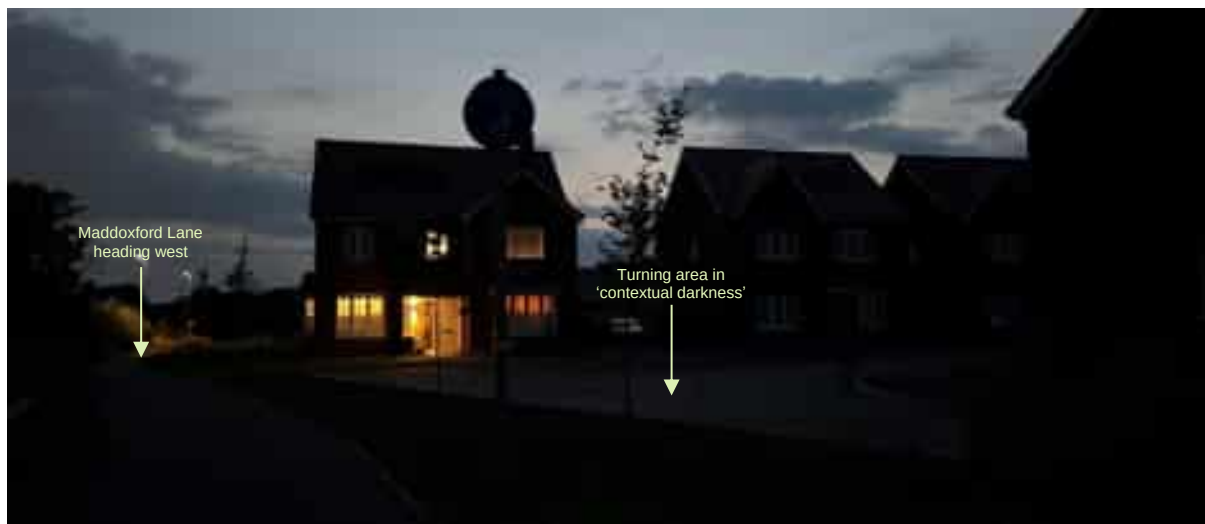
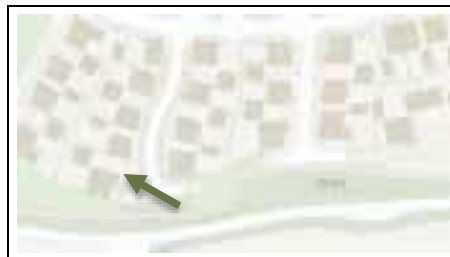
**Figure H: AoS1W West Oakland Road Turning Area - Dusk**

View looking northwest towards the development from the turning area. No street light column is observed to be installed to the turning area of Oakland Road. Beyond domestic interior and porch amenity lighting, there is no lighting to the turning area which remains in 'contextual darkness' beyond the minimal light egress from adjacent residential properties.

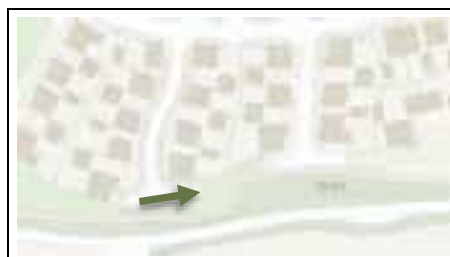
**Figure I: AoS1W (West) Hedgerow South of Oakland Road - Night**

View looking east towards the tree line and low-level hedgerow between the development edge and Maddoxford Lane. The hedgerow and tree line are in 'natural darkness' with no light spill from the development. The light column visible in the image to the left is associated with AoS1E (turning area) to the east.

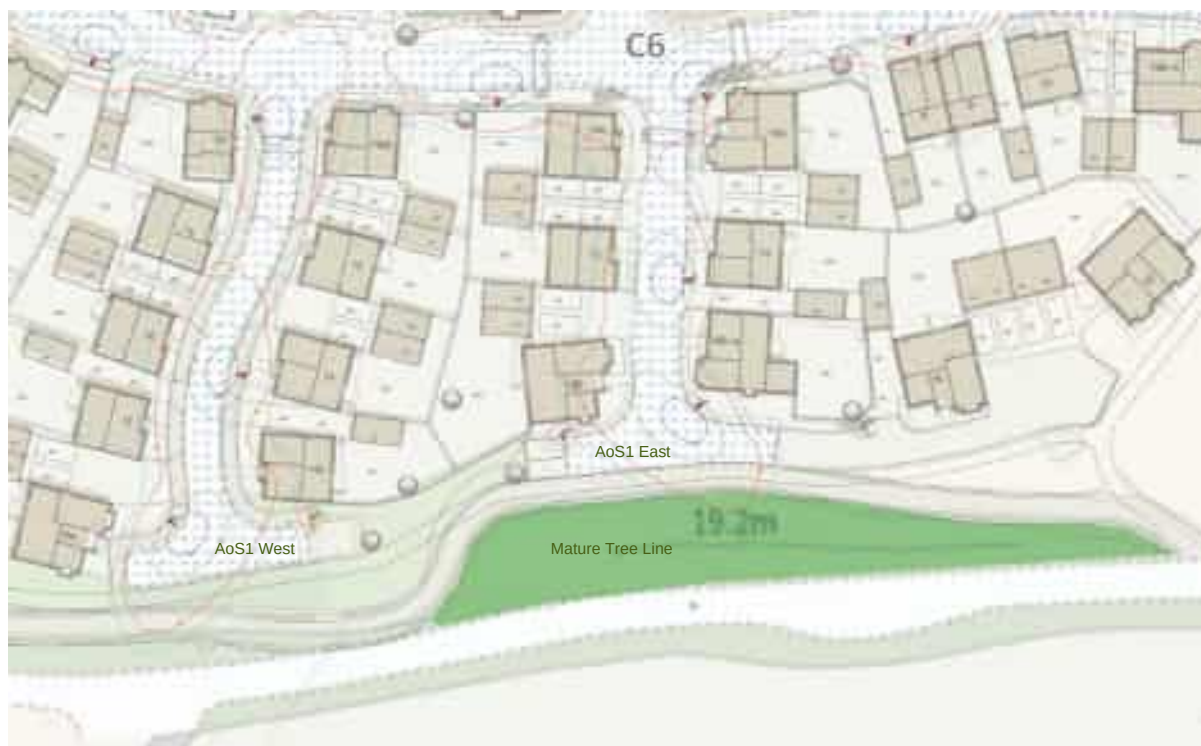
## Figure J: AoS1 - C6 - Potential Light Spill to Tree Line

Extract from the Proelectric street lighting design documentation with ISOLux contours. AoS to the south of Parcel C6 and north of Maddoxford Lane. Isolines show light spill to the mature tree line and hedgerow (approximate location highlighted in **Green**).

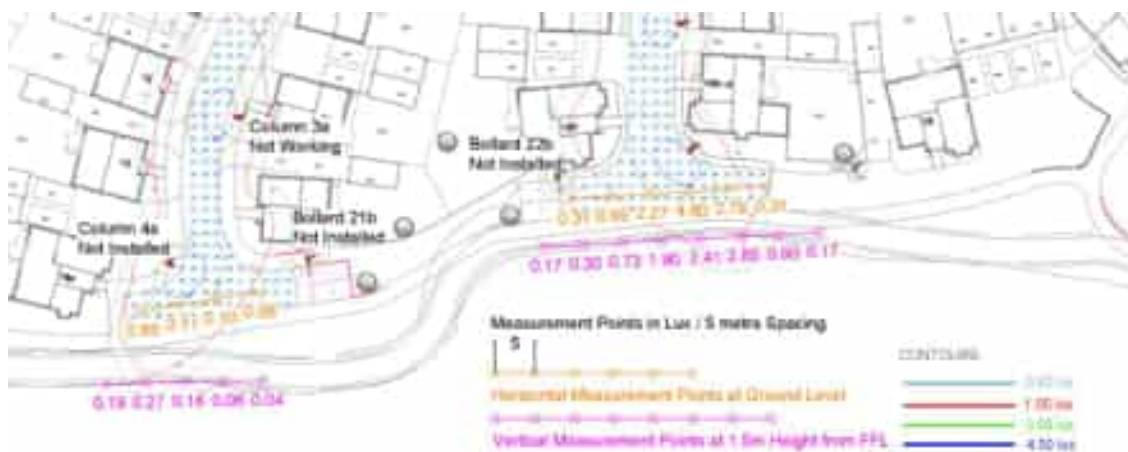
## Figure K: AoS1 Oakland Road Turning Areas East & West – Lux Survey Results

The results from the eastern turning area, where the lighting was installed and functional, show the horizontal illuminance is broadly in line with the modelling by Proelectric considering the Maintenance Factor was applied to the modelling, and differences in the exact spacing of measurement locations. The ISOlux contours do broadly represent the as built light distribution where the equipment is functional.

The vertical measurements do show increased levels of illumination above the required 1 lux limit imposed to protect the quality of habitats such as the mature tree line at the boundary.

The vertical illuminance levels recorded as part of the survey peak at 2.85 lux at 1.5 metres above ground level. It should be noted that this elevated light level is constrained to a very small area of the hedgerow (approximately 10 metres in length) and at relatively low height (below 2.5 metres in height).

Should mitigation be deemed necessary, this may be applied to reduce the light spill to this specific area bring it down to below the 1 lux threshold on the vertical plane representing the tree line.

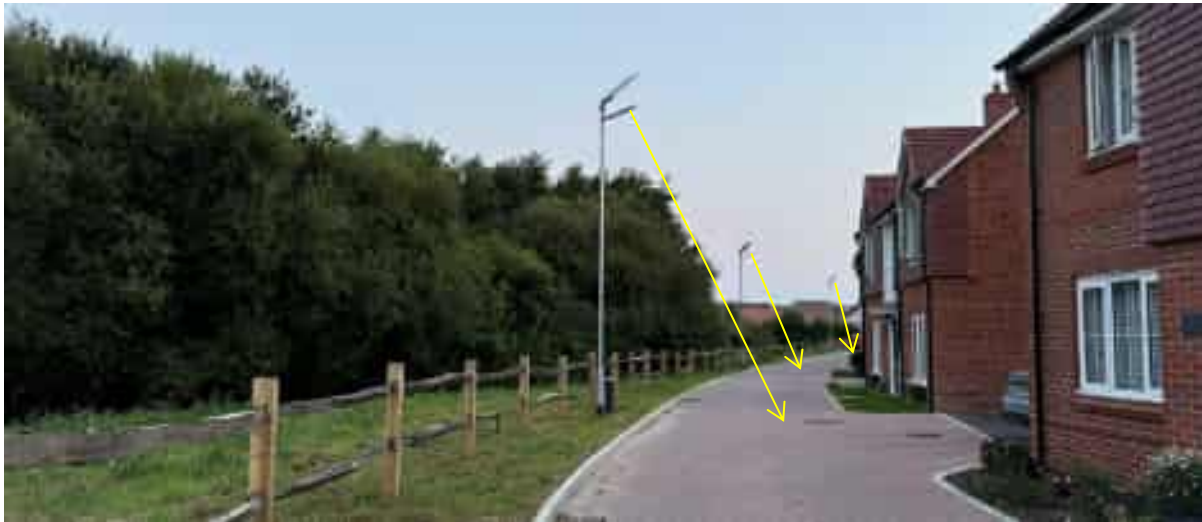
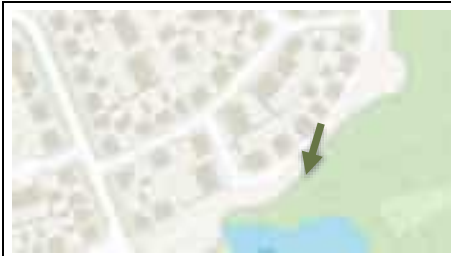
**Figure N: AoS2 Merion Road - Day**

View looking southwest towards the tree line south of the development area shown to the left of the image. The street light columns to the access road to frontages is shown to the right of the image. The streetlight is angled upwards at 22° and is oriented away from the tree line at the boundary (marked).

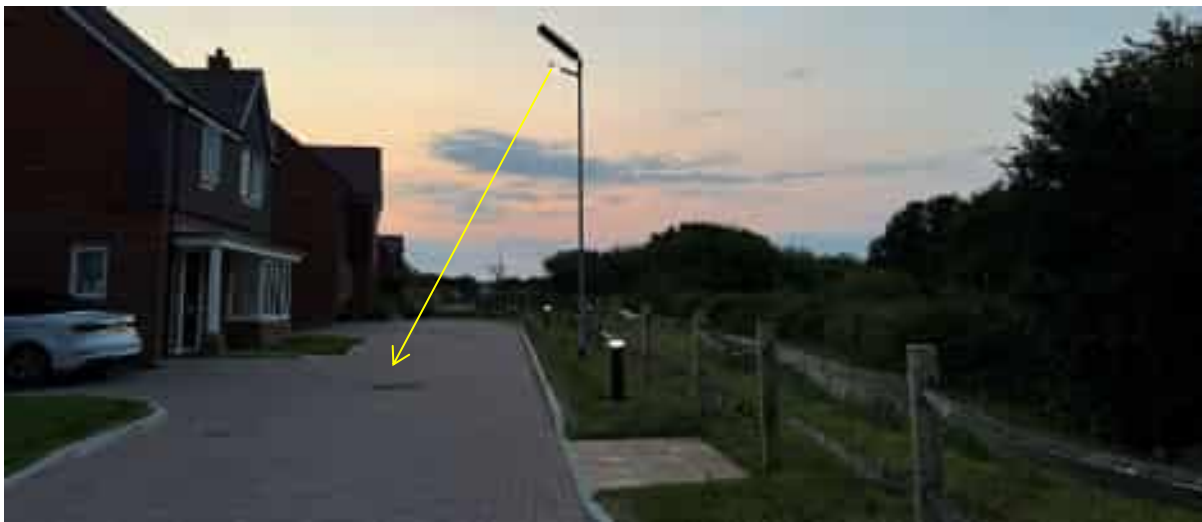
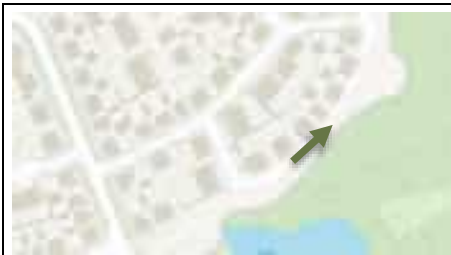
**Figure O: AoS2 Merion Road - Dusk**

View looking northeast towards the development shown to the left of the image and the tree line to the south of the development shown to the right of the image. The streetlight columns orientated towards the development and away from the tree line. Additional bollard lighting is observed to be installed and operational but not shown on the lighting plans.

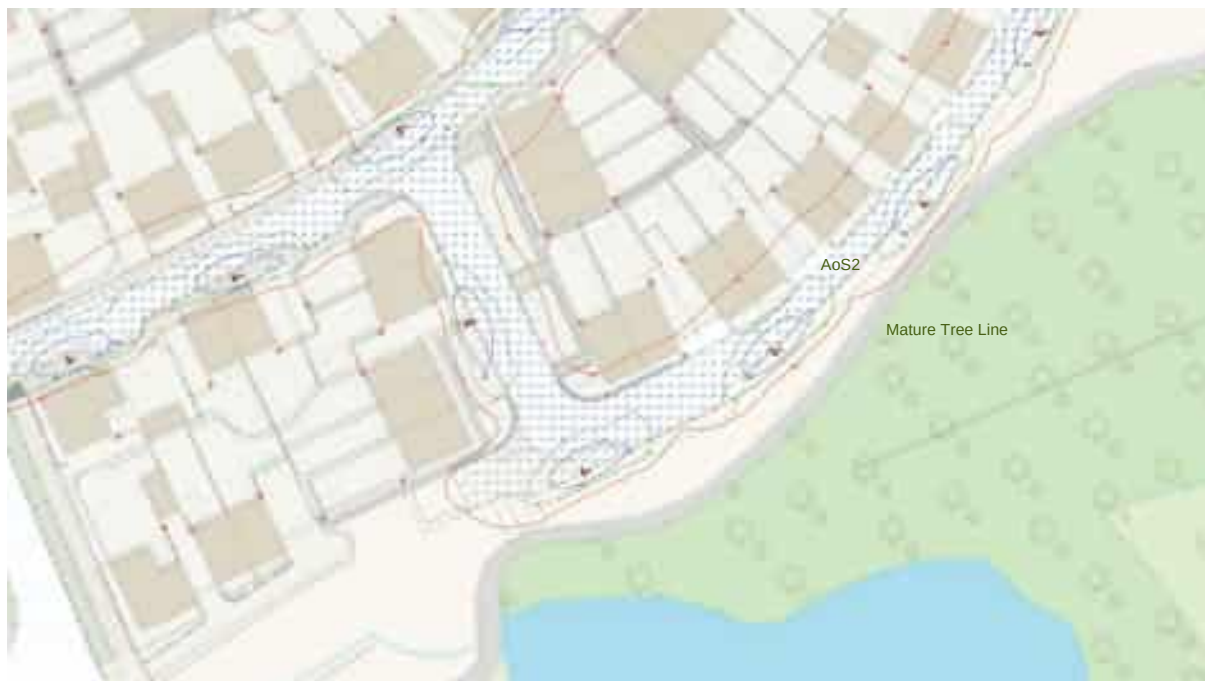
**Figure Q: AoS2 – B4 - Potential Light Spill to Mature Tree Line**

Extract from the Proelectric street lighting design documentation with ISOLux contours. AoS to the southeast of Parcel B4. Isolines show light spill to the land beyond the development to the south and east towards the mature tree lines (approximate area highlighted in **Green**).

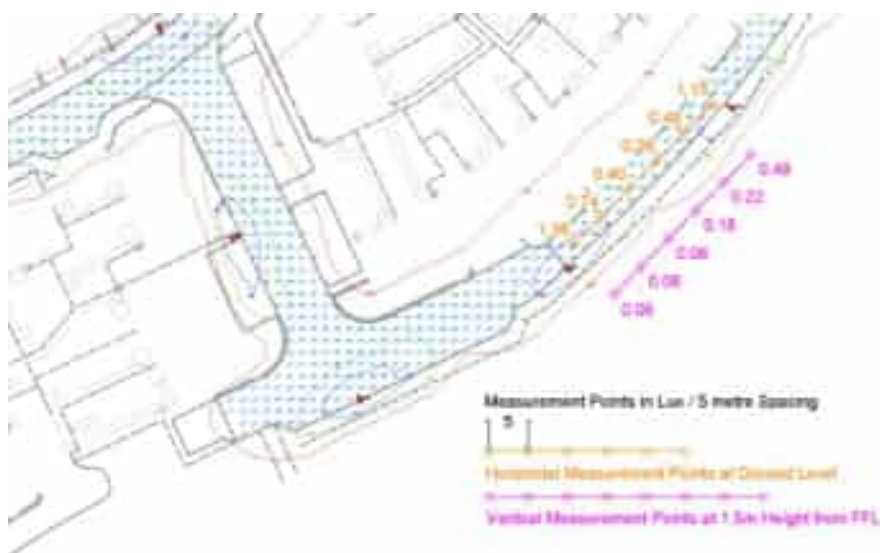
**Figure R: AoS2 Merion Road – Lux Survey Results**

The light levels recorded in the horizontal survey are consistent with the 'inactive' state although these measurements were recorded with human presence in the area. This may indicate the presence detection is deactivated or not working for these fixtures, and this affects the recorded results by showing a significantly lower level of illumination than that shown in the ISOLux contours provided by Prolectric.

Further evidence to demonstrate the extent of illumination under 'active' illumination is provided in **Appendix A** based on photometric modelling of the as built scheme. This is intended to provide reassurance that should the scheme be commissioned as per the original design, the level of light spill to the tree line is still below the stated illuminance limit.

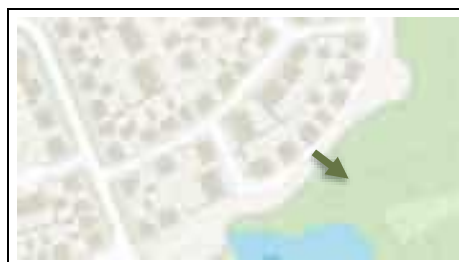
### Figure S: AoS2 Merion Road Tree Line – Lux Measurement Locations

The vertical illuminance levels recorded as part of the survey peak at 0.48 lux at 1.5 metres above ground level under the 'inactive' state. It should be noted that this tree line is topographically lower than the roadway due to a steep bank between. The 1.5 metres is above grade at the tree line, not above the roadway surface.

Measurement locations are superimposed in approximate locations (5 metre spacing at 1.5 metres above FFL). Values in Lux / Illuminance Limit = Max <1lux.

View looking southeast towards the tree line from the access road to frontages. The extent of the light spill to the tree line is minimal or at baseline for 'contextual darkness'. Due to the relatively low output of the street light fixtures, their optical control and orientation towards the core of the development, very little back light spill is observed.
