# St Martin's Close

Bishopstoke, SO50 6BH

Design & Access Statement | Rev B

February 2024

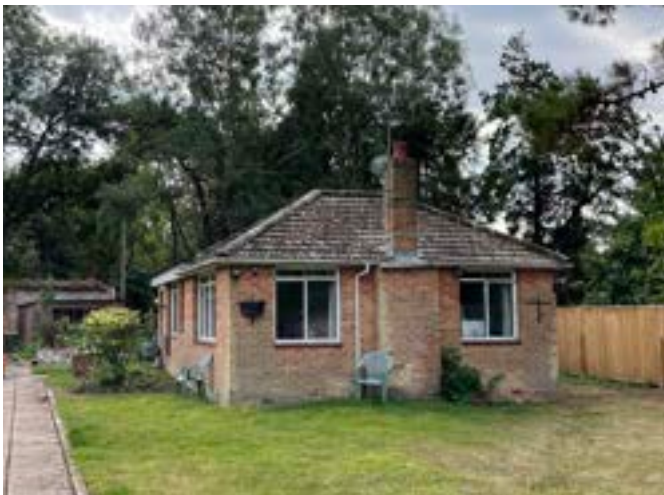
Existing bungalow in disrepair

The proposals are to demolish an existing bungalow on site, and replace this with two family homes.

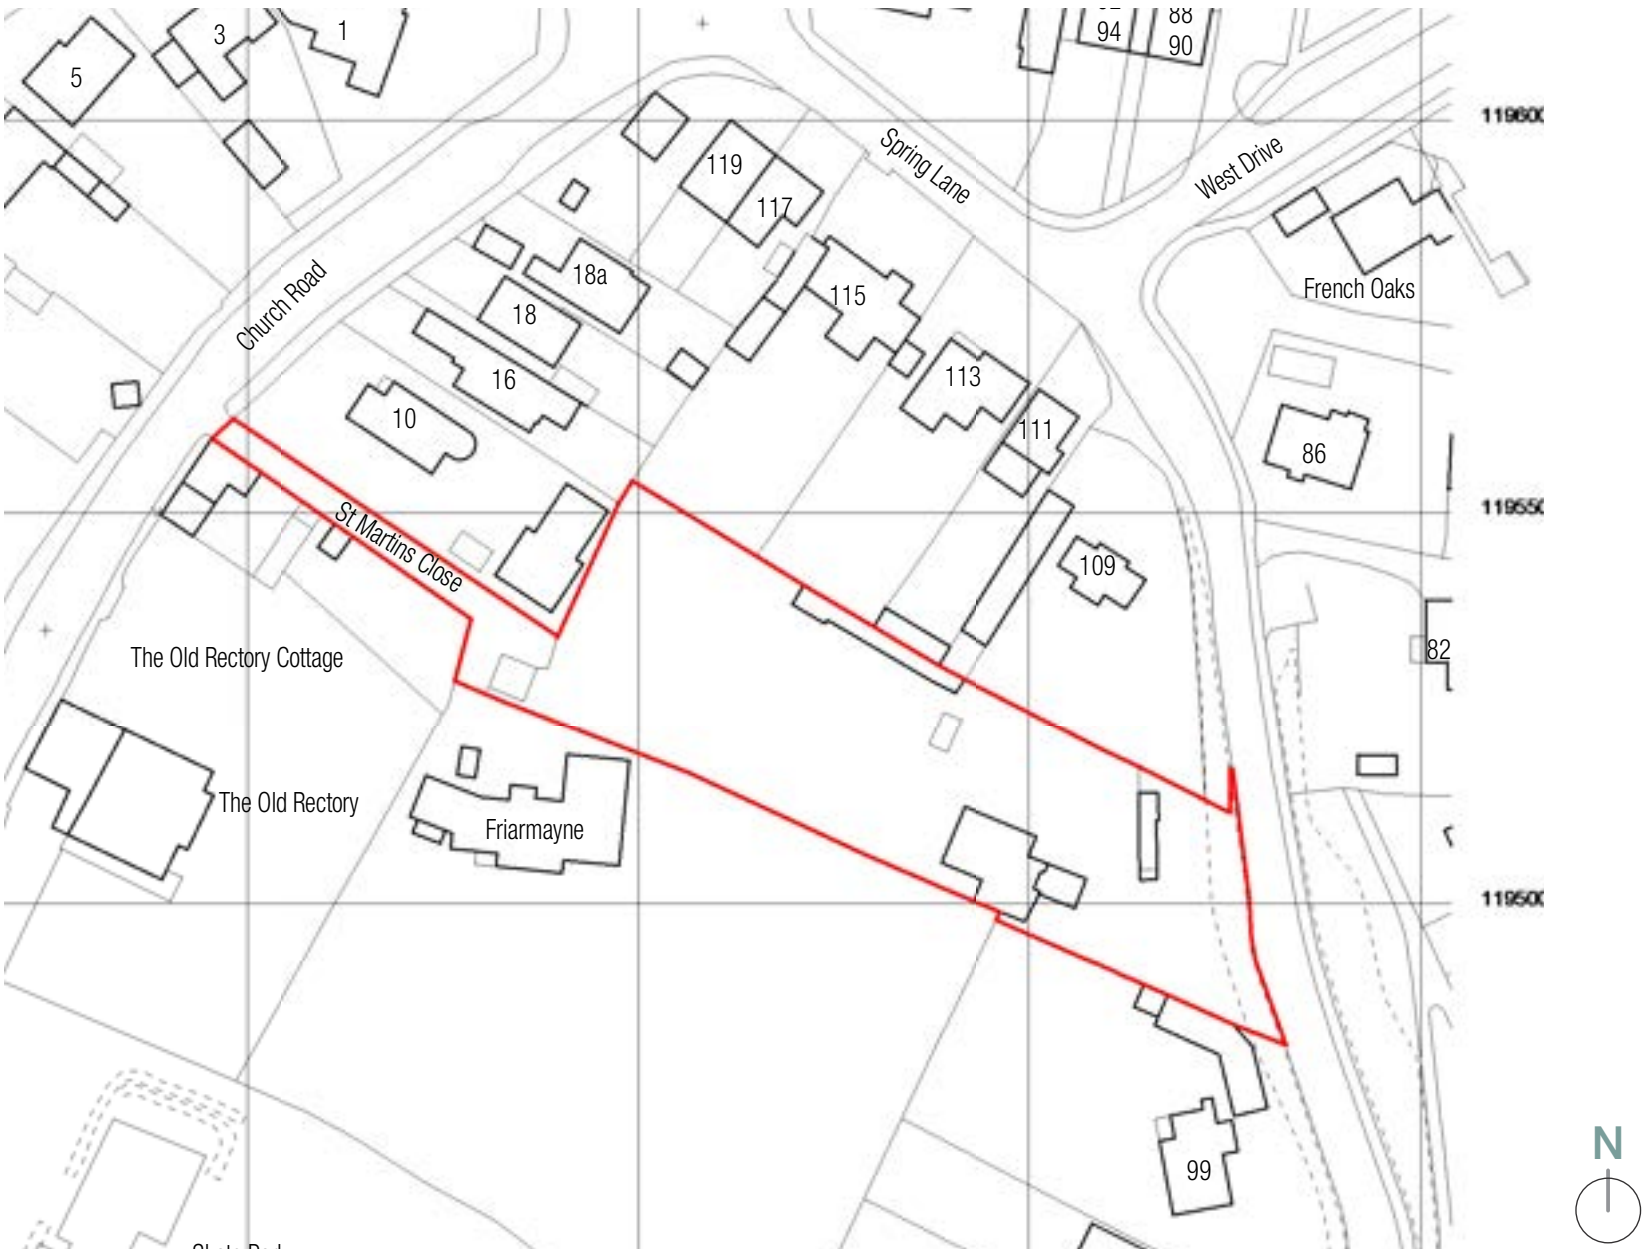
Site Location Plan

Site Area:

- 2,761 m²
- 0.2761 Hectares
- 0.68 Acres

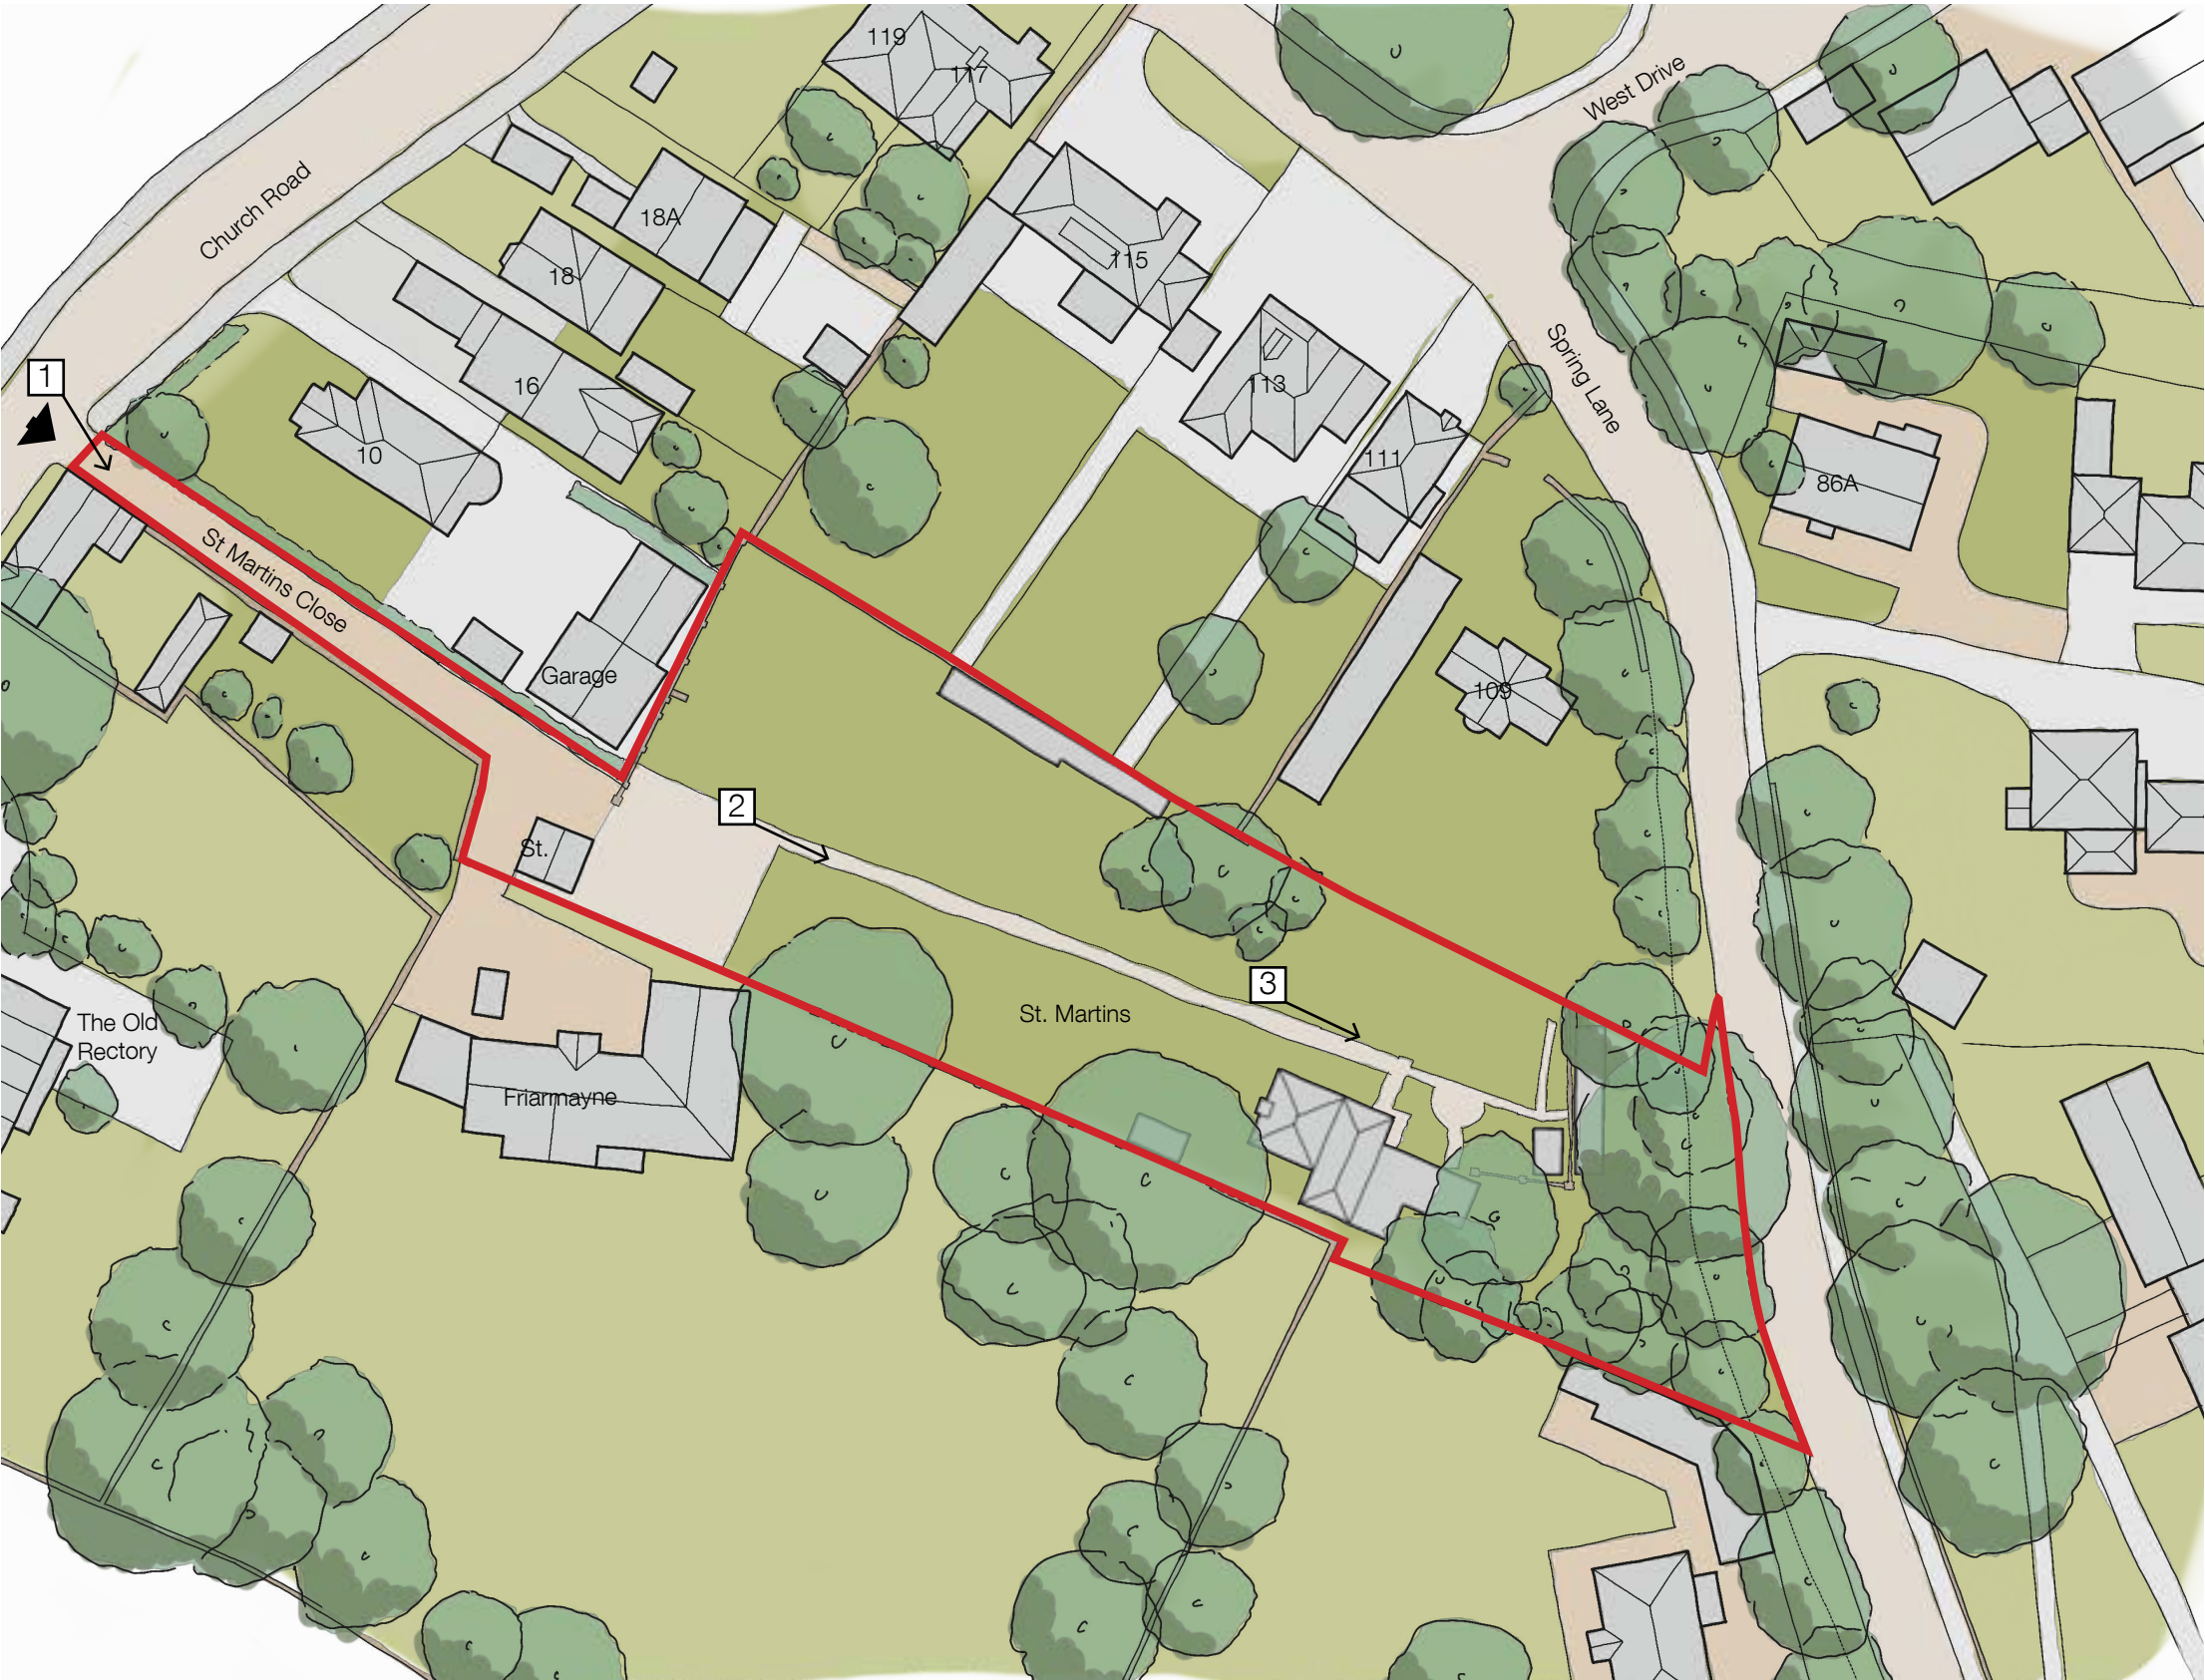
The site currently contains a single storey dwelling to the south east of the property, with a small garage store to the north west adjacent to the access road.

The site is enclosed with historic brick boundary walls around all sides, in varying states of repair and replacement.

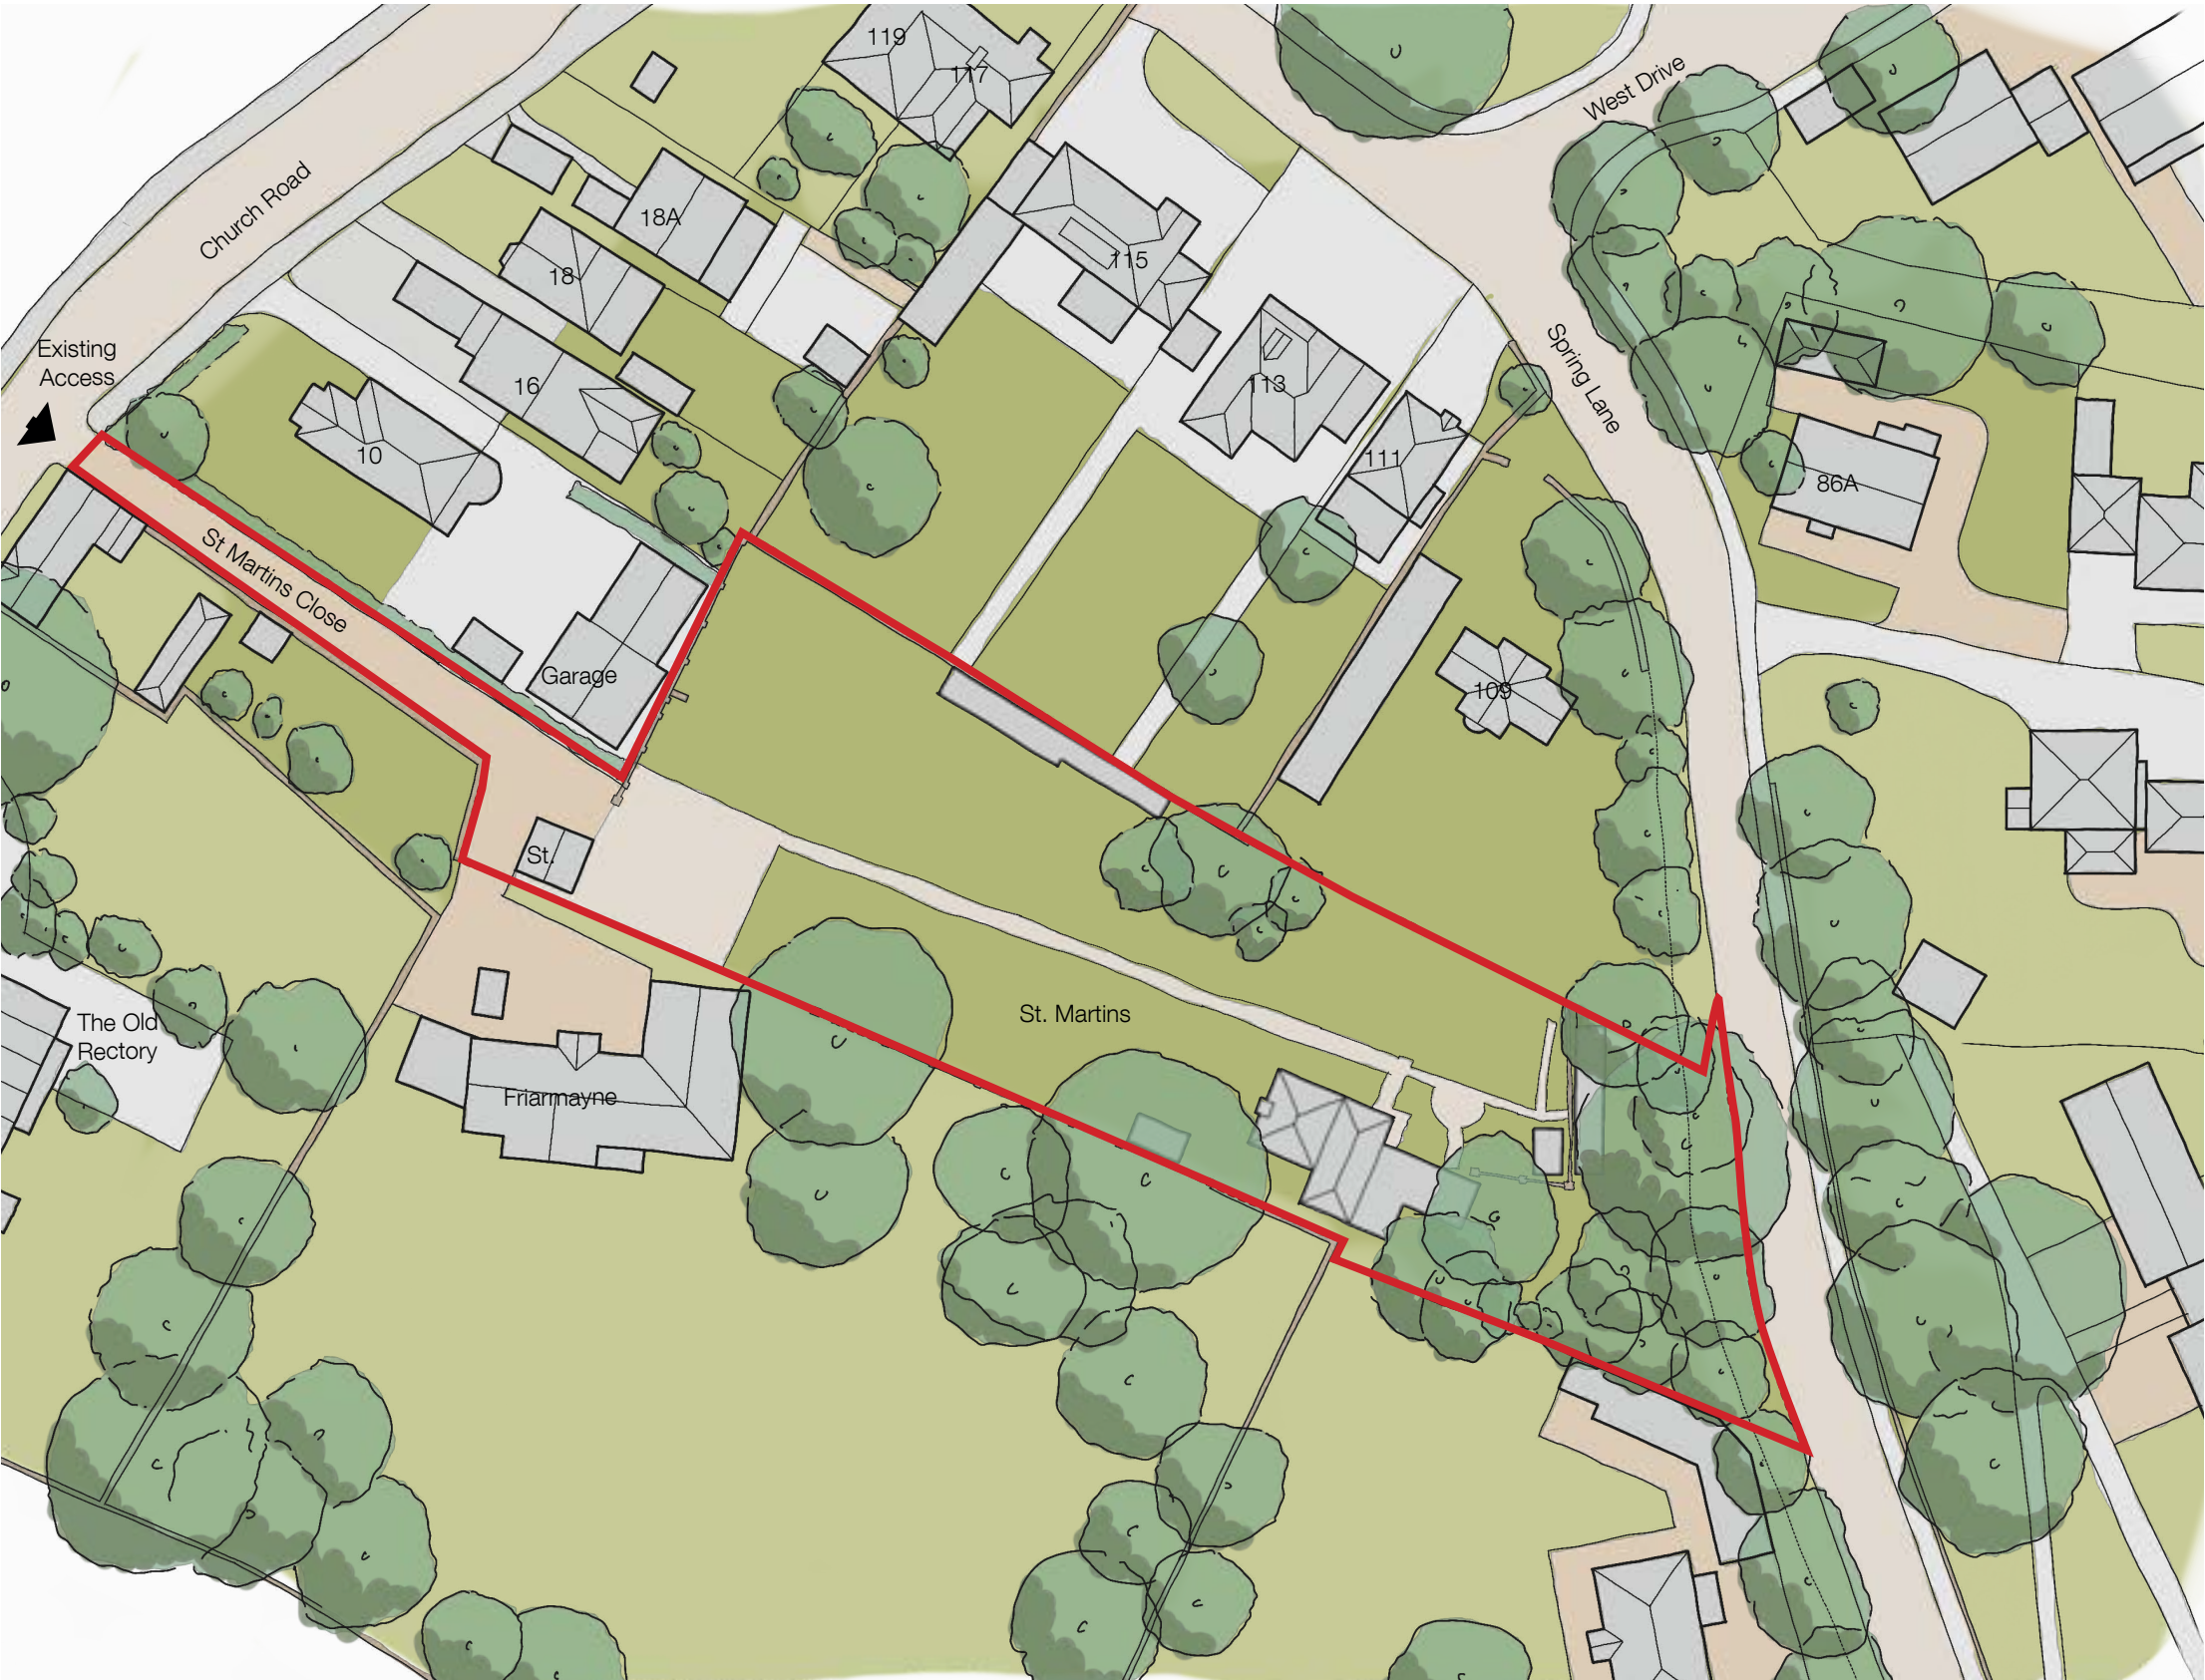
## 4.4 Existing Site Plan

The site lies between Church Road and Spring Lane, with access via a small single drive road off of Church Road. Other properties, including the listed Old Rectory to the south, neighbour the property.

The site covers an area of approximately 0.28 hectares, and includes several structures, both historic and more recently constructed. Brick boundary walls dating back to the 19th century line the sites borders, with a derelict greenhouse sited next to the northern wall. A single storey dwelling is located in the south-east corner of the site, with an associated garage to the west.

The site is accessed via a small single carriageway running west to east from Church Road to the site. The eastern edge of the site is located close to Spring Lane.

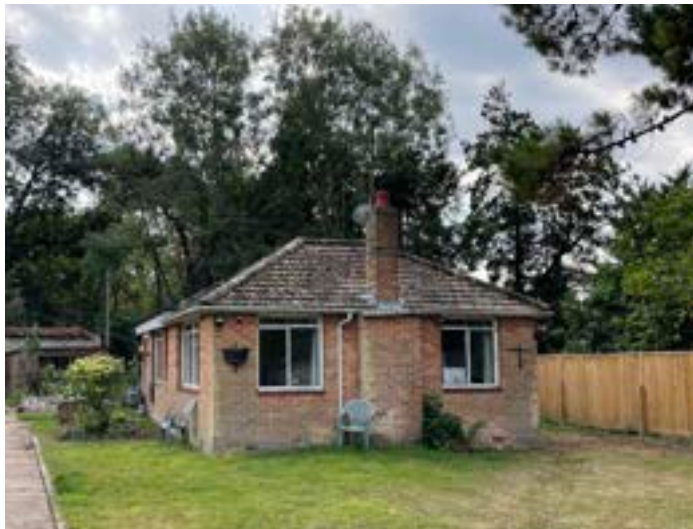
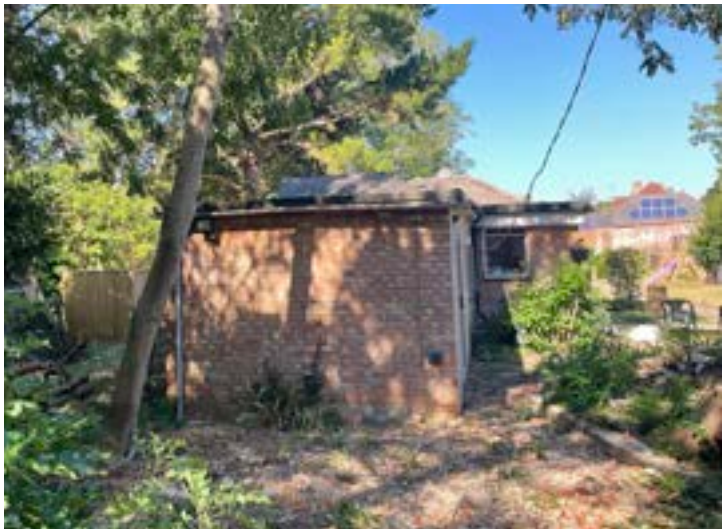
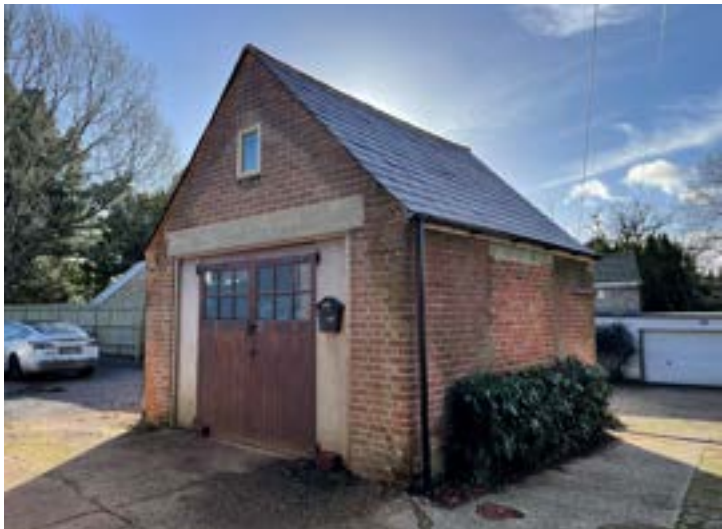
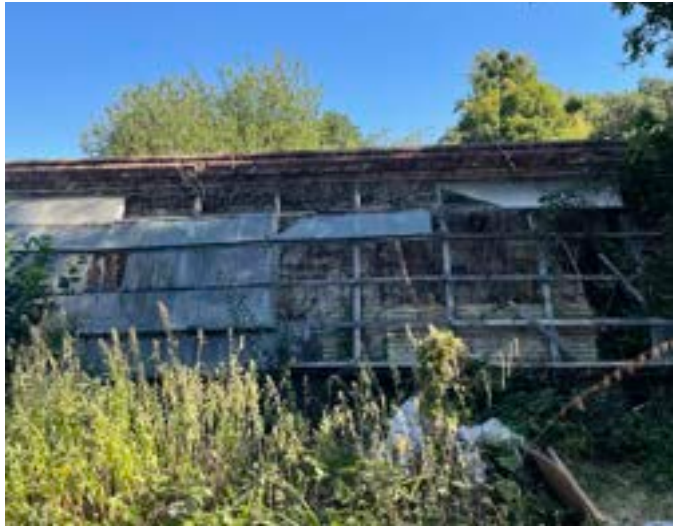
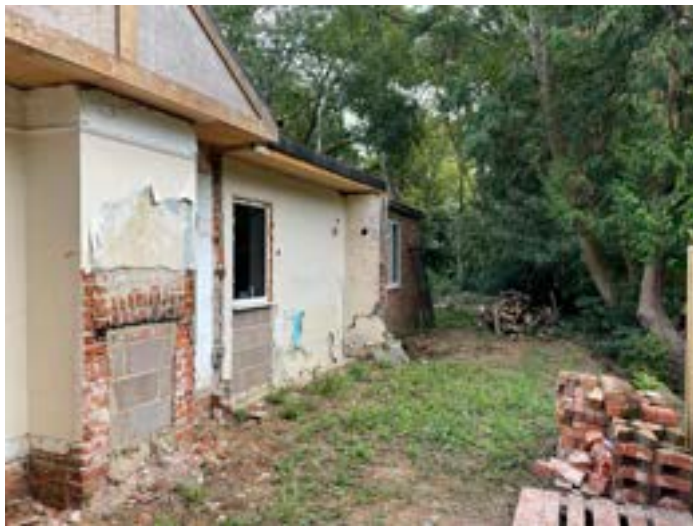
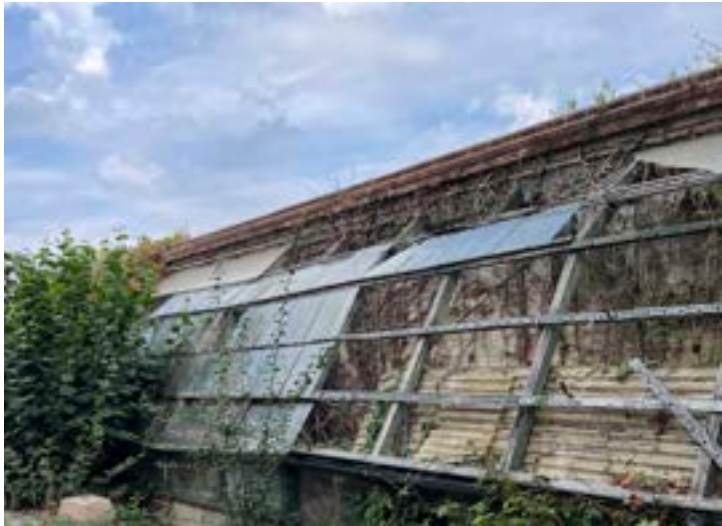
The site currently contains a single storey dwelling to the south east, with a garage to the north west adjacent to the access road.

There is a collection of sheds and caravans which contribute towards the overall feeling of clutter throughout the plot.

Along the northern boundary wall sits a derelict greenhouse. This structure is not listed but is of notable heritage value. The structure is in disrepair, with many of the glass panels missing or broken, and the structure in poor condition.

*The heritage of the site has diminished over time due to the deterioration of the historic greenhouse.*

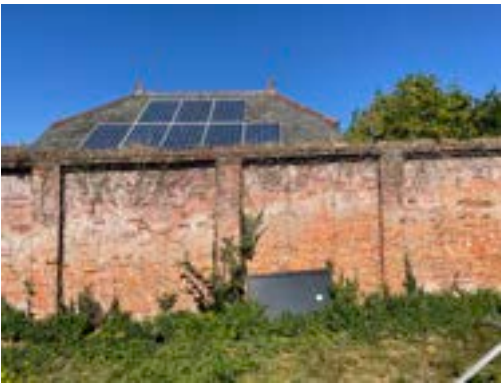
1 - The segment of wall to the north-west of the site appears in reasonable condition, forming a barrier between the site and the properties to the north. This wall lies outside of the site boundary.

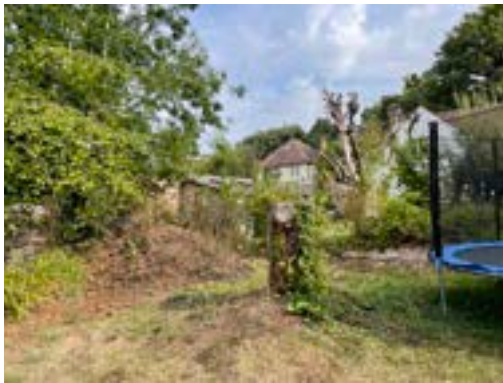
2 - The north-eastern section of the boundary wall was demolished by the neighbouring properties approximately 20 years ago due to structural collapse, and is now left open.

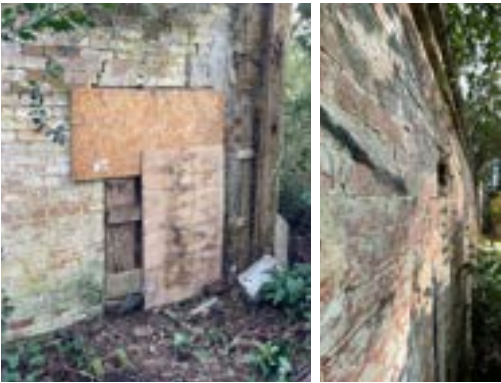
3 - The eastern boundary wall is derelict, with cracks throughout the structure and a high level of damage from climbing plants.

1 - Reclaim the historic bricks from the eastern section of derelict wall and use them to re-build the section of wall to the north, within the neighbouring property boundary.

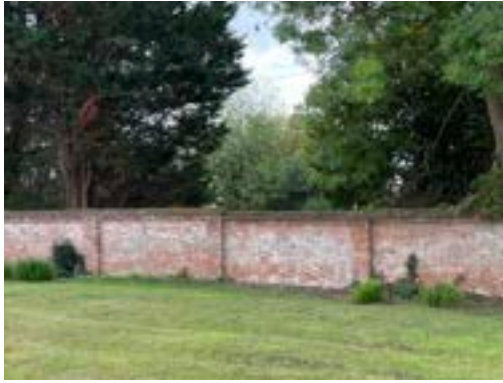
4 - The eastern half of the southern boundary wall was demolished and then rebuilt to match the existing due to structural collapse. This wall falls within the site boundary.

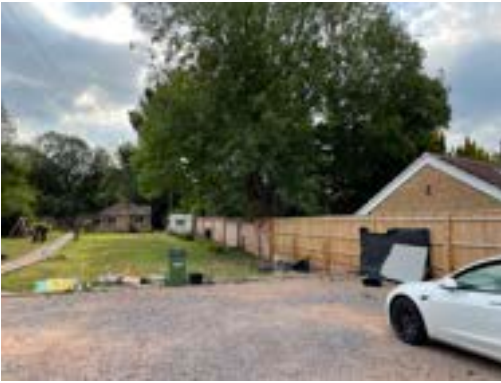
5 - The western half of the southern boundary wall collapsed and has been replaced with fencing, maintaining the boundary between the two properties.

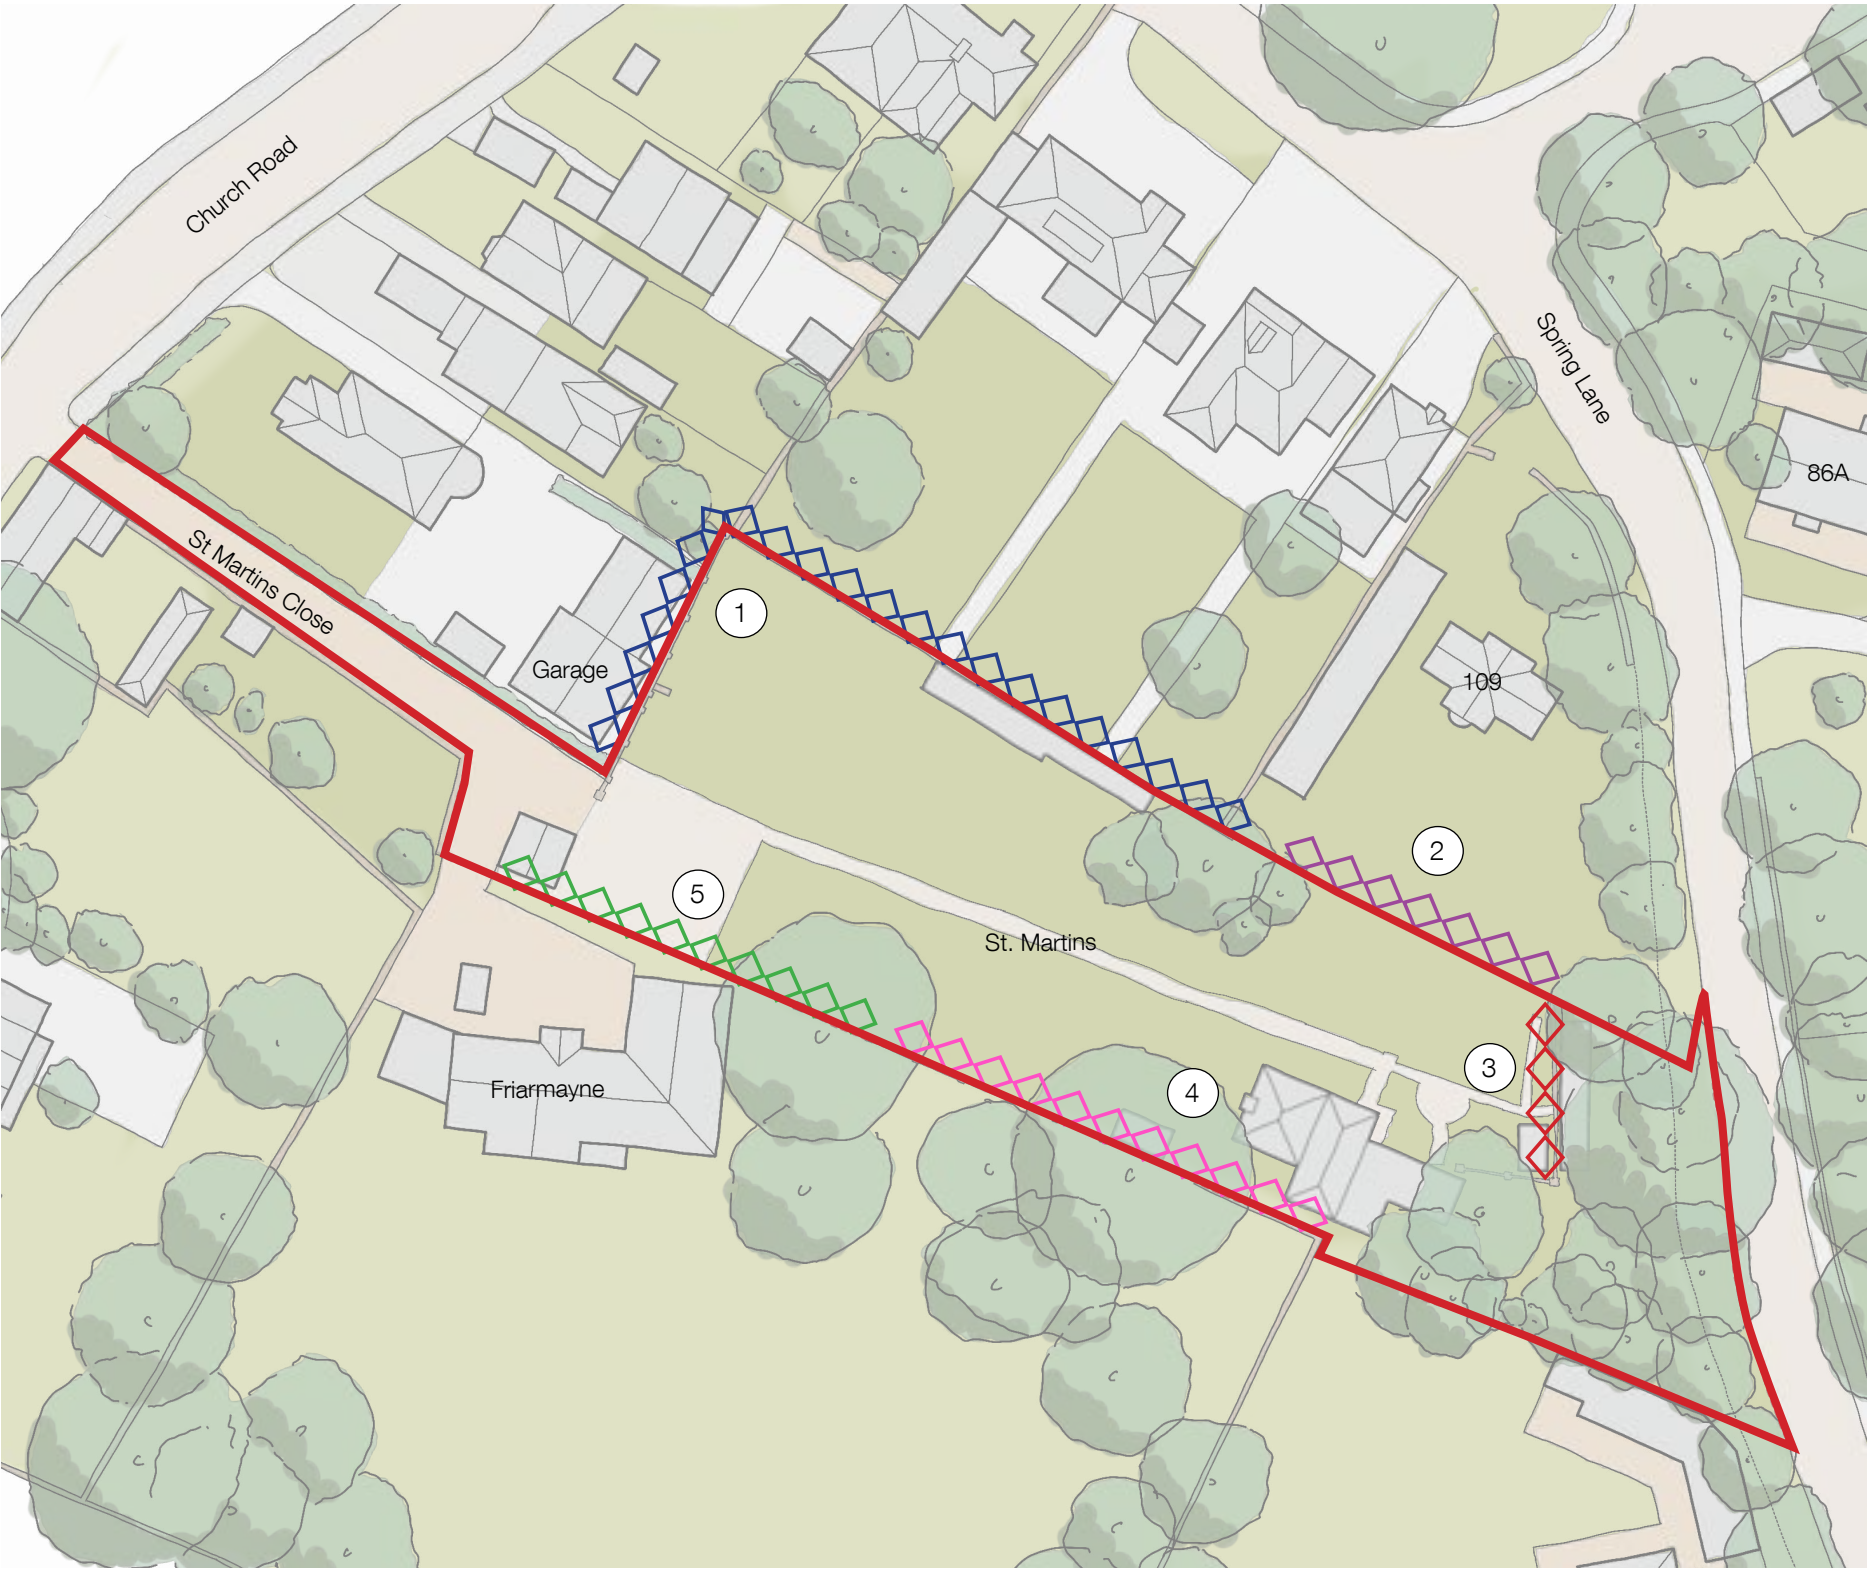
*The heritage of the site has diminished over time due to the deterioration of the historic brick boundary walls*

| Maintained Boundary Walls | | Rebuilt Boundary Walls | |
| Derelict Boundary Walls | | Replaced Boundary Walls | |
| | | Demolished Boundary Walls | |

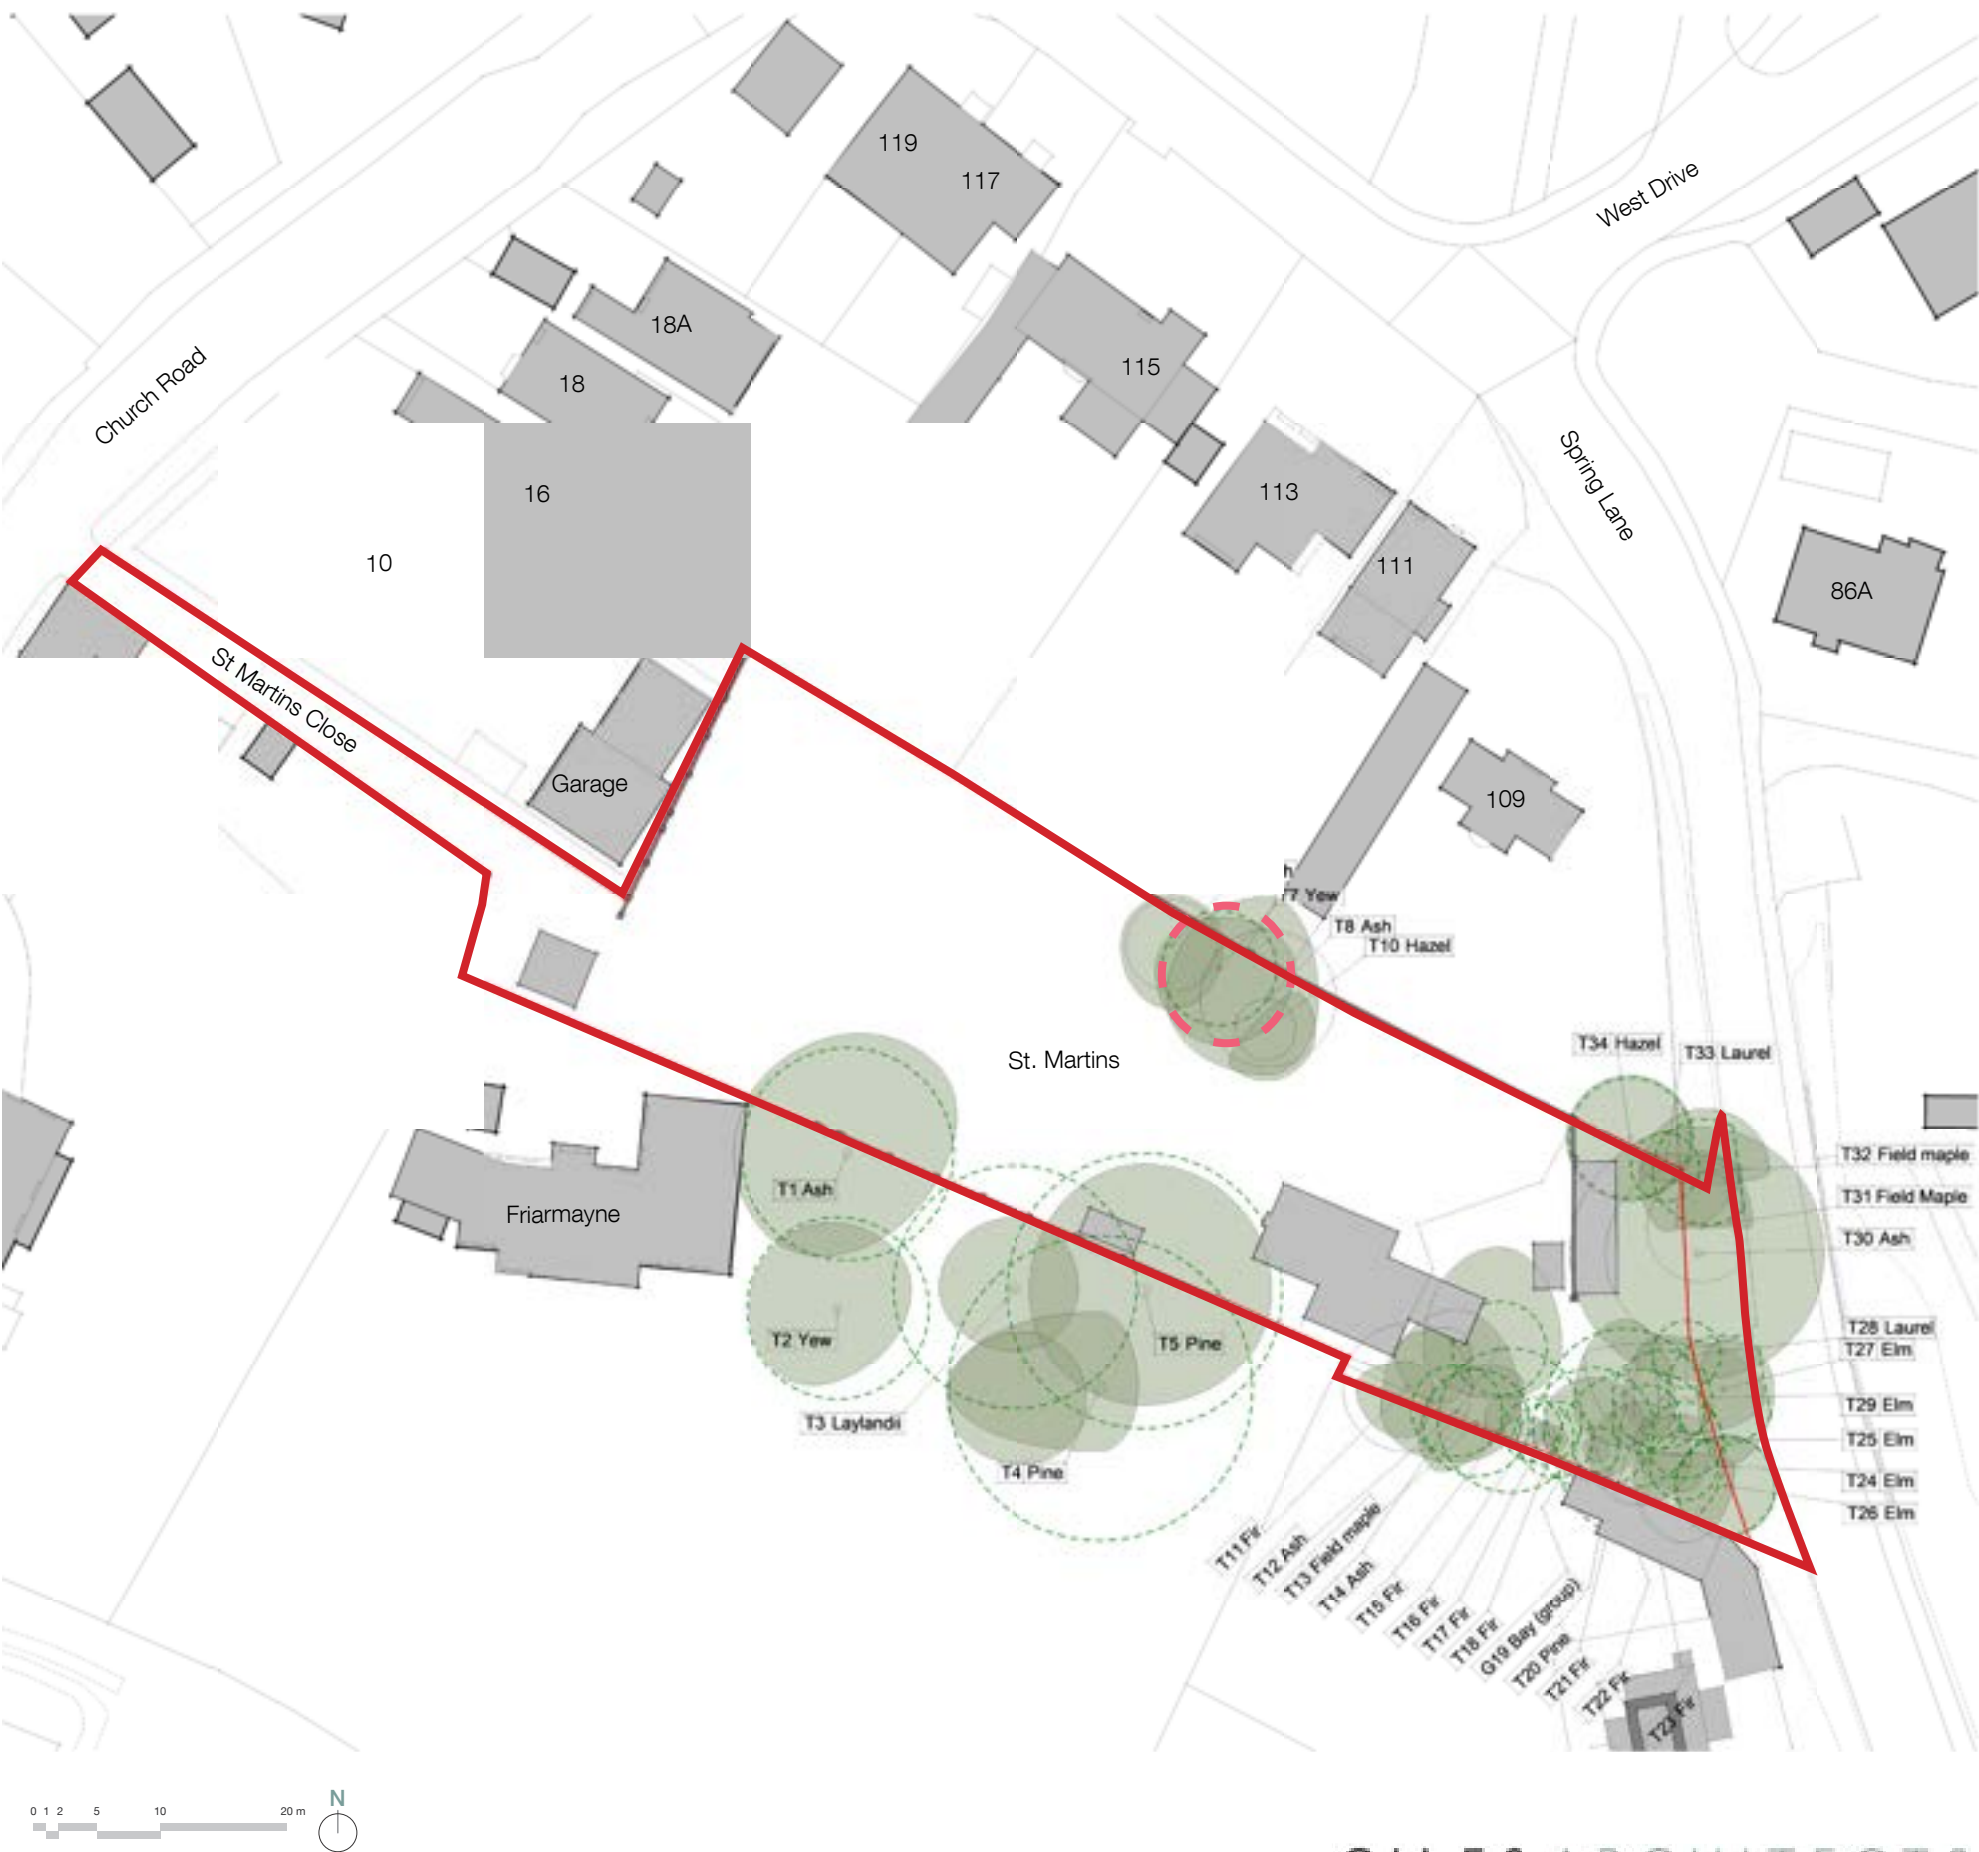
A detailed tree survey has been undertaken by Bishops Waltham Tree Care in order to ascertain the properties of the trees on site.

The majority of the trees on the site are found to the east, alongside the border with Spring Lane, with a small cluster to the north and several canopies overhanging from the property to the south.

Only one Class A tree is present on site, the yew tree to the north that is subject to a Tree Preservation Order.

Root Protection Zones

Canopy

Yew Tree (TPO)
