# St Martin's Close

Bishopstoke, SO50 6BH

Design & Access Statement | Rev B

February 2024

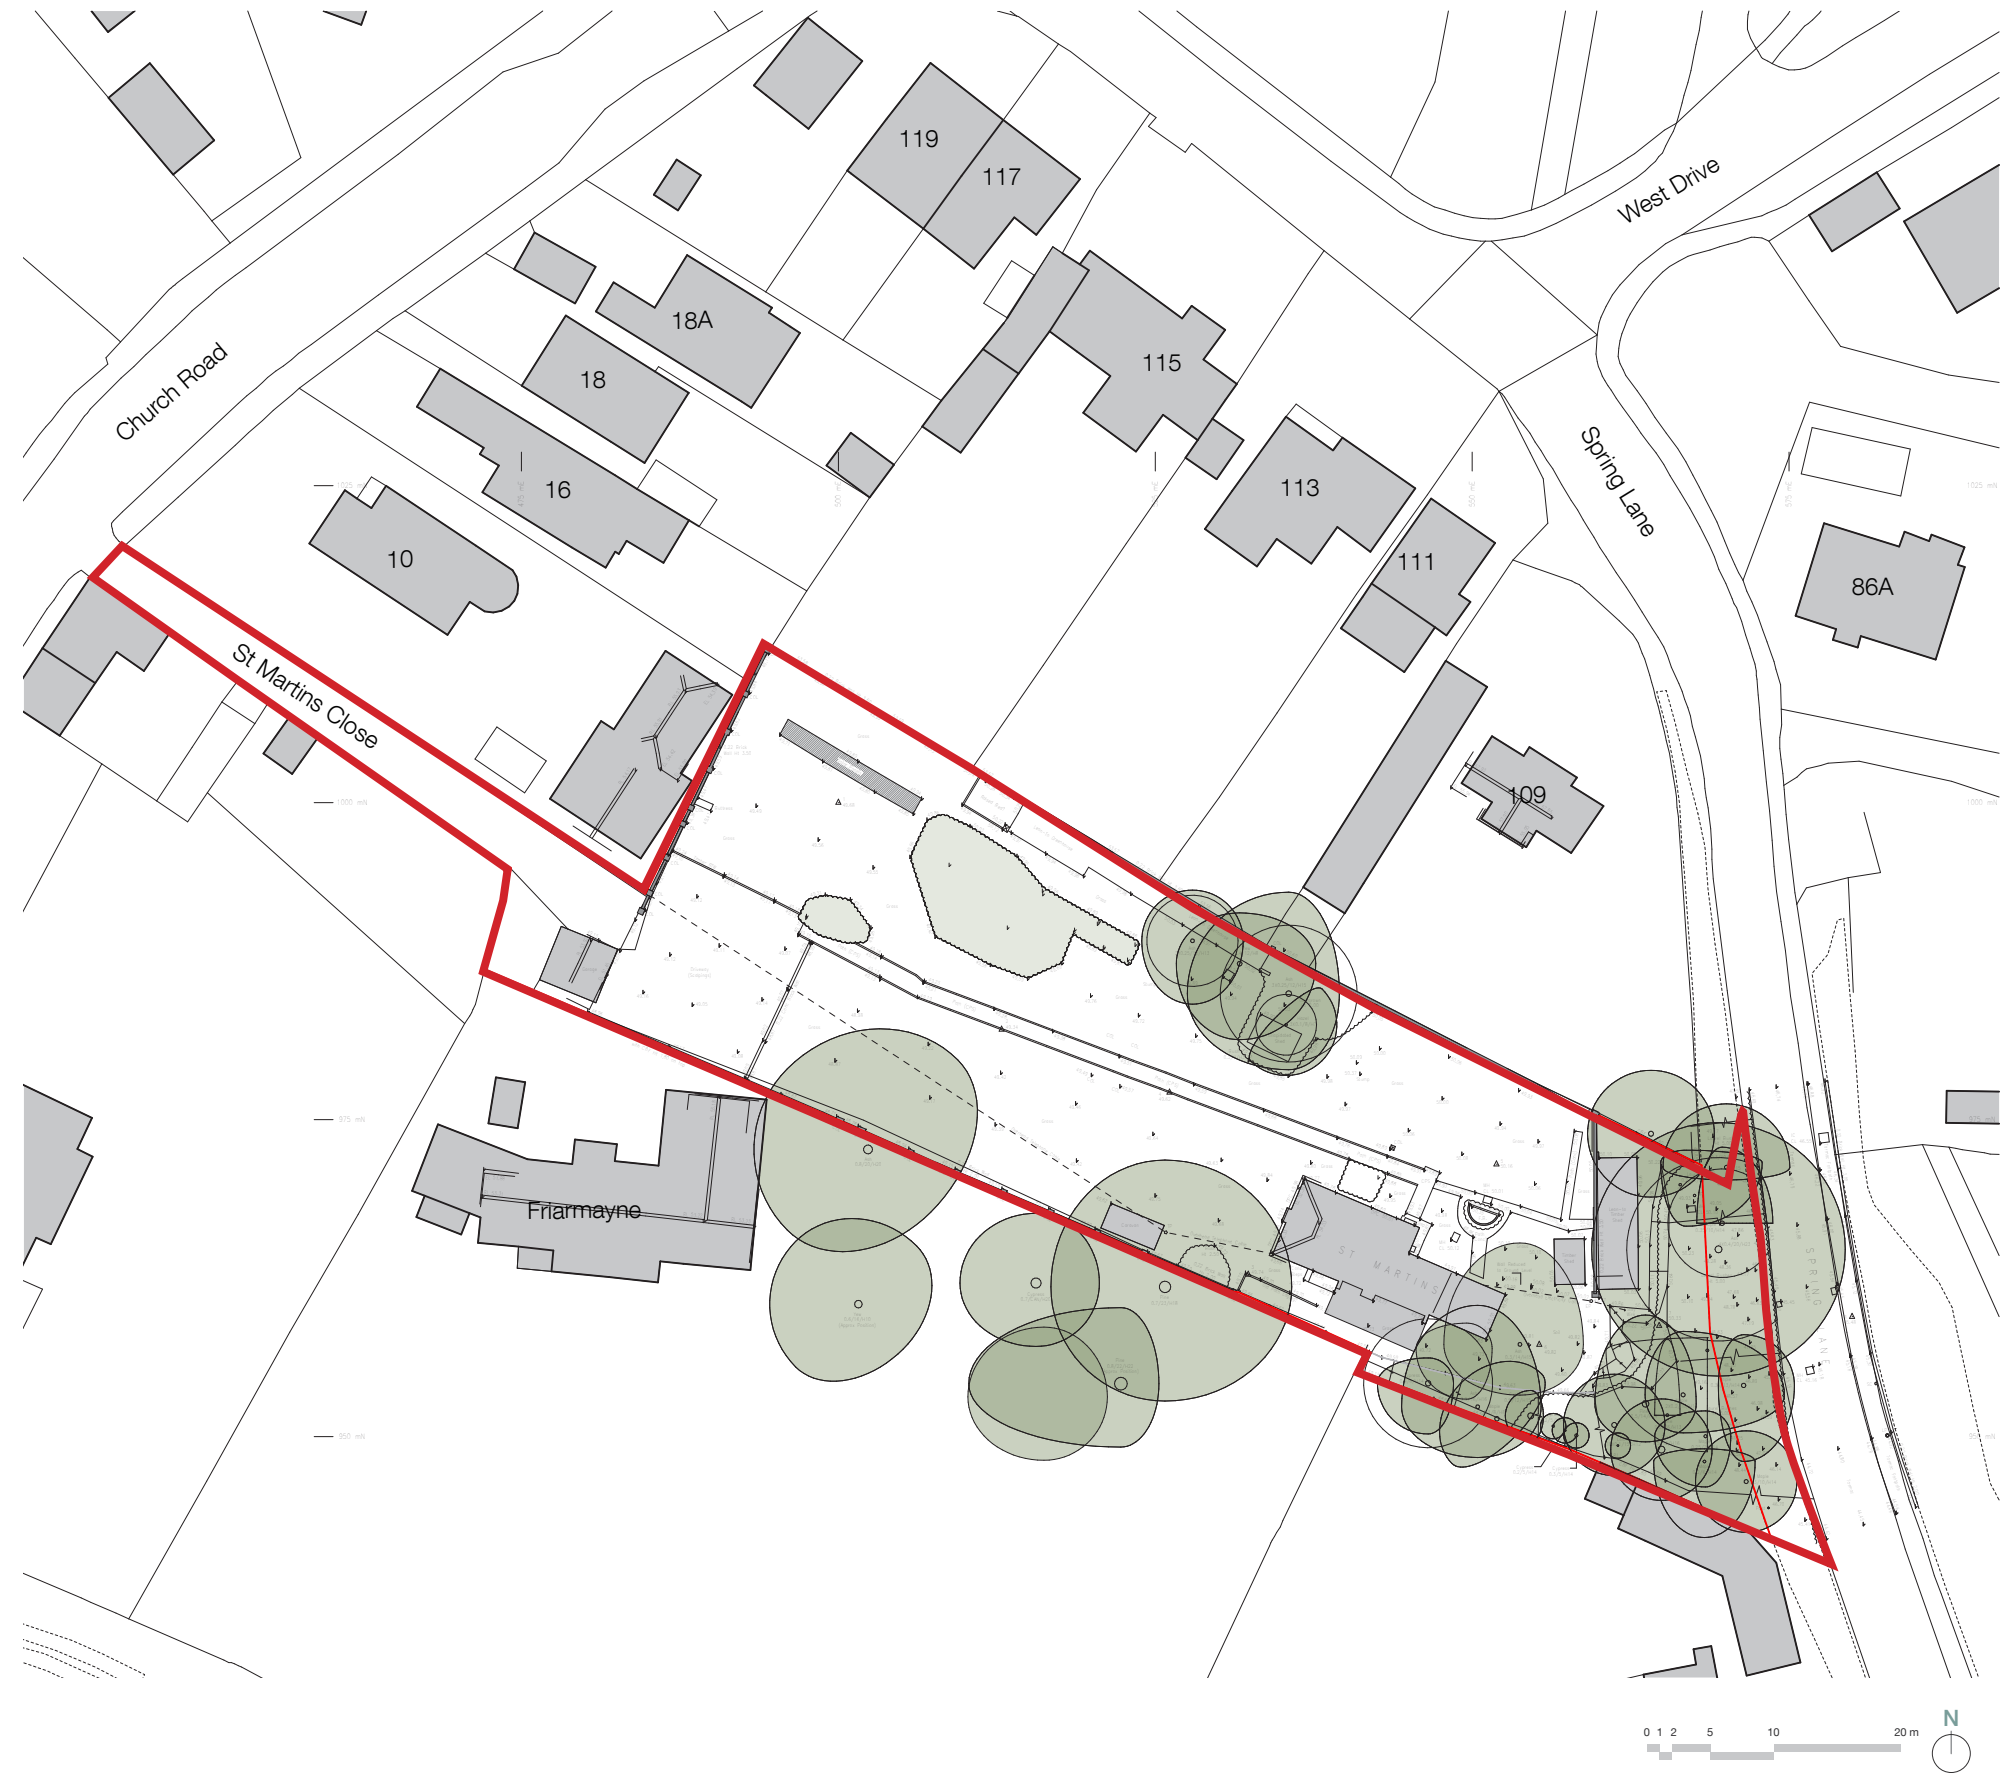
4.9 Existing Topo Survey

Diagrammatic Section AA showing the change in relief towards Spring Lane.

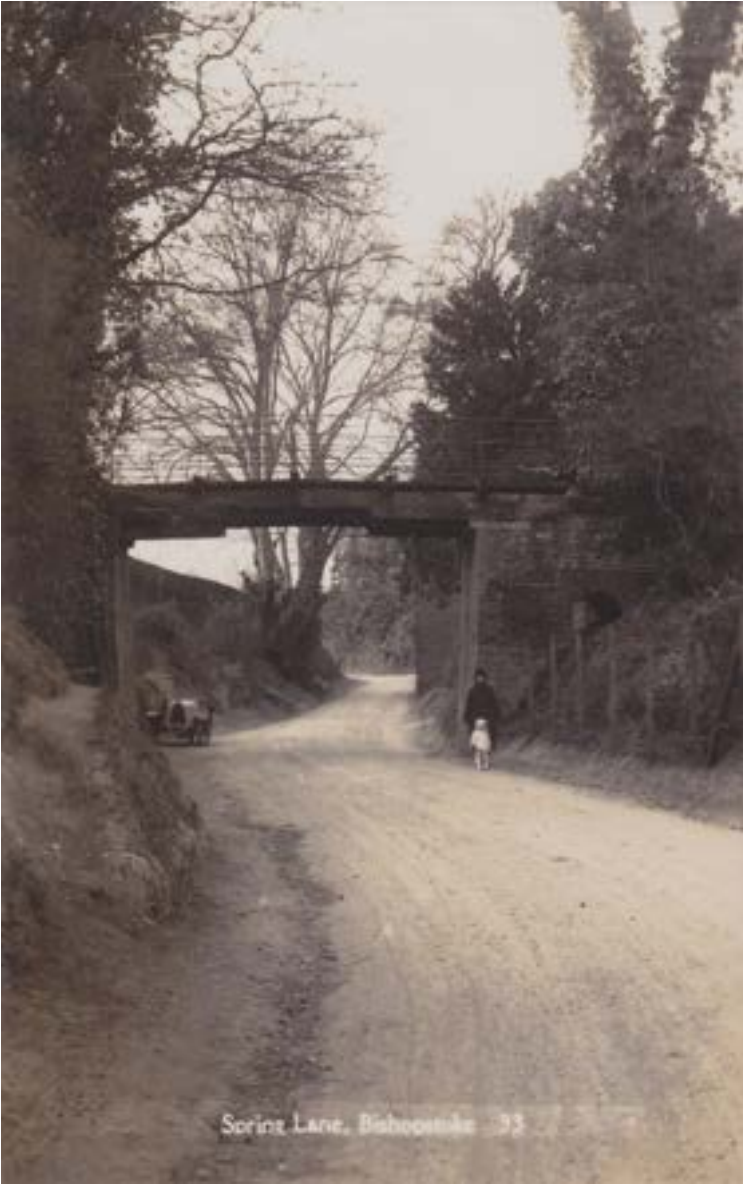
Historic photograph of the bridge over Spring Lane into the site.

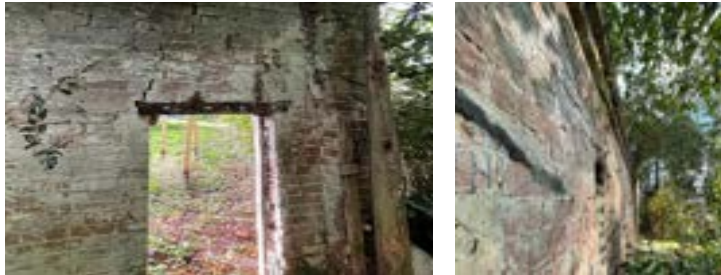
1 - Reclaim the historic bricks from the eastern section of derelict wall and use them to re-build the section of wall to the north, within the neighbouring property boundary.

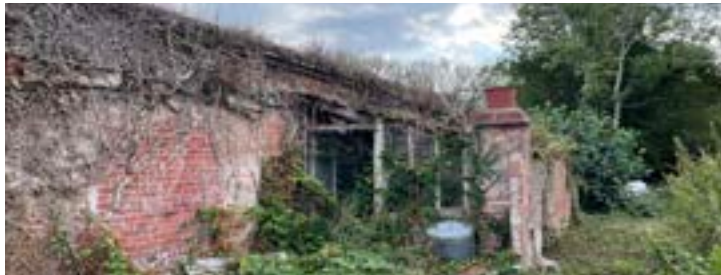
2 - Remove planting from existing walls and re-point as required. Refurbish existing greenhouse with timber and glass. to match the existing.

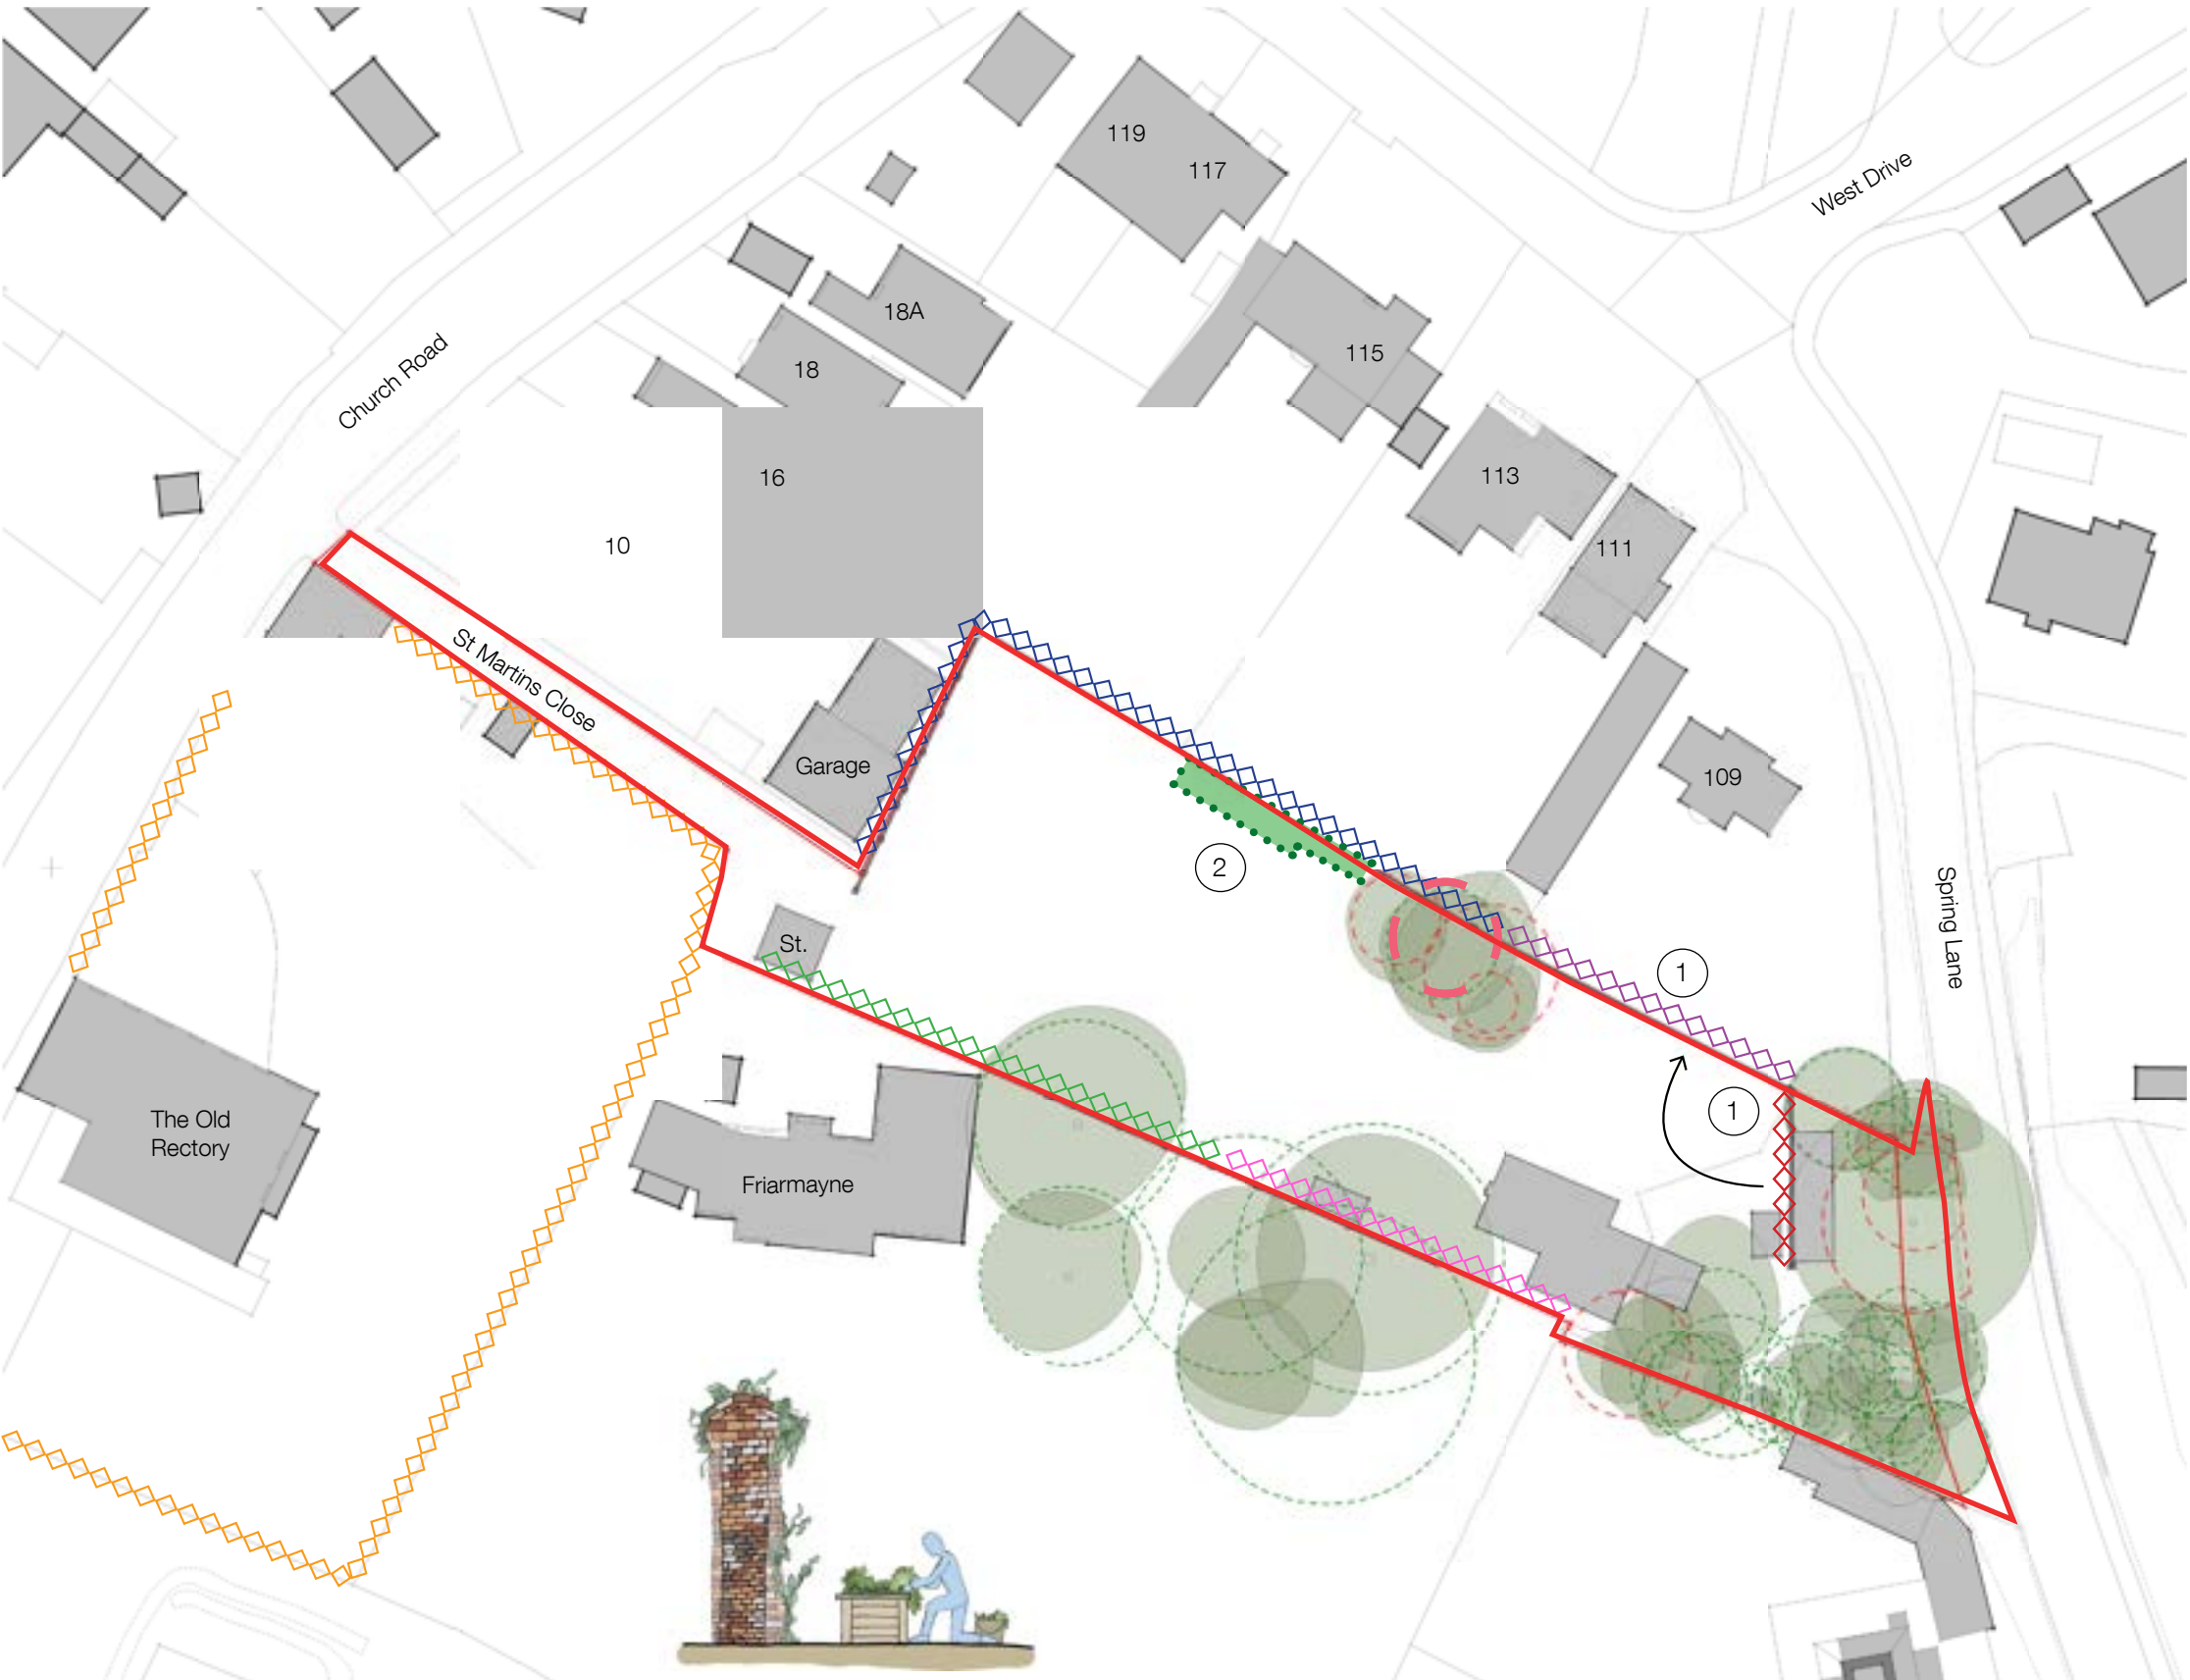
Restore Kitchen Garden Heritage

- Historic Greenhouse
- Demolished Boundary Walls
- Listed Boundary Walls
- Rebuilt Boundary Walls
- Replaced Boundary Walls
- Retained Boundary Walls
- Derelict Boundary Walls

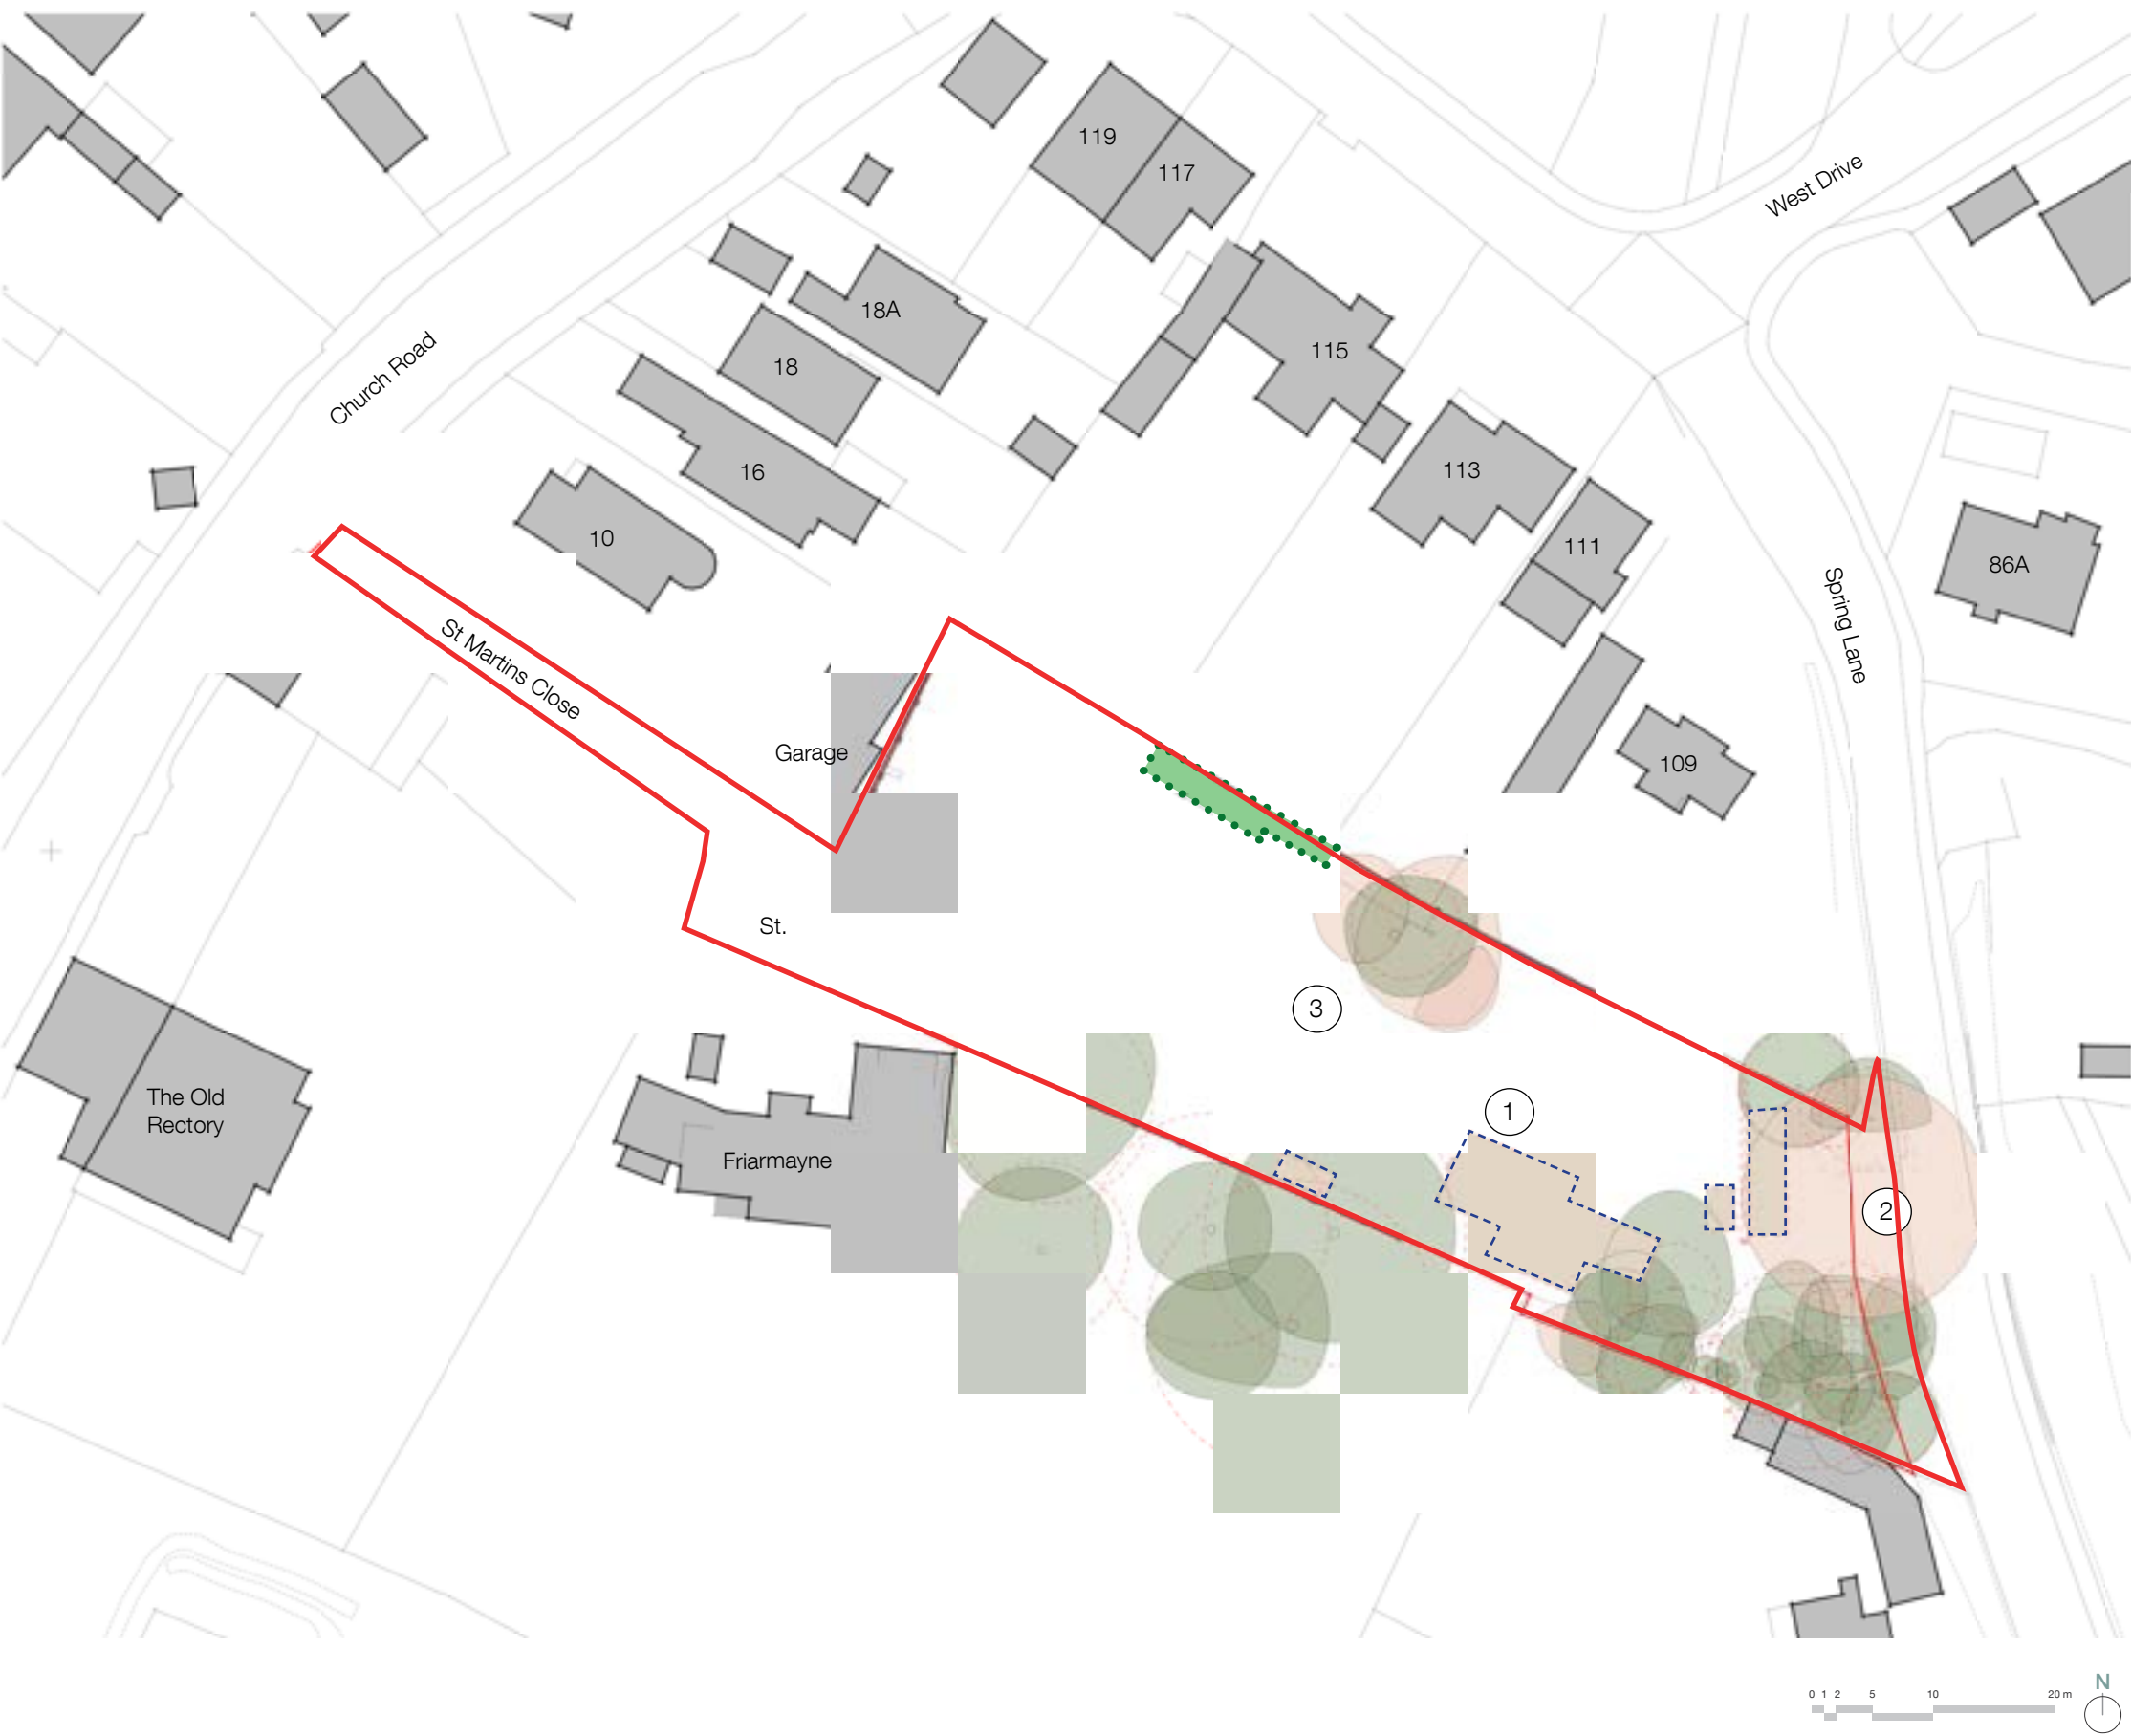
5.6 Site Demolition Plan

Demolished Structures

Derelict Greenhouse to be refurbished

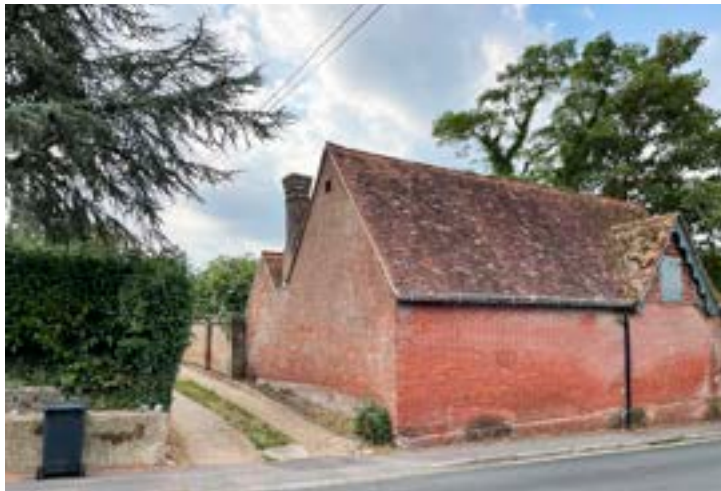
The existing site access that will serve Plot 1.

The proposal is for plot one to be accessed via the existing shared drive along Church Road. Plot two will be accessed via a new private drive along Spring Lane.

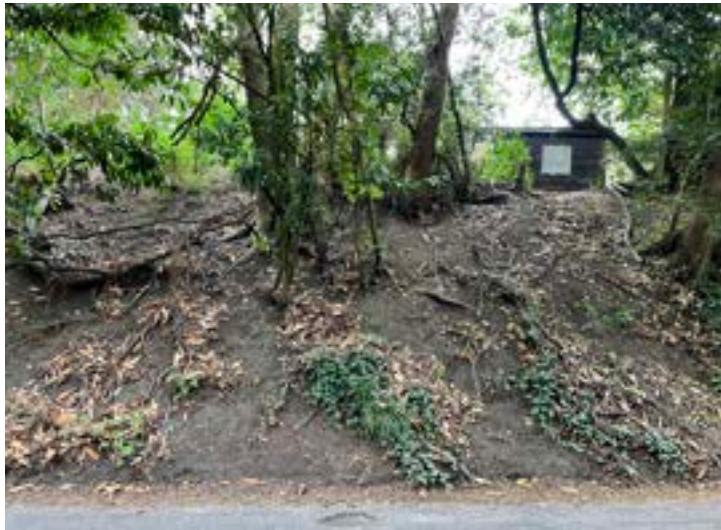
Location of proposed new access drive for Plot 2

The new drive will be cut into the bank, where there is a four meter level change in which a 1:6 private drive will be created towards the north-east of the plot. Visibility splays can be achieved in the proposed access drive location.

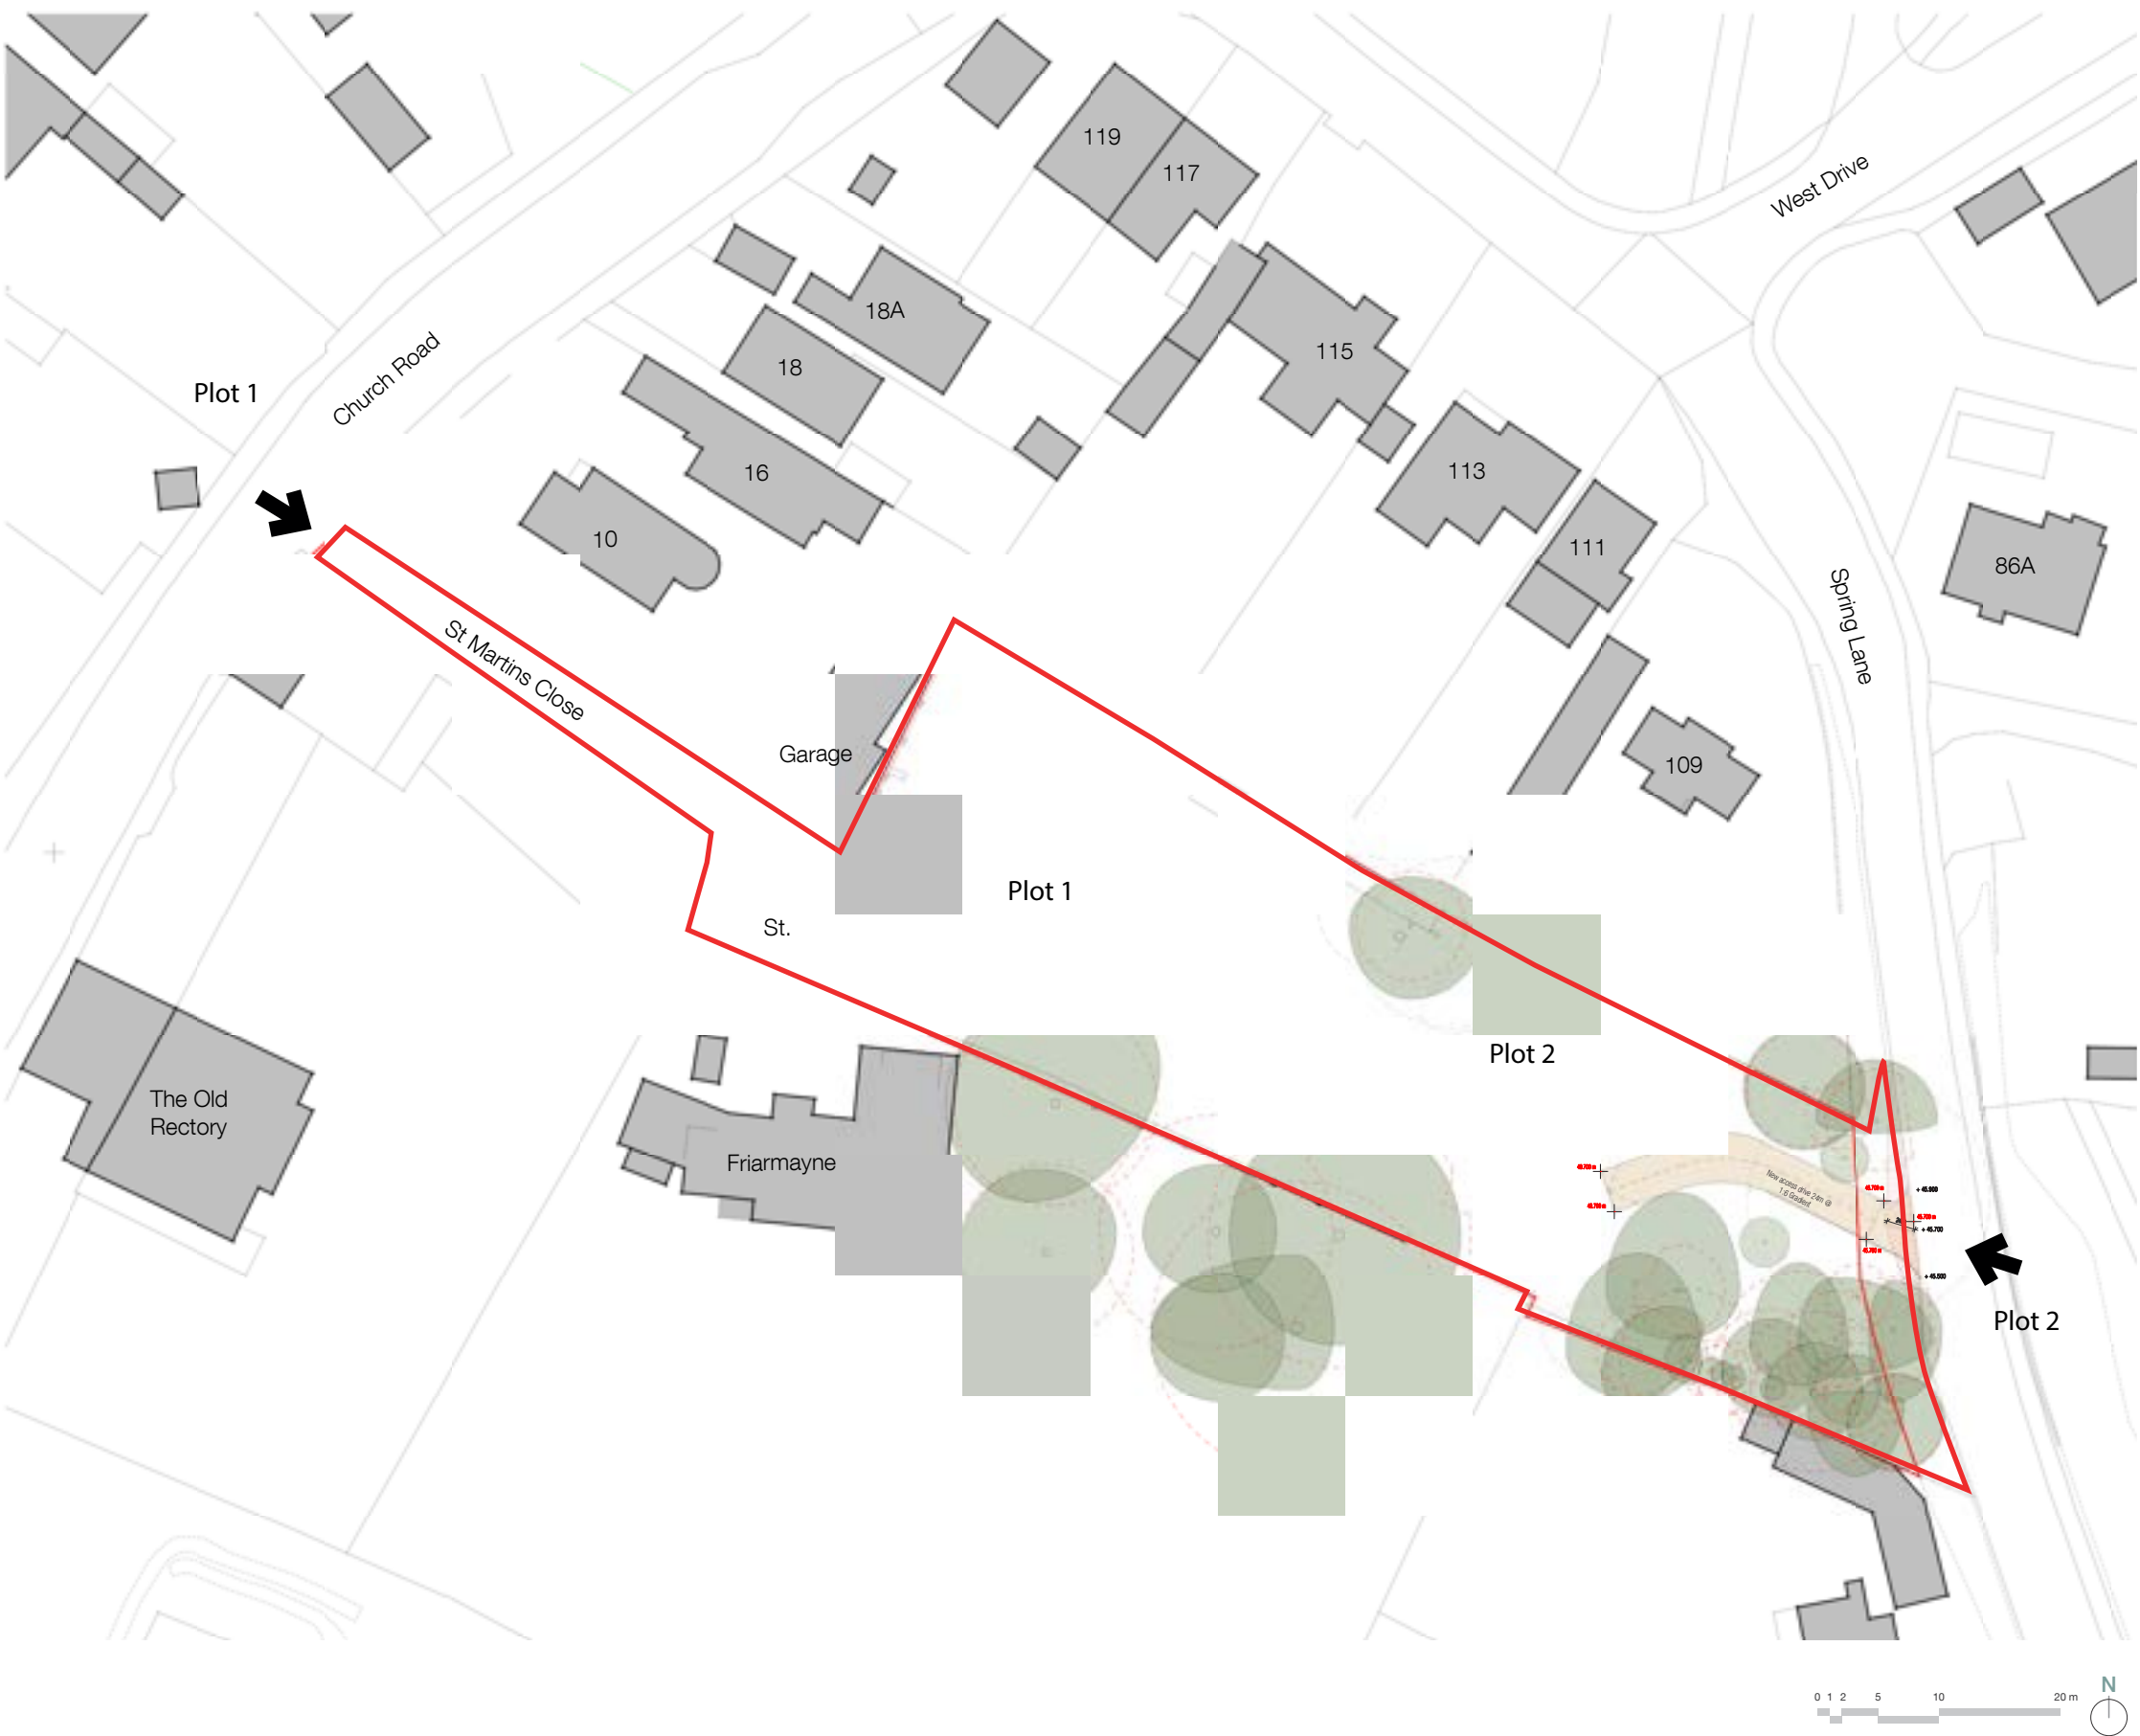
## 5.7 Site Access

The existing site access from Church Road is a single track, making it unsuitable for an additional dwelling. Therefore a new private access drive from Spring Lane is proposed to serve the second plot.

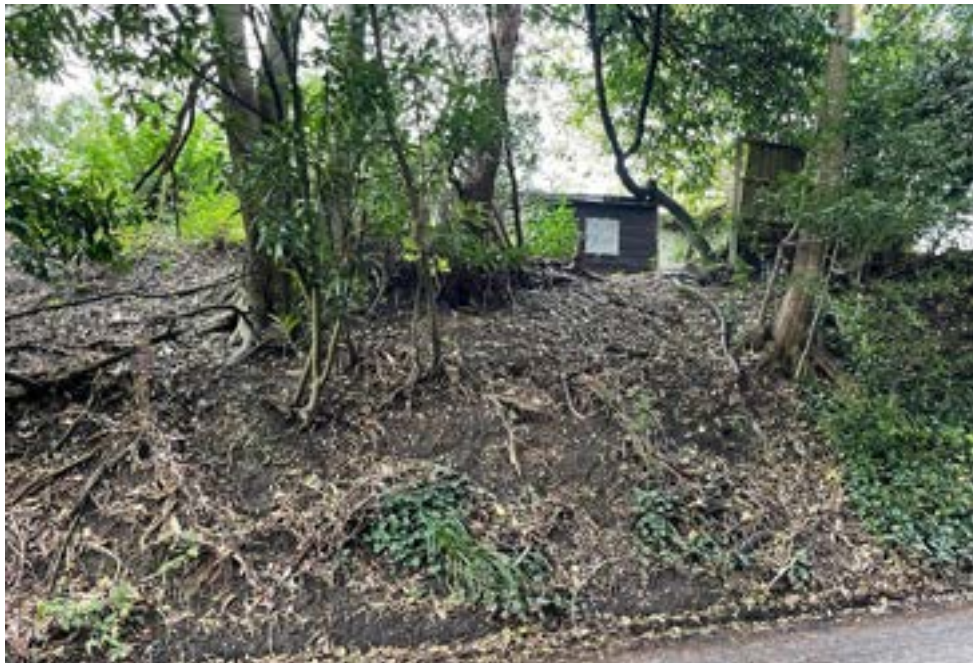
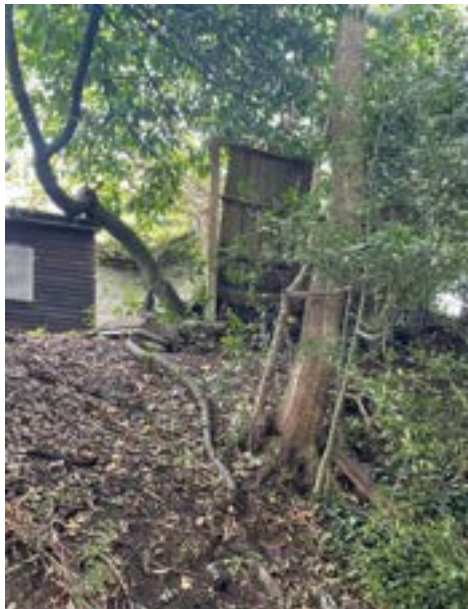
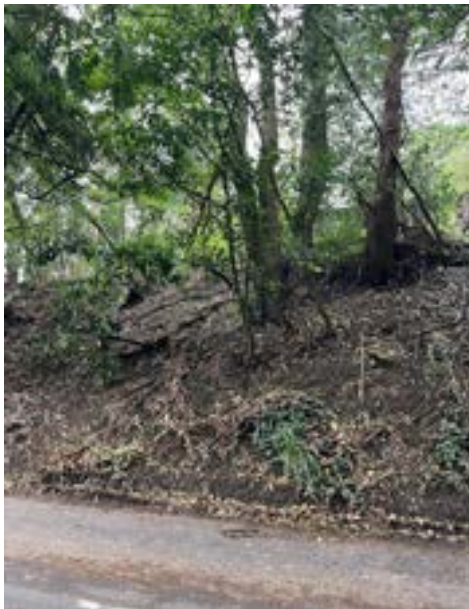
Existing Bank

The existing bank along Spring Lane is in a poor state of upkeep, with few low lying plants or shrubs and an array of dilapidated structures, such as the fence and shed pictured below. For much of its length the bank has bare earth as opposed to the verdant greenery as described in the Conservation Area Appraisal Plan. Spring Lane generally is feeling tired and neglected and is in need of a visual improvements.

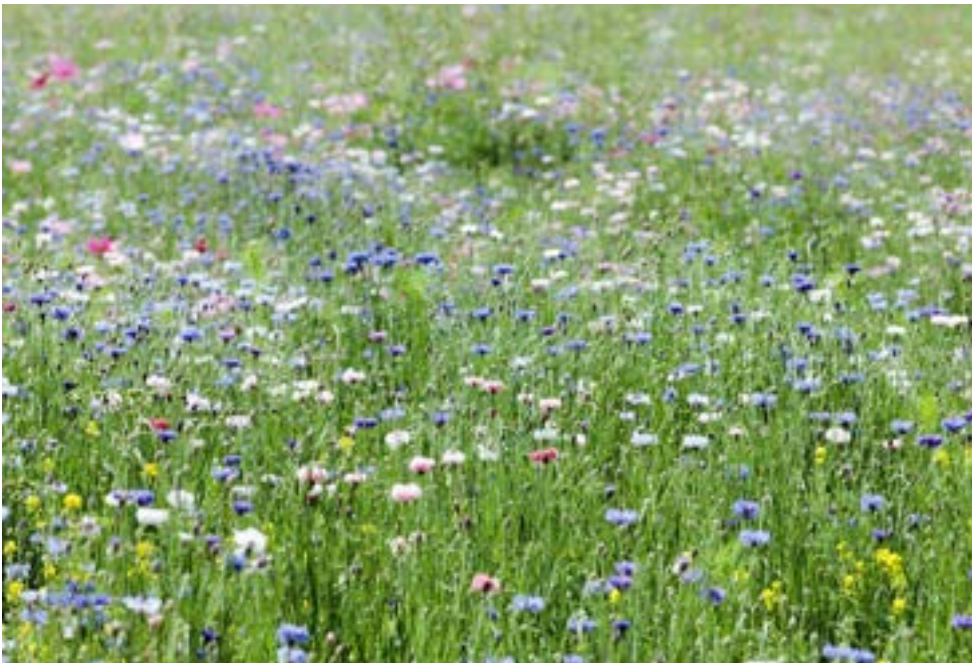
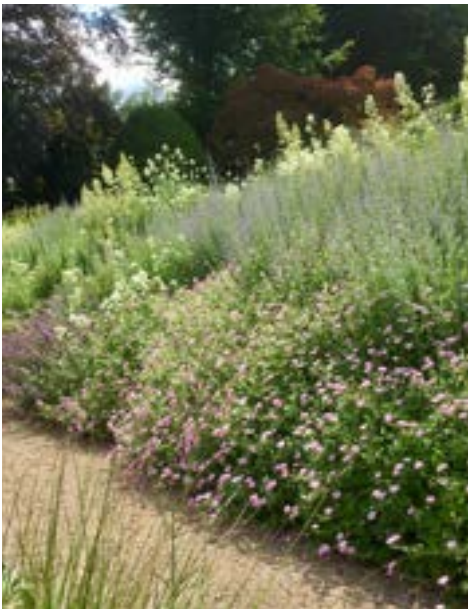
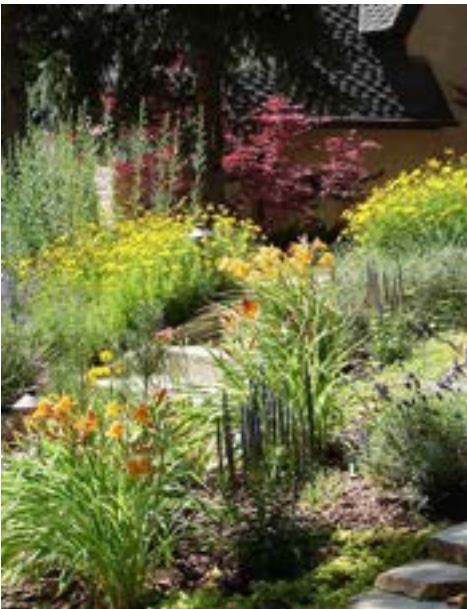
Proposed Bank

Biodiverse wildflower planting along the southern section of the bank improves the view down Spring Lane by removing the barren areas of topsoil, whilst not interfering with the root protection zones. Wildflower plug planting suitable for dappled shade cover would be provided.

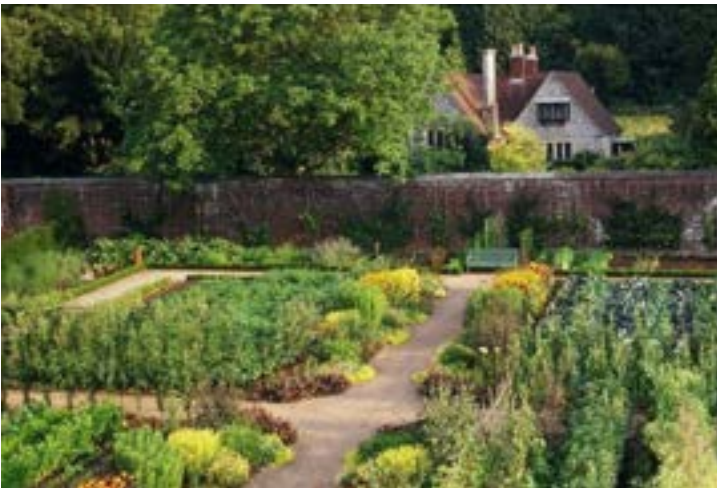
Key Axis ← →

Grid created from historic structures <----->

Derelict Greenhouse to be restored

The site layout strategy has been developed from the concept of a traditional kitchen garden grid arrangement and has been explored based on the key axis of the site generated from the significant boundary walls and the historic greenhouse.
