# St Martin's Close

Bishopstoke, SO50 6BH

Design & Access Statement | Rev B

February 2024

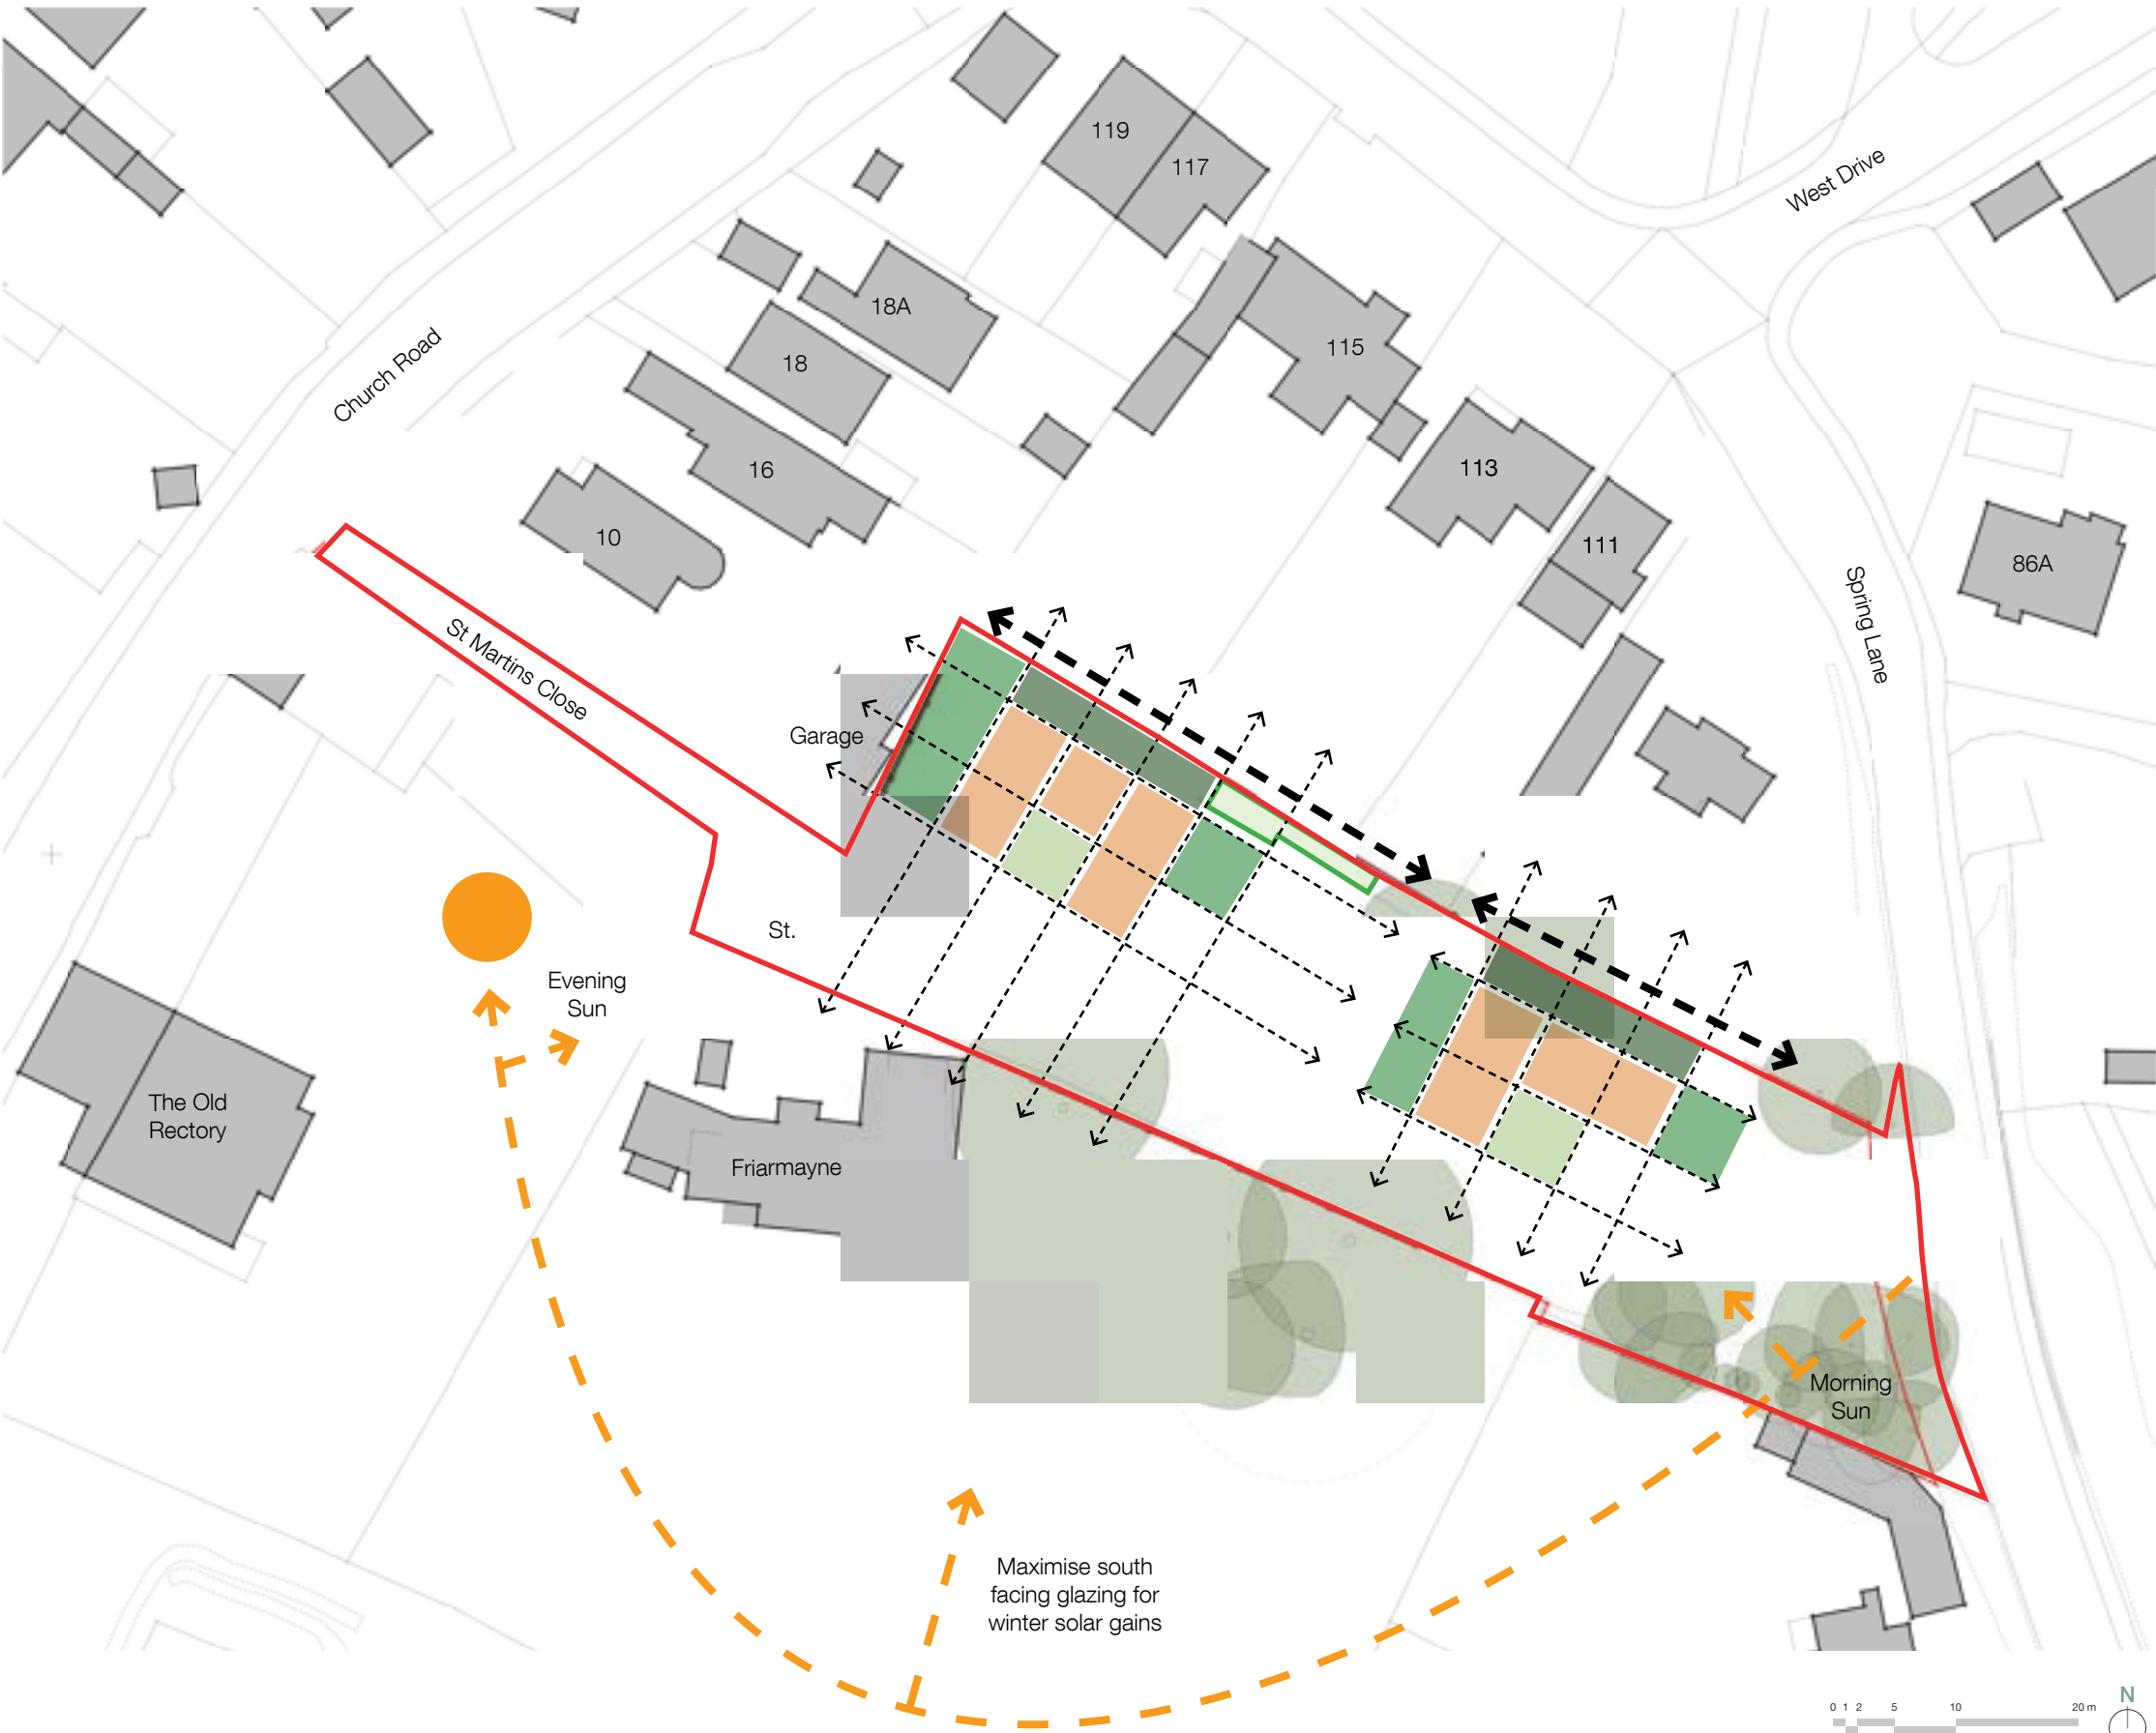
5.11 Site Strategy

A series of internal accommodation and circulation spaces have been distributed around the same grid structure, surrounding the external courtyard and kitchen gardens.

- South facing external courtyard
- East and West facing external courtyard
- North facing external courtyard
- Proposed building footprint

- Key Axis ← →
- Grid created from historic structures <----->
- Derelict Greenhouse to be restored [Green dotted box]
