## CAMPBELL ROAD, EASTLEIGH - VALIDATION REPORT

## Remediation Validation Report (R1)

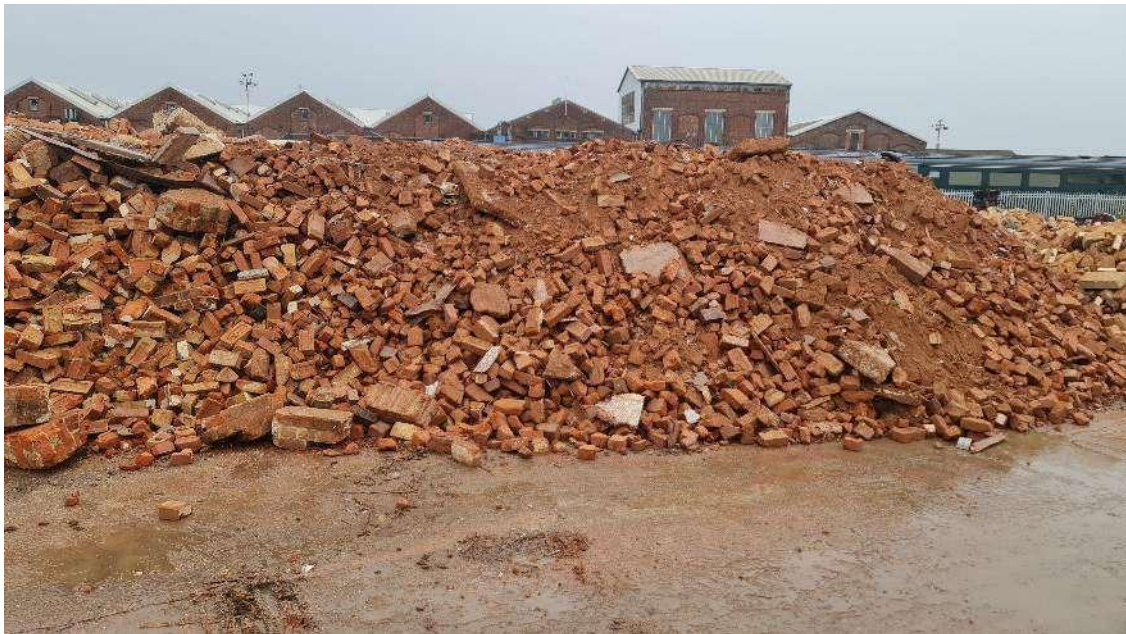
Figure 5 – Demolition Stockpile (prior to crushing).

Hardstanding areas (predominantly reinforced concrete) were broken out and stockpiled to await crushing. The underlying ashy made ground was removed and stockpiled as per the agreed stockpile management plan (see Appendices D of declared MMP), there were deviations from this in terms of actual stockpile locations, however the basic principles were adhered to. Equally, the underlying natural clay was removed to the required depth and stockpiled separately. All materials were visually inspected prior to stockpiling. During each watching brief visit, a check was carried out to ensure stockpiles were appropriately separated to avoid potential cross contamination.

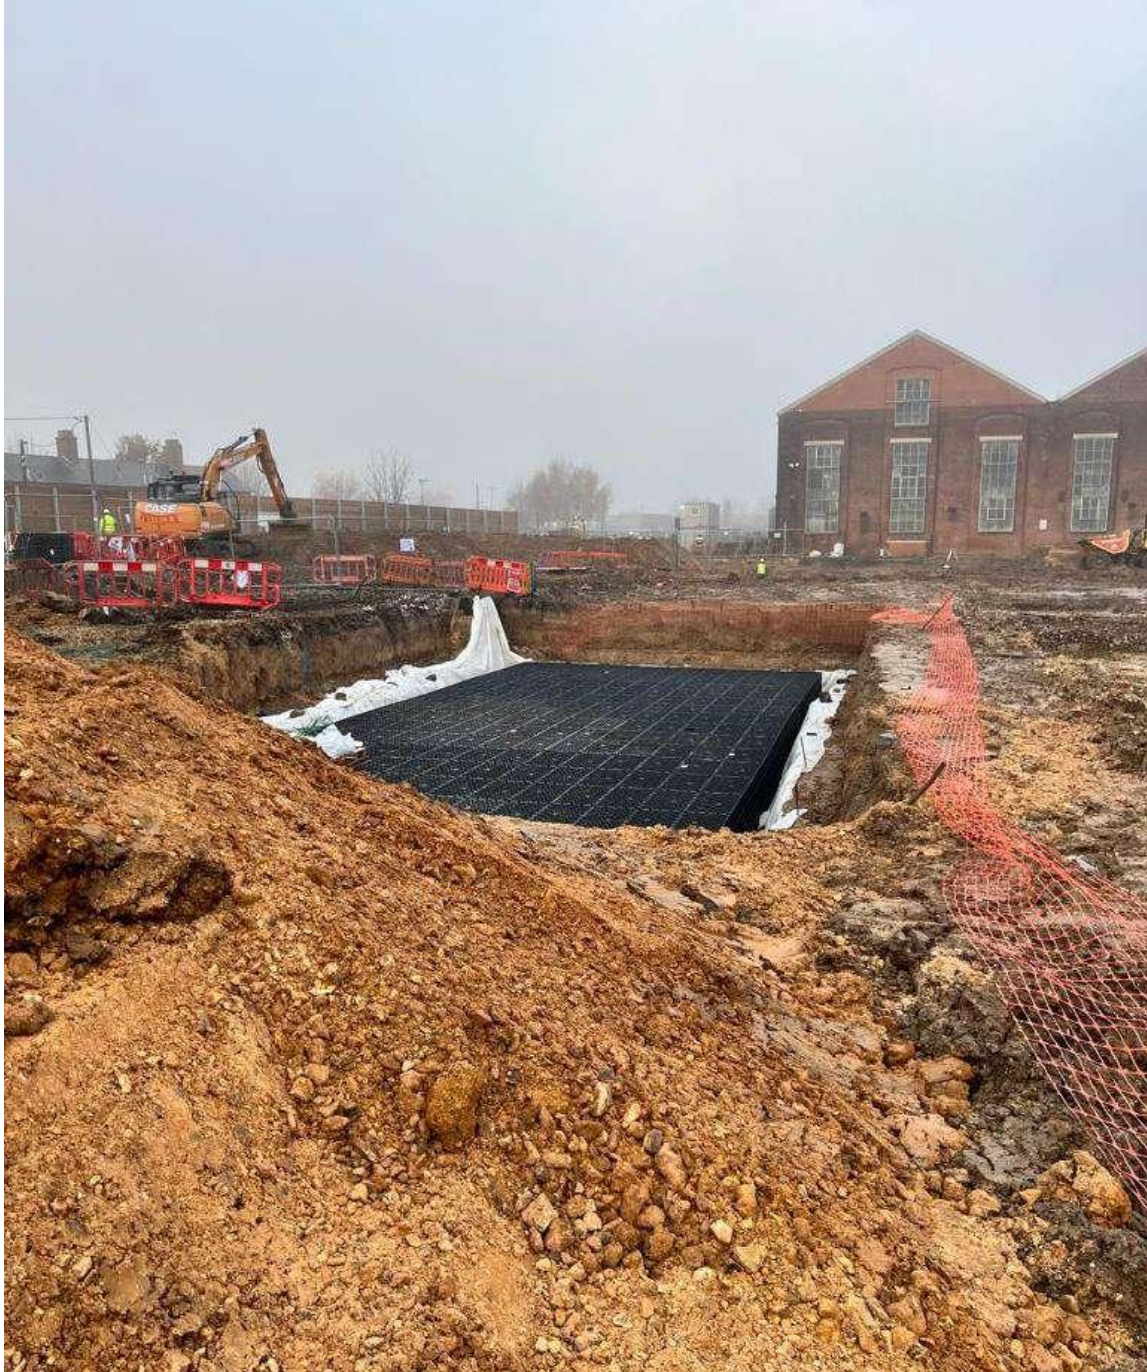
Figure 10 – Watching brief during drainage & service ducts.

Excavated soils from the installation of attenuation tanks, manhole installations, storm / foul drainage runs and required service ducts were visually inspected and stockpiled in accordance  
November 2023

with the requirements of the stockpile management plan and agreed MMP. All materials that visually appeared to be ashy in appearance was stockpiled accordingly. All natural soils / clays were stockpiled accordingly.

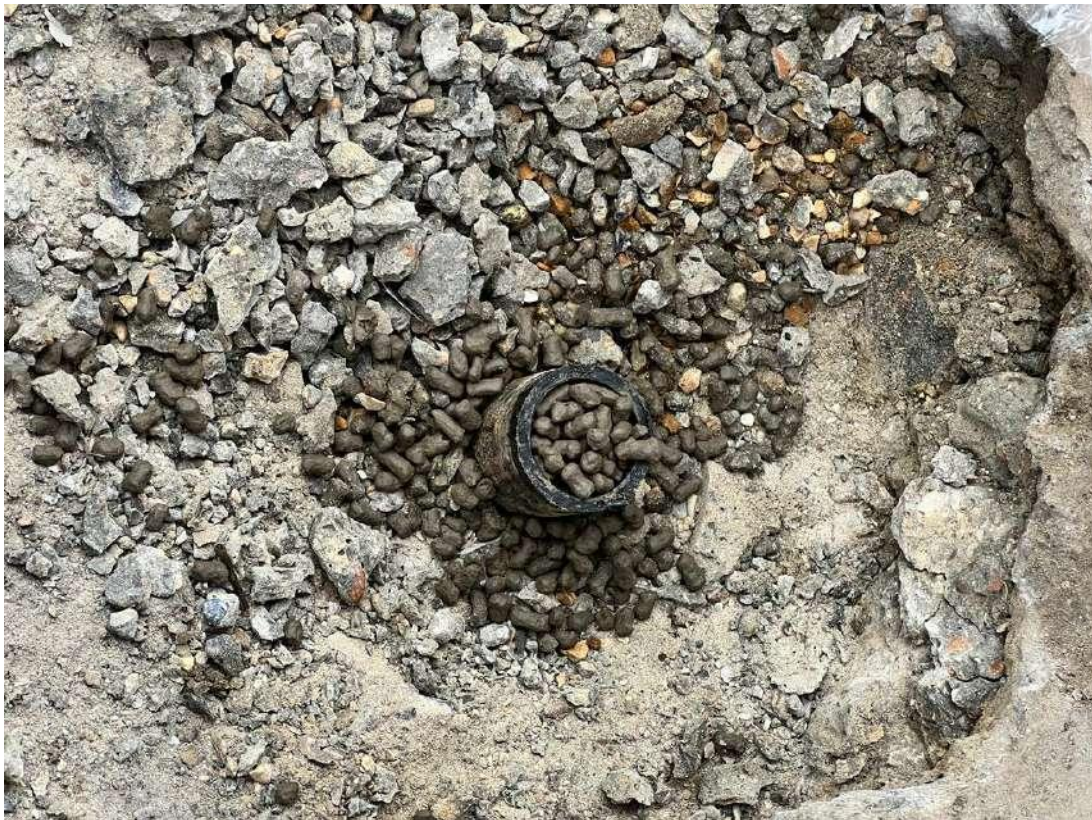
Figure 11 – Decommissioning boreholes.

A full and thorough investigation of the development site was undertaken to identify historical (deep) boreholes. These were decommissioned to ensure potential onsite contamination was not transported to the underlying aquifer (river terrace deposits) via the preferential pathway offered by the borehole installation.

The boreholes Envirotreast installed as part of the gas monitoring investigation (albeit shallow) were equally decommissioned on completion of this part of the works.

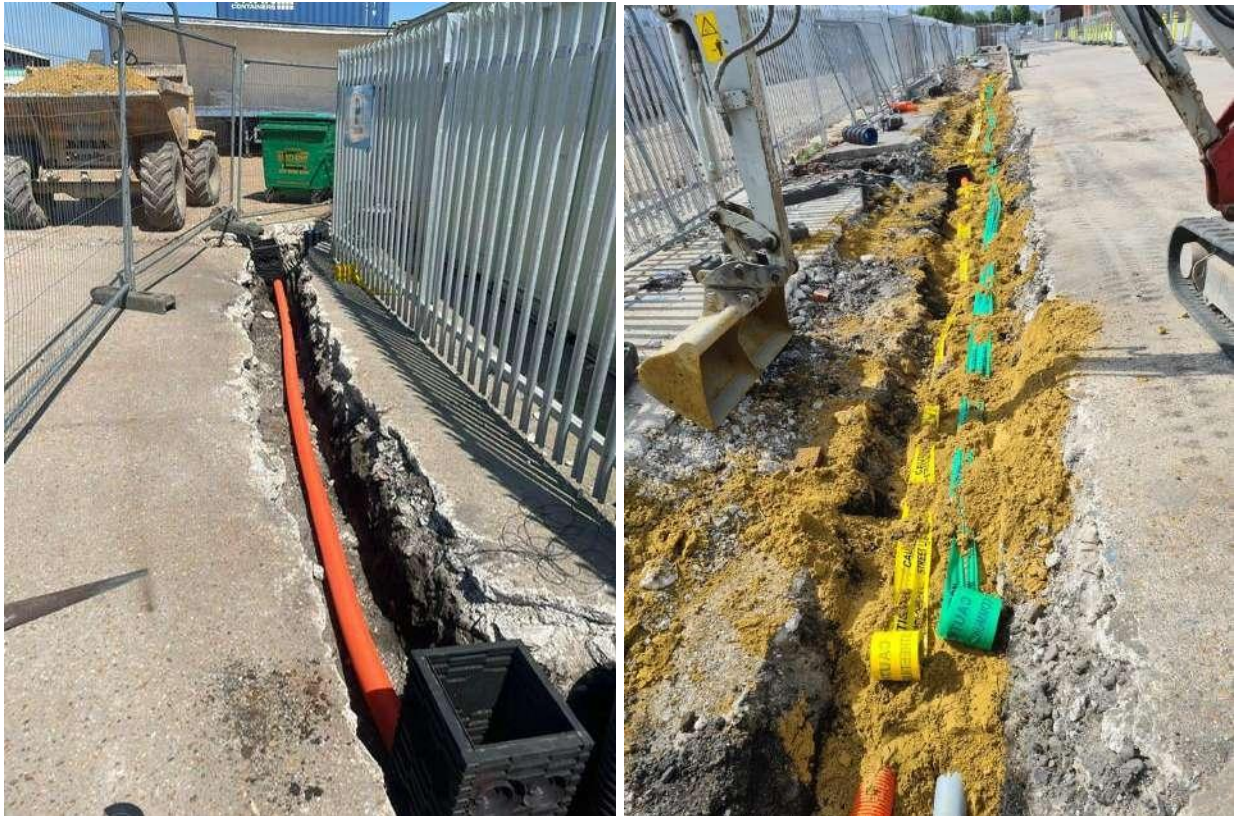
Figure 12 – Services Installation.

The excavation of service duct corridors was carried out as per the requirements / recommendations of the Delta Simons Site Investigation report.

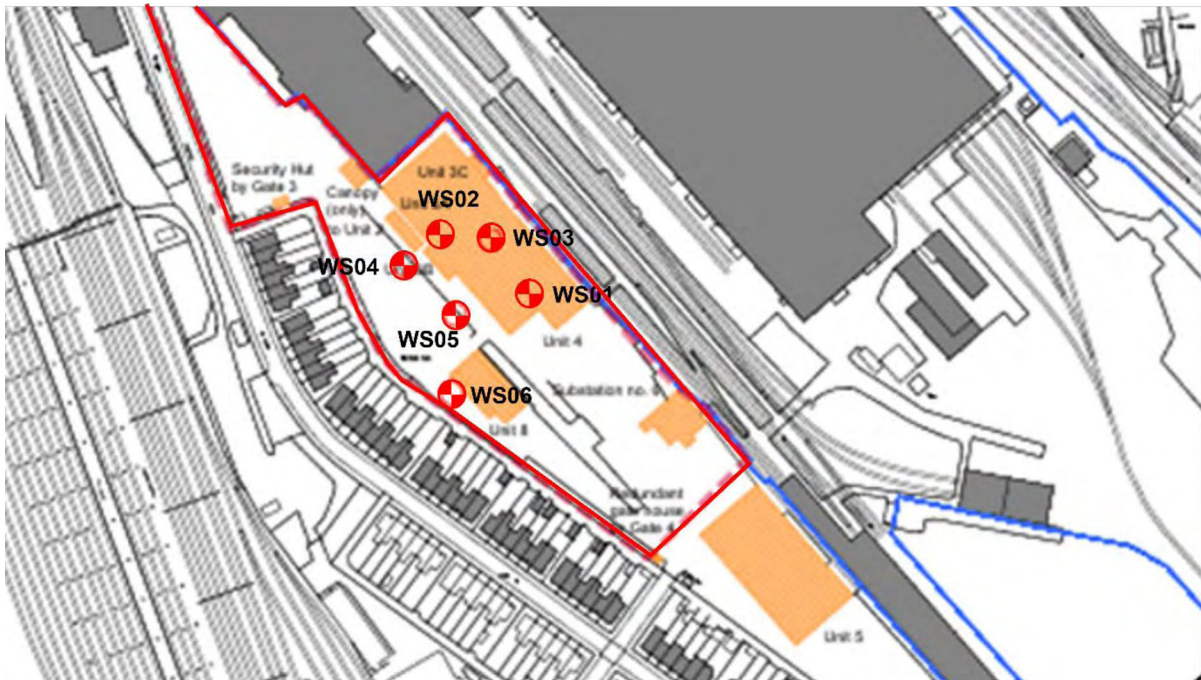
Figure 1 – Borehole locations.

The location of the windowless boreholes is shown in Figure 1 below.

Borehole were extended to prove the natural soils (clays).

No installations were required in any of the boreholes

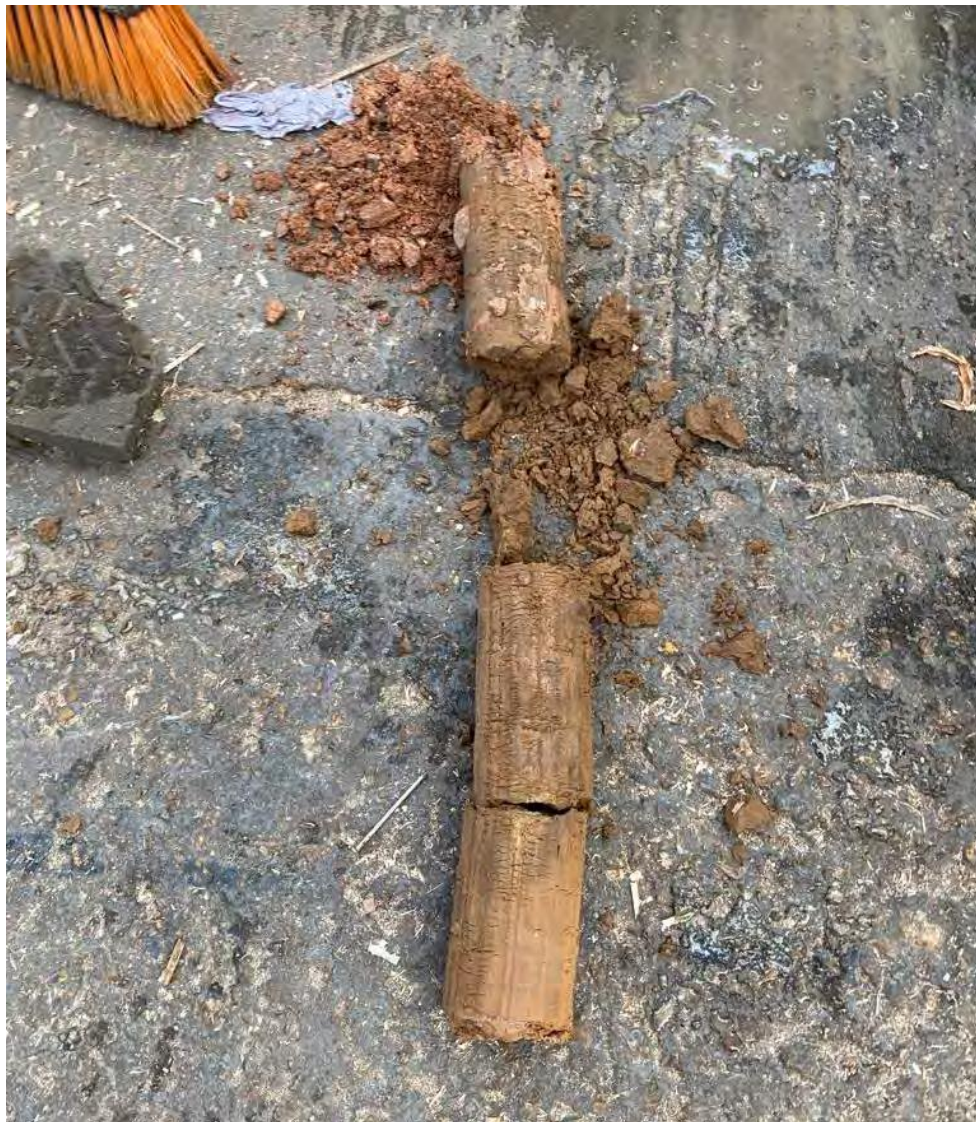
Figure 2 – Typical Natural Soils encountered.

The natural soils were anticipated, and environmental testing indicated the soils to be **non-hazardous**. Although WAC testing was not undertaken, it is anticipated that these soils would be **inert**. No asbestos was detected in any of the samples.

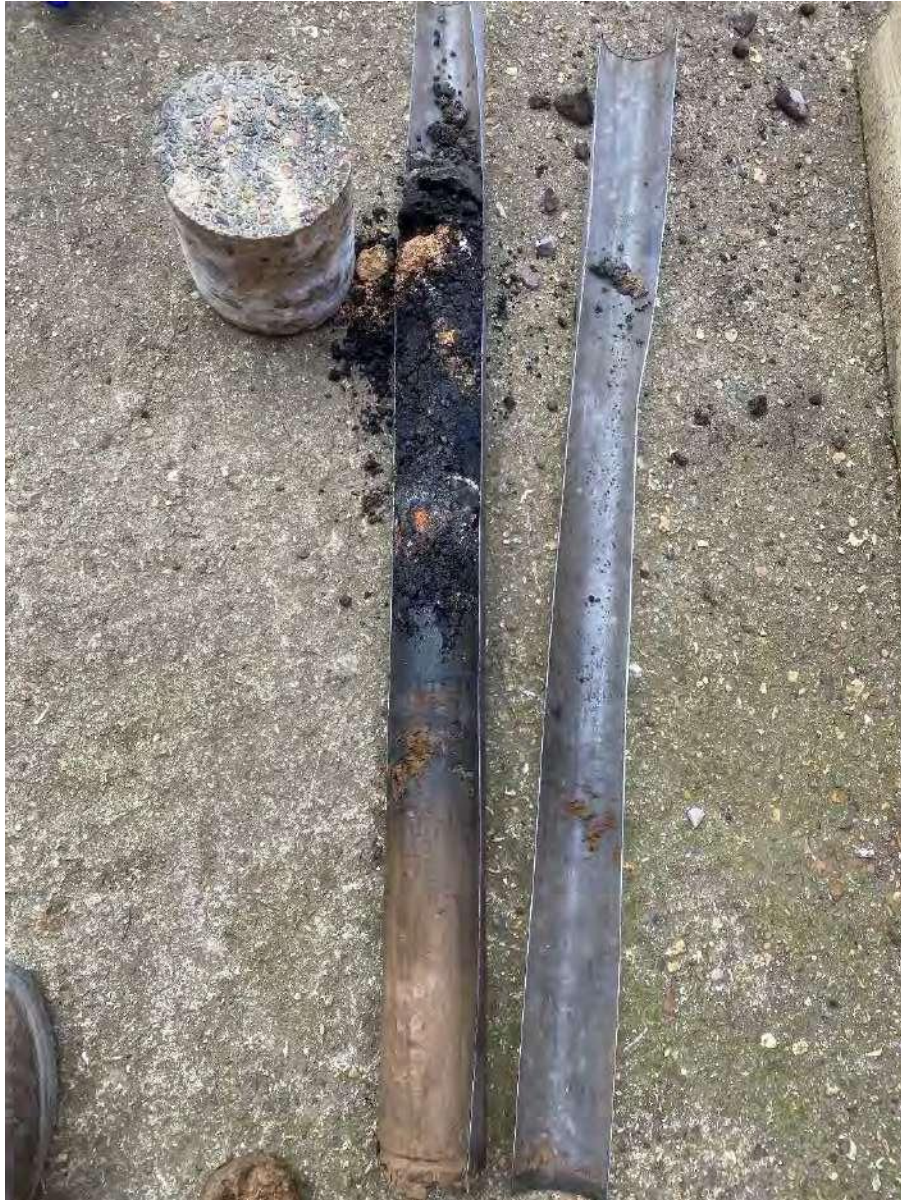
Figure 3 – Typical made ground soils encountered.

Environmental testing of the made ground indicated the soils to be **non-hazardous**. Although WAC testing was not undertaken, it is anticipated that these soils would **not** meet the **inert** thresholds. No asbestos was detected in either of the samples.
