**TREES AT BISHOPSTOKE MEMORIAL HALL, CHURCH ROAD, BISHOPSTOKE,  
EASTLEIGH, SO50 6 LQ.**

**Brief:** Re-survey trees that have a potential impact on the planned demolition of Bishopstoke Memorial Hall, Church Road, Bishopstoke, Eastleigh, SO50 6 LQ, marked on the plans provided as Area A. Comment upon their condition, suitability for retention and the impact they may have upon the proposed demolition.

# TREE SURVEY FOR BISHOPSTOKE MEMORIAL HALL, CHURCH ROAD, BISHOPSTOKE, EASTLEIGH, SO50 6LQ

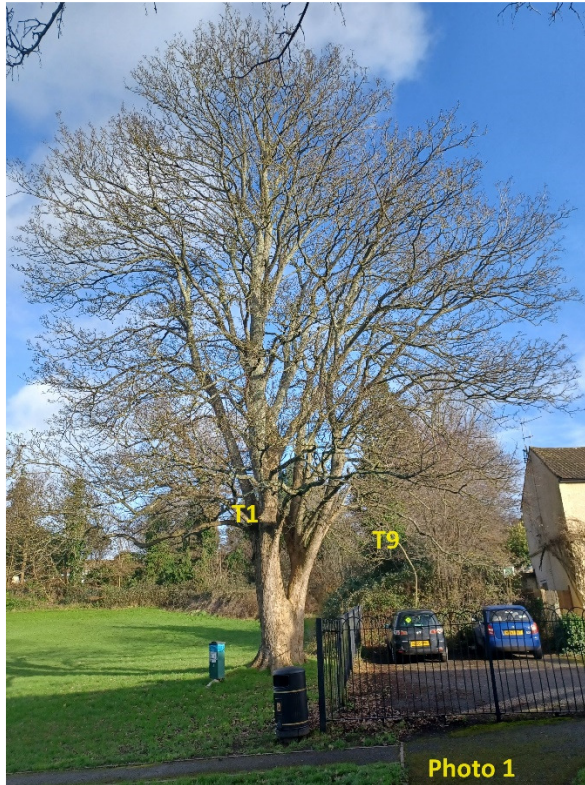
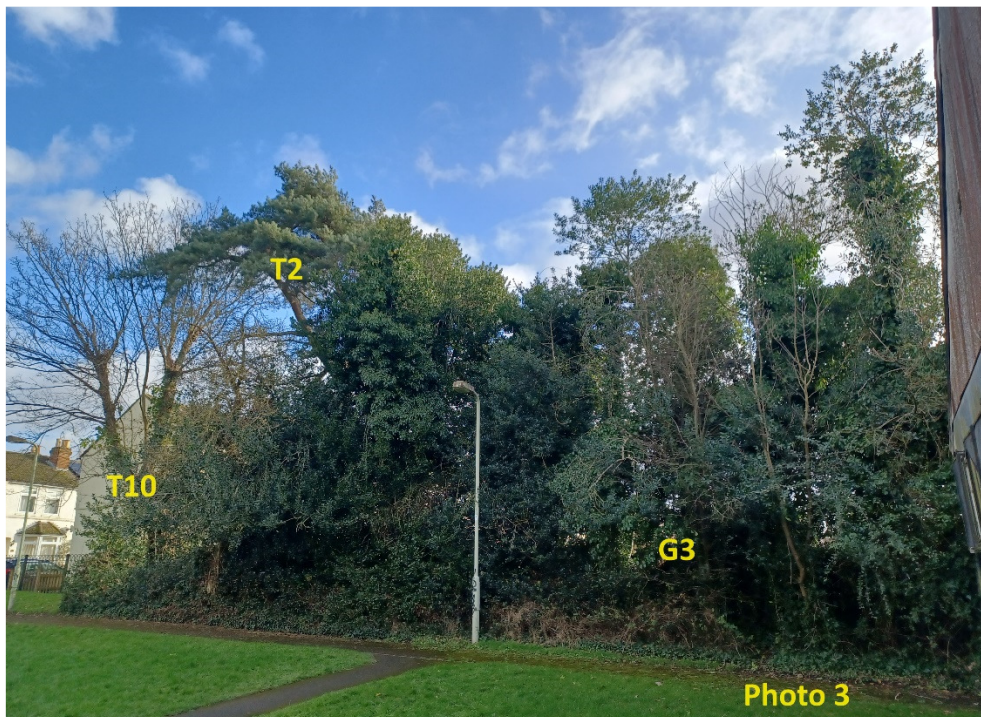
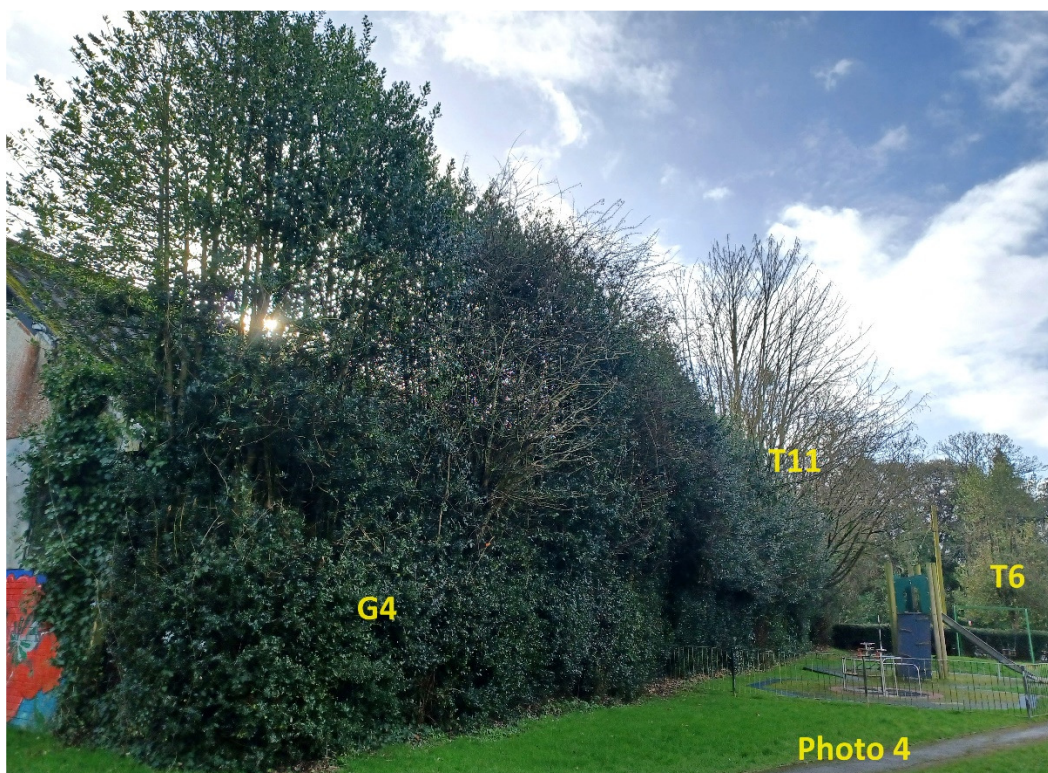
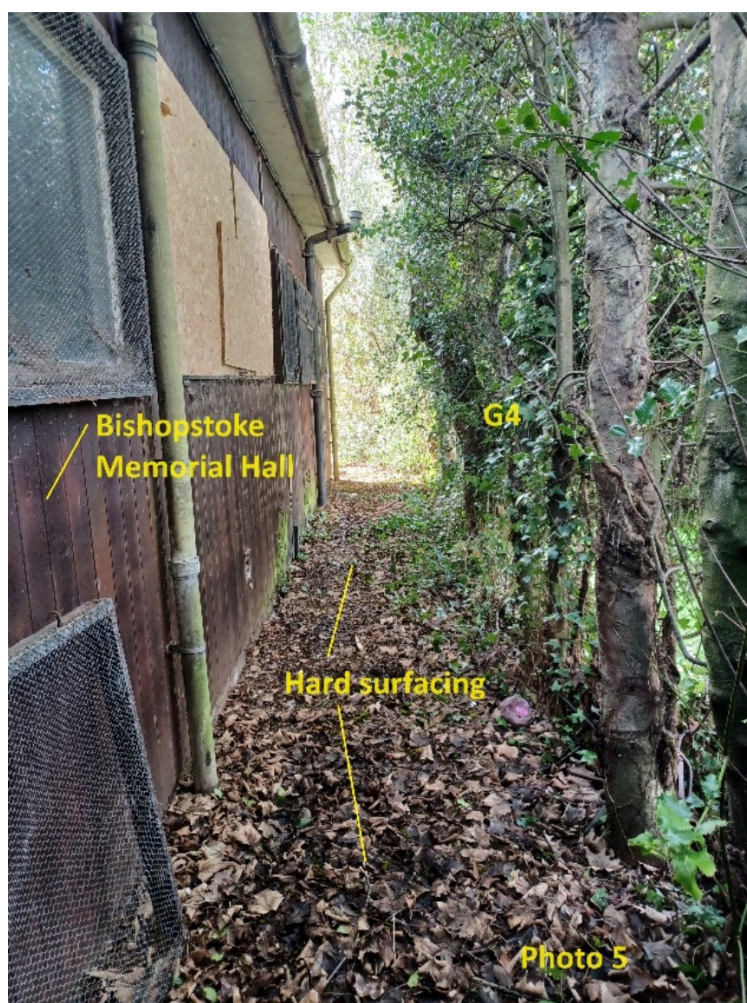
The proposed access route as shown in figure 1 is impacted by T1. Photo 1 shows the position of T1 in relation to the existing tarmacked road, a tarmacked path that leads through the recreational ground and the current grassed area that will make up the proposed access route. In order to protect the roots of T1, a heavy-duty ground protection mat will need to be installed within the RPA of T1 in order to prevent root damage. The ground protection matting will need to be to a specification that will be able to protect the tree roots from compaction and damage from the heavy machinery that will be entering the site. Heras fencing, as shown in figure 3 will also need to be erected as shown in drawing 5332. This is to prevent the storage of demolition equipment and materials, and an increased footfall through the RPA. As highlighted in figure 1, ground mats for the diversion of the existing path will be placed down to protect the surface of the recreation area and the RPA of T1. The Heras fencing is there to minimise the impact on T1, from the increased footfall within that part of the RPA and to reduce those that wish to stray from the path within the short section within the RPA.
