## Appendix 2A - Ross Blakemore Proof of Evidence

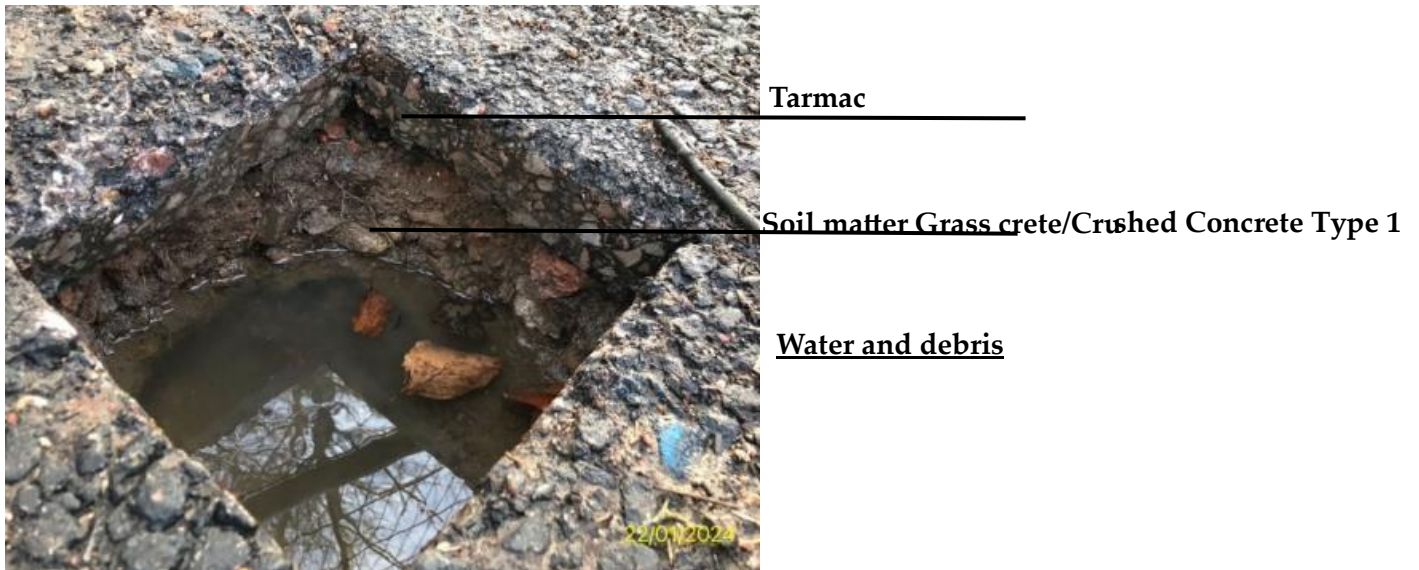
### Image 3: Trial Hole 2 - Annotated

Image 3: Trial Hole 2 tarmac layer and below this was a single layer of stone hardcore, the geotextile membrane is not visible in this photo because of the water.
