## Appendix 4A - Ross Blakemore Proof of Evidence

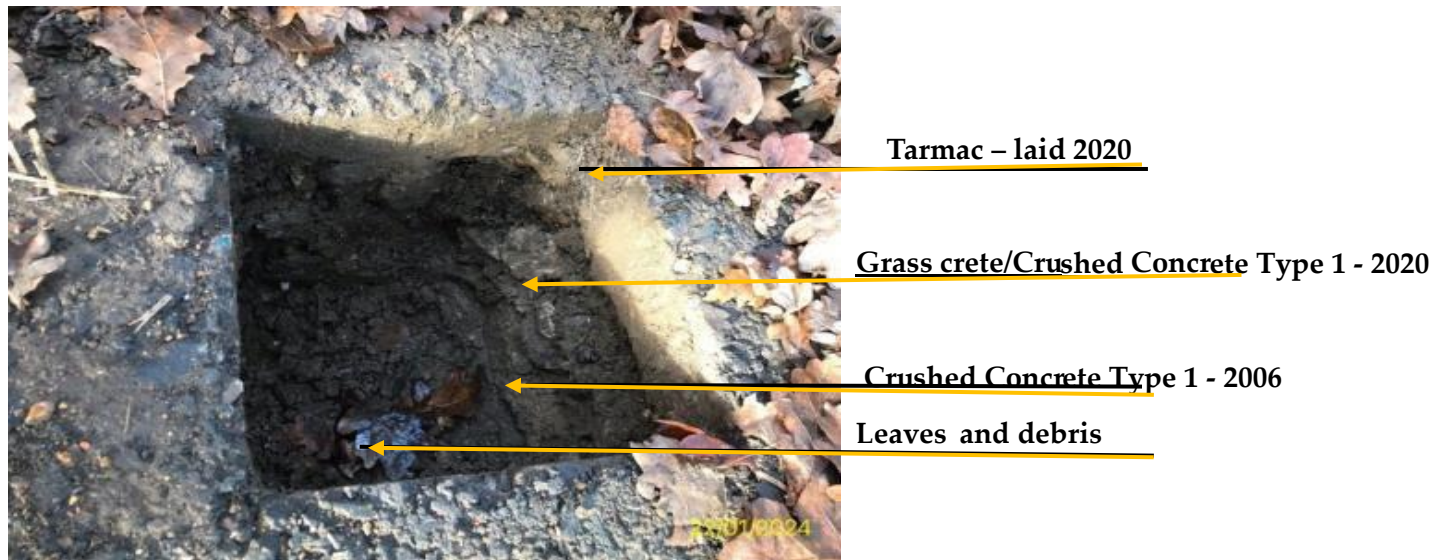
Image 5: Trial Hole 4 – Annotated

Image 5: Trial Hole 4 tarmac layer and below this was a single layer of stone hardcore, the geotextile membrane is not visible in this photo because of soil that has buried it over time.
