**Appendix 1A - Ross Blakemore Proof of Evidence**

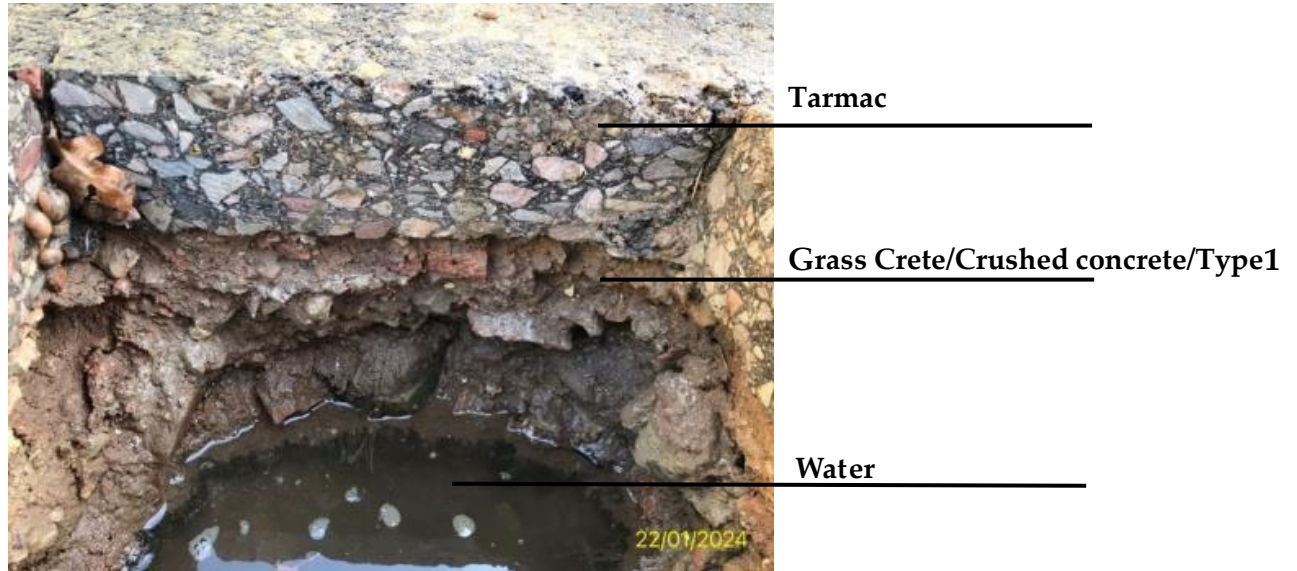
**Image 2: Trial Hole 1 - Annotated**

**Image 2: Trial Hole 1 – tarmac layer and below this was a single layer of stone hardcore, the geotextile membrane is visible in this photo just below the waterline.**
