## **Preliminary bat roost assessment**

| Site Location | 38 Yardley Road, Hedge End, Hampshire, SO30 0HQ |
| Document reference | CE4495 |

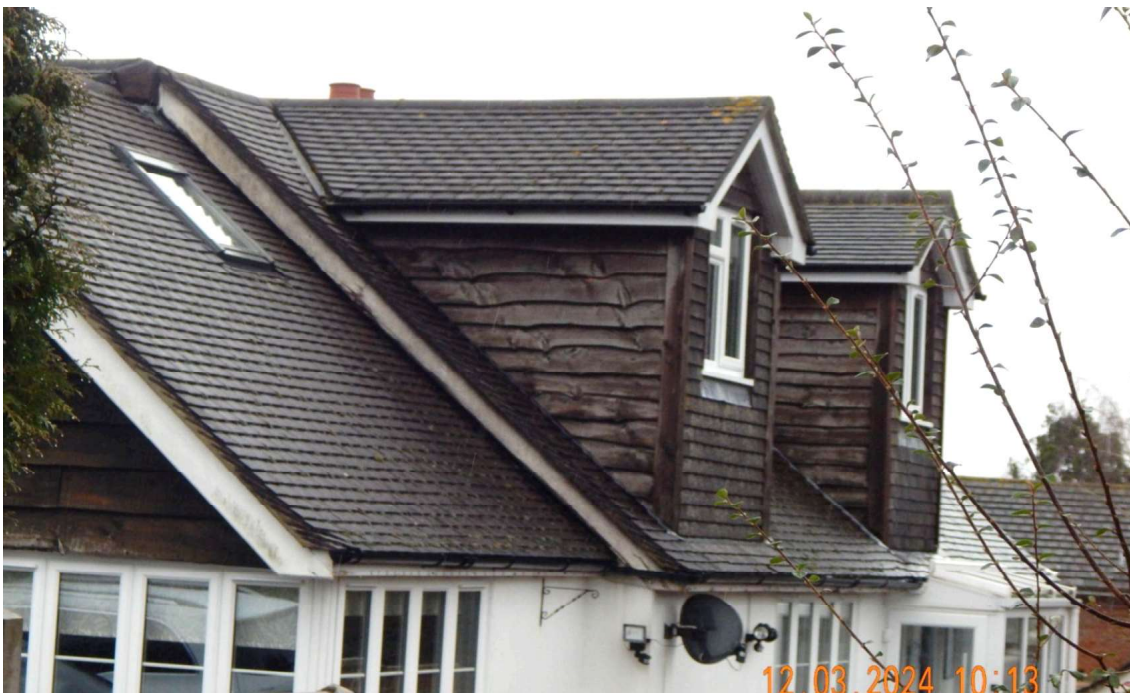
Image 2 – South facing elevation of the property offering vertical timber claddings to the former windows where gaps of adequate proportions to offer likely shelter for crevice dwelling bats were observed

- 6.6** In line with best practice survey guidelines, a structure that has demonstrated moderate value must have a further two emergence surveys to rule out or confirm activity from bats. These survey should be carried out within the recommended survey season from May to September with at least one of these visits during the optimal time of May to August.

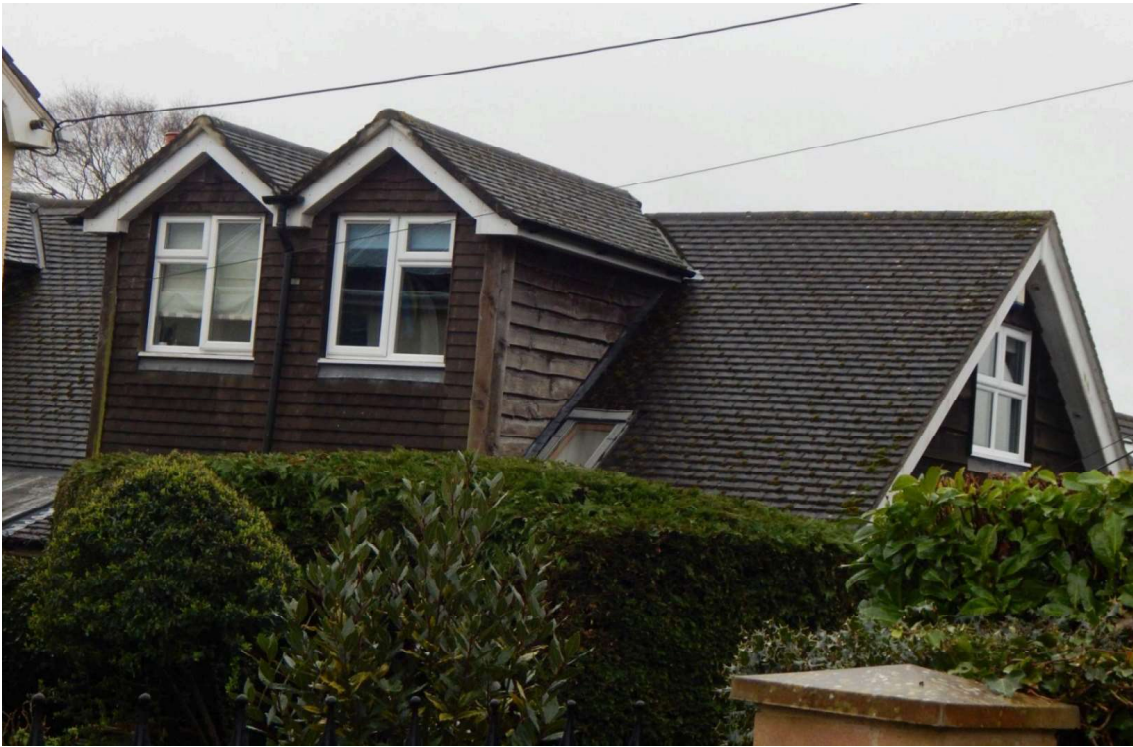
Image 3 – North facing elevation of the property offering vertical timber claddings to the former windows where gaps of adequate proportions to offer likely shelter for crevice dwelling bats were observed

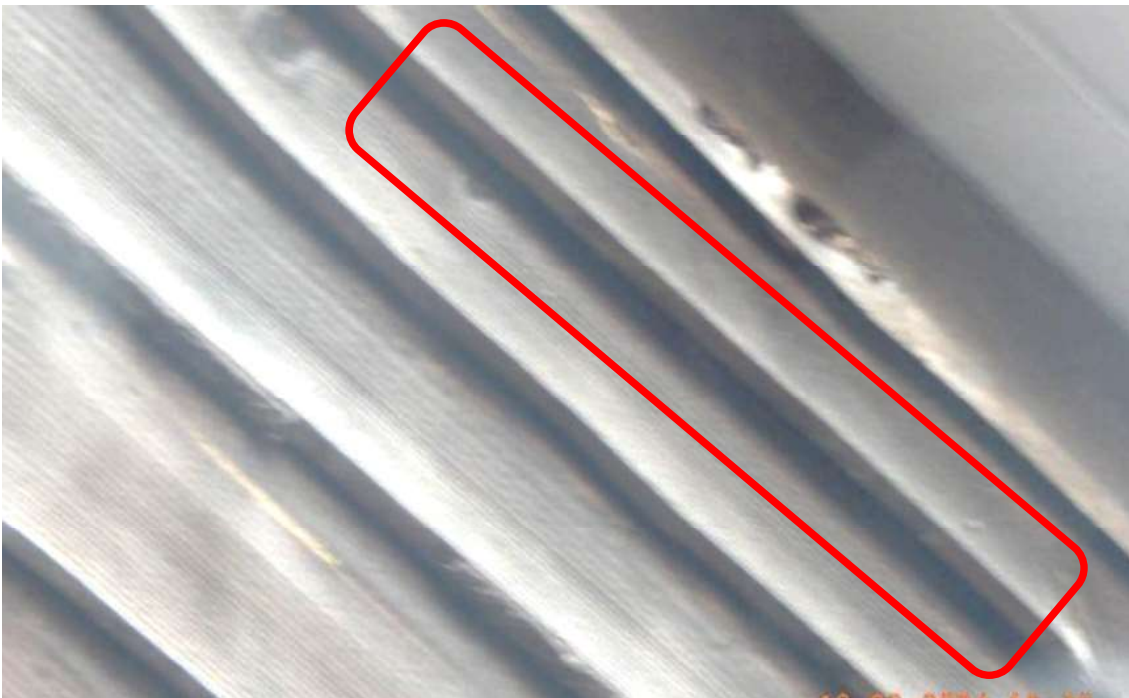
Image 4 – Example of gaps within the timber claddings as per images two and three

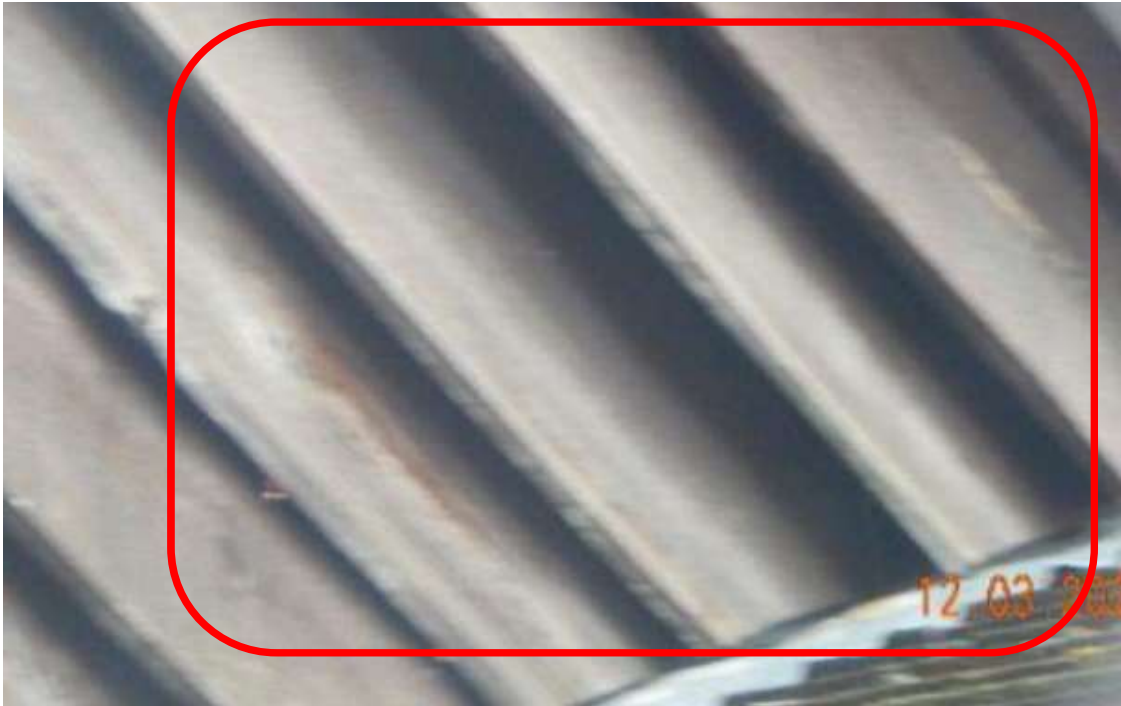
Image 5 – Example of gaps within the timber claddings as per images two and three

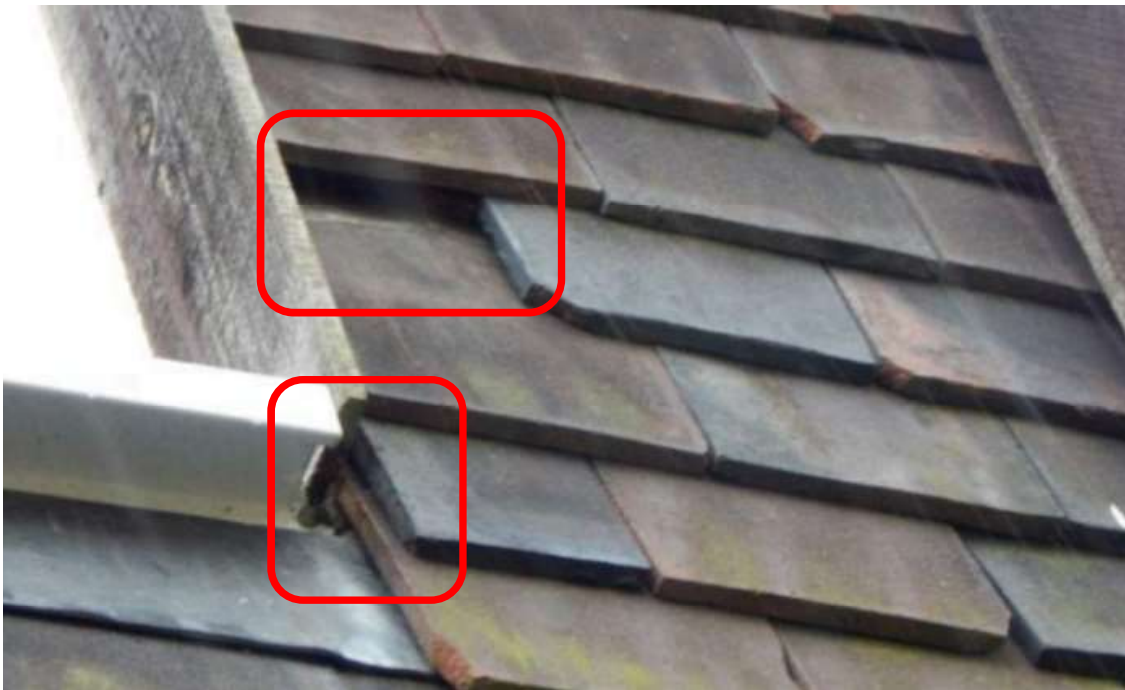
Image 6 – Evidence of gaps within the vertical hanging tiles to the dormer windows which look to offer further roosting features of value to crevice dwelling bats

**6.8** It is advised that no further works take place to the identified areas of value to bats at this stage as this may cause disturbance to bats and their roosts. see section 2.0 of this report

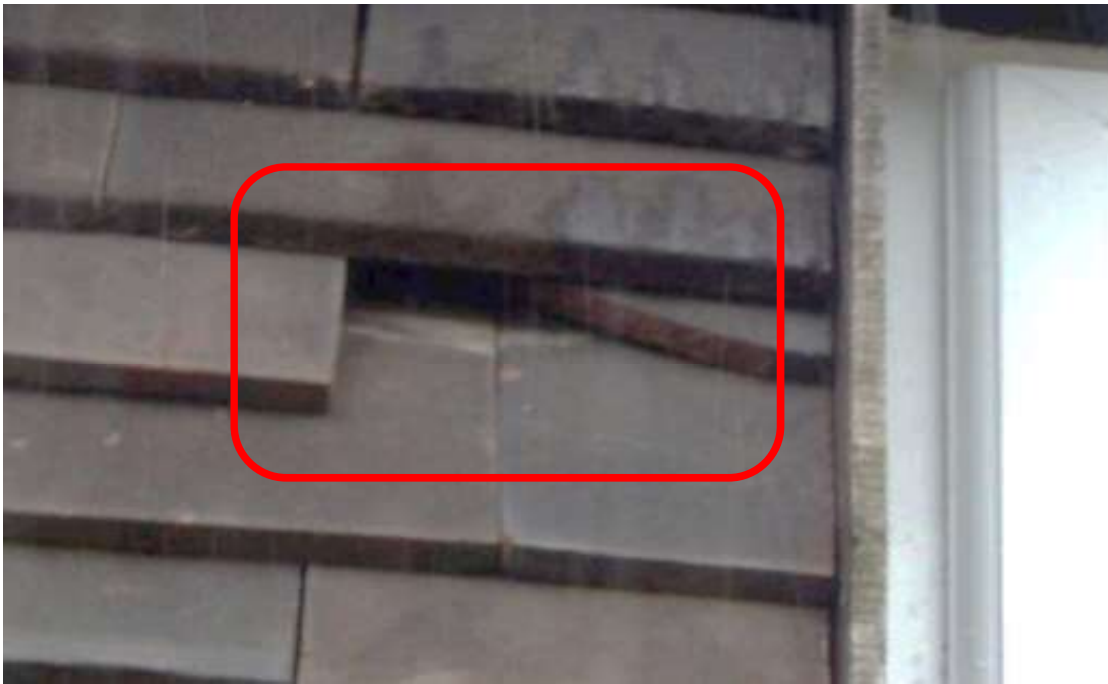
Image 7 – Evidence of gaps within the vertical hanging tiles to the dormer windows which look to offer further roosting features of value to crevice dwelling bats

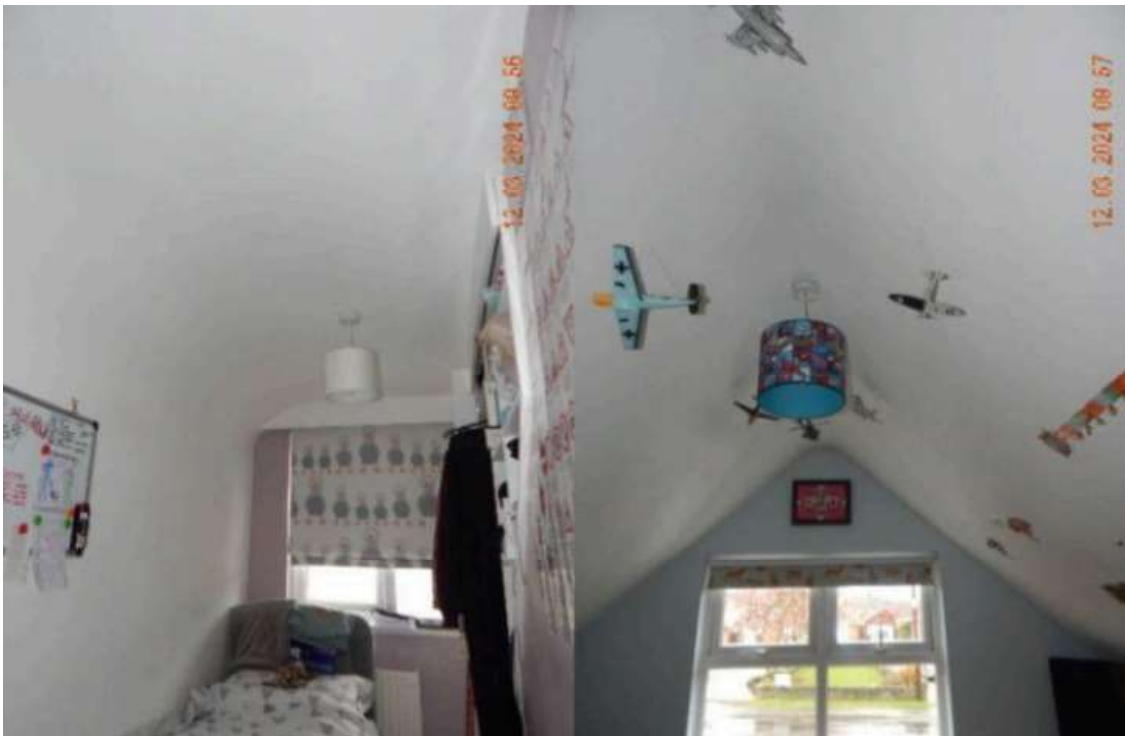
| Internal | Features of value to bats | Notes |
|---|---|---|
| Membrane coverings | Unknown | The 1 <sup>st</sup> floor areas are vaulted below the roof coverings and covered by plasterboard. |

Image 8 – Internal views from within the upper floor areas of the property offering no enclosed roof void spaces

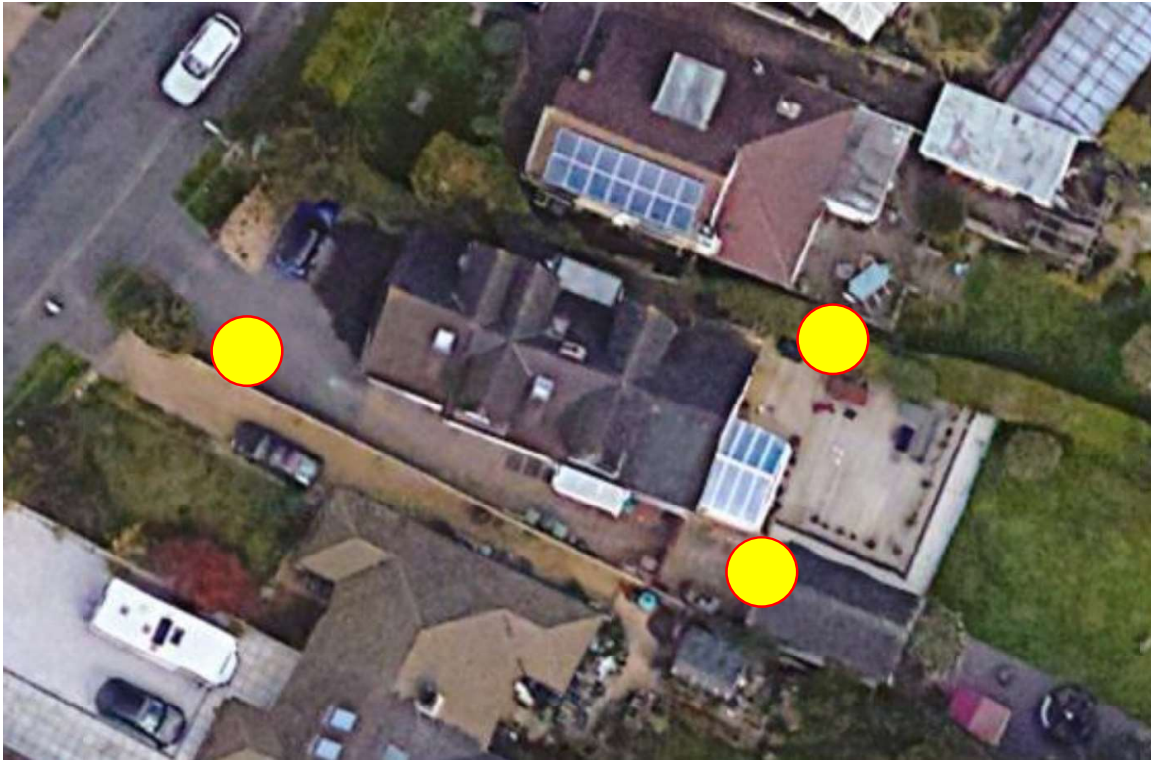
#### Appendix 4: Emergence Survey Location Points

Below site view to show suitable surveyor location points during each emergence survey to maintain visibility of the property.

In line with best practice survey guidelines, a total of three surveyors will be required to visually cover all elevations of the structure during each emergence survey.
