# Arboricultural Impact Assessment and Method Statement

**Client:** PEP

**Site:** Bubbs Lane Cycleway  
Horton Heath  
SO30 2ND

**Reference:** TCTC-18999

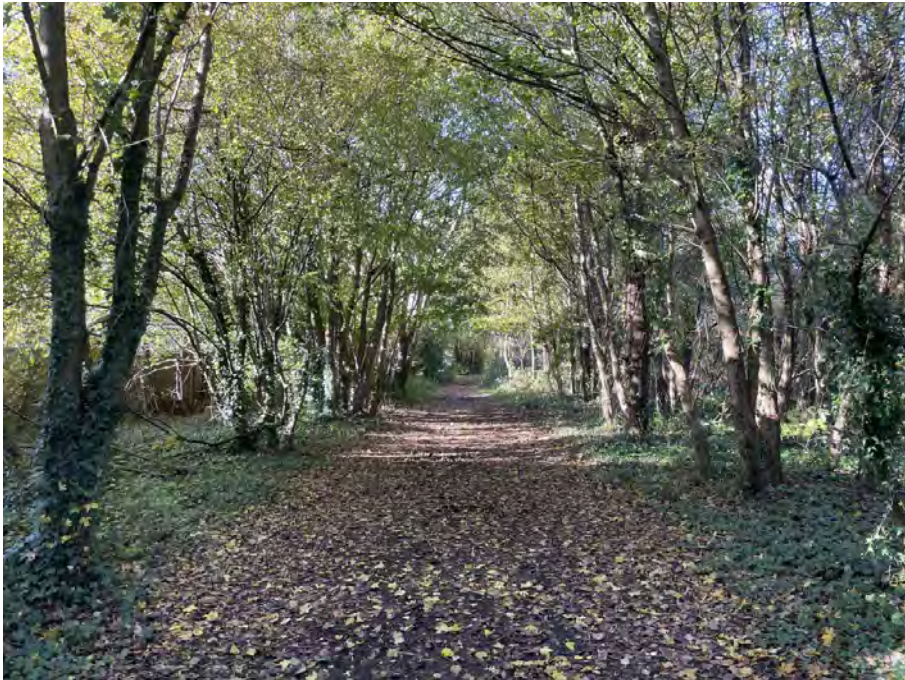
TC.1 (06.11.23) Northern end, rear of residential properties

Park. Trees consist mainly of those from young to early maturity with occasional older trees. The track is currently informal and quite narrow in places.

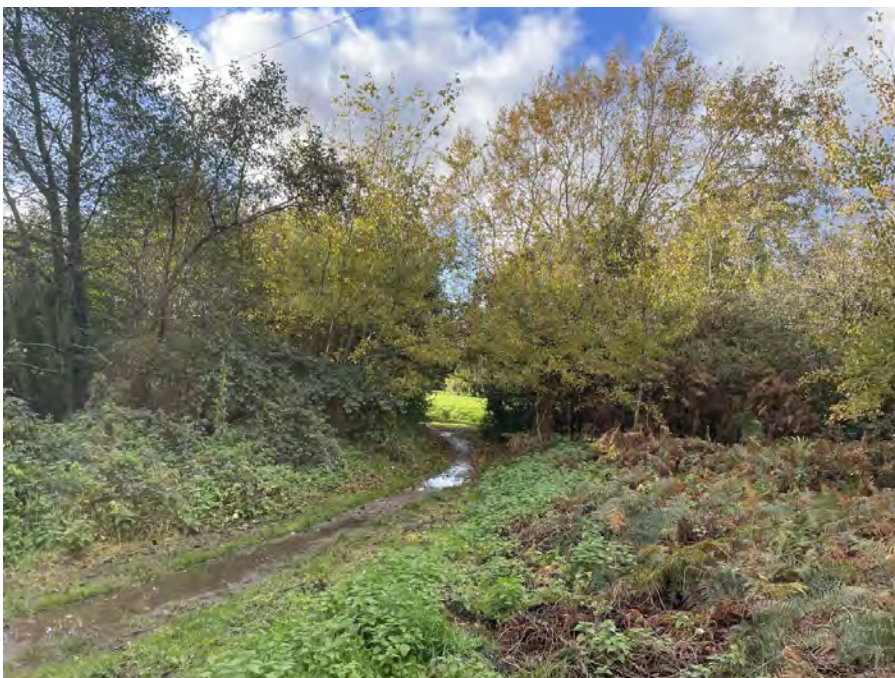
TC.2 (06.11.23) Central area

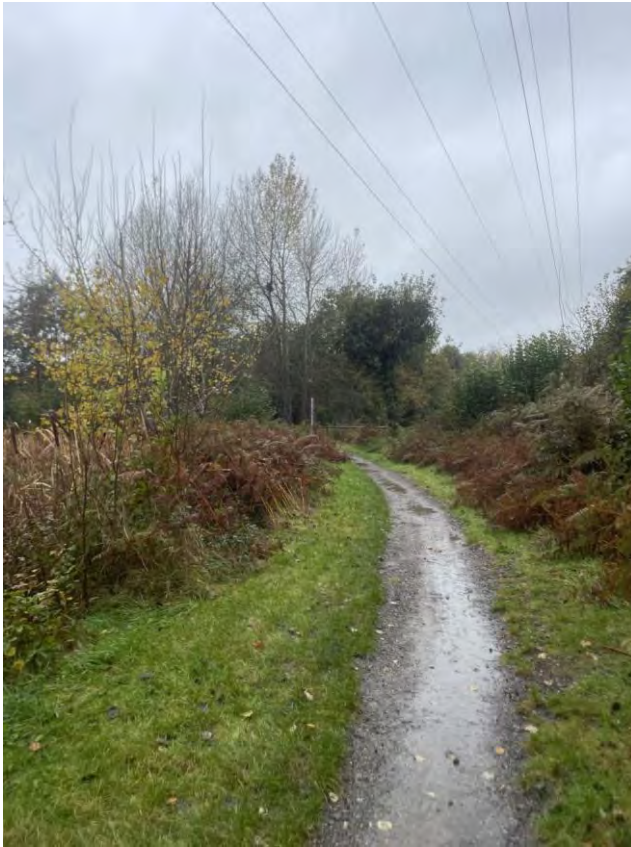
TC.3 (06.11.23) Towards southern area
